AMAFA PHOTOGRAPHIC REPORT FOR PROPOSED ADDITIONS AND ALTERATIONS TO 1236 SOUTH COAST ROAD, MOBENI, DURBAN

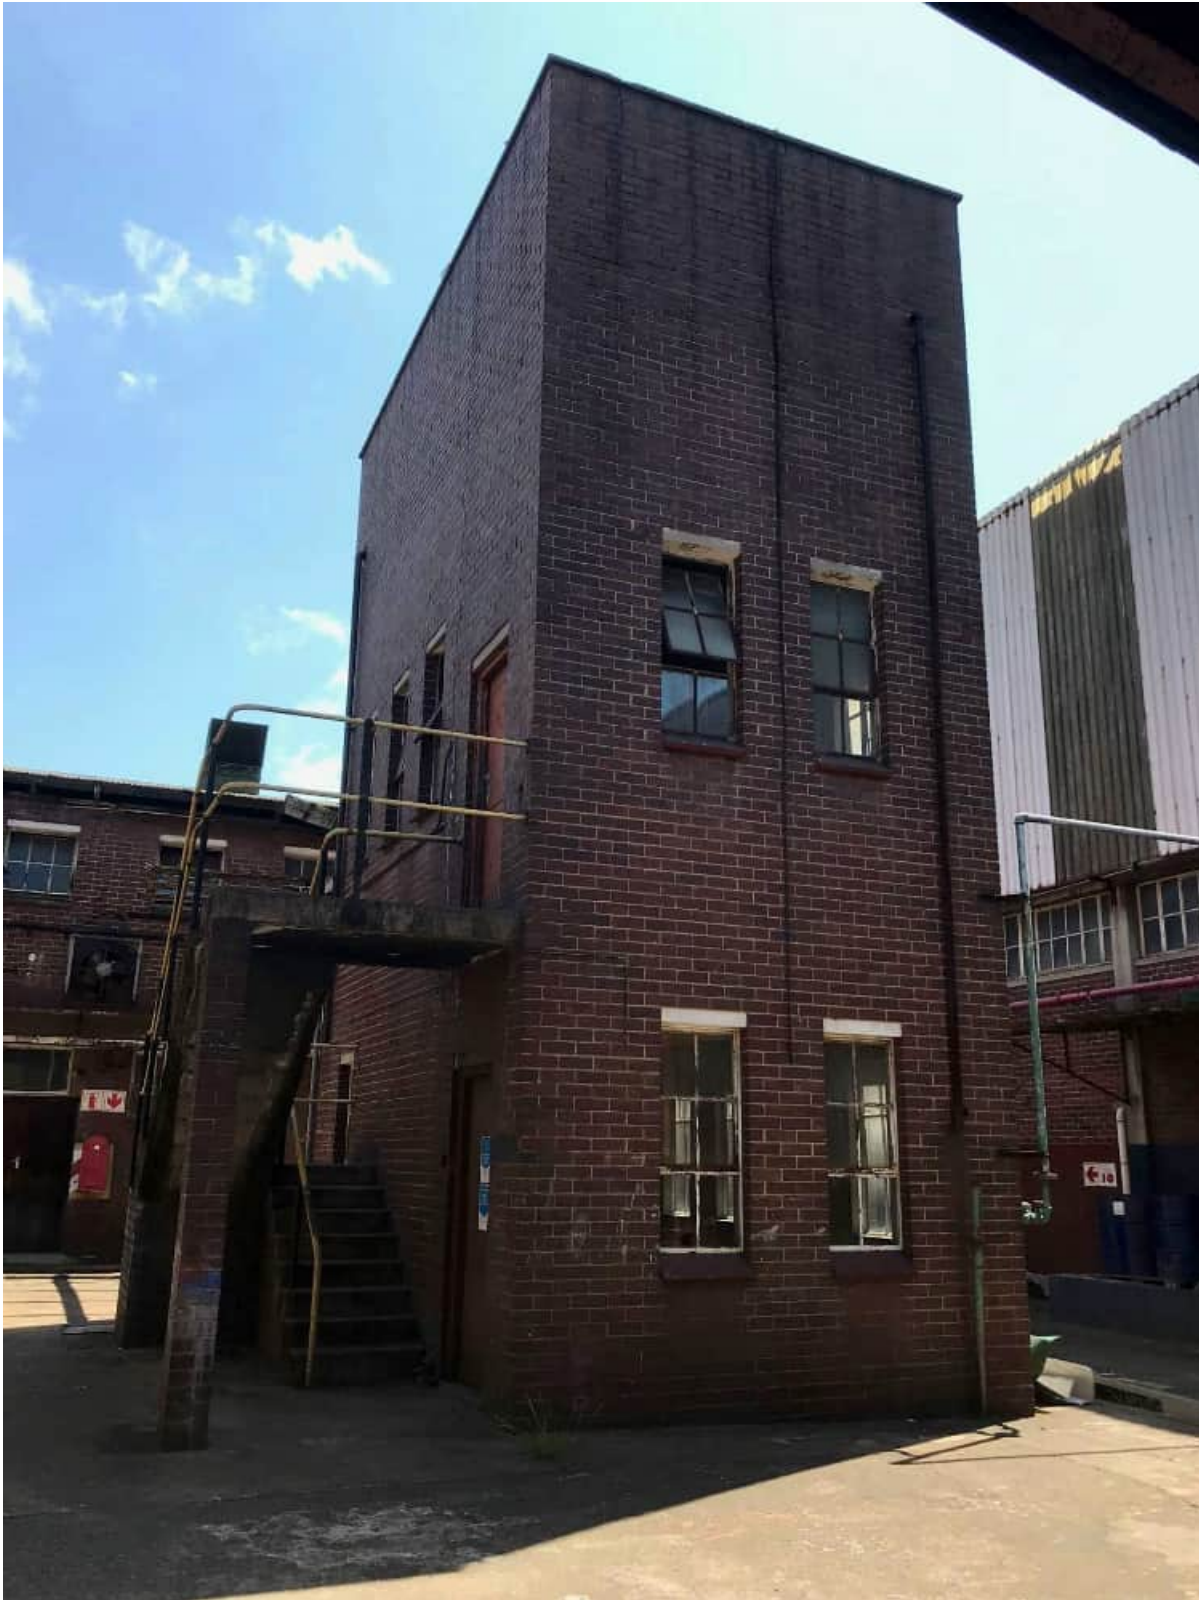
Figure 28.) Eastern view of staff quarters. Building is proposed for demolition given the condition of the structure.

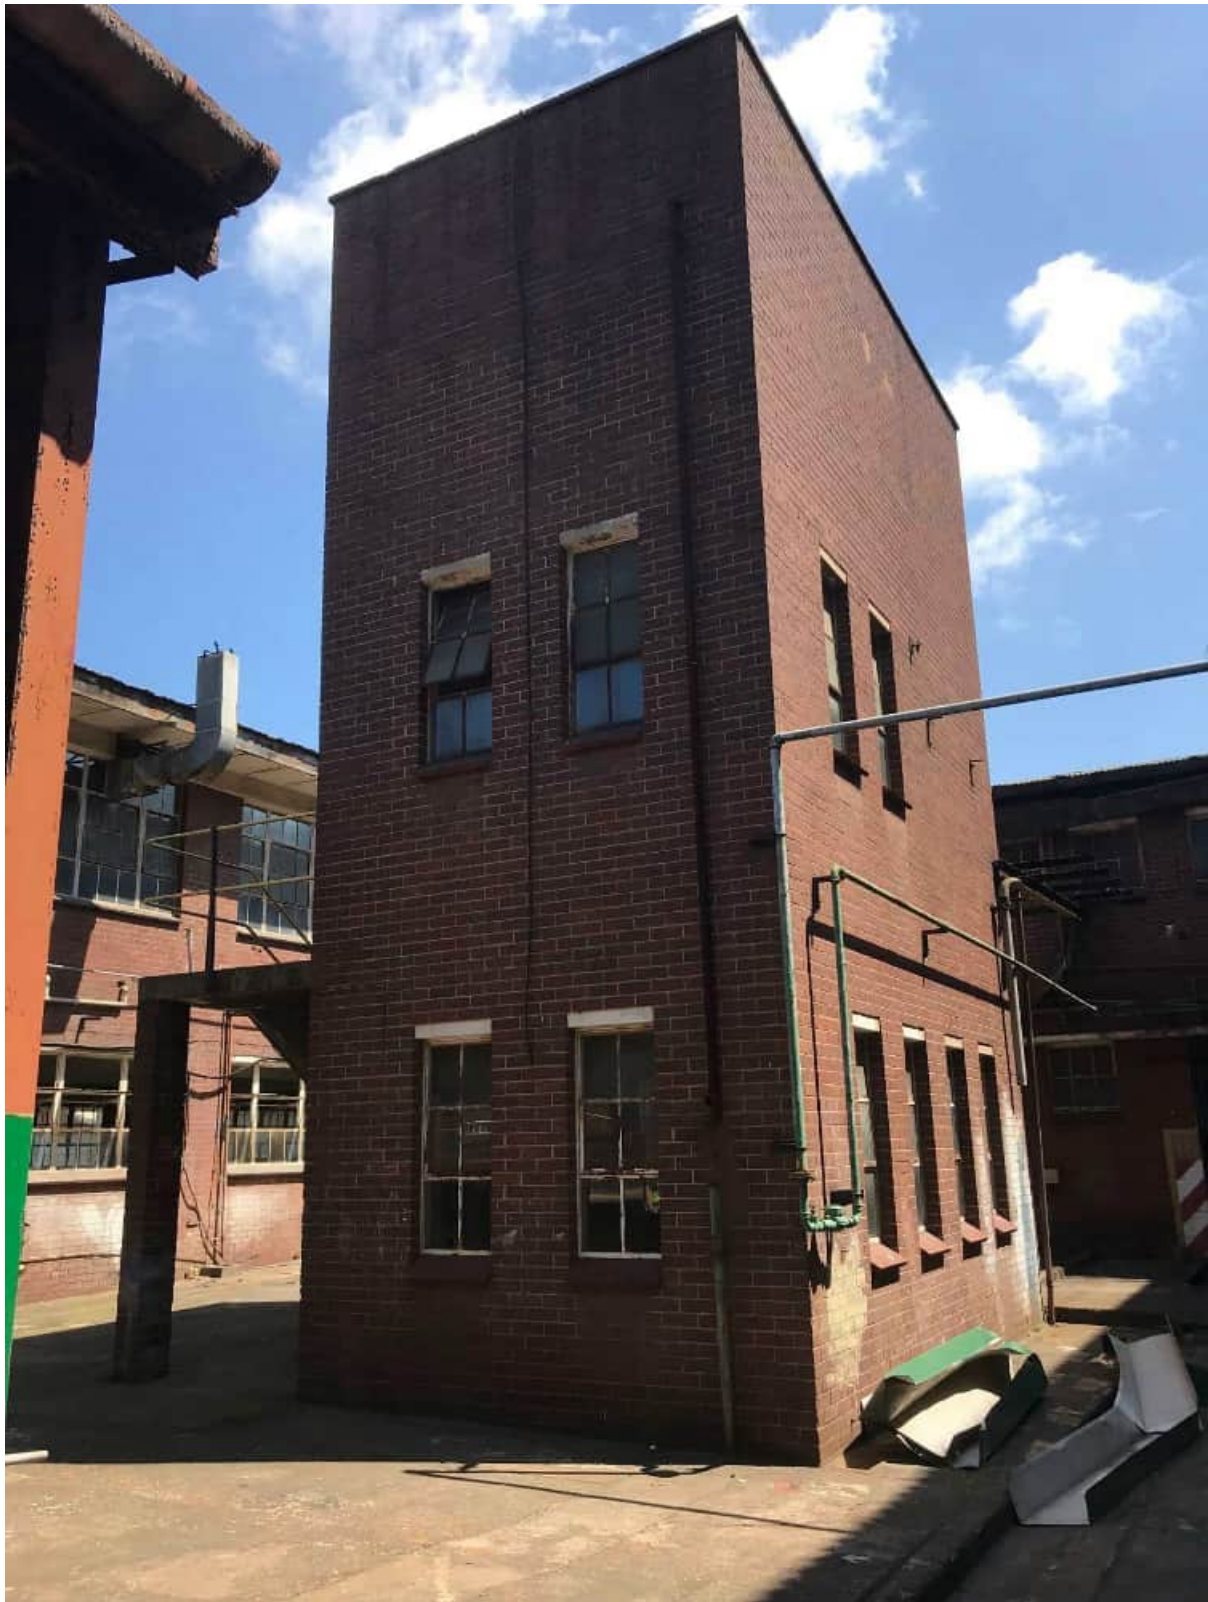
Figure 29.) North Eastern view of staff quarters. Building is proposed for demolition given the condition of the structure.

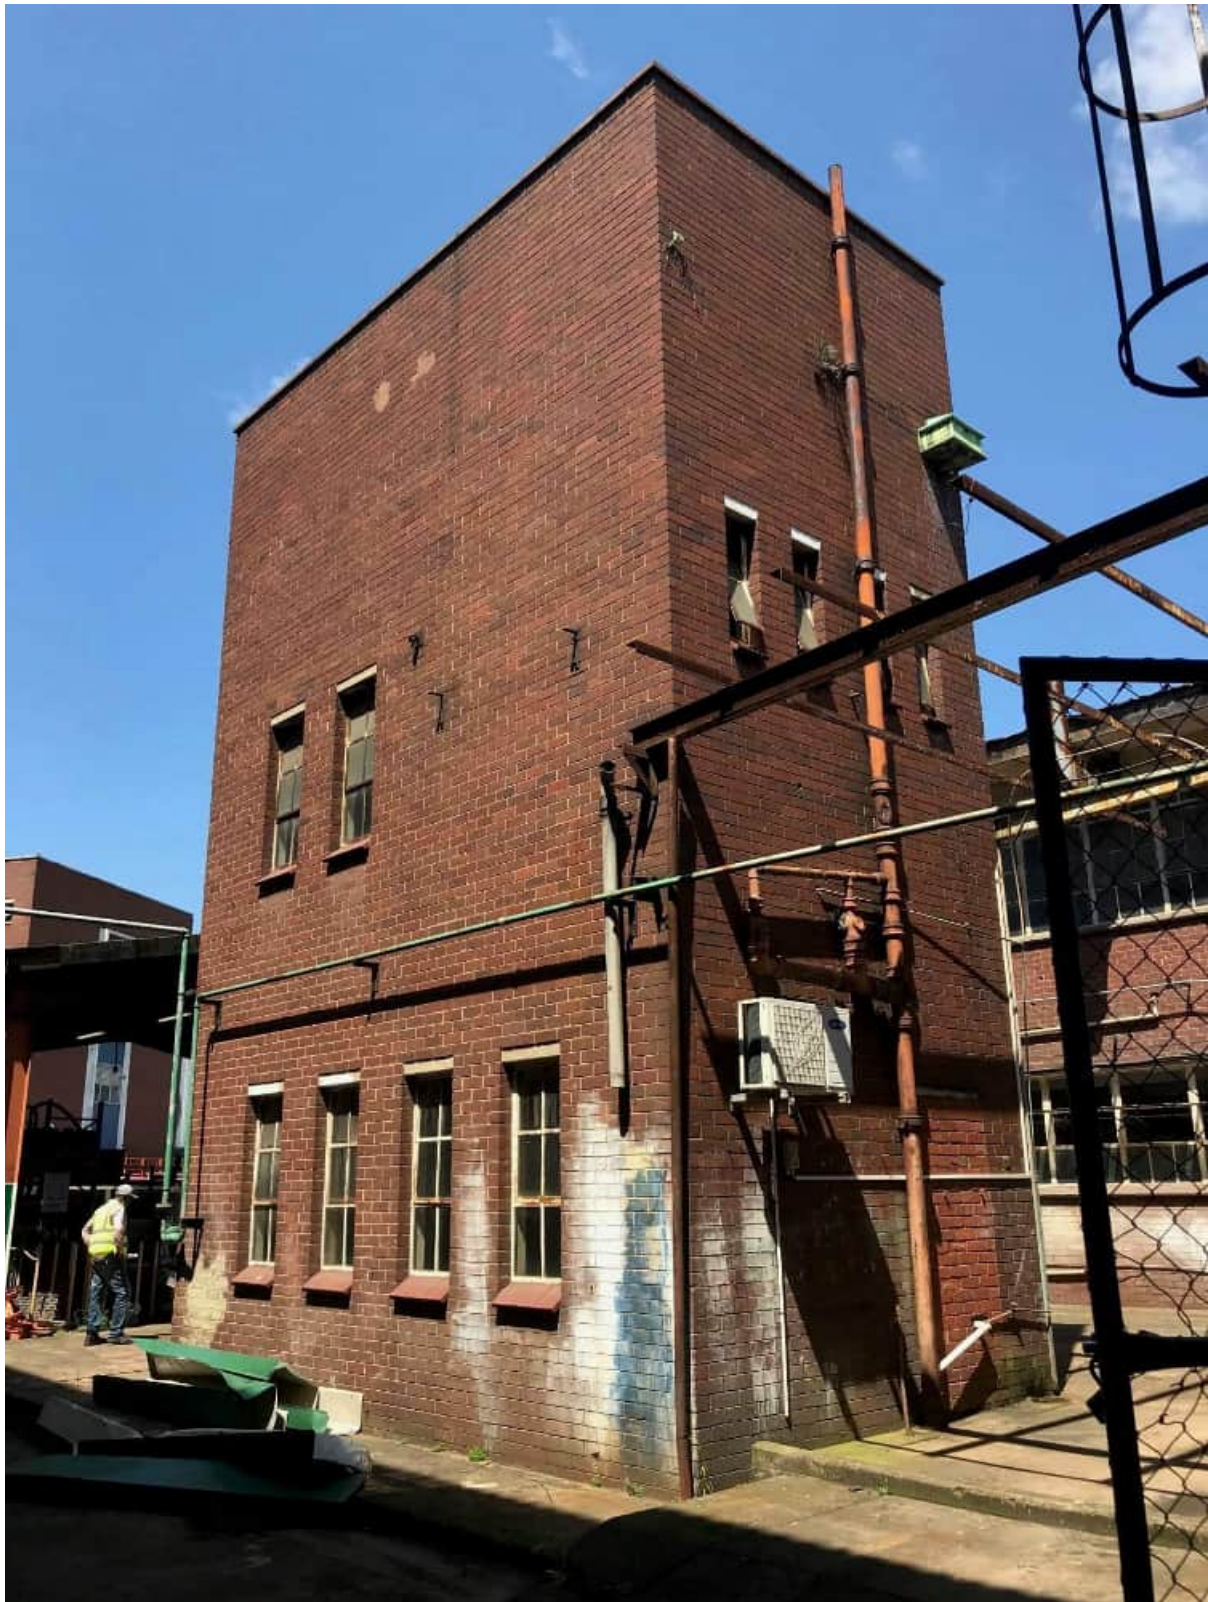
Figure 30.) North/North west view of staff quarters. Building is proposed for demolition given the condition of the structure.

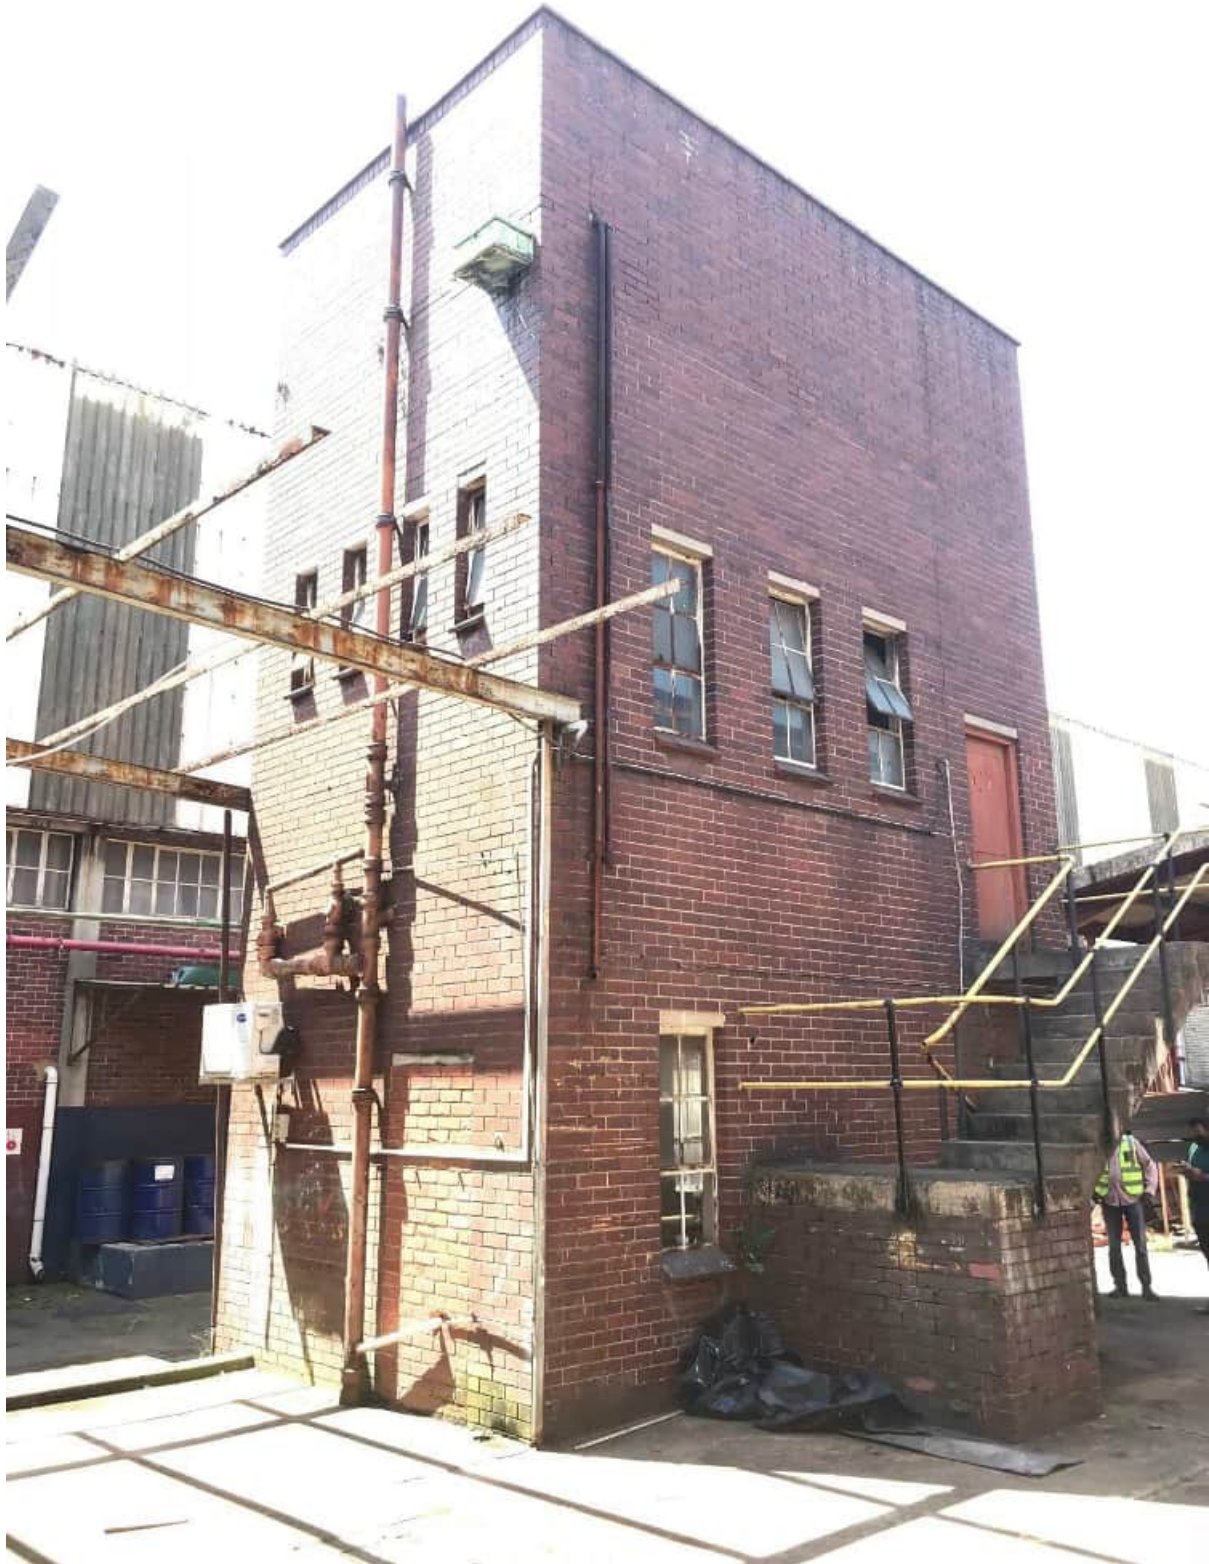
Figure 31.) West view of staff quarters. Building is proposed for demolition given the condition of the structure.

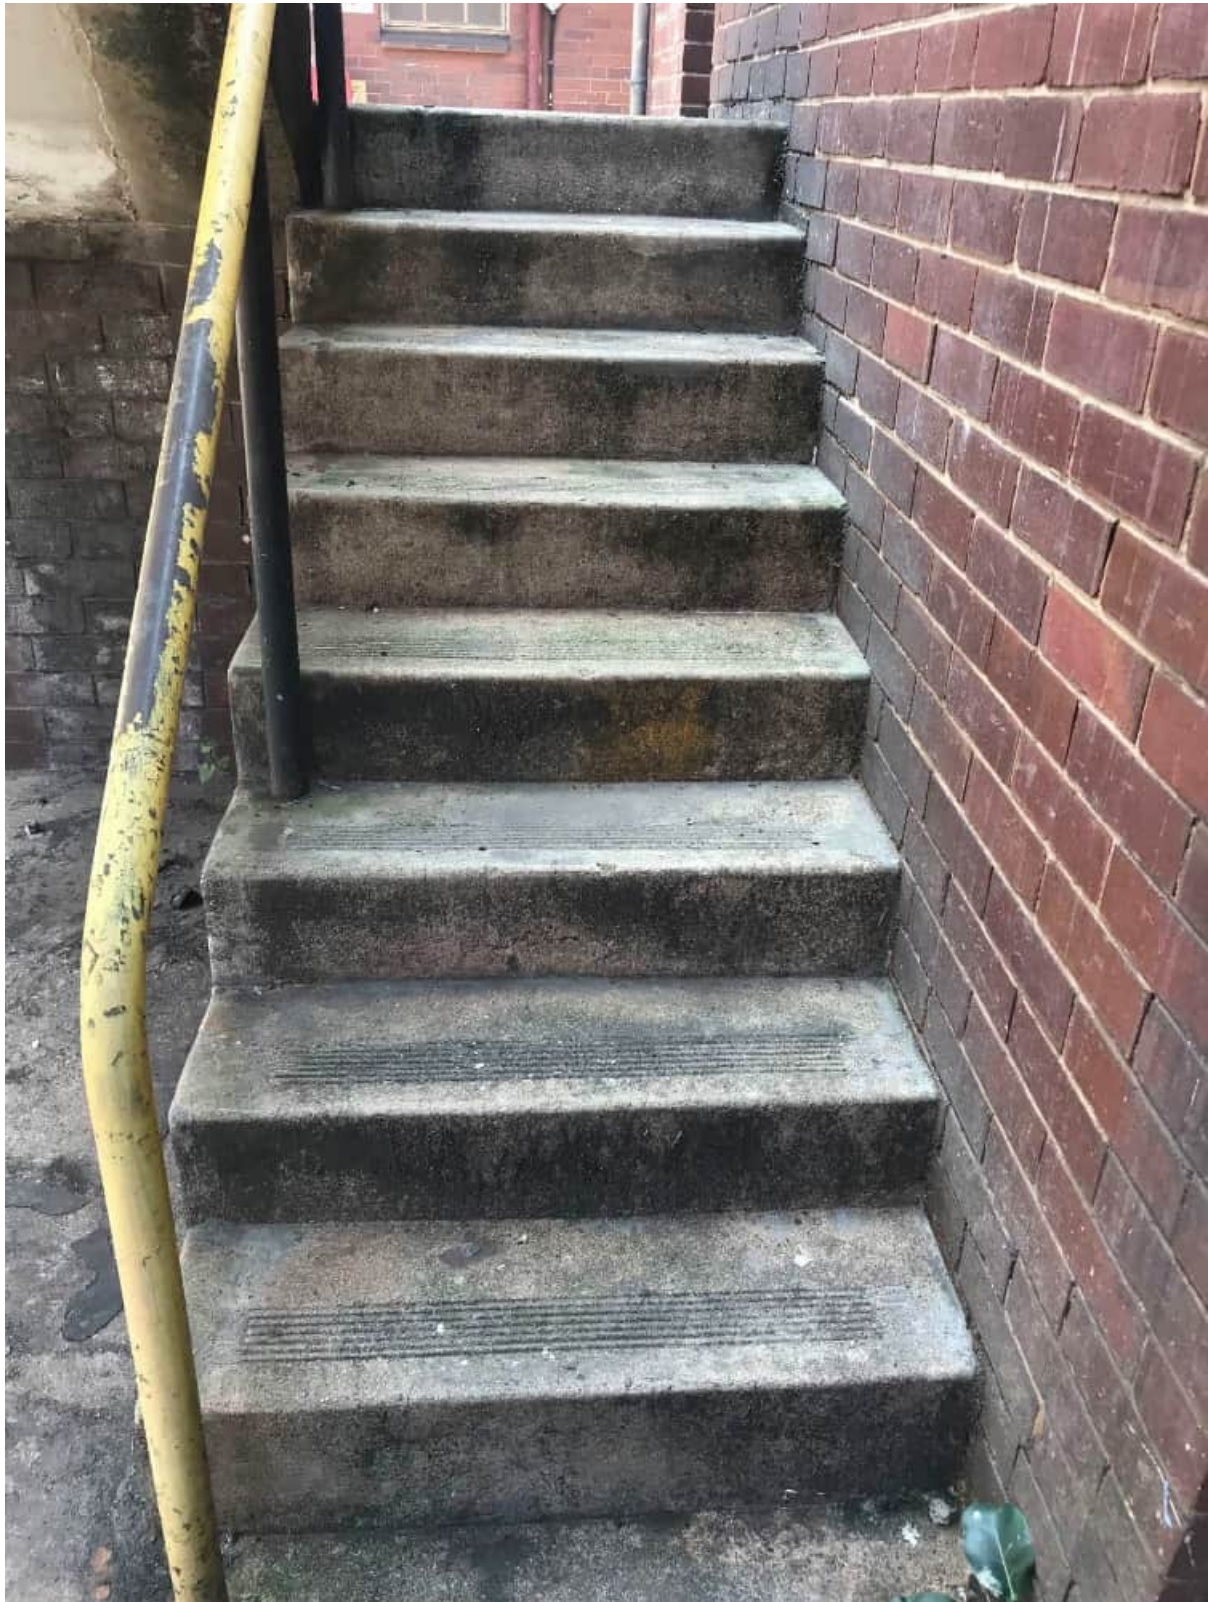
Figure 35.) View illustrating spalling concrete staircase.

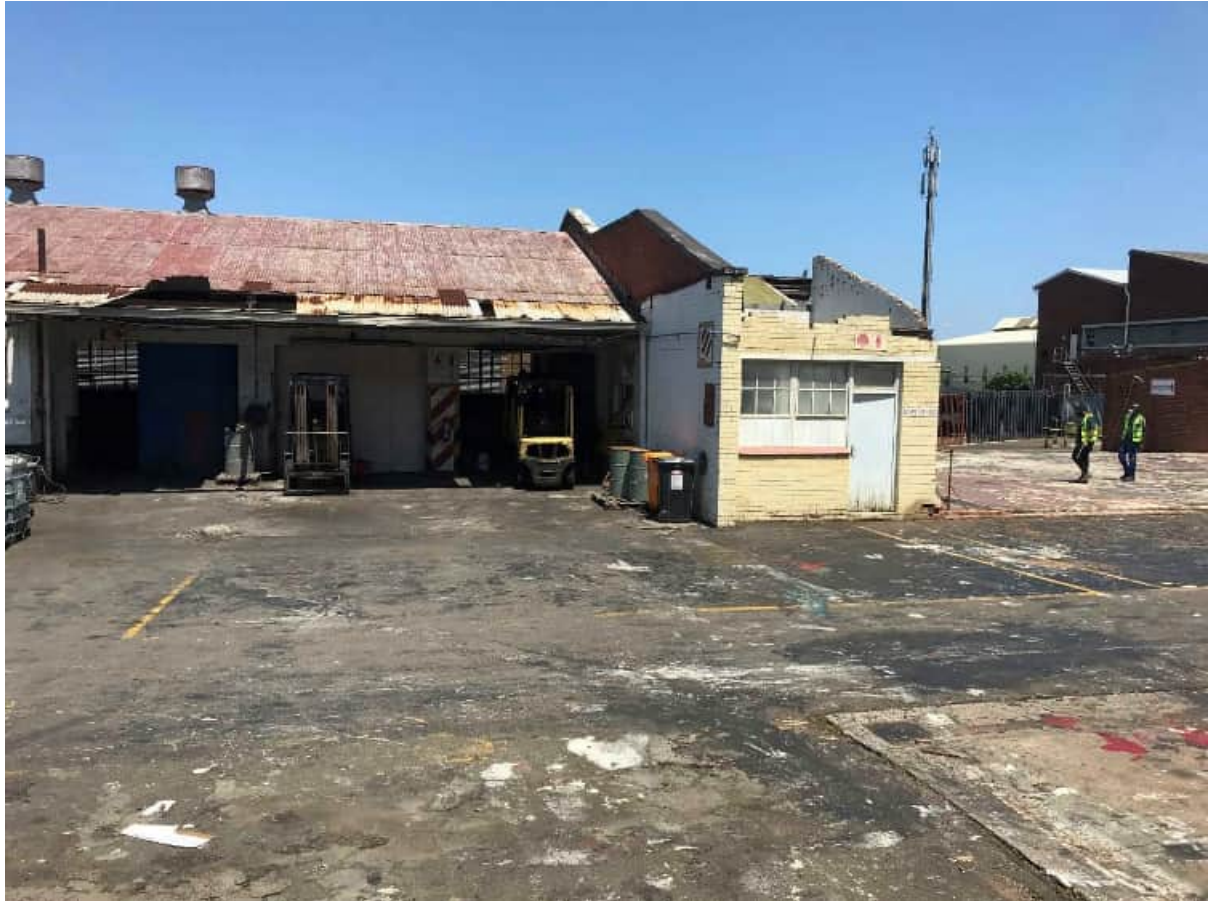
Figure 39.) View illustrating the north west façade of the garage bays that are proposed for demolition. Clearly indicative of the deteriorative conditions and safety hazard.

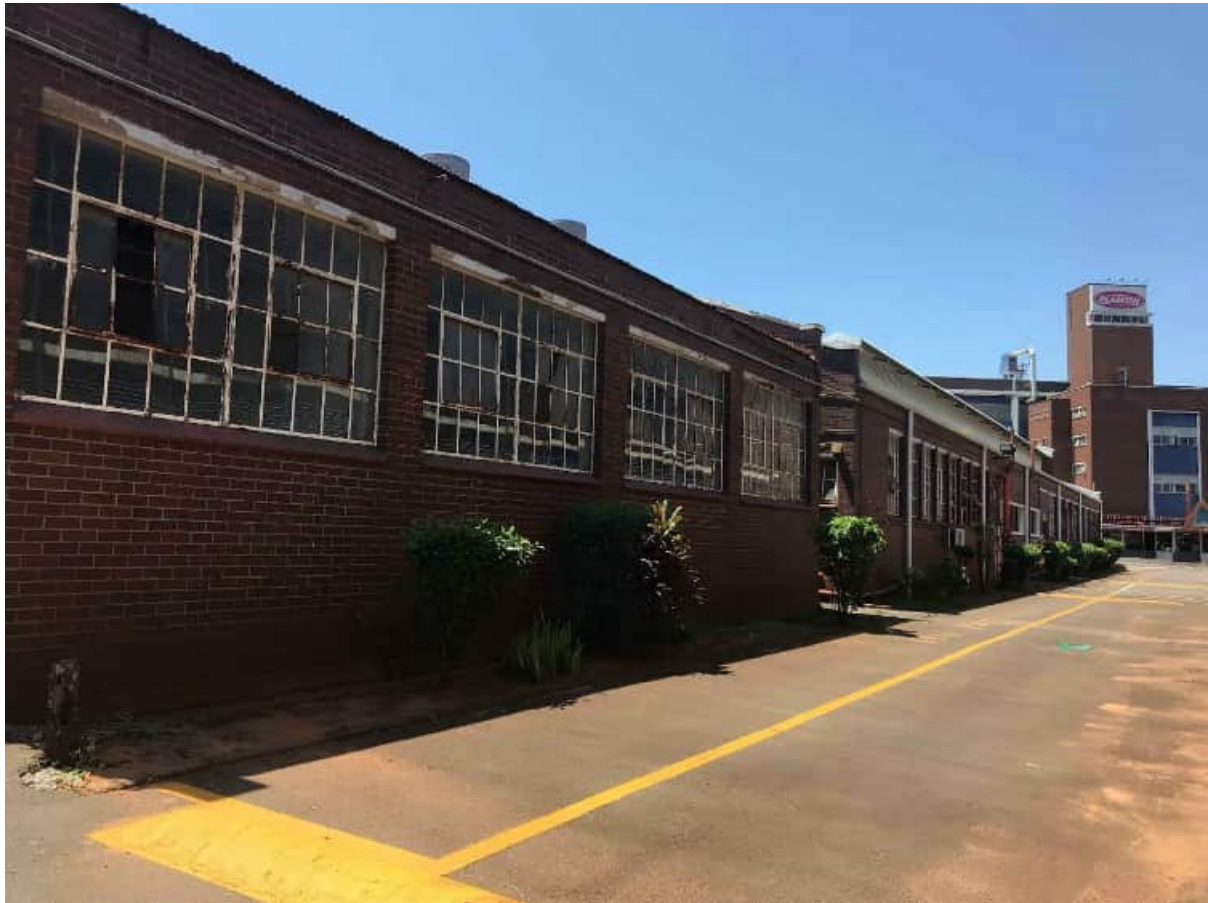
Figure 40.) View illustrating the South Eastern façade of the garage bays that are proposed for demolition as well as the façade of the office building. Clearly indicative of the deteriorative conditions and safety hazard.
