**ANNEX A : PHOTOGRAPHS
IN REFERENCE TO MOTIVATION AND DRAWINGS PROVIDED**

**PROPOSAL: ALTERATIONS TO EXISTING RESTAURANT
AT 18 LILIAN NGOYI ROAD
WINDERMERE, DURBAN**

PORTION 50 (of 38) of ERF 1368 DURBAN

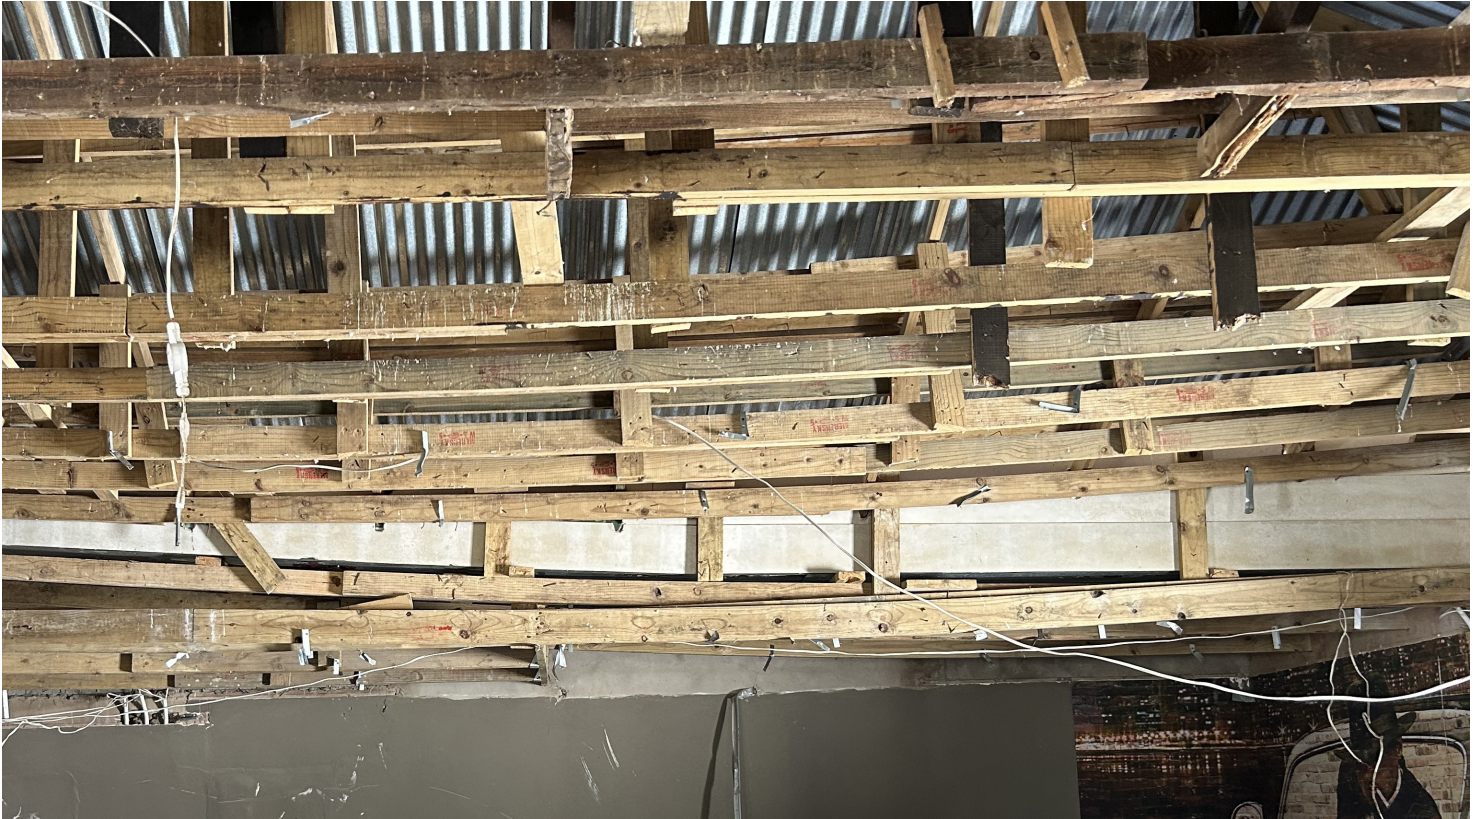
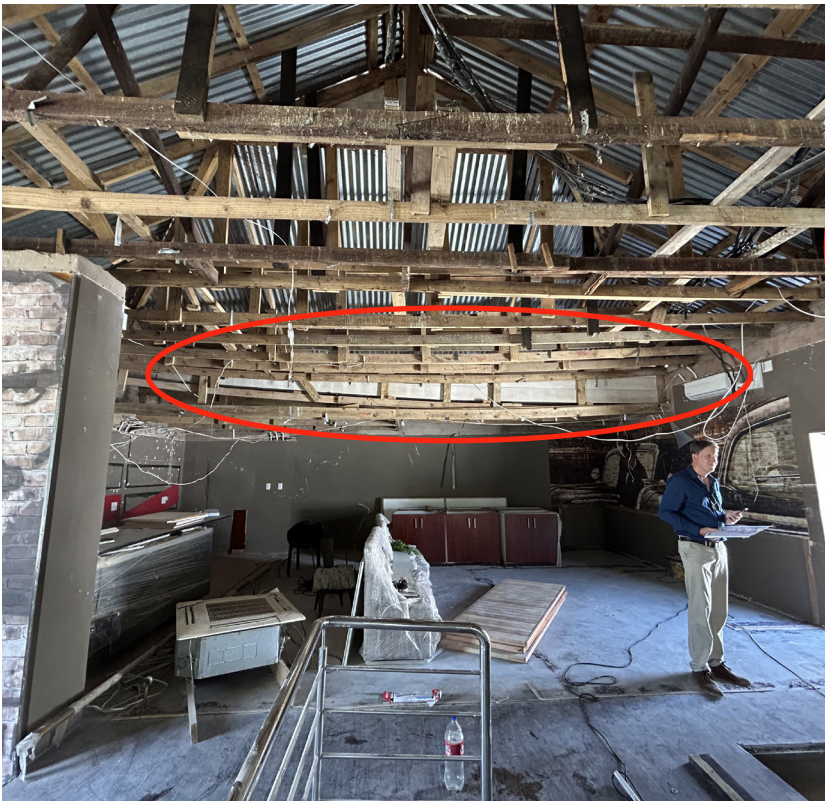
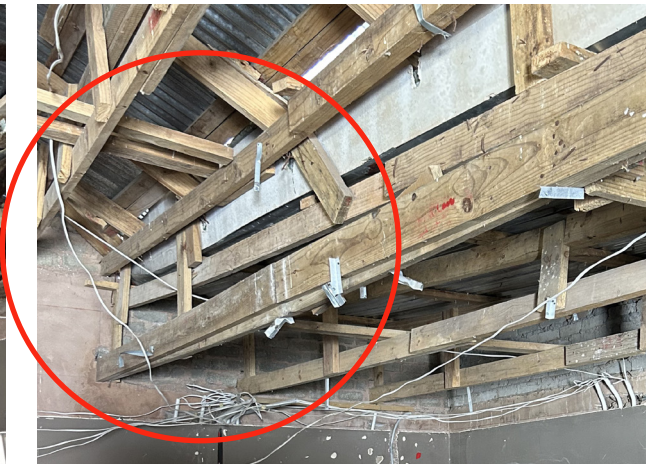
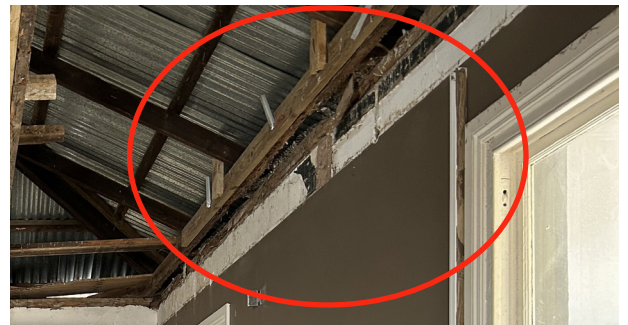
PHOTO REFERENCE LETTER: A
CONDITION OF EXISTING MAIN ROOF

site photos of existing roof structure
23/01/2023

MAIN ROOF: structural elements are deemed unsafe and need to be replaced with new. Replace roof sheeting to match existing finish, position & shape

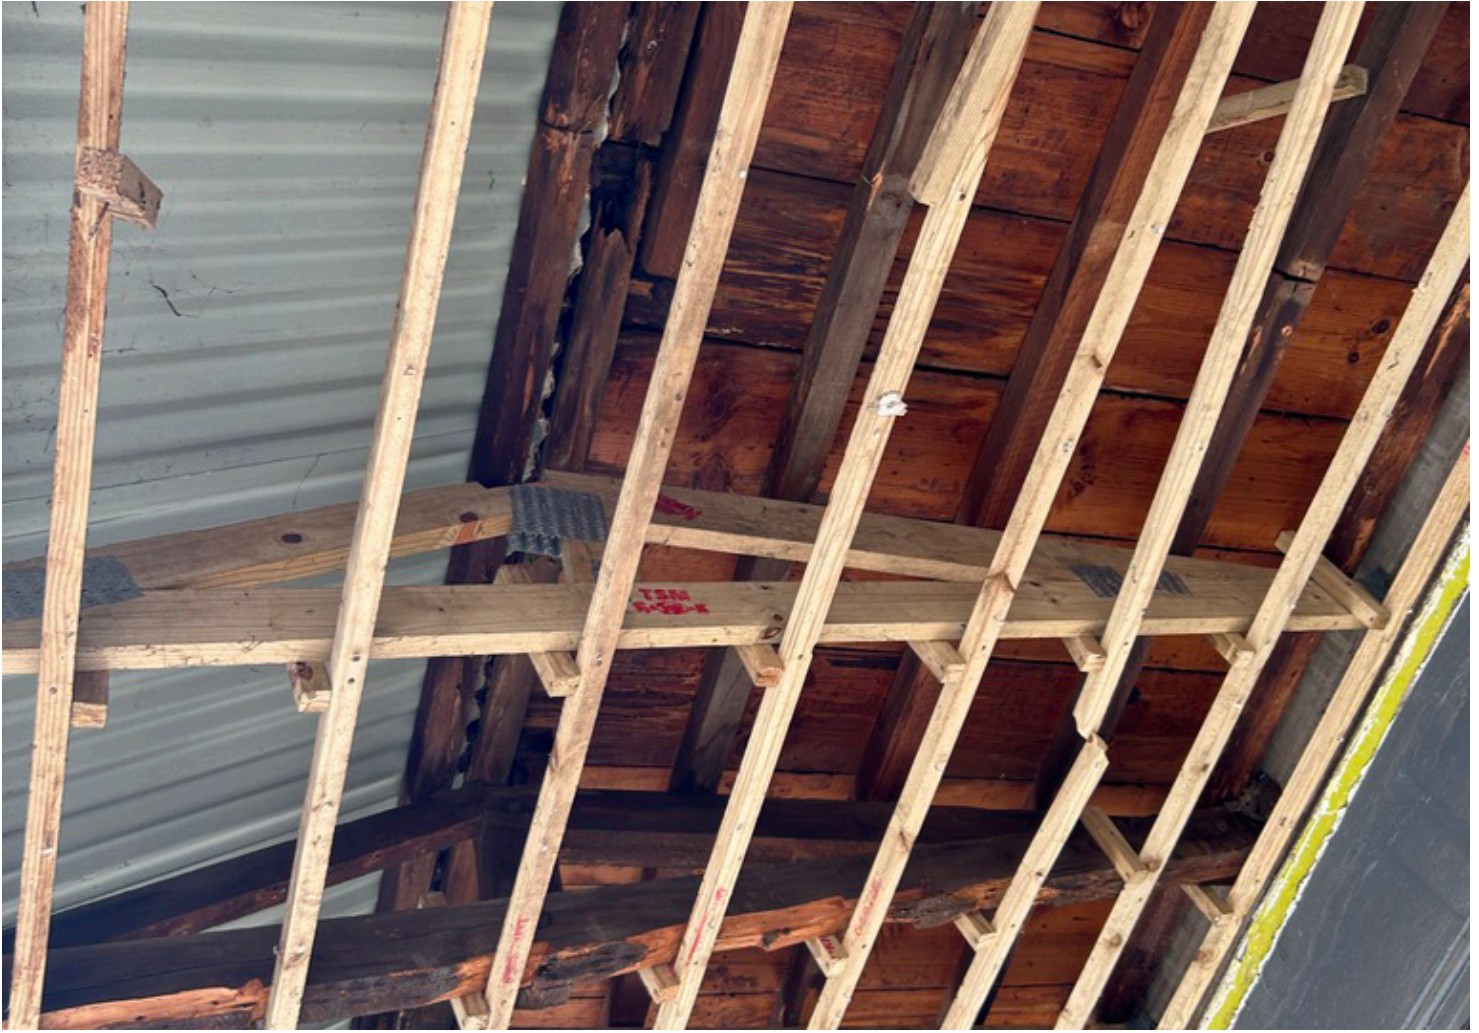
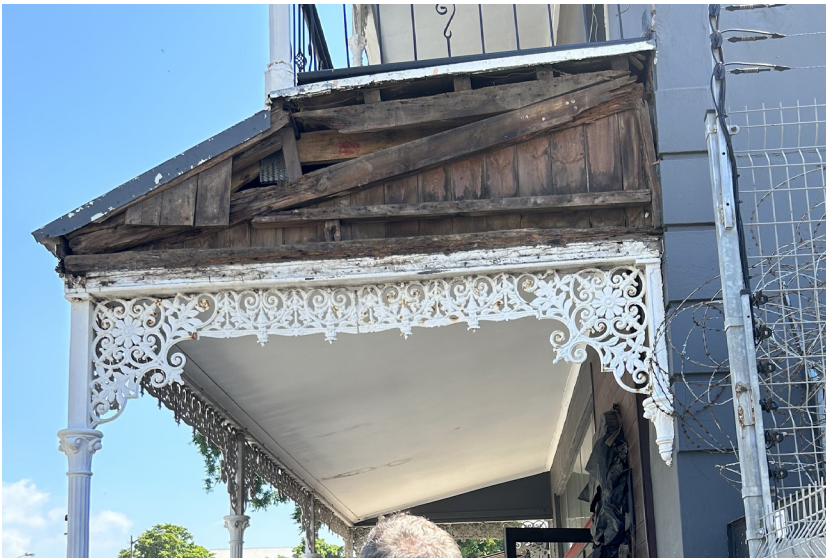
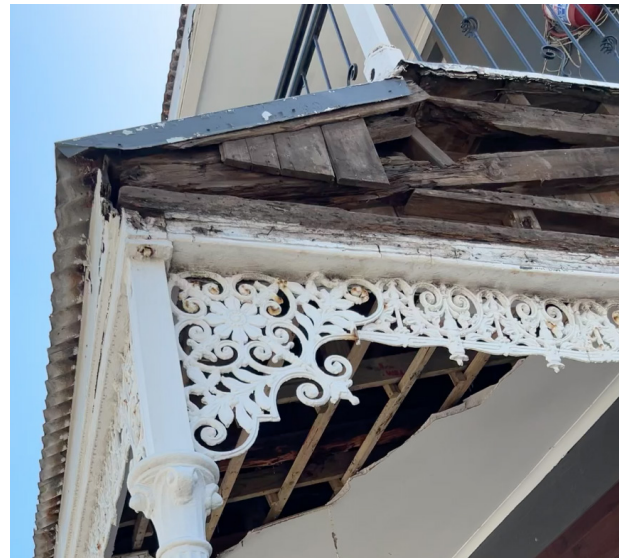
PHOTO REFERENCE LETTER: B
CONDITION OF EXISTING VERANDA ROOF

site photos of existing veranda structure
23/01/2023

VERANDA: timber structure unsafe and inadequate support for first floor columns. New structure required to support columns and balcony. Urgent as these elements overhang pavement. Replace roof sheet to match existing

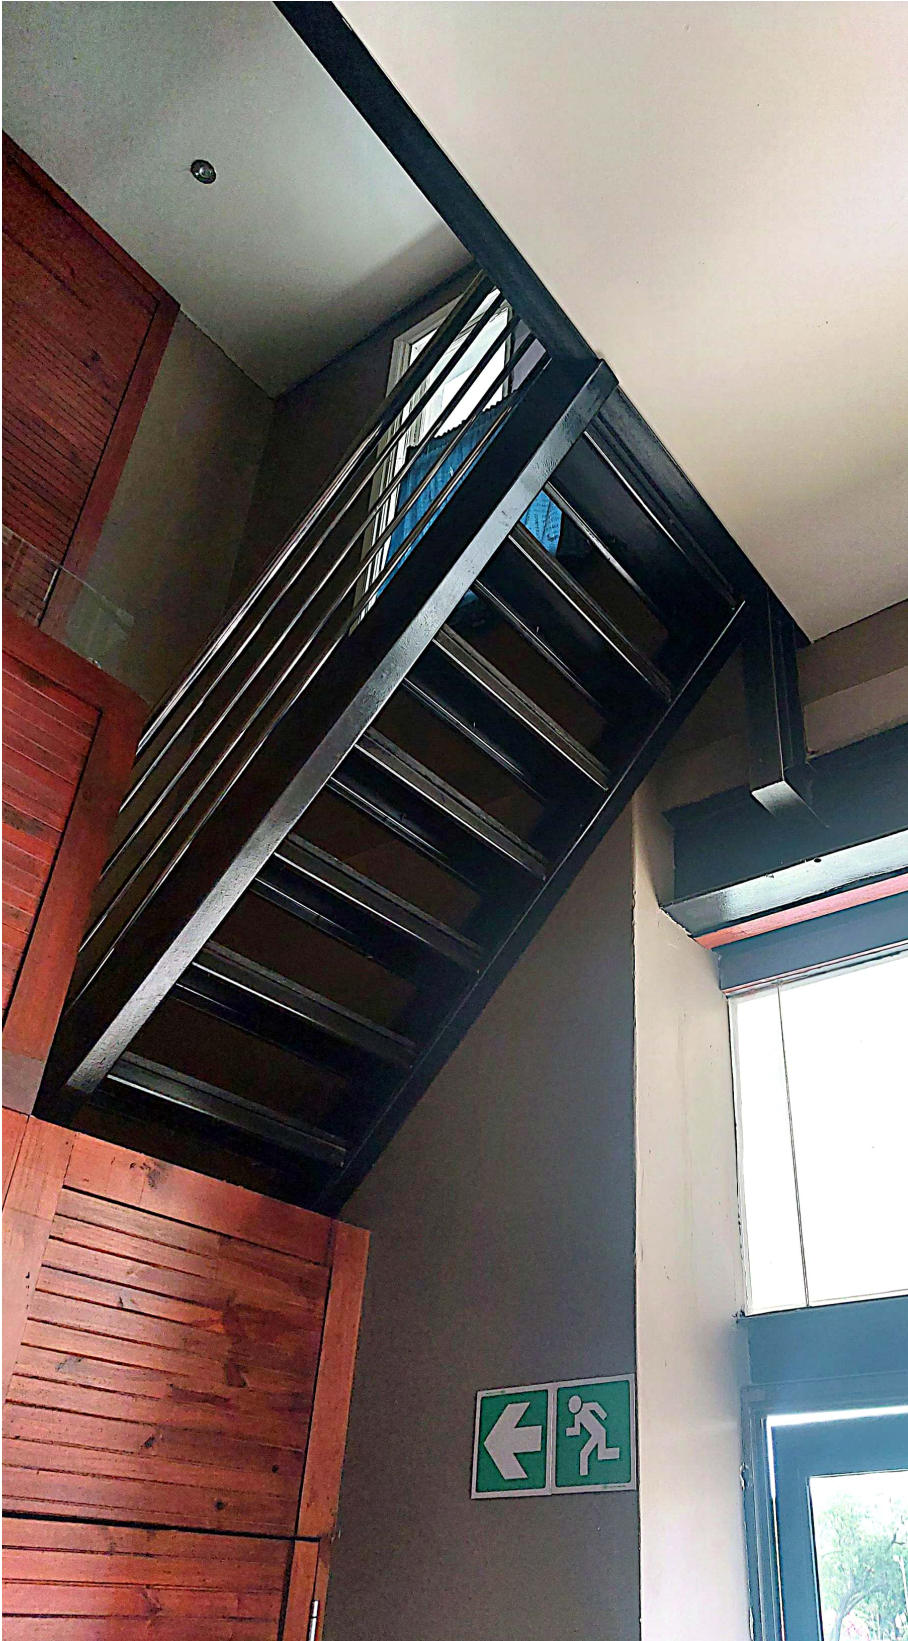
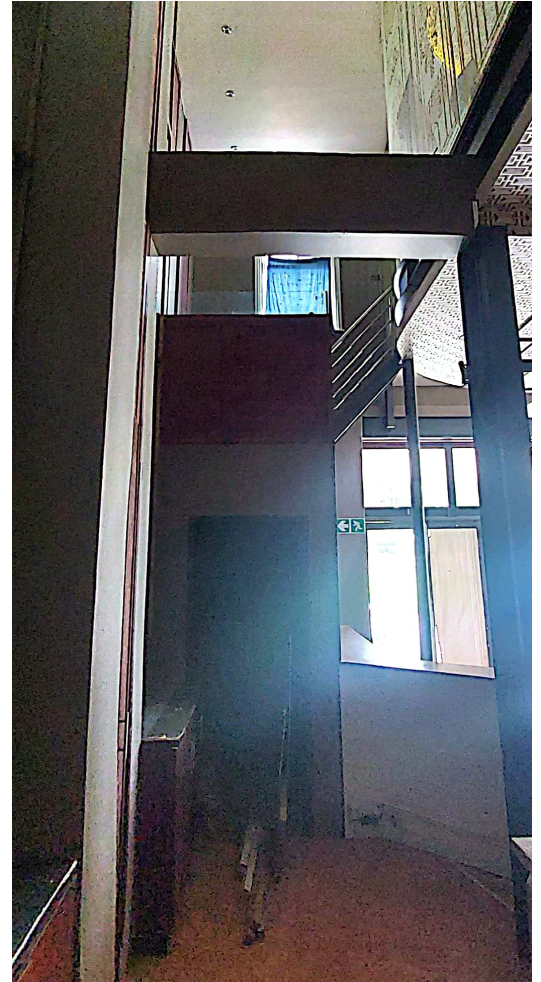
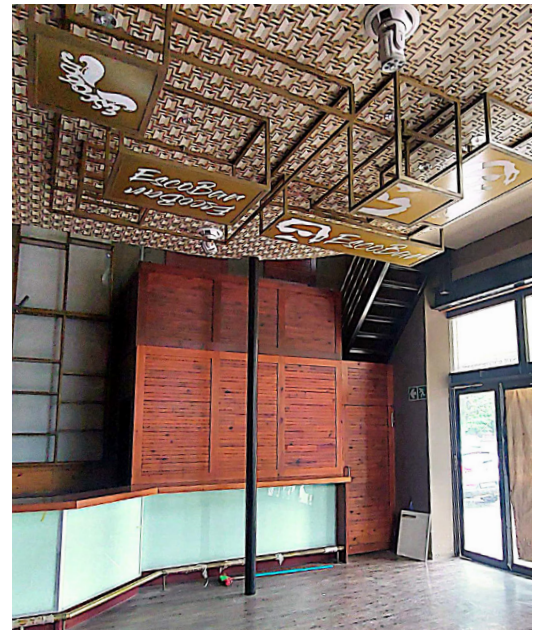
PHOTO REFERENCE NUMBER: 1
CONDITION OF EXISTING SERVICE STAIR

site photos of existing service stair and partition walls
01/12/2022

The current service stair is not compliant with regulation M of SANS, a new replacement stair has been proposed to allow safe access to the existing first floor. Existing stair riser exceeds maximum allowance.

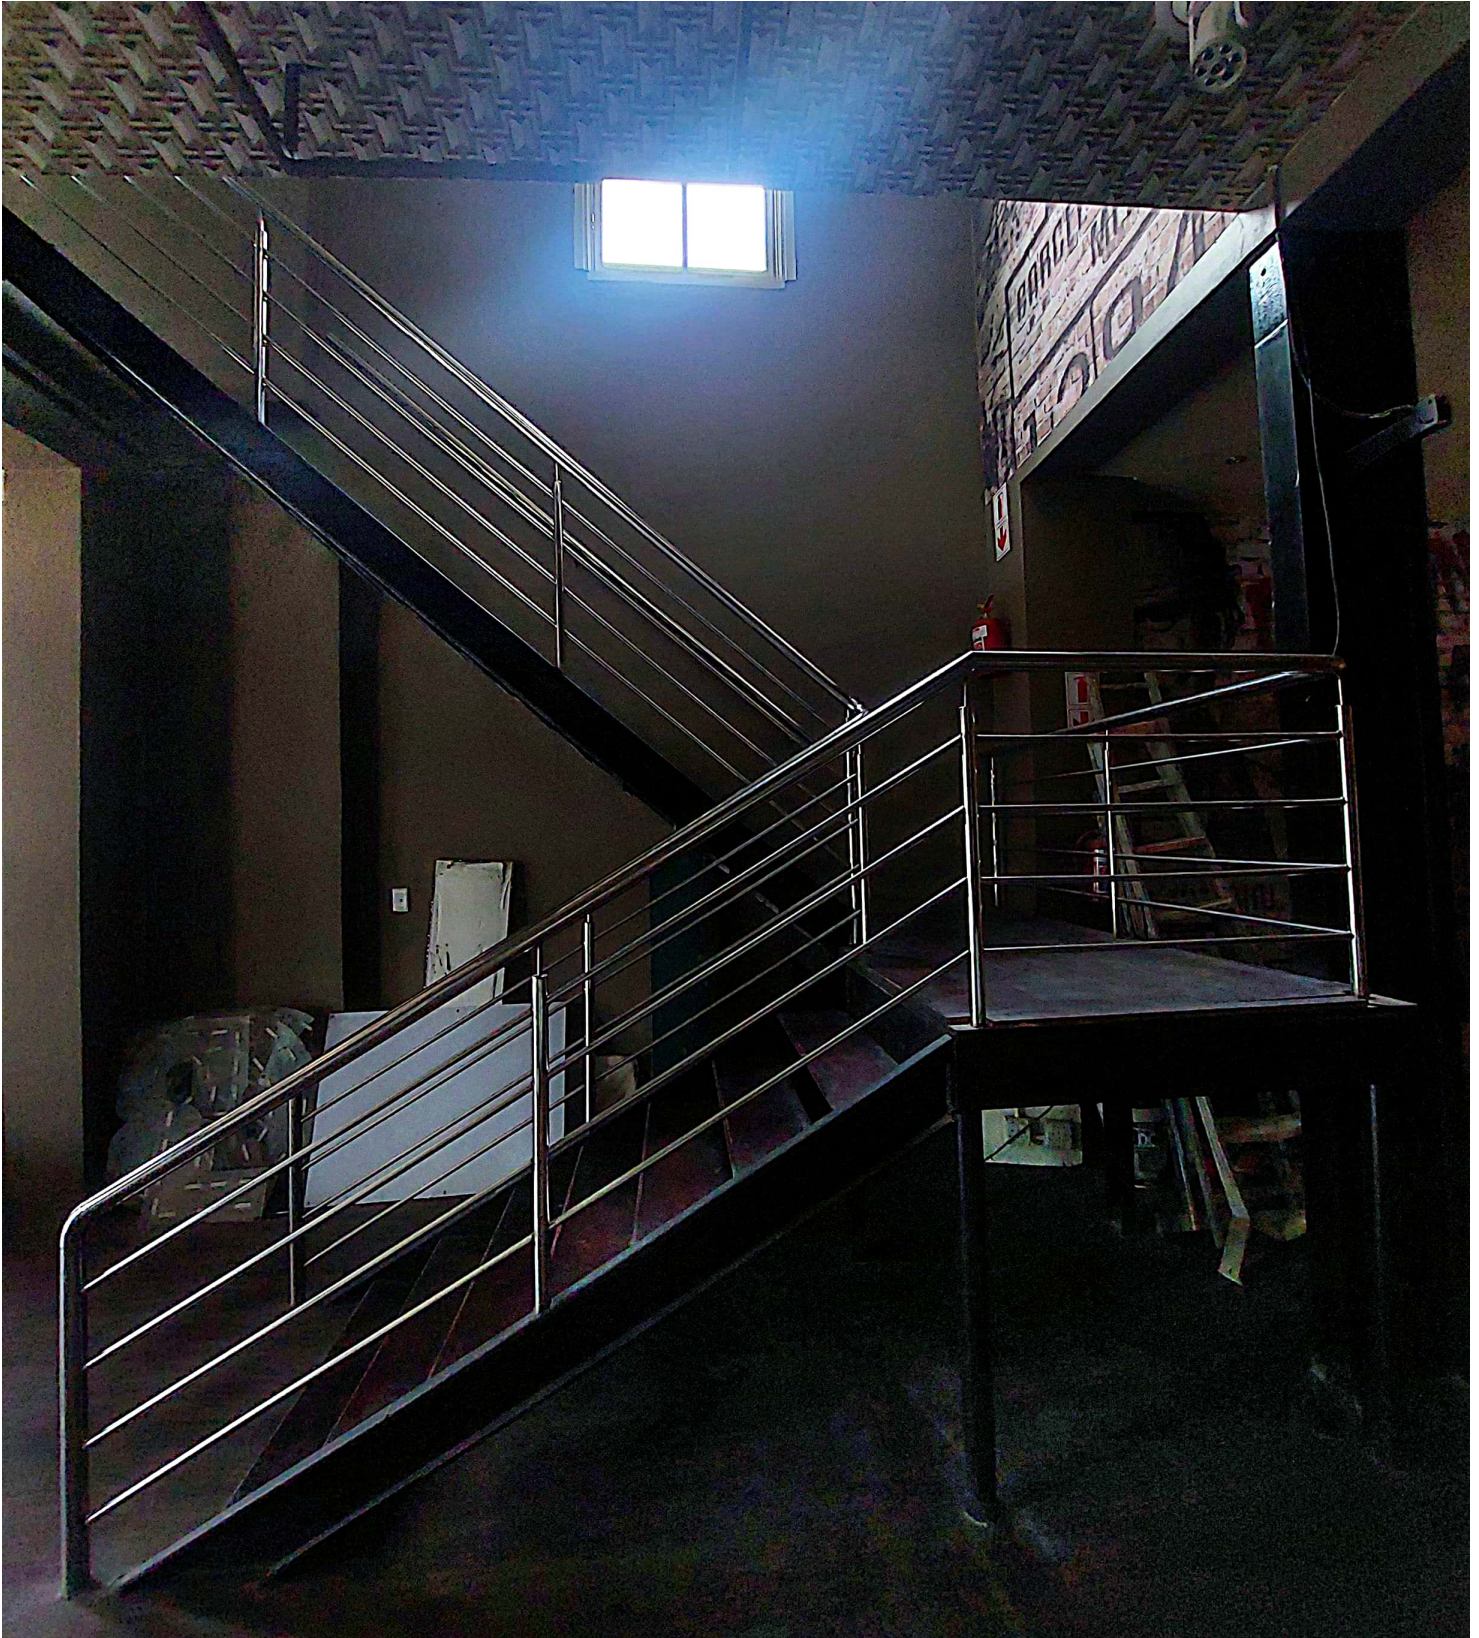
PHOTO REFERENCE NUMBER: 2
CONDITION OF EXISTING MAIN STAIR

site photos of existing main stair
01/12/2022

The current main stair is not compliant with regulation M of SANS, a new replacement stair has been proposed to allow safe access to the existing first floor. Existing stair risers are inconsistent, bowing and too steep.

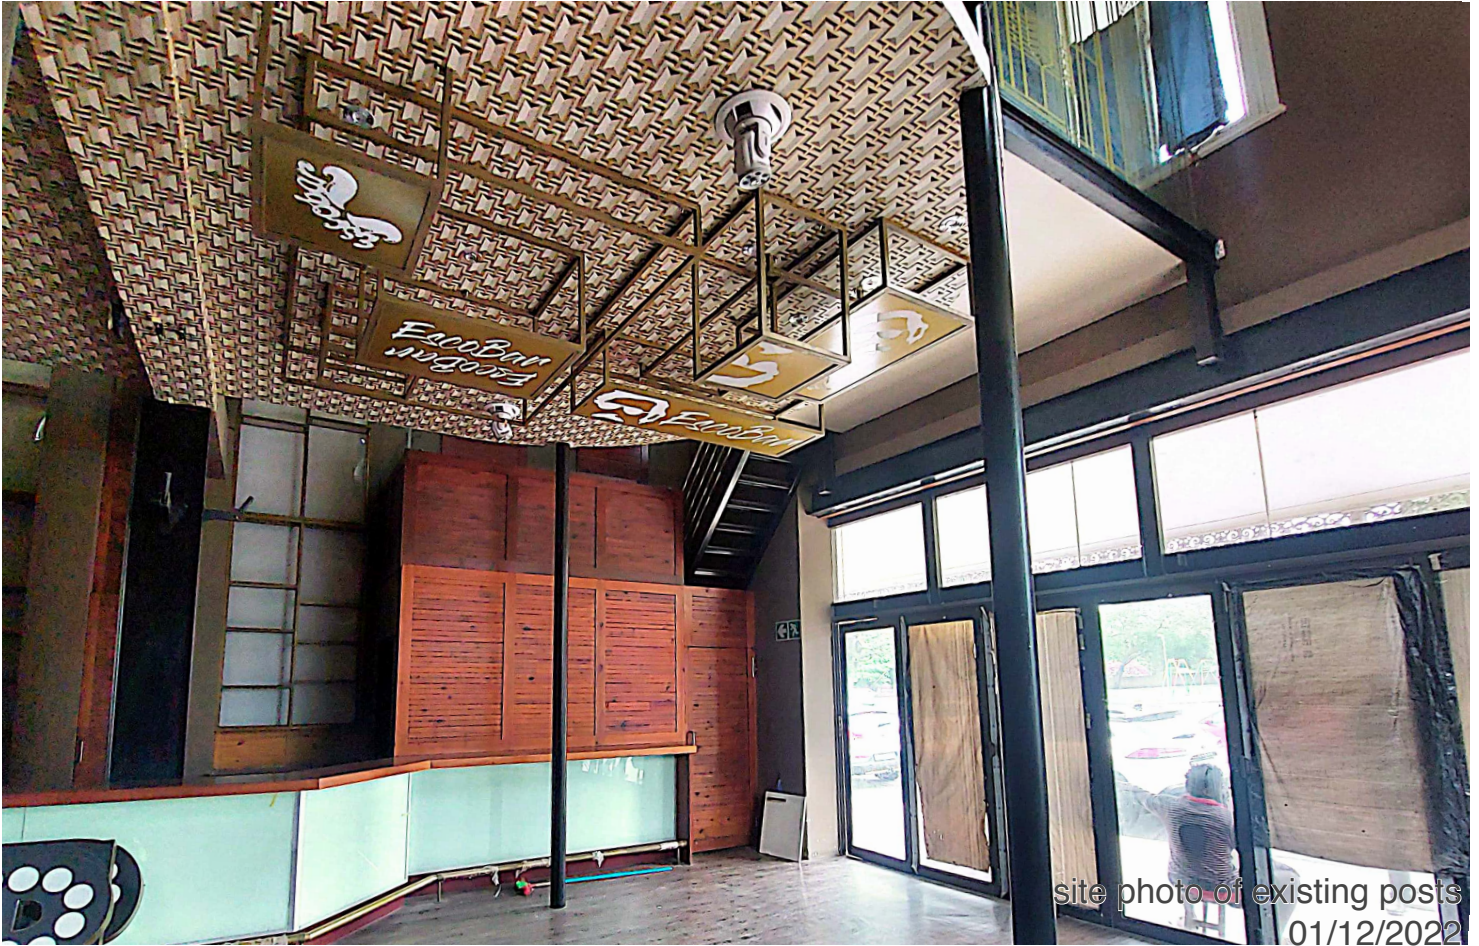
PHOTO REFERENCE NUMBER: 4
EXISTING STEEL ROUND POSTS

site photo of existing posts
01/12/2022

2 round steel posts at the groundfloor level were installed circa 2021/2022 to support double volume voids in the floor above. The posts and voids are not historical features and do not enhance the historical character of the building.

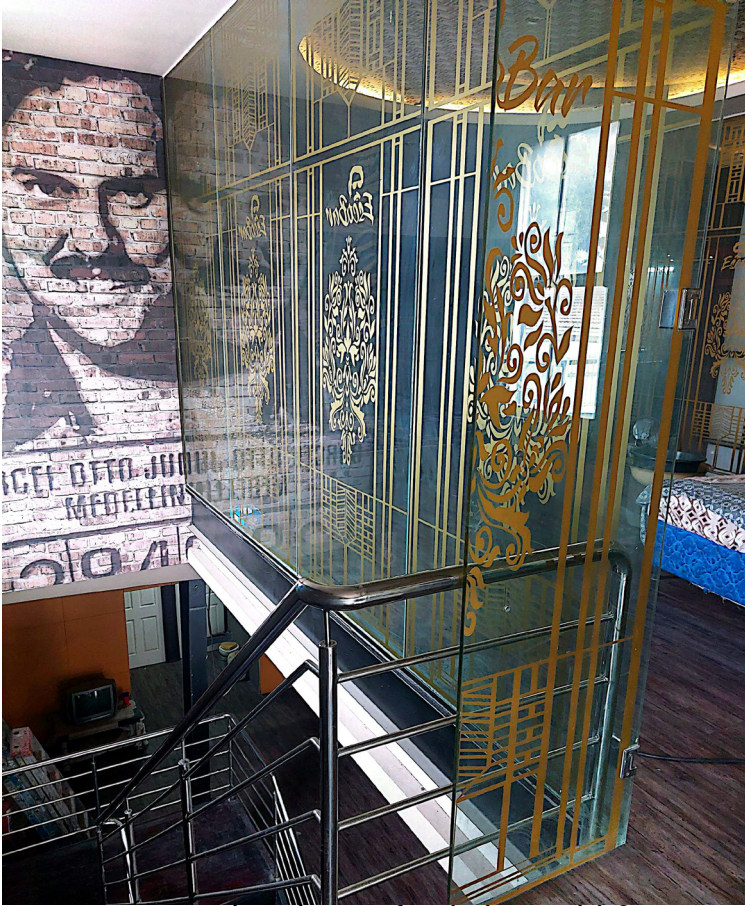
PHOTO REFERENCE NUMBER: 5
EXISTING VOIDS AND SCREEN PARTITIONS

site photo of existing void & screen
from first floor level: 01/12/2022

Existing voids and glass screen partitions are to be removed and a new floor finish installed to match the existing.

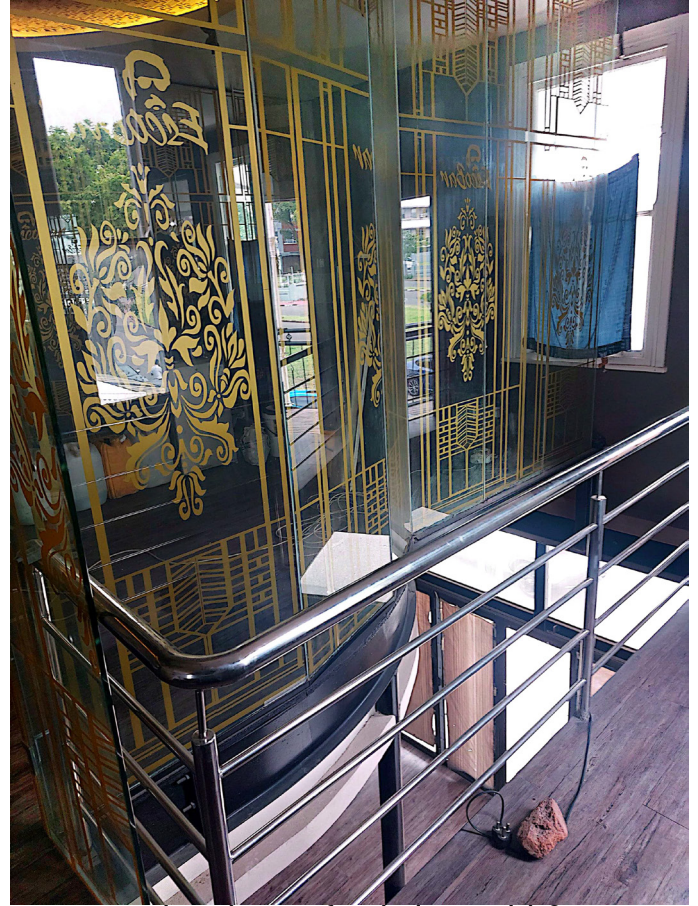
site photo of existing void & screen
from first floor level: 01/12/2022

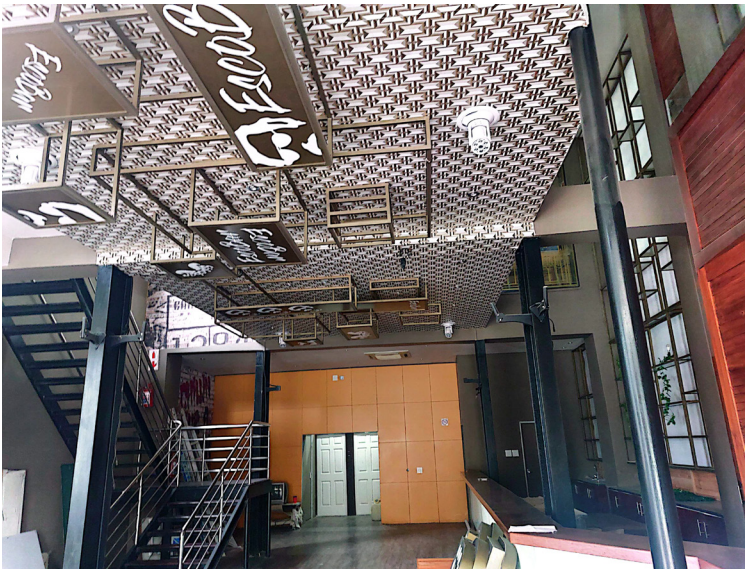
site photo of existing voids
from ground floor entrance: 01/12/2022

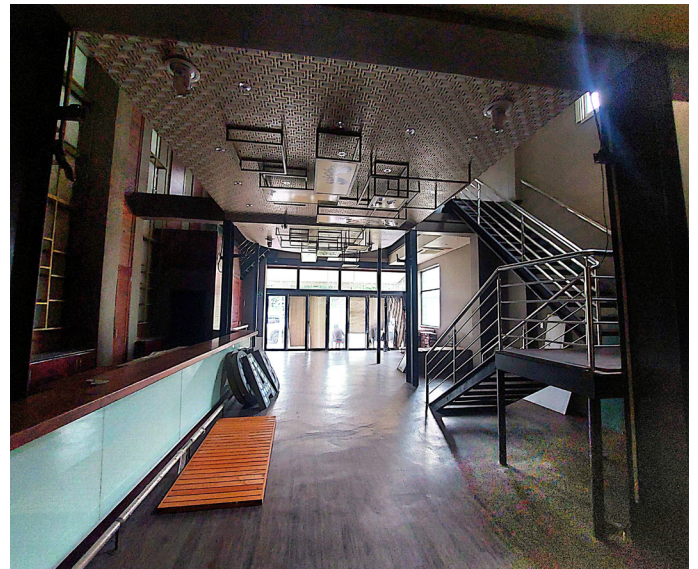
site photo of existing voids
from ground floor level: 01/12/2022

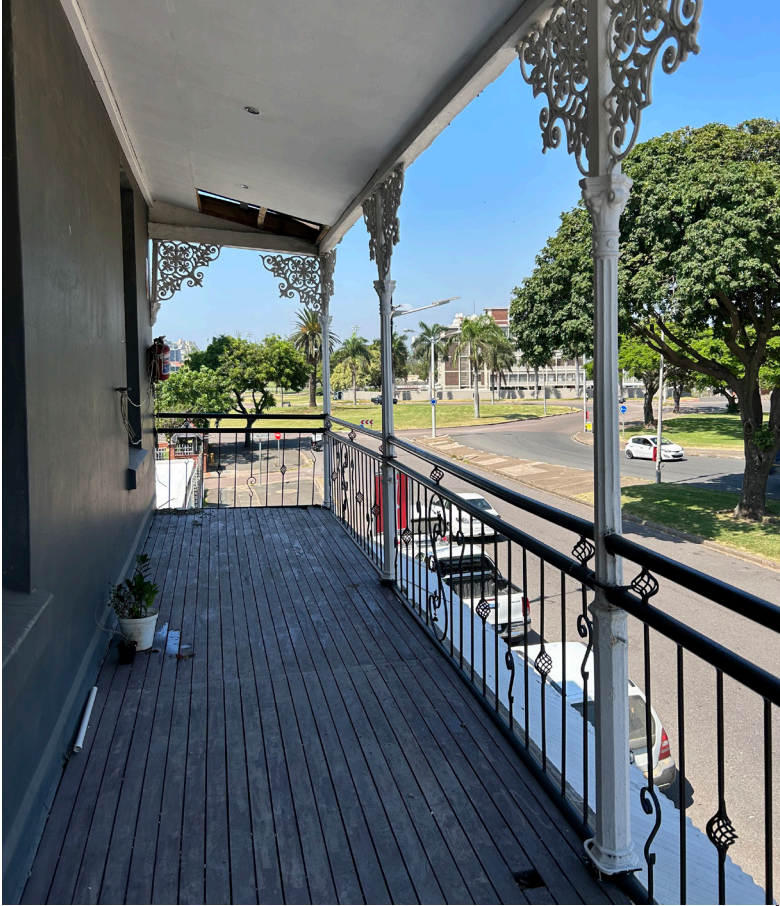
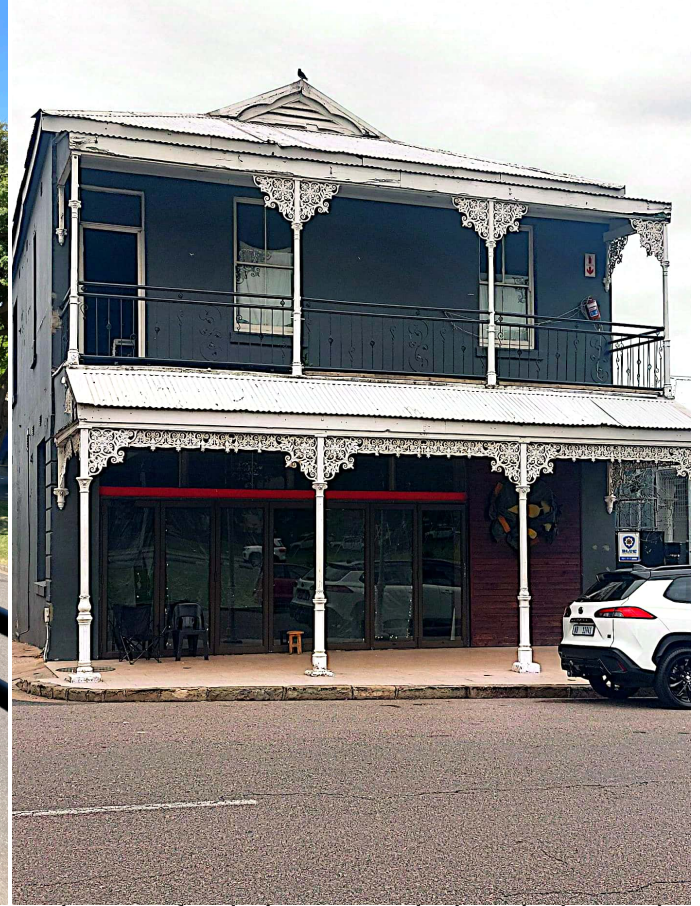
PHOTO REFERENCE NUMBER: 7
BALCONY BALUSTRADE

site photos of existing wrought iron balustrade
01/12/2022

Existing wrought iron balcony balustrade is to be removed and a timber balustrade to match the original is to be installed. New stainless steel handrail to be installed as per previous approved drawings to achieve SANS 1m height compliance
