IZIKO MUSEUMS | **EXISTING BUILDING CONDITION REPORT**

REF. CSM/Architects/12/2015

BO-KAAP MUSEUM

DATE: APRIL 2018 | **STATUS:** FINAL

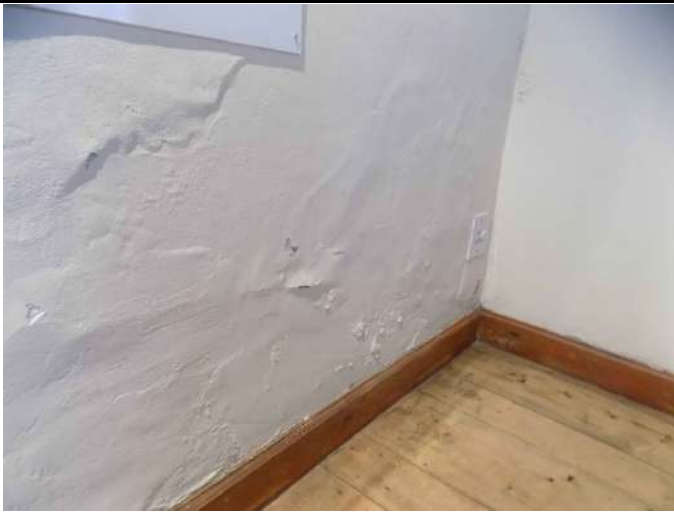
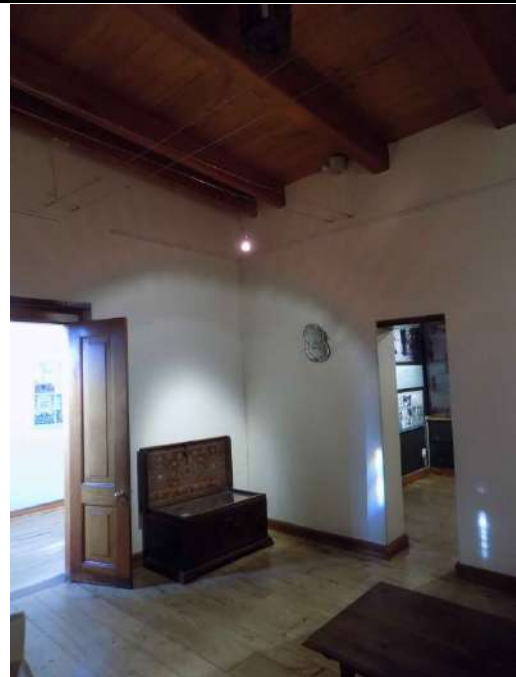
PROJECT	IZIKO MUSEUMS OF SOUTH AFRICA: EXISTING CONDITION BUILDING REPORTS AND 5-YEAR MAINTENANCE PLANS		
BUILDING	BO KAAP MUSEUM		
DOCUMENT	DATA SHEET		
	AREA	INTERNAL ROOMS	
		ROOM NUMBER	101
		ROOM NAME	EXHIBITION ROOM 1

Item	Description	Condition
Floor	Construction & finish	Suspended timber floor with varying width planking (yellow wood or similar)	Floor in good condition. Clear floor finish worn through in areas.
	Skirting	100 mm profiled timber skirting with varnish. Later addition.	Skirting in good condition.
	Services	None.	Not applicable.
Walls	Construction & finish	Plastered masonry with paint finish.	Plaster & paint in poor condition. Various areas with damp issues visible. Possibly from parapet walls
	Openings	600 x 2,100 opening to room 103	Opening in good condition.
	Dado	None.	Not applicable.
	Services	X4 plug points, PIR, catenary lights	See applicable services report.
Ceiling	Construction & finish	Timber planking on large format timber beams with varnish finish(yellow wood or similar).	See structural report. Ceiling visually in good condition.
	Cornice	None.	Not applicable.
	Services	Centre light fitting. Smoke detector	See applicable services report.

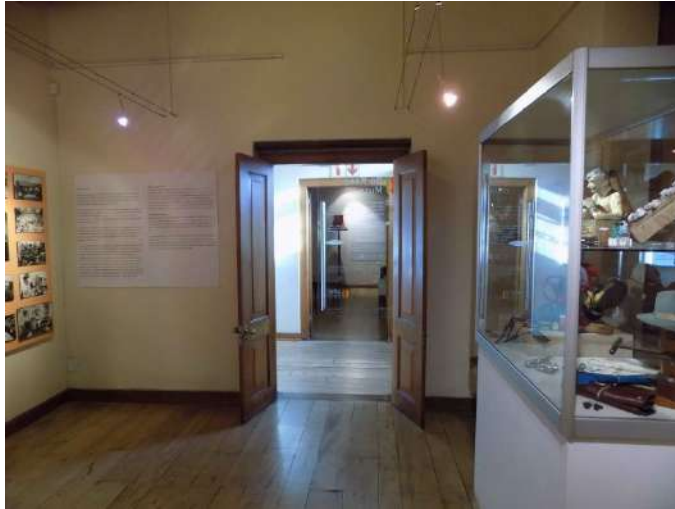
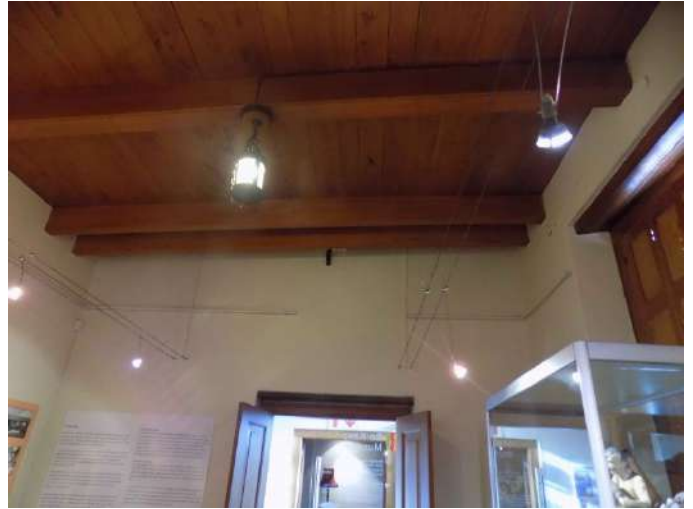
PROJECT	IZIKO MUSEUMS OF SOUTH AFRICA: EXISTING CONDITION BUILDING REPORTS AND 5-YEAR MAINTENANCE PLANS		
BUILDING	BO KAAP MUSEUM		
DOCUMENT	DATA SHEET		
	AREA	INTERNAL ROOMS	
		ROOM NUMBER	102
		ROOM NAME	EXHIBITION ROOM 3

Item	Description	Condition
Floor	Construction & finish	Suspended timber floor with varying width planking (yellow wood or similar)	Floor in good condition. Clear floor finish worn through in areas.
	Skirting	100 mm profiled timber skirting with varnish. Later addition.	Skirting in good condition.
	Services	None.	Not applicable.
Walls	Construction & finish	Plastered masonry with paint finish.	Plaster & paint in poor condition. Various areas with damp issues visible. Possibly from parapet walls
	Openings	None.	Not applicable.
	Dado	None.	Not applicable.
	Services	X4 plug points, PIR, catenary lights	See applicable services report.
Ceiling	Construction & finish	Timber planking on large format timber beams with varnish finish(yellow wood or similar).	See structural report. Ceiling visually in good condition.
	Cornice	None.	Not applicable.
	Services	Centre light fitting. Smoke detector	See applicable services report.

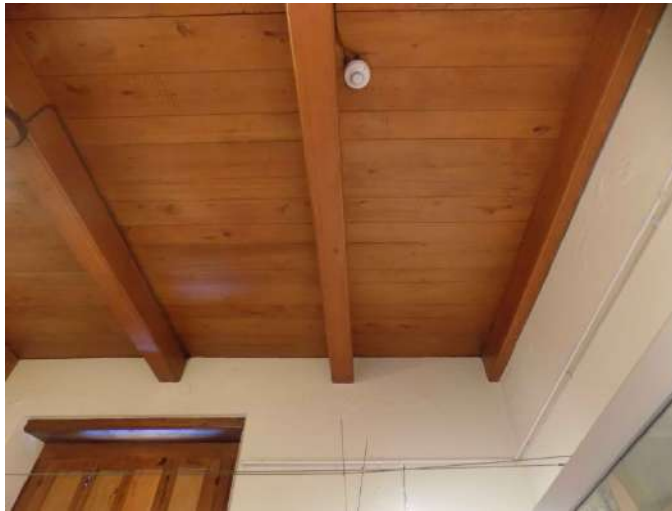
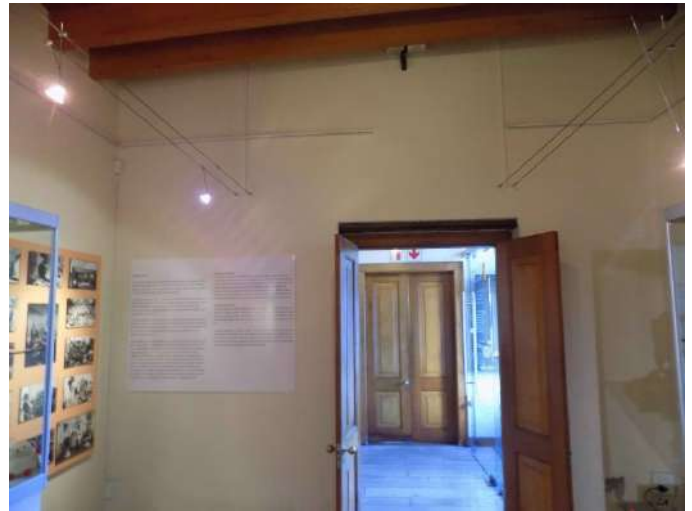
PROJECT	IZIKO MUSEUMS OF SOUTH AFRICA: EXISTING CONDITION BUILDING REPORTS AND 5-YEAR MAINTENANCE PLANS		
BUILDING	BO KAAP MUSEUM		
DOCUMENT	DATA SHEET		
	AREA	INTERNAL ROOMS	
		ROOM NUMBER	103
		ROOM NAME	EXHIBITION ROOM 2

Item	Description	Condition
Floor	Construction & finish	Suspended timber floor with varying width planking (yellow wood or similar)	Floor in good condition. Clear floor finish worn through in areas.
	Skirting	100 mm profiled timber skirting with varnish. Later addition.	Skirting in good condition.
	Services	None.	Not applicable.
Walls	Construction & finish	Plastered masonry with paint finish.	Plaster & paint in poor condition. Various areas with damp issues visible. Possibly from parapet walls
	Openings	600 x 2,100 opening to room 101 950 x 2,100 opening to room 104 with 70 x 114 timber frame with clear finish.	Openings in good condition. Frame in good condition.
	Dado	None.	Not applicable.
	Services	X4 plug points, PIR, catenary lights	See applicable services report.
Ceiling	Construction & finish	Timber planking on large format timber beams with varnish finish(yellow wood or similar).	See structural report. Ceiling visually in good condition.

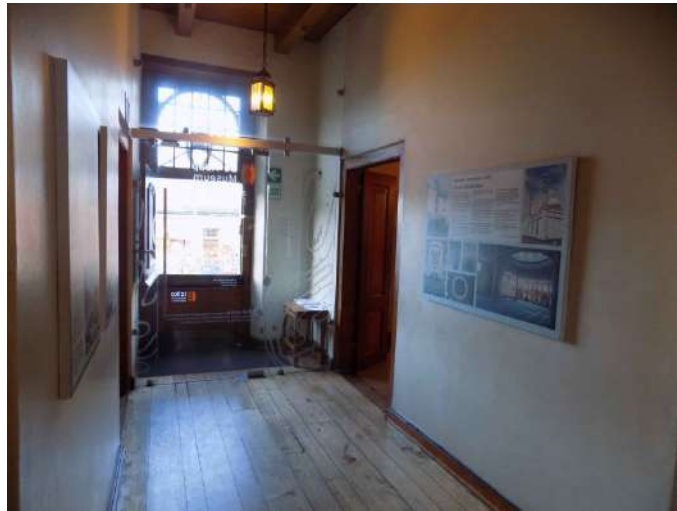
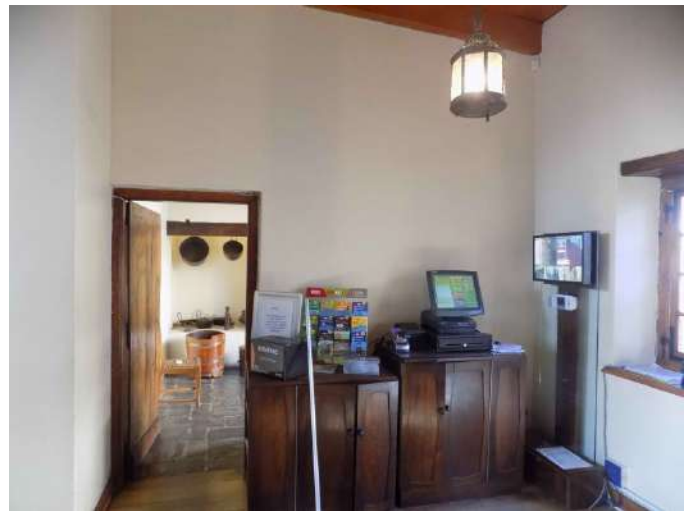
PROJECT	IZIKO MUSEUMS OF SOUTH AFRICA: EXISTING CONDITION BUILDING REPORTS AND 5-YEAR MAINTENANCE PLANS		
BUILDING	BO KAAP MUSEUM		
DOCUMENT	DATA SHEET		
	AREA	INTERNAL ROOMS	
		ROOM NUMBER	104
		ROOM NAME	INFO BOOTH

Item	Description	Condition
Floor	Construction & finish	Suspended timber floor with varying width planking (yellow wood or similar)	Floor in good condition. Clear floor finish worn through in areas.
	Skirting	100 mm profiled timber skirting with varnish. Later addition.	Skirting in good condition.
	Services	None.	Not applicable.
Walls	Construction & finish	Plastered masonry with paint finish.	Plaster & paint in poor condition. Various areas with damp issues visible from parapet walls.
	Openings	950 x 2,100 opening to room 104 with 70 x 114 timber frame with clear finish.	Openings in good condition. Frame in good condition.
	Dado	None.	Not applicable.
	Services	X4 plug points, PIR, catenary lights	See applicable services report.
Ceiling	Construction & finish	Timber planking on large format timber beams with varnish finish(yellow wood or similar).	See structural report. Ceiling visually in good condition.

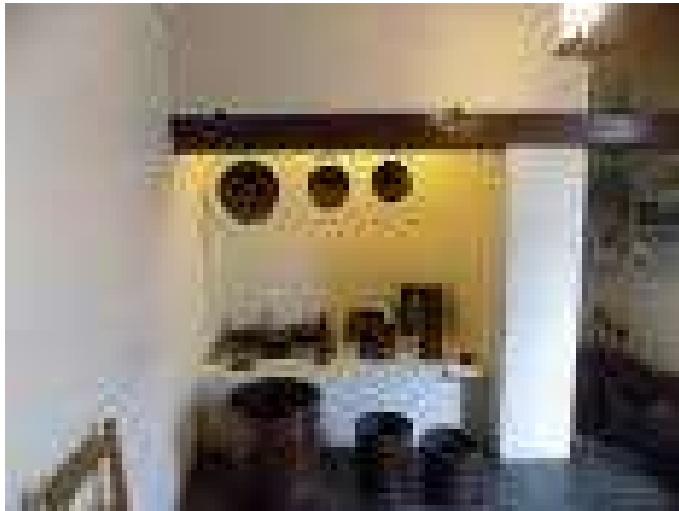
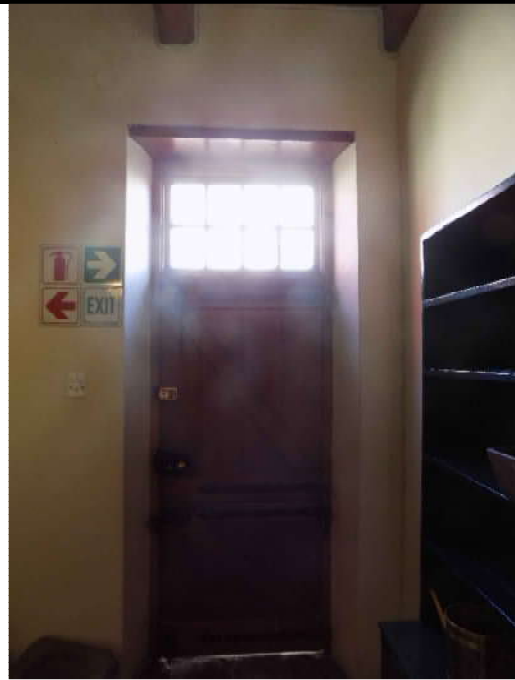
PROJECT	IZIKO MUSEUMS OF SOUTH AFRICA: EXISTING CONDITION BUILDING REPORTS AND 5-YEAR MAINTENANCE PLANS		
BUILDING	BO KAAP MUSEUM		
DOCUMENT	DATA SHEET		
	AREA	INTERNAL ROOMS	
		ROOM NUMBER	105
		ROOM NAME	EXHIBITION ROOM 4

Item	Description	Condition
Floor	Construction & finish	Slate tiles with clear finish on concrete surface bed.	Floor in good condition.
	Skirting	None.	Not applicable.
	Services	None.	Not applicable.
Walls	Construction & finish	Plastered masonry with paint finish.	Plaster & paint; fair condition spalling plaster in one area on internal wall
	Openings	1775 (w) x 1765 (h) chimney opening 1170 deep with 190 x 130 timber beam	Openings in good condition. Frame in good condition.
	Dado	None.	Not applicable.
	Services	X1 chandelier / lantern	See applicable services report.
Ceiling	Construction & finish	Timber planking on large format timber beams with varnish finish(yellow wood or similar).	See structural report. Ceiling visually in good condition.
	Cornice	None.	Not applicable.
	Services	X1 chandelier / lantern	See applicable services report.
Door 105	Size & description	950 x 2,100 hinged timber single door with clear varnish finish.

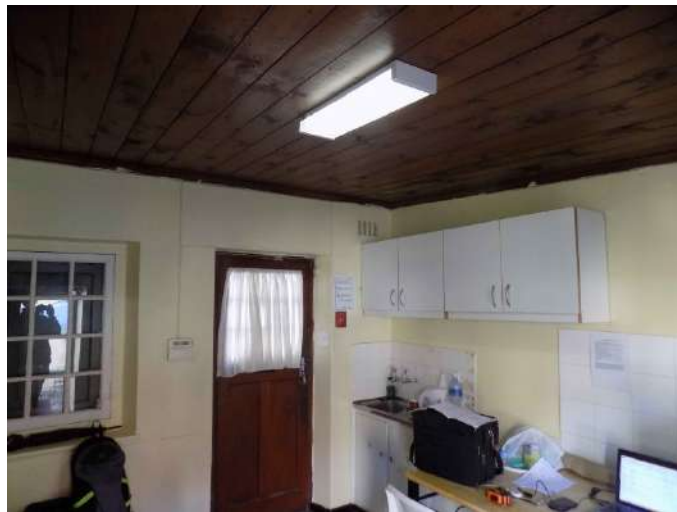
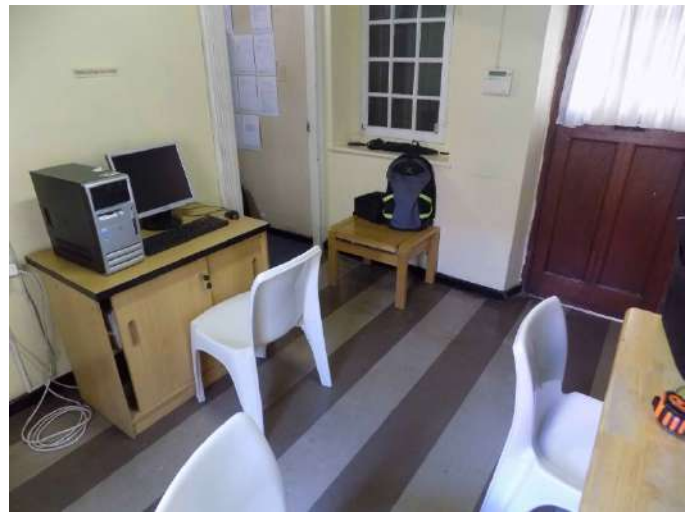
PROJECT	IZIKO MUSEUMS OF SOUTH AFRICA: EXISTING CONDITION BUILDING REPORTS AND 5-YEAR MAINTENANCE PLANS		
BUILDING	BO KAAP MUSEUM		
DOCUMENT	DATA SHEET		
	AREA	INTERNAL ROOMS	
		ROOM NUMBER	106
		ROOM NAME	STAFF KITCHEN

Item	Description	Condition
Floor	Construction & finish	Vinyl floor tiles cement screed and concrete surface bed..	Floor in fair condition.
	Skirting	75mm bullnose timber skirting with paint finish.	Skirting in fair condition.
	Services	None.	Not applicable.
Walls	Construction & finish	Plastered masonry with paint finish.	Plaster & paint in poor condition. Various areas with damp issues visible. Possibly from parapet walls
	Openings	None.	Not applicable.
	Dado	None.	Not applicable.
	Services	Various electrical services	See applicable services report.
Ceiling	Construction & finish	Timber tongue & groove planking with stain and varnish finish.	See structural report. Ceiling visually in good condition.
	Cornice	Coved timber cornice with stain and varnish finish.	Cornice in fair condition
	Services	Fluorescent light point.	See applicable services report.
Door 107	Size & description	985 x 2,095 hinged timber single stable door with internal clear finish and external paint finish.

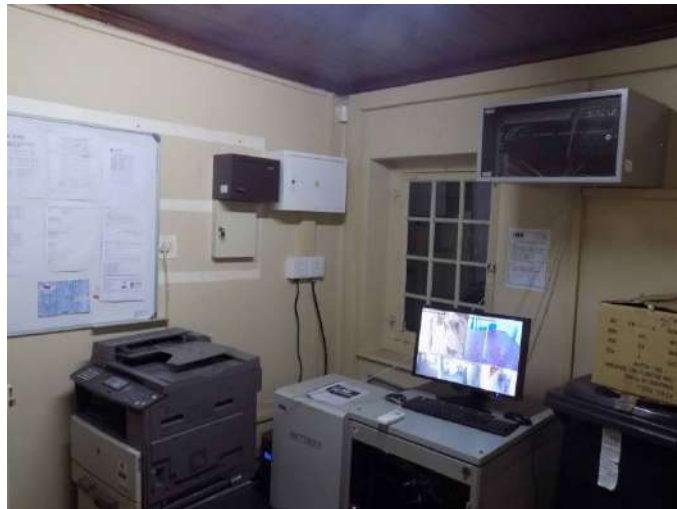
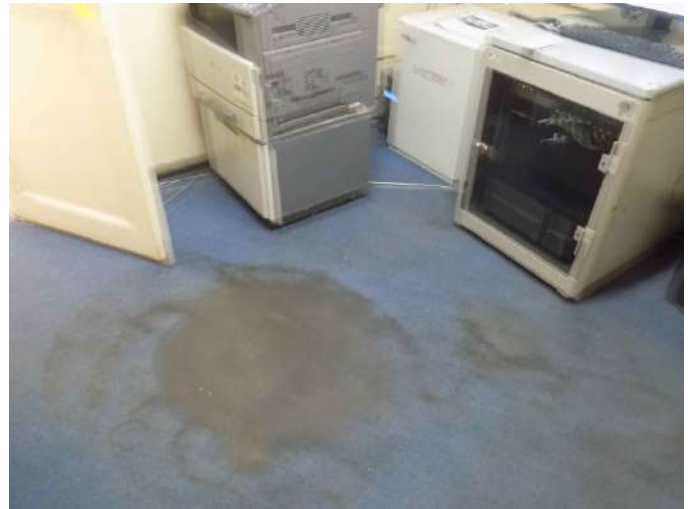
PROJECT	IZIKO MUSEUMS OF SOUTH AFRICA: EXISTING CONDITION BUILDING REPORTS AND 5-YEAR MAINTENANCE PLANS		
BUILDING	BO KAAP MUSEUM		
DOCUMENT	DATA SHEET		
	AREA	INTERNAL ROOMS	
		ROOM NUMBER	107
		ROOM NAME	SERVER ROOM

Item	Description	Condition
Floor	Construction & finish	Carpet on vinyl floor tiles cement screed and concrete surface bed..	Floor in poor condition. Carpet heavily stained.
	Skirting	75mm bullnose timber skirting with paint finish.	Skirting in fair condition.
	Services	None.	Not applicable.
Walls	Construction & finish	Plastered masonry with paint finish.	Plaster & paint in poor condition. Various areas with damp issues visible. Possibly from parapet walls
	Openings	None.	Not applicable.
	Dado	None.	Not applicable.
	Services	Various electrical services	See applicable services report.
Ceiling	Construction & finish	Timber tongue & groove planking with stain and varnish finish.	See structural report. Ceiling visually in good condition.
	Cornice	Coved timber cornice with stain and varnish finish.	Cornice in fair condition
	Services	Fluorescent light point.	See applicable services report.
	Frame & architrave	70 x 114 timber frame with internal clear finish and external paint finish.	Frame in fair condition.

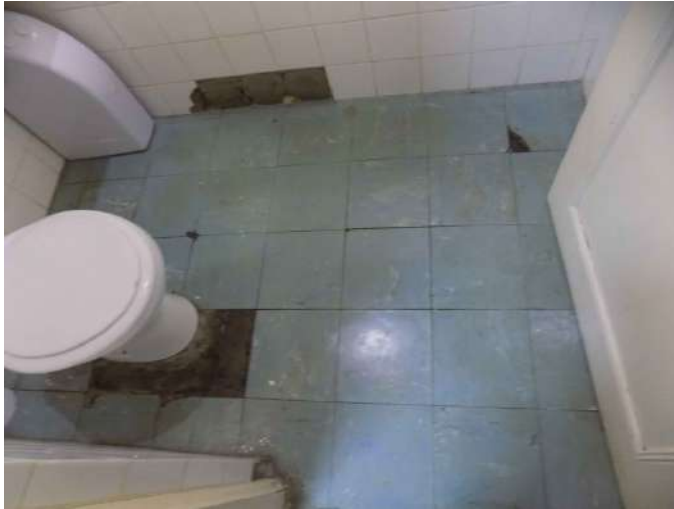
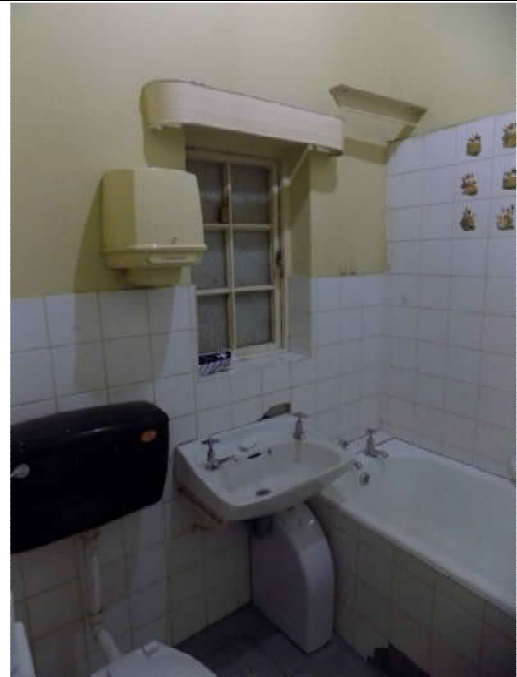
PROJECT	IZIKO MUSEUMS OF SOUTH AFRICA: EXISTING CONDITION BUILDING REPORTS AND 5-YEAR MAINTENANCE PLANS		
BUILDING	BO KAAP MUSEUM		
DOCUMENT	DATA SHEET		
	AREA	INTERNAL ROOMS	
		ROOM NUMBER	108
		ROOM NAME	WC

Item	Description	Condition
Floor	Construction & finish	Vinyl floor tiles cement screed and concrete surface bed..	Floor in poor condition. Tiles broken and missing.
	Skirting	None.	Not applicable.
	Services	None.	Not applicable.
Walls	Construction & finish	Plastered masonry with paint finish. Ceramic wall tiles	Plaster & paint in fair condition. Tiles cracked, broken and missing.
	Openings	None.	Not applicable.
	Dado	None.	Not applicable.
	Services	Various electrical services	See applicable services report.
	Ceiling	Construction & finish	Timber tongue & groove planking with stain and varnish finish.
	Cornice	Coved timber cornice with stain and varnish finish.	Cornice in fair condition
	Services	Fluorescent light point.	See applicable services report.
Door 110	Size & description	985 x 2,095 hinged timber single door with paint finish.	
	Frame & architrave	70 x 114 timber frame with paint finish. Profiled timber architrave with paint finish.	Frame in fair condition. Profiled timber architrave with paint finish.

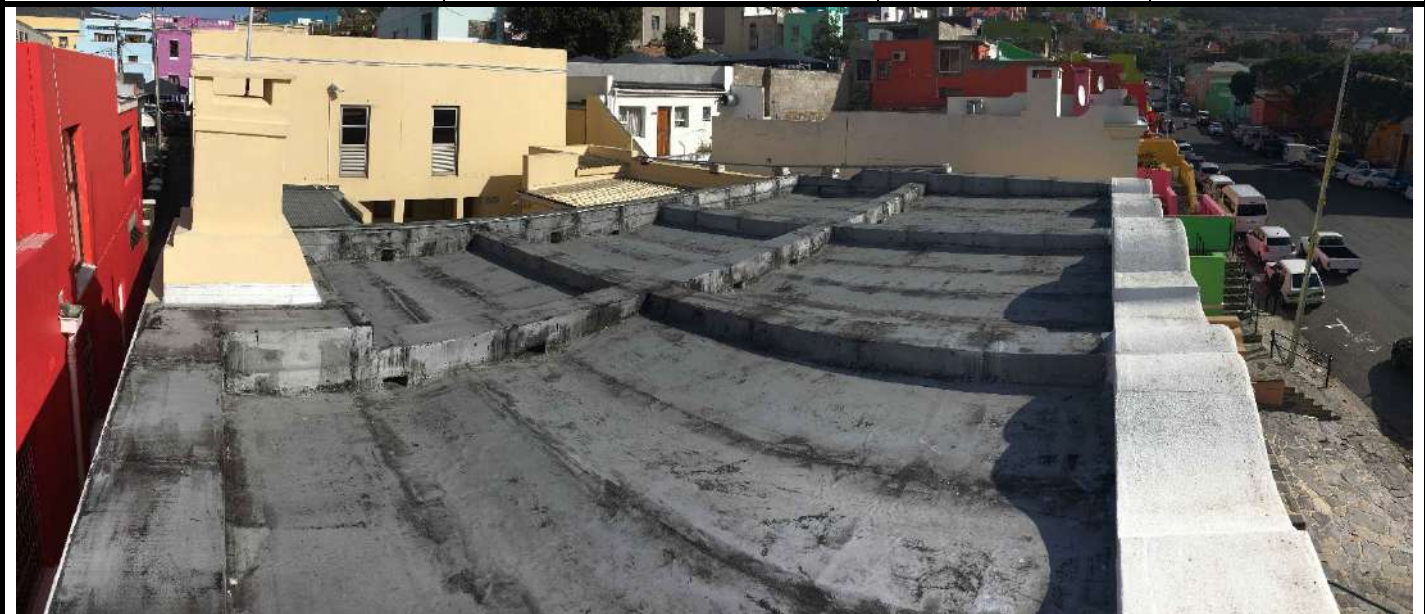
Item	Description	Condition
Roofs	Construction & finish	Concrete slab with torch on waterproofing.	Waterproofing worn through.
	Flashings	Torch-on counter flashing	Flashing worn through.
	Rainwater equipment	Custom made plastic spouts.	Spots in poor condition.
Walls	Type	Plastered masonry with torch-on waterproofing.	Walls in fair condition. Waterproofing poor.
	Openings	Various openings to allow water runoff to spouts	Openings in fair condition.
	Services	None.	Not applicable.
Skylights & roof Windows	Size & description		
	Frame	None.	Not applicable.
	Opener	None.	Not applicable.
	Flashing	None.	Not applicable.
	Glazing	None.	Not applicable.
	Ironmongery	None.	Not applicable.
Equipment & fixtures	Electrical	Minor electrical conduiting.	See applicable services report.
	Mechanical	Minor mechanical conduiting.	See applicable services report.
	Other	None.	Not applicable.

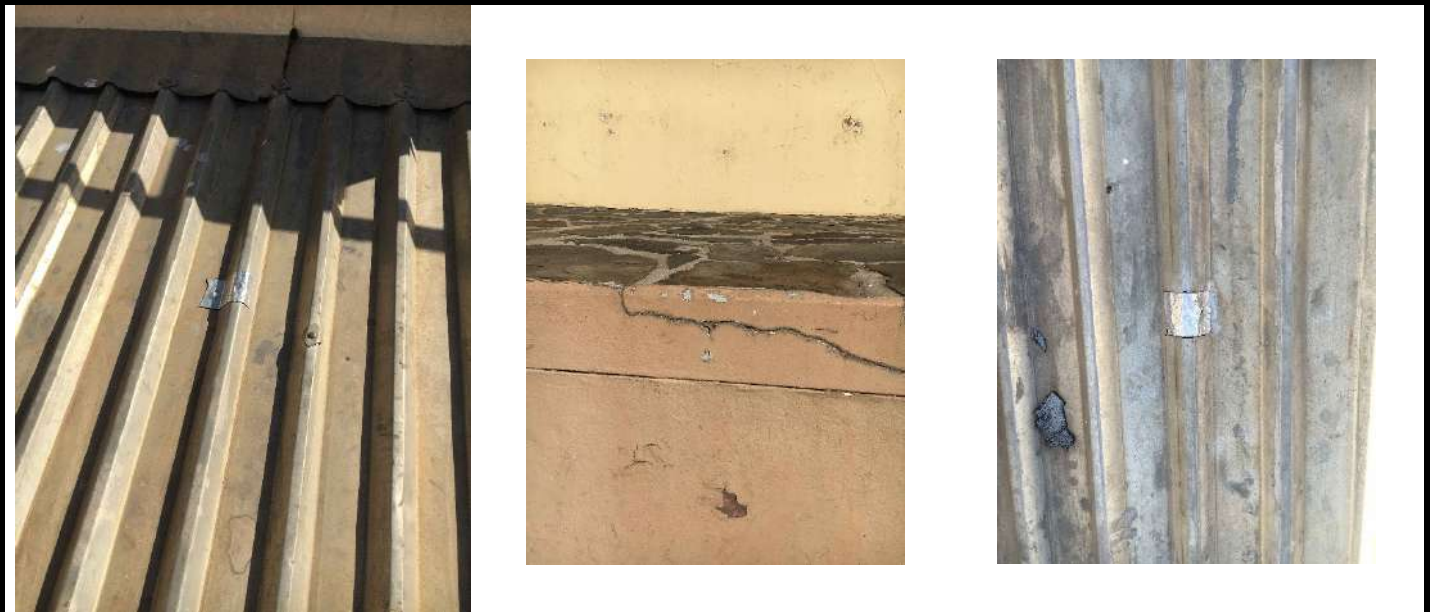
Item	Description	Condition
Roofs	Construction & finish	Galvanised IBR roof sheets	Sheeting in poor condition.
	Flashings	Steel counter flashing over	Flashing worn through.
	Rainwater equipment	Clay Gutters and downpipe.	Equipment in poor condition.
Walls	Type	Plastered masonry with slate tiles	Water seepage visible on parapet
	Openings	None.	Not applicable.
	Services	None.	Not applicable.
Skylights & roof Windows	Size & description		
	Frame	None.	Not applicable.
	Opener	None.	Not applicable.
	Flashing	None.	Not applicable.
	Glazing	None.	Not applicable.
	Ironmongery	None.	Not applicable.
Equipment & fixtures	Electrical	Minor electrical conduiting.	See applicable services report.
	Mechanical	Minor mechanical conduiting.	See applicable services report.
	Other	None.	Not applicable.

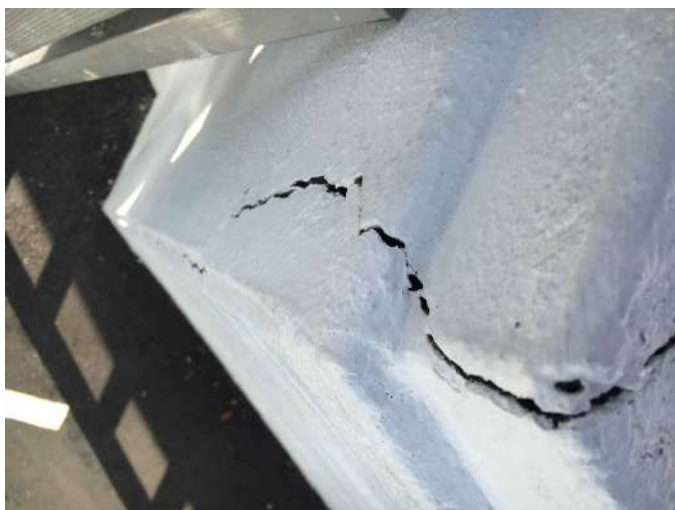
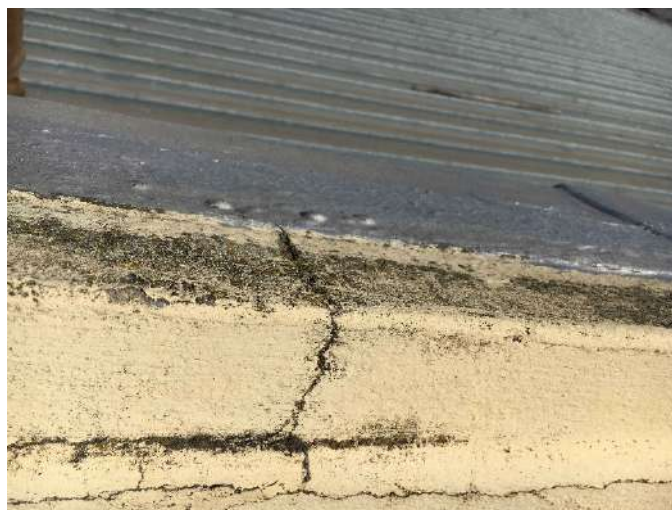
Item	Description	Condition
Roofs	Construction & finish	Galvanised IBR roof sheets	Sheeting in poor condition.
	Flashings	Steel counter flashing over	Flashing in poor condition.
	Rainwater equipment	Metal box gutter and downpipe.	Equipment in poor condition.
Walls	Type	Plastered masonry with paint finish.	Parapets in poor condition. Water seepage evident.
	Openings	None.	Not applicable.
	Services	None.	Not applicable.
Skylights & roof Windows	Size & description		
	Frame	None.	Not applicable.
	Opener	None.	Not applicable.
	Flashing	None.	Not applicable.
	Glazing	None.	Not applicable.
	Ironmongery	None.	Not applicable.
Equipment & fixtures	Electrical	None.	Not applicable.
	Mechanical	None.	Not applicable.
	Other	None.	Not applicable.

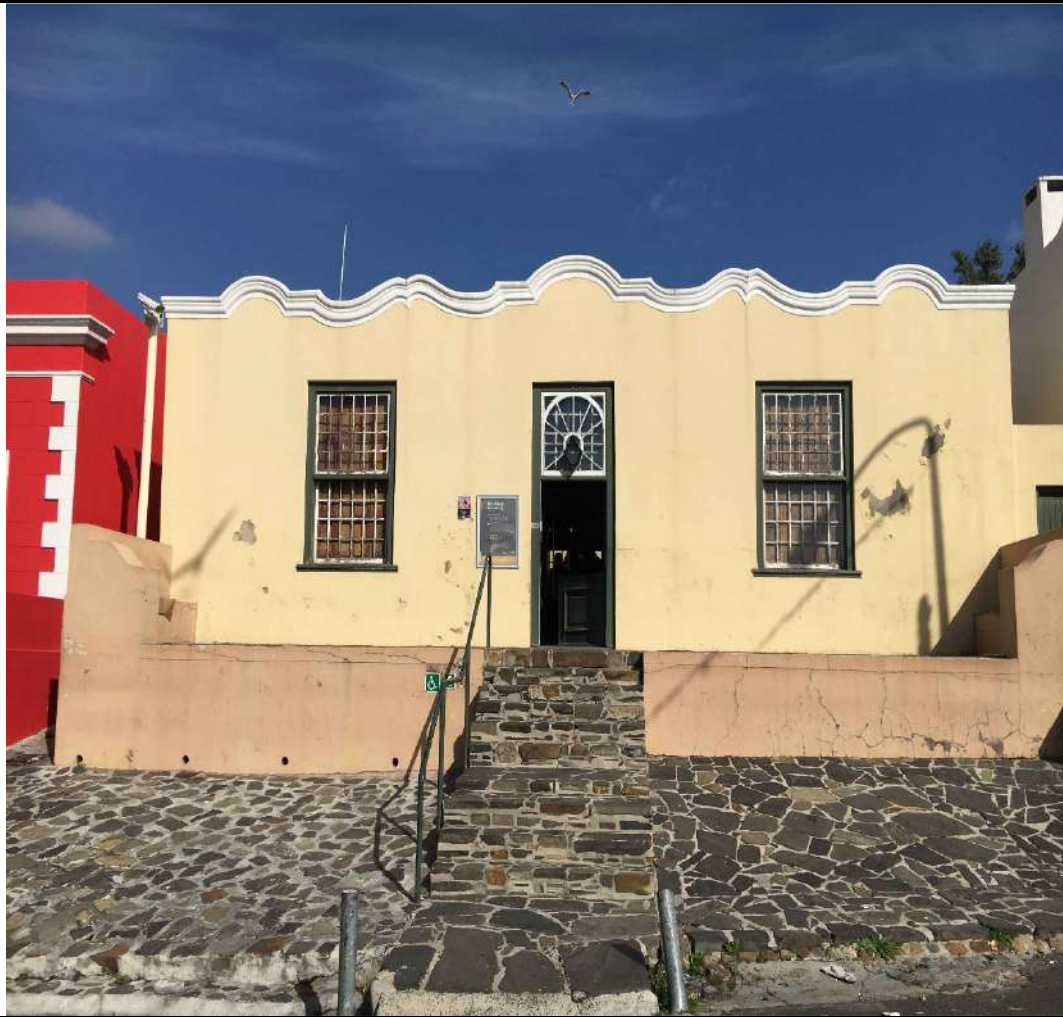
Item	Description	Condition
Floor	Construction & finish	Slate paving with non-slip rough finish	Floor in good condition.
	Skirting	None.	Not applicable.
	Services	Stormwater pipes, manholes and	See applicable services report.
Walls	Construction & finish	Plastered masonry with paint finish.	Walls in reasonable condition.
	Openings	None.	Not applicable.
	Mouldings	Plaster moulds on top of parapet with paint finish.	Mouldings in good condition.
	Services	Various stormwater and electrical services	See applicable services report.
Door	See room 104.		
Window	See room 101 and 102		
Equipment & fixtures	Electrical	None.	Not applicable.
	Mechanical	Rain water sleeves	Sleeves in good condition.
	Other	Staircase and balustrade	Paint worn out.

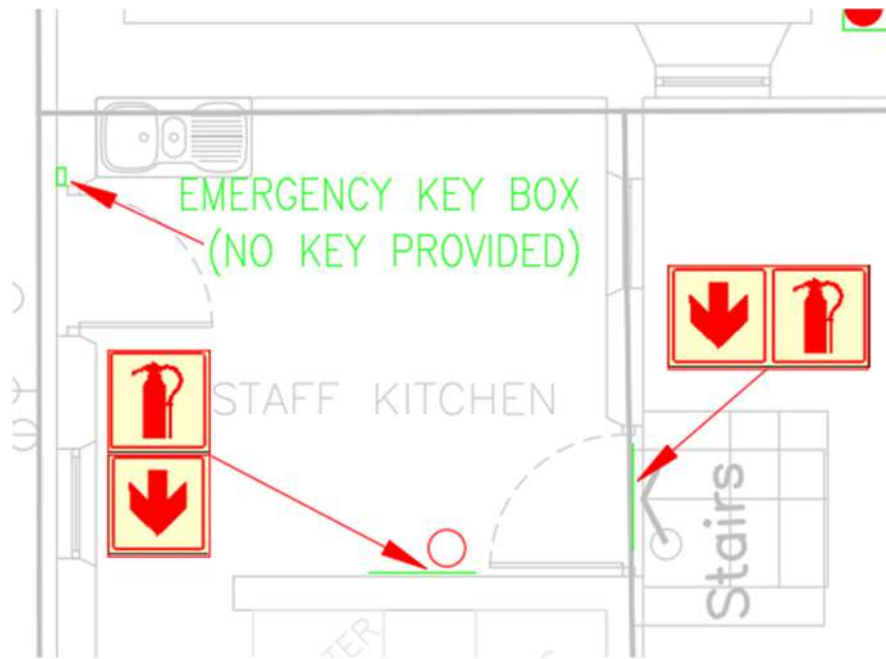
NOTES		
FIRE PROTECTION	Condition	Fire signage in order. No key provided in emergency key box.
	Recommendation	Remove existing key box.
HVAC	Condition	-
	Recommendation	
DOMESTIC WATER STORAGE	Condition	-
	Recommendation

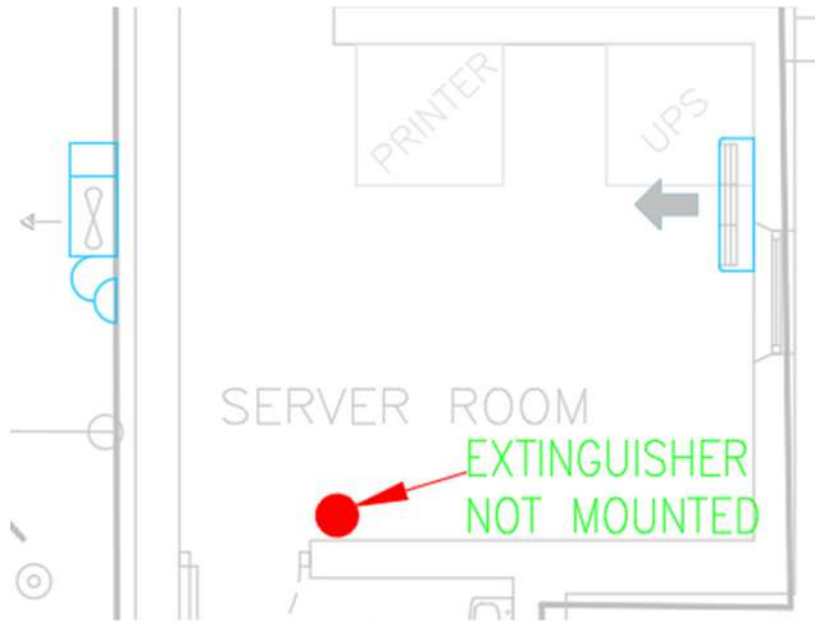
**ROOM No:
Server Room**

NOTES
FIRE PROTECTION	Condition	Extinguisher not mounted. No fire signage for extinguisher.
	Recommendation	Extinguisher to be provided with wooden backing board and mounted at correct height. Signage to be installed.
HVAC	Condition	Mid wall unit in working condition.
	Recommendation	Mechanical fresh air to be provided.
DOMESTIC WATER STORAGE	Condition	
	Recommendation

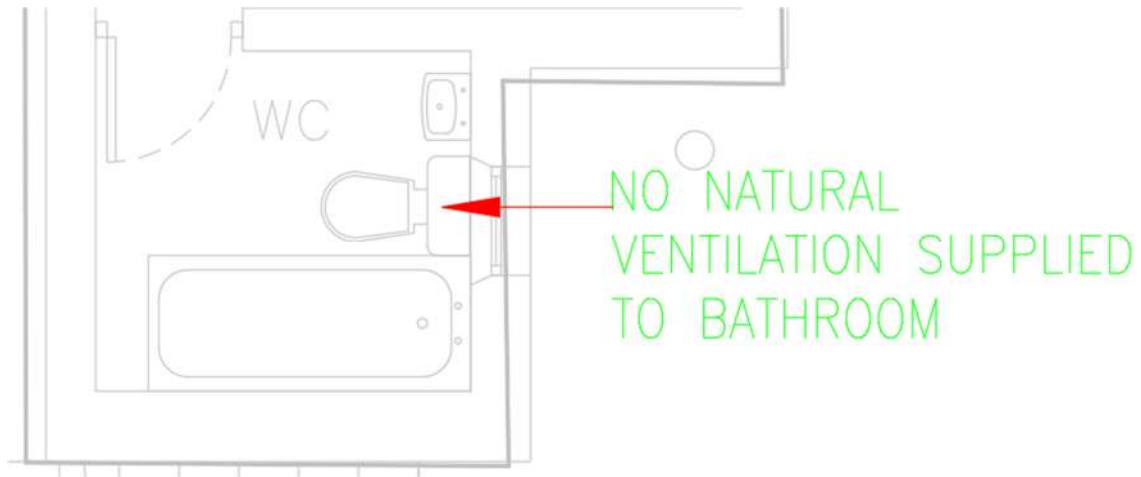
**ROOM No:
Bathroom**

NOTES		
FIRE PROTECTION	Condition	-
	Recommendation	
HVAC	Condition	No natural ventilation supplied to bathroom.
	Recommendation	Mechanical extraction fan to be installed.
D O P	Condition	-
	Recommendation

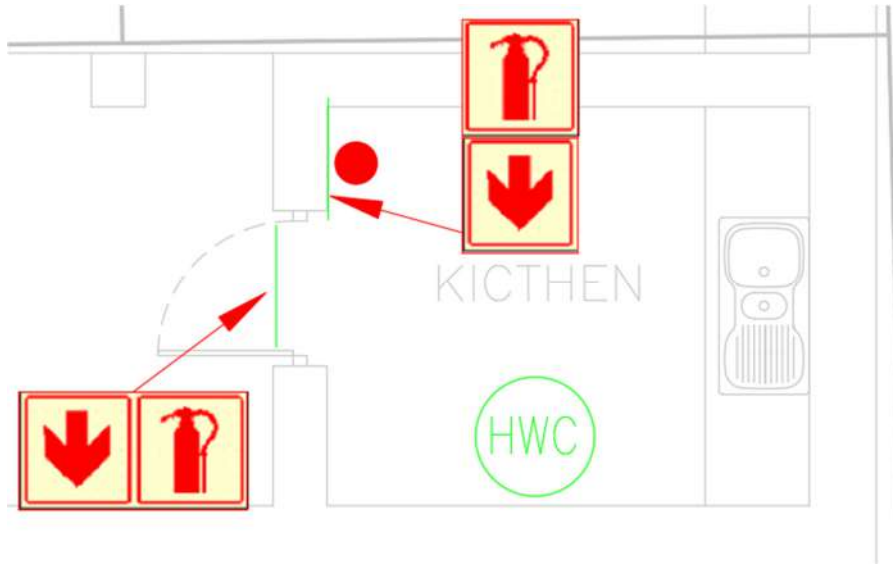
NOTES
FIRE PROTECTION	Condition	Fire equipment & fire signage in order.
	Recommendation	
HVAC	Condition	-
	Recommendation	
DOMESTIC WATER STORAGE	Condition	Geyser fairly old, but still in working condition.
	Recommendation	Geyser to be replaced with heat pump / solar technology.

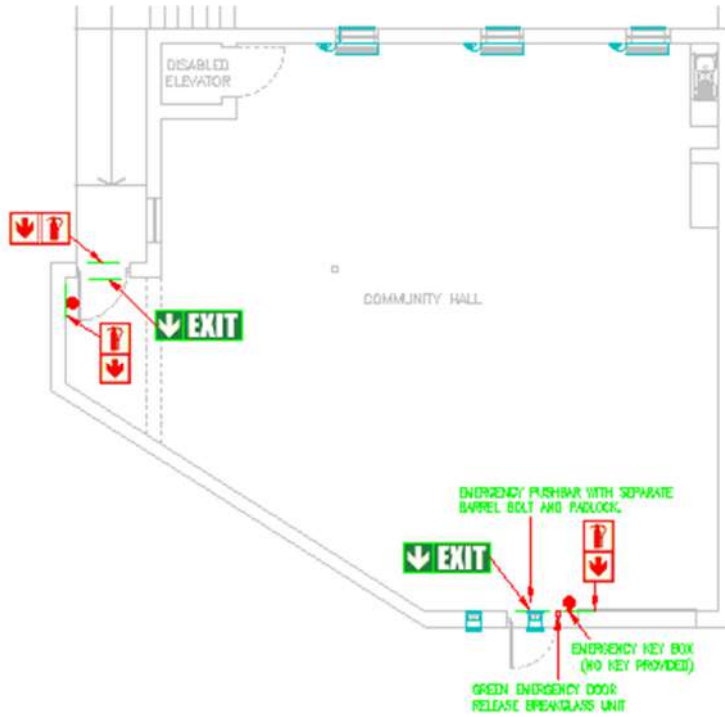
NOTES
FIRE PROTECTION	Condition	Fire signage in order. Escape door provided with emergency push bar, barrel bolt with padlock as well as an access-controlled maglock. No key provided in box for padlock.
	Recommendation	Barrel bolt, padlock & key box to be removed. Emergency push bar to be removed.
HVAC	Condition	All in working condition, but fairly old.
	Recommendation	Units to be replaced with inverter driven, energy efficient air conditioning units.
DOMESTIC WATER STORAGE	Condition	-
	Recommendation

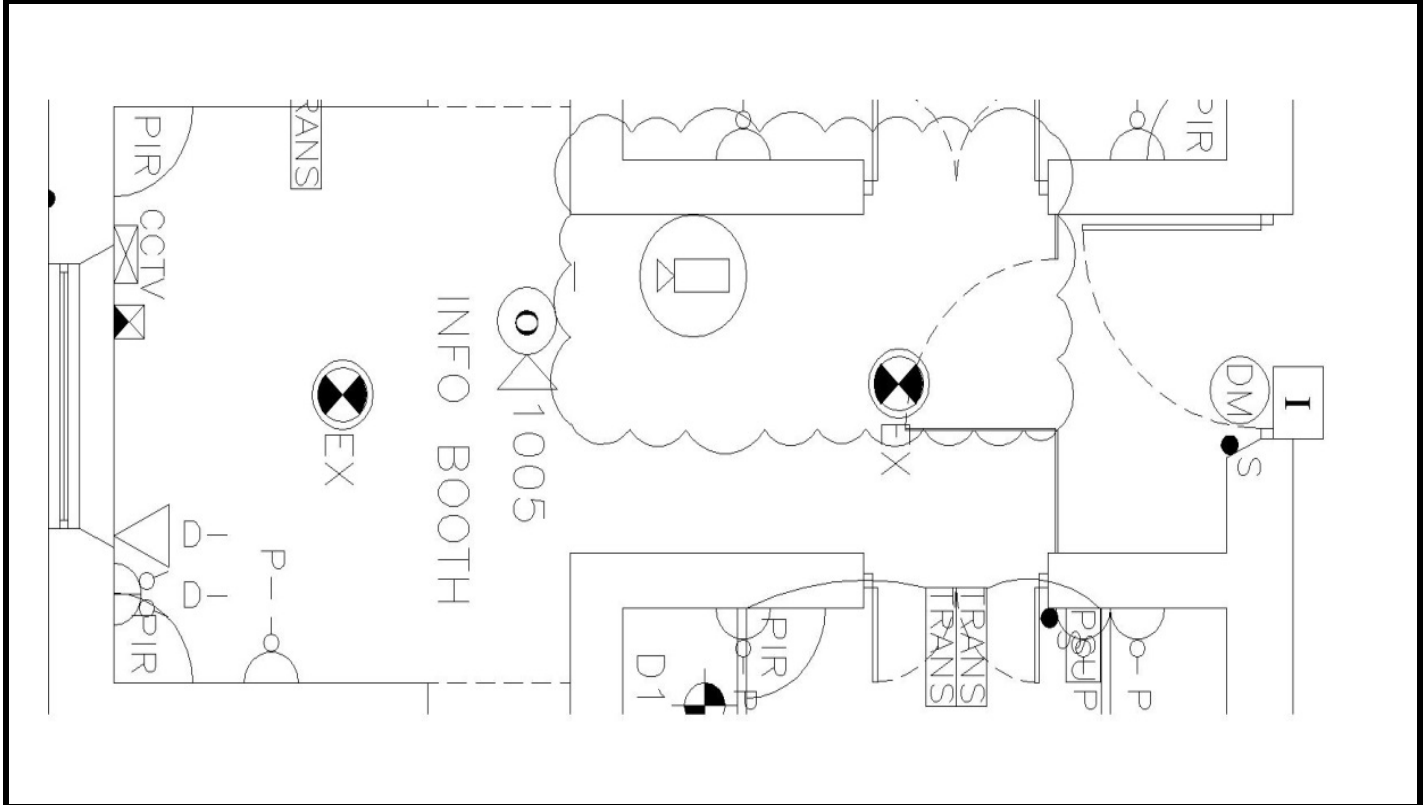
NOTES	
PLUGS	Condition The plugs in this room are in a reasonable state. There is a mixture of surface mounted and flush mounted plugs. Extension cords are connected to some plug socket outlets. Data and telephone cabling all surface along wall.
	Recommendation Remove all surface mounted socket outlets & wiring and supply install 2 compartment power skirting with new 16A Single SSO's, data outlets and telephone points.
	Type of plugs 4x4 16A Single SSO, data and telephone
	Wiring To be removed and replaced.
LIGHTING	Existing Lighting 2 x Pendant lights. Lighting (lux) levels in this room seems to be adequate.
	Wiring To be insulation tested and replaced based on typed report.
	Recommendation Re-lamp existing light fittings with energy efficient light fittings.
ACCESS CONTROL	Condition The entire access control / alarm & CCTV installation are done in surface wiring glued along the walls or via Ega ducting

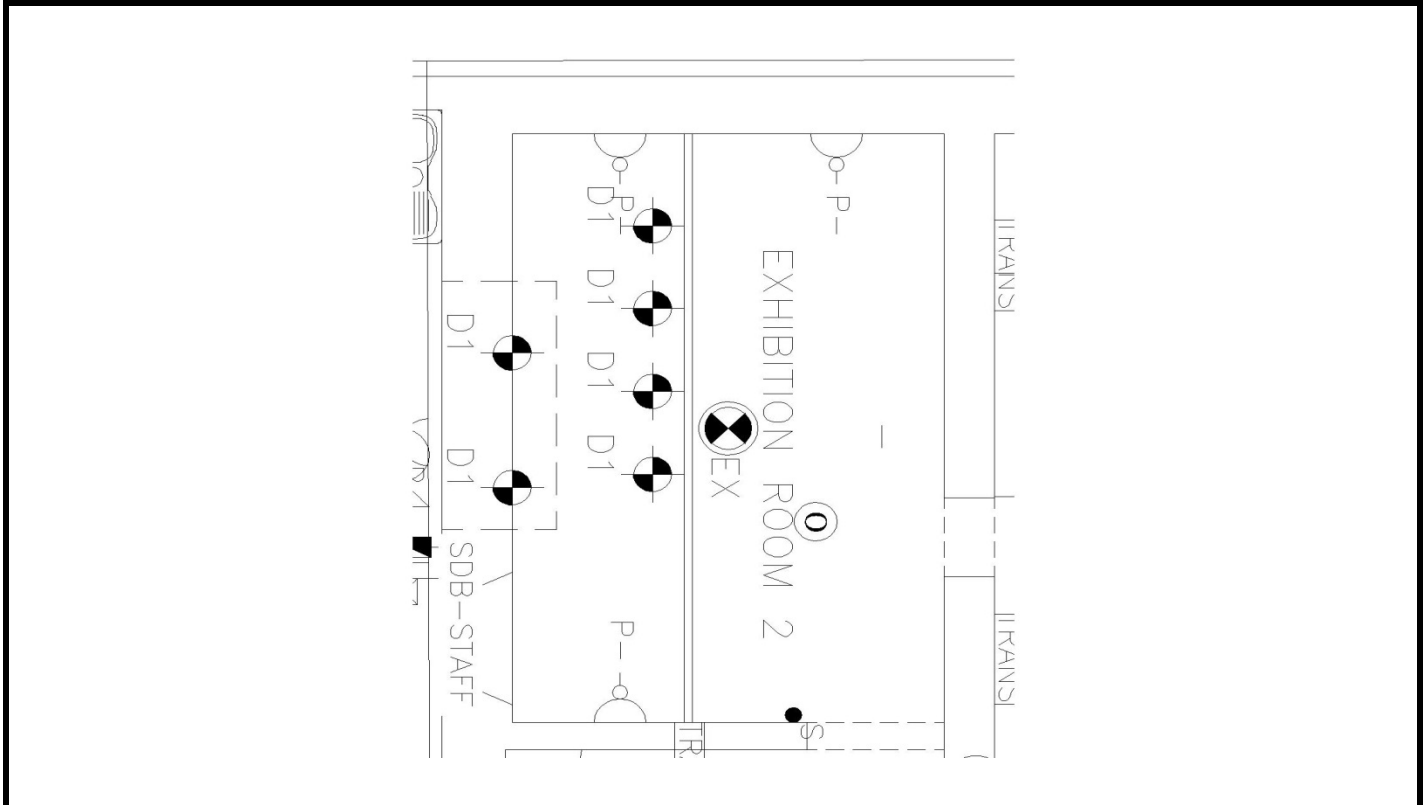
NOTES	
PLUGS	Condition The plugs are in a reasonable state. Surface electrical wiring connected directly from the plugs.
Recommendation	The surface plugs will have to be removed and wiring chased-in via conduiting. All plugs will have to be earth leakage tested and replaced based on report.
Type of plugs	4x4 16A Double SSO.
Wiring	To be insulation tested and replaced based on typed report.
LIGHTING	Existing Lighting Existing pendant light fittings and open wire halogen down lights with exposed transformers. Lighting (lux) levels in this room seems to be adequate.
Wiring	To be insulation tested and replaced based on typed report.
Recommendation	Existing pendant light fittings to remain but should be re-lamped with energy efficient lamp. Remove existing open wire down light system and replace with LED track down light system.
Condition	The entire access control / alarm & CCTV installation are done in surface wiring glued along the walls or via Ega ducting.

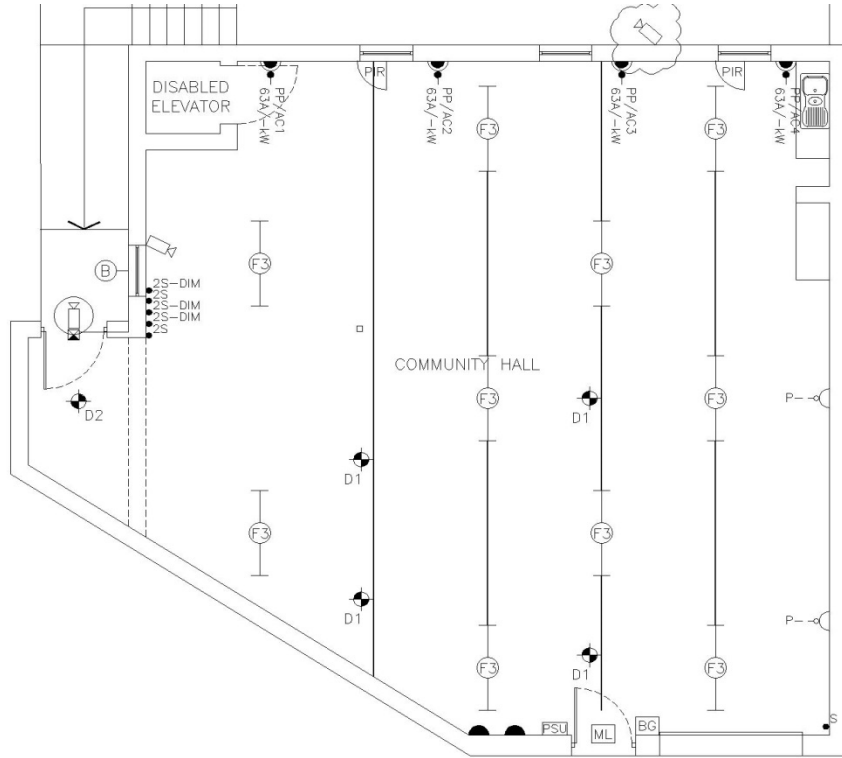
NOTES		
PLUGS	Condition	Plugs sockets and isolator in this area are in a poor state. Some extract fans are plugged in 6 amp sockets
	Recommendation	Remove and replace all plug sockets. Remove all 6amp sockets that connected to extract air fans and replace with isolators. Isolators to Console AC units isolators to be replaced and wire ways to be chased-in to units
	Type of plugs	Various
	Wiring	Electrical wiring to be insulation tested and replaced based on typed report. Some extract fans might be connected on lighting circuits, these circuits must be separated and wiring replaced.
LIGHTING	Existing Lighting	Light fittings indicated as per layout. Lighting lux levels in this area is adequate.
	Wiring	To be insulation tested and replaced based on typed report.
	Recommendation	Replace halogen track down light lamps with LED lamps.
ACCESS CONTROL	Condition	The entire access control / alarm & CCTV installation are done in surface wiring glued along the walls or via Ega ducting.

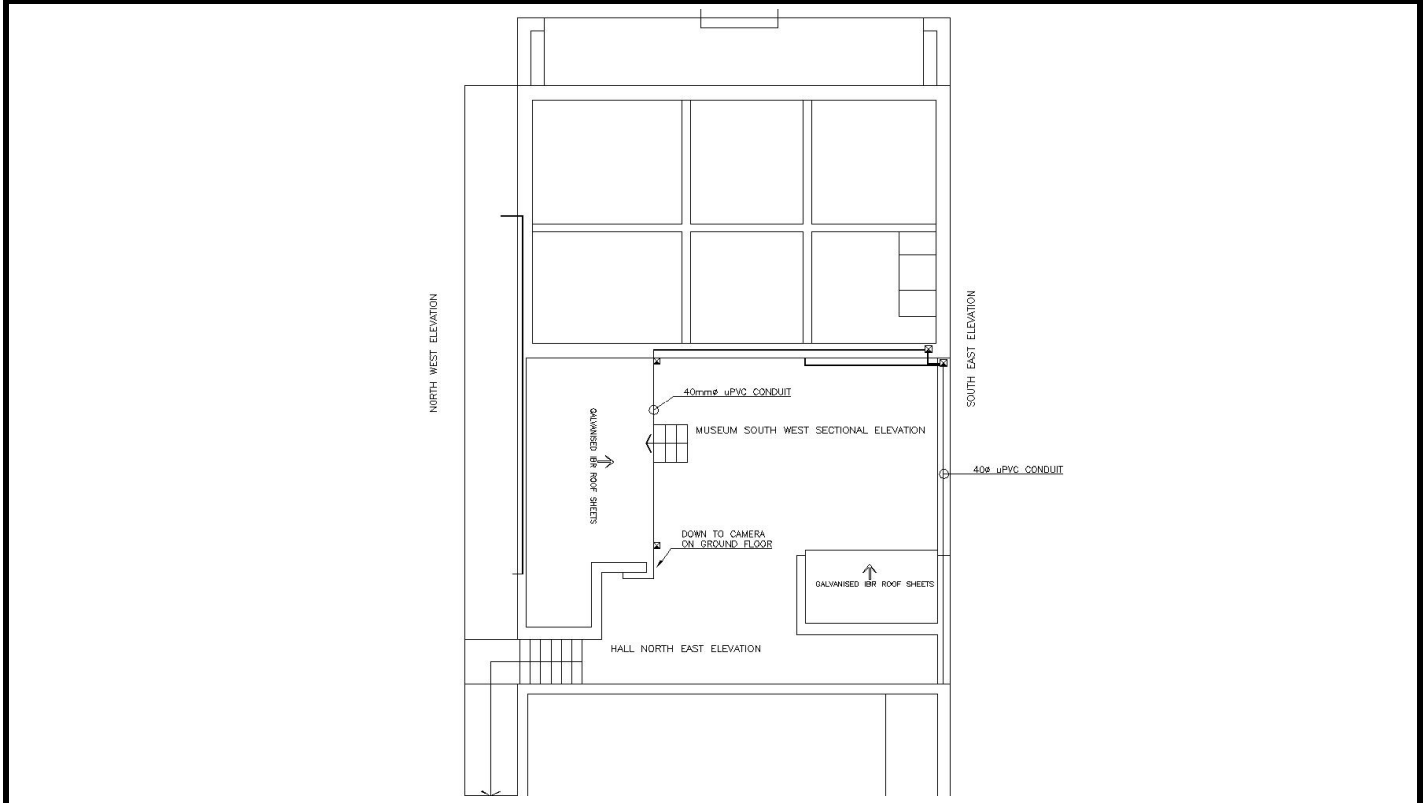
NOTES		
PLUGS	Condition	Existing conduits are not properly saddled onto parapet wall. Concrete blocks are loosely stacked on top of each other, this poses a safety risk. Round boxes externally installed not all IP65 rated.
	Recommendation	Safely remove concrete blocks and install proper bends on galvanised conduit. Saddles to be spaced according SANS 10142 regulations. IP65 rated draw boxes to be installed externally.
	Type of plugs	N/A
	Wiring	N/A
LIGHTING	Existing Lighting	N/A
	Wiring	N/A
	Recommendation	N/A
ACCESS CONTROL	Condition	Currently no Access Control on roof.
	Recommendation	Install a few Outdoor cameras to monitor the roof.
