PROJECT:
Roofscape Renovation, Repairs and Upgrading.
Iziko Building - BO-KAAP MUSEUM (IBK)
21 Whale Street, Cape Town
FOR Iziko Facilities Management
ON March 2023

DRAWING TITLE:
Roof Plan
Iziko Bo-Kaap Museum (IBK)

BO-KAAP MUSEUM

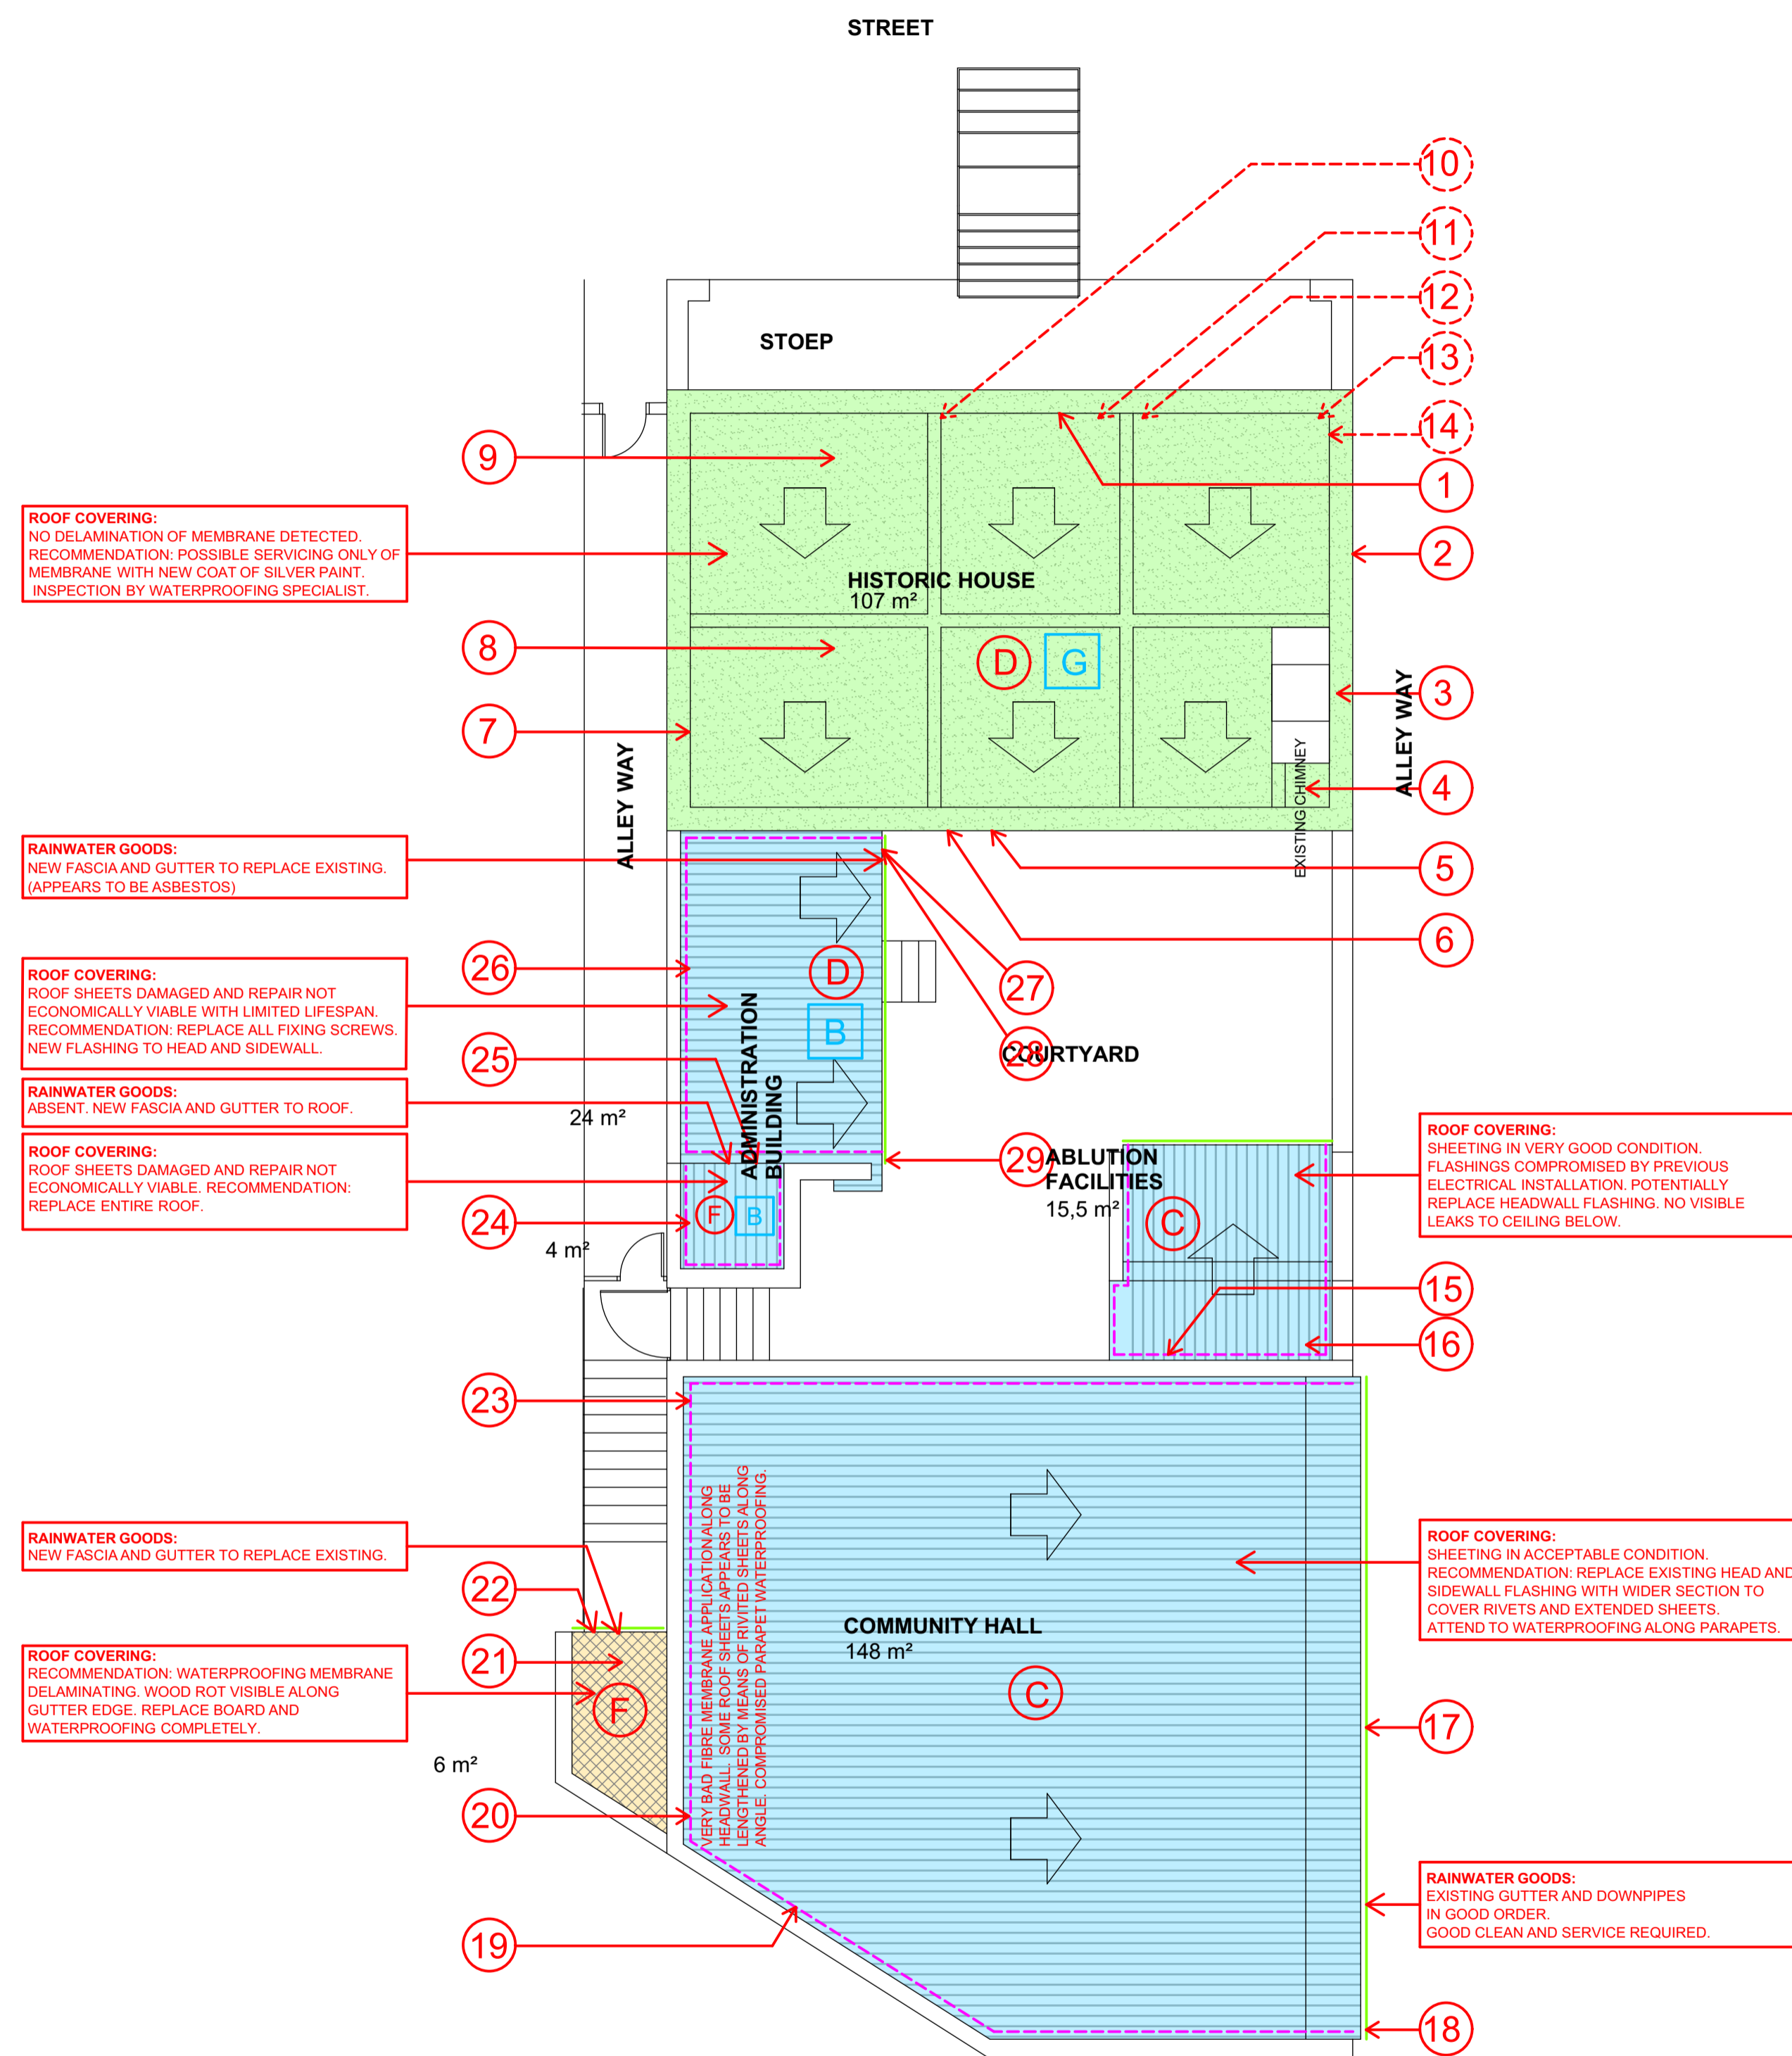
ROOF PLAN LAYOUT 1:100

ROOF COVERING:
NO DELAMINATION OF MEMBRANE DETECTED.
RECOMMENDATION: POSSIBLE SERVICING ONLY OF
MEMBRANE WITH NEW COAT OF SILVER PAINT.
INSPECTION BY WATERPROOFING SPECIALIST.

RAINWATER GOODS:
NEW FASCIA AND GUTTER TO REPLACE EXISTING.
(APPEARS TO BE ASBESTOS)

ROOF COVERING:
ROOF SHEETS DAMAGED AND REPAIR NOT
ECONOMICALLY VIABLE WITH LIMITED LIFESPAN.
RECOMMENDATION: REPLACE ALL FIXING SCREWS.
NEW FLASHING TO HEAD AND SIDEWALL.

RAINWATER GOODS:
ABSENT. NEW FASCIA AND GUTTER TO ROOF.

ROOF COVERING:
ROOF SHEETS DAMAGED AND REPAIR NOT
ECONOMICALLY VIABLE. RECOMMENDATION:
REPLACE ENTIRE ROOF.

RAINWATER GOODS:
NEW FASCIA AND GUTTER TO REPLACE EXISTING.

ROOF COVERING:
RECOMMENDATION: WATERPROOFING MEMBRANE
DELAMINATING. WOOD ROT VISIBLE ALONG
GUTTER EDGE. REPLACE BOARD AND
WATERPROOFING COMPLETELY.

ROOF COVERING:
SHEETING IN VERY GOOD CONDITION.
FLASHINGS COMPROMISED BY PREVIOUS
ELECTRICAL INSTALLATION. POTENTIALLY
REPLACE HEADWALL FLASHING. NO VISIBLE
LEAKS TO CEILING BELOW.

ROOF COVERING:
SHEETING IN ACCEPTABLE CONDITION.
RECOMMENDATION: REPLACE EXISTING HEAD AND
SIDEWALL FLASHING WITH WIDER SECTION TO
COVER RIVETS AND EXTENDED SHEETS.
ATTEND TO WATERPROOFING ALONG PARAPETS.

RAINWATER GOODS:
EXISTING GUTTER AND DOWNPIPES
IN GOOD ORDER.
GOOD CLEAN AND SERVICE REQUIRED.
