February 23rd 2023

WATERPROOFING REPORT FOR BOO-KAAP MUSEUM, 71 WALE ST. CAPE TOWN

ROOF INSPECTION ON 17TH FEBRUARY

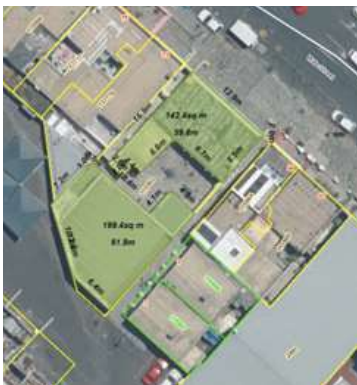
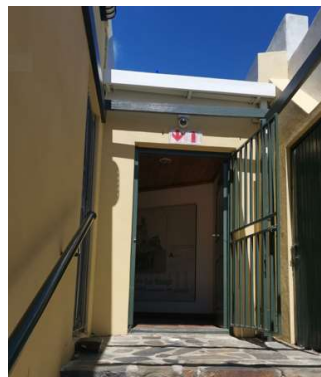
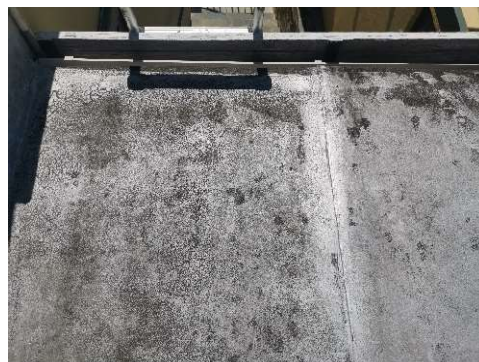
ENTRANCE ROOF TO COMMUNITY CENTRE.

The waterproofing is basically sound.

Clean debris in gutter.

Wire brush surface and apply two coats of water based Bituminous Aluminium paint.

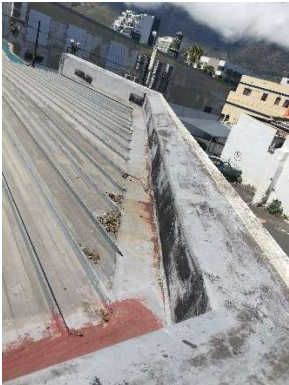
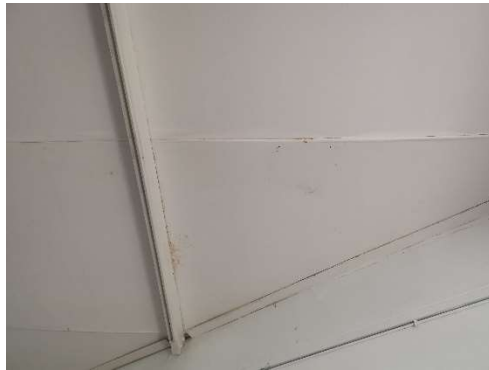
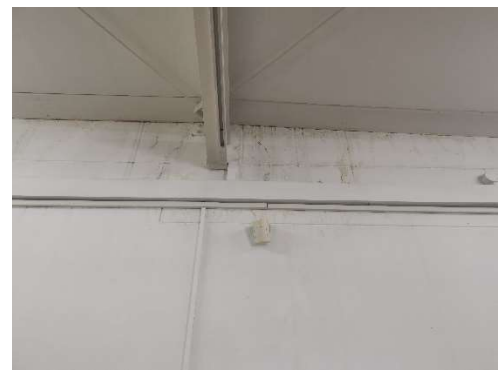
UPPER ROOF TO COMMUNITY CENTRE

I would recommend that this roof replaced shortly as there are signs of water ingress below roof head and along gutter above windows.

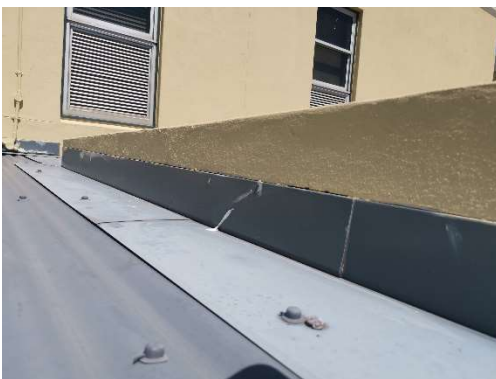
ABLUTION BLOCK TO COMMUNITY CENTRE

Roof appears sound with no sign of water ingress.

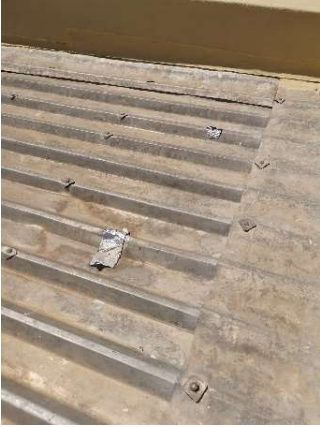
LOWER ROOF AND ROOF TO MAIN BUILDING

Although some fixings have been treated with Flash Harry self adhesive patches there is no evidence of any water ingress. Keep monitoring roof over winter period.

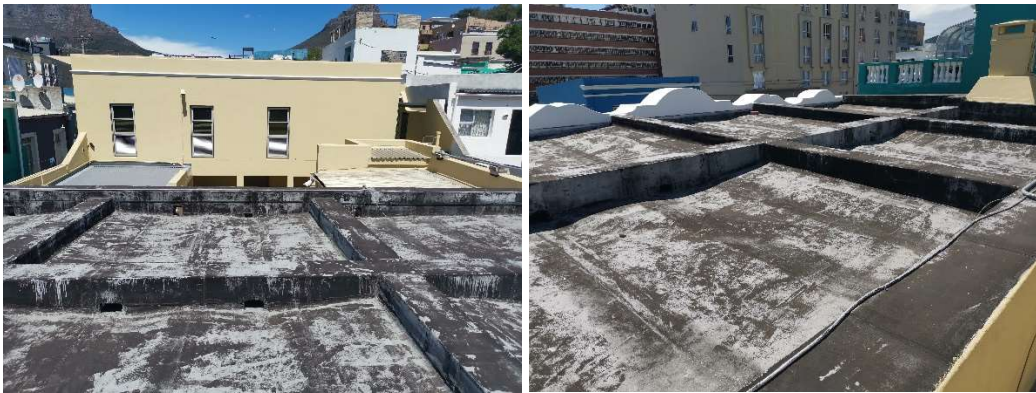
RECOMMENDATIONS FOR UPPER ROOF TO MAIN BUILDING

The waterproofing is basically sound.
Wire brush surface and apply two coats of water based Bituminous Aluminium paint.
If properly maintained the life expectancy of this membrane will be undetermined.
