APMH HERITAGE SITE AND CONSERVATION MANAGEMENT PLAN

ROBBEN ISLAND HOUSE NUMBER 85

COURSE CODE: MHS724

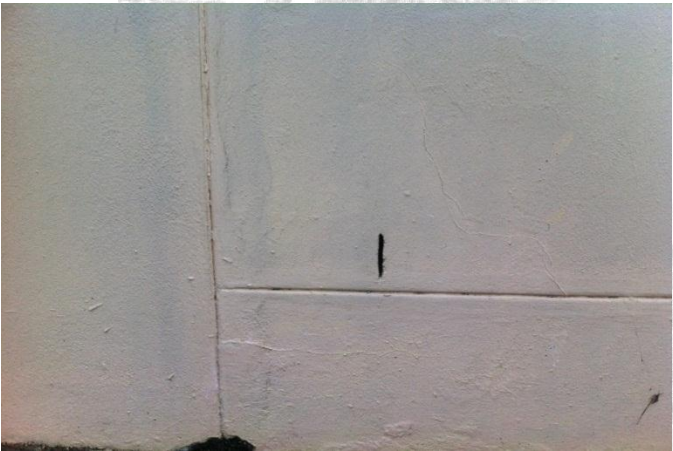
Slips in the wall

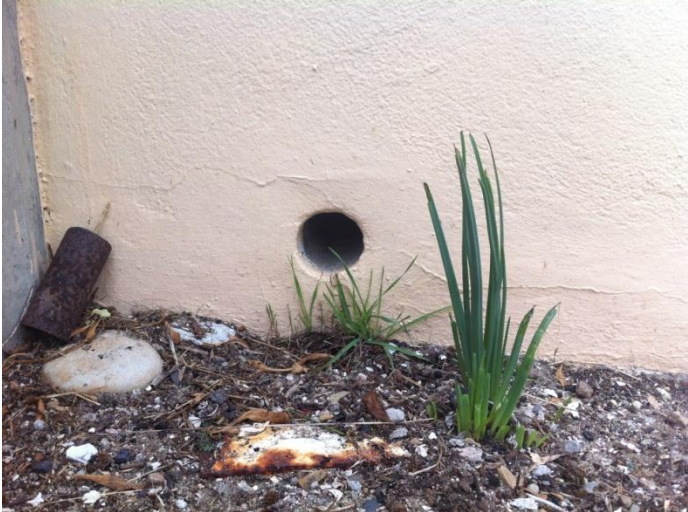
Detail of rust and vegetation

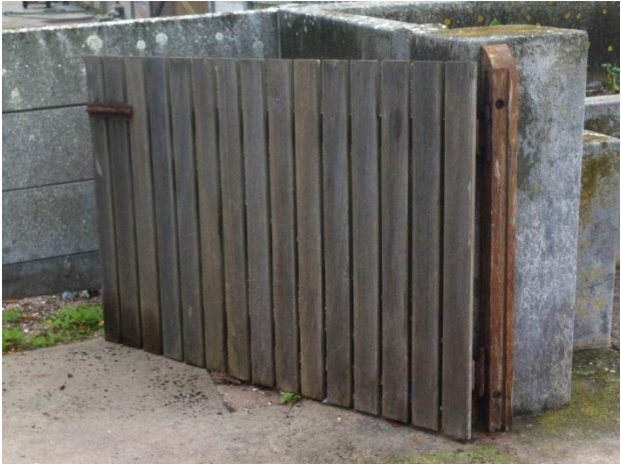
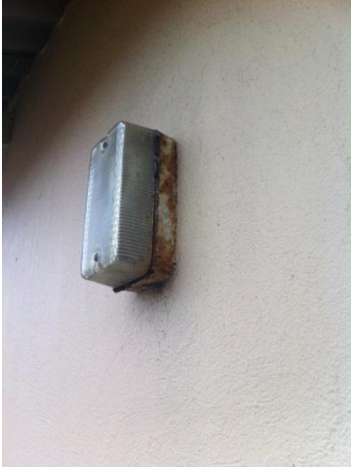
Rusty gate and details of lighting

- Gates and frames: should be inspected for rust, neutralized and retouched every two years
- Walls: must be inspected for damage and should be checked annually.

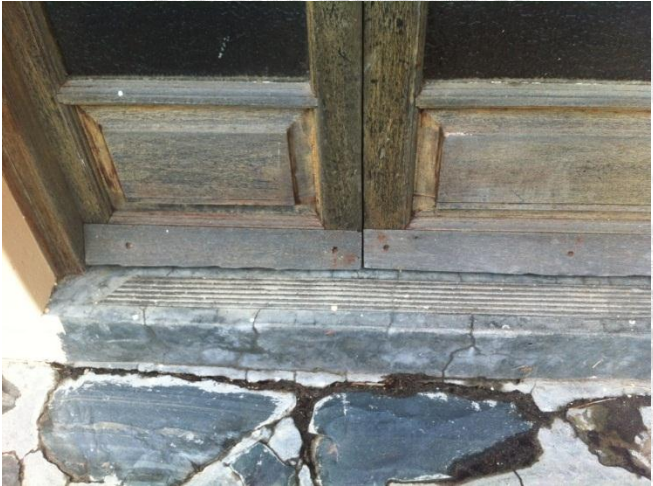
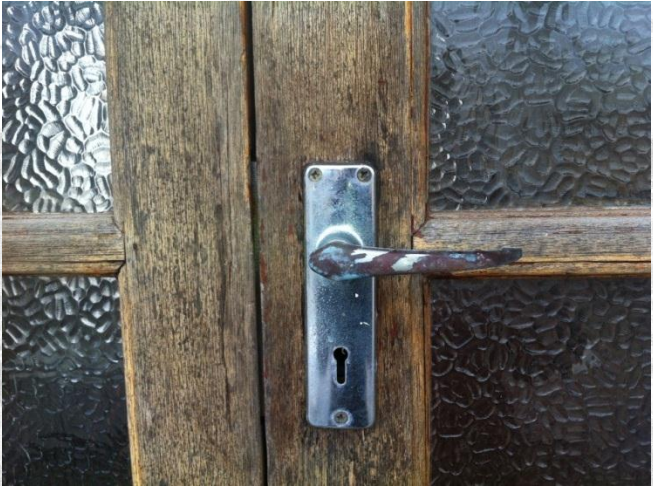
Details of cracked cement and rusting door handles

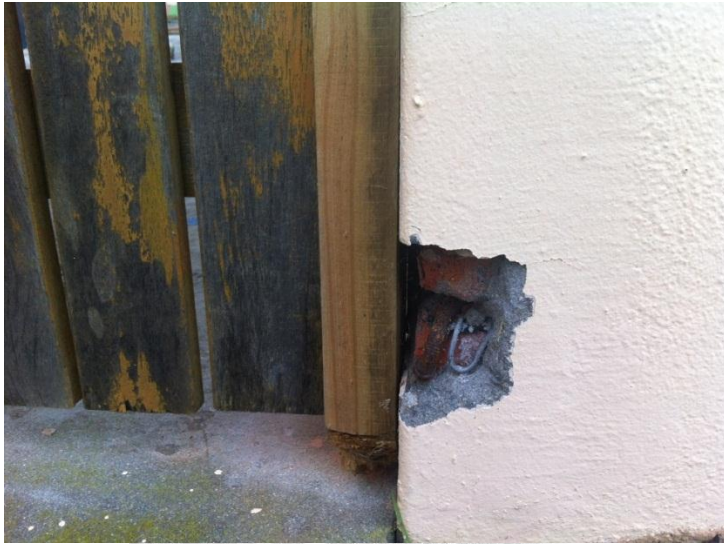
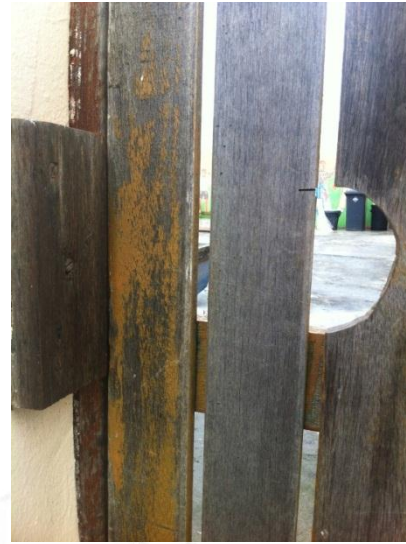
Cracking plaster
