KZN Childrens Hospital Trust
KZN Children's Hospital
Nurses Quarters Concrete Repairs

REP/S/004

Issue 0 | 7 August 2012

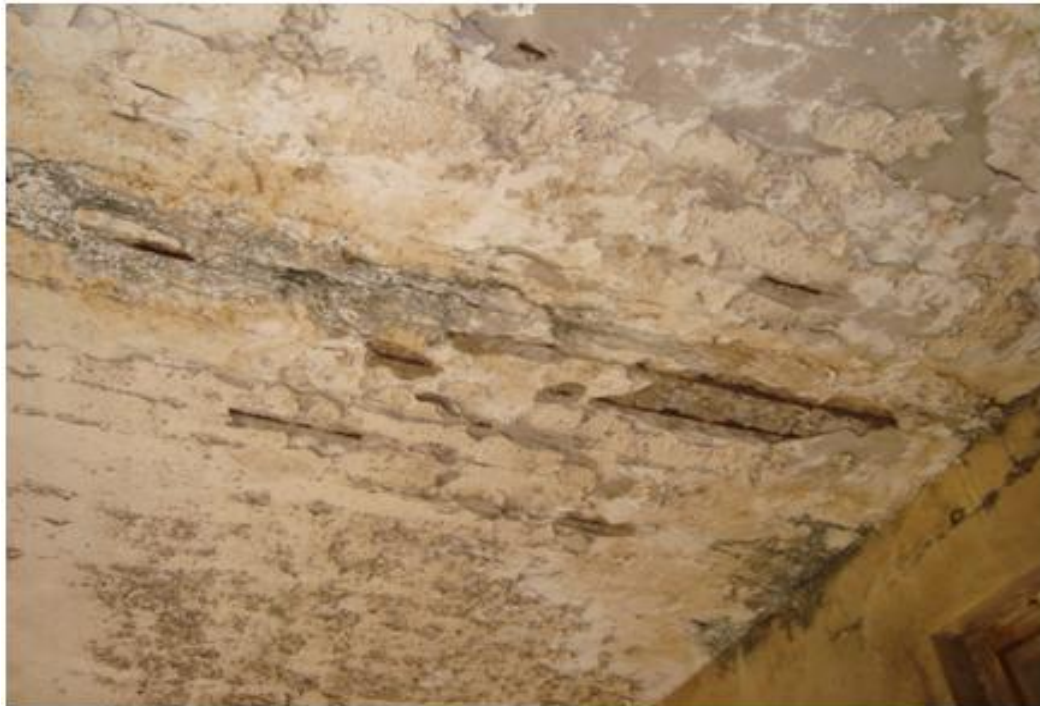
The reinforced concrete in the facade has suffered considerable damage over the previous 90 years as can be seen in the figures 1-4 below.

Figure 1 Spalling rebar at bottom of slab over East entrance veranda

All concrete in the facade will need to be replaced or repaired. Based on cost estimates of previous work in the precinct it would most likely be more economical to replace rather than to repair reinforced concrete elements. These elements include:

- Roof ring beam
- East facade window frames
- Any existing concrete above and below windows
- 1st floor slab over ground veranda on East facade
- Concrete columns on east facade veranda

It would most likely be more economical to remove the east facade over the veranda and the portion of the 1st floor slab over the veranda and then rebuild it. The second floor slab could be retained from a structural point of view.

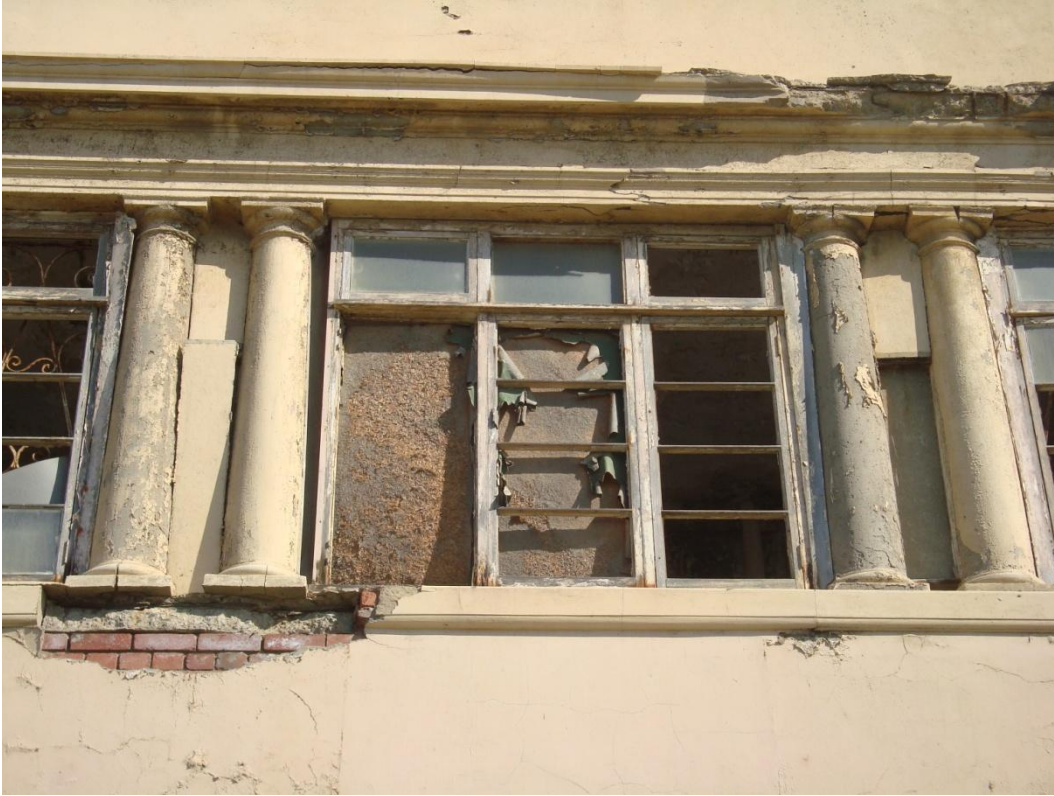
Figure 2 Window frame over East facade

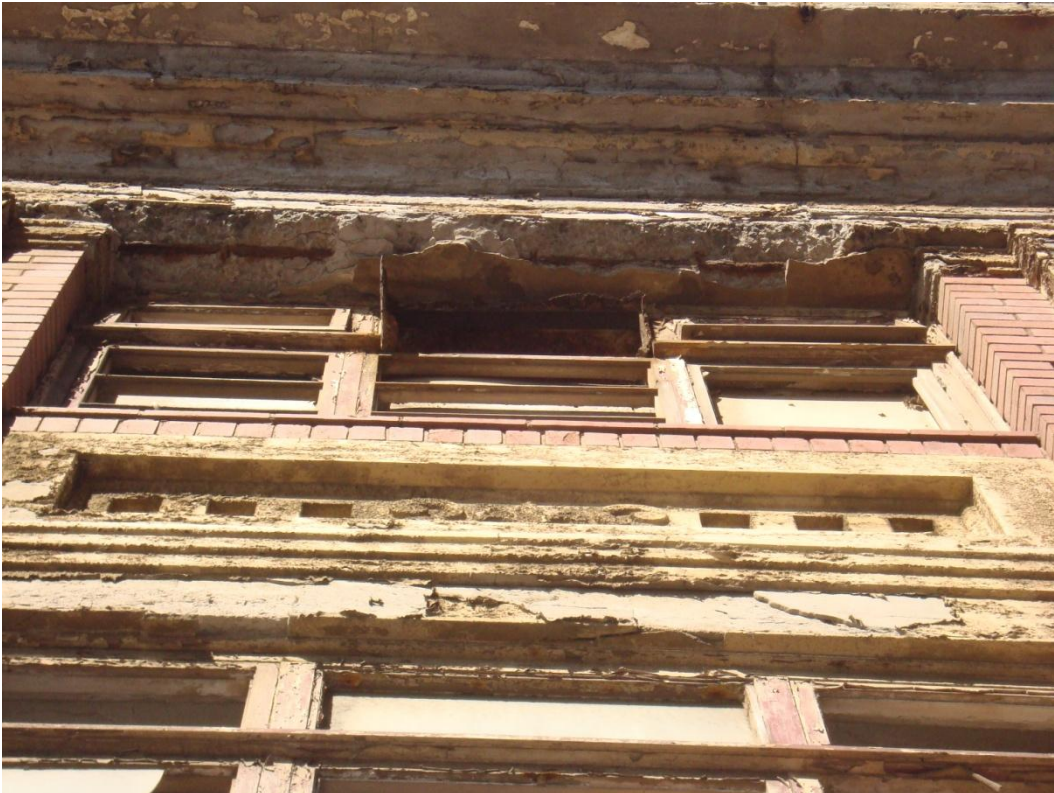
Figure 3 Roof ring beam on North facade

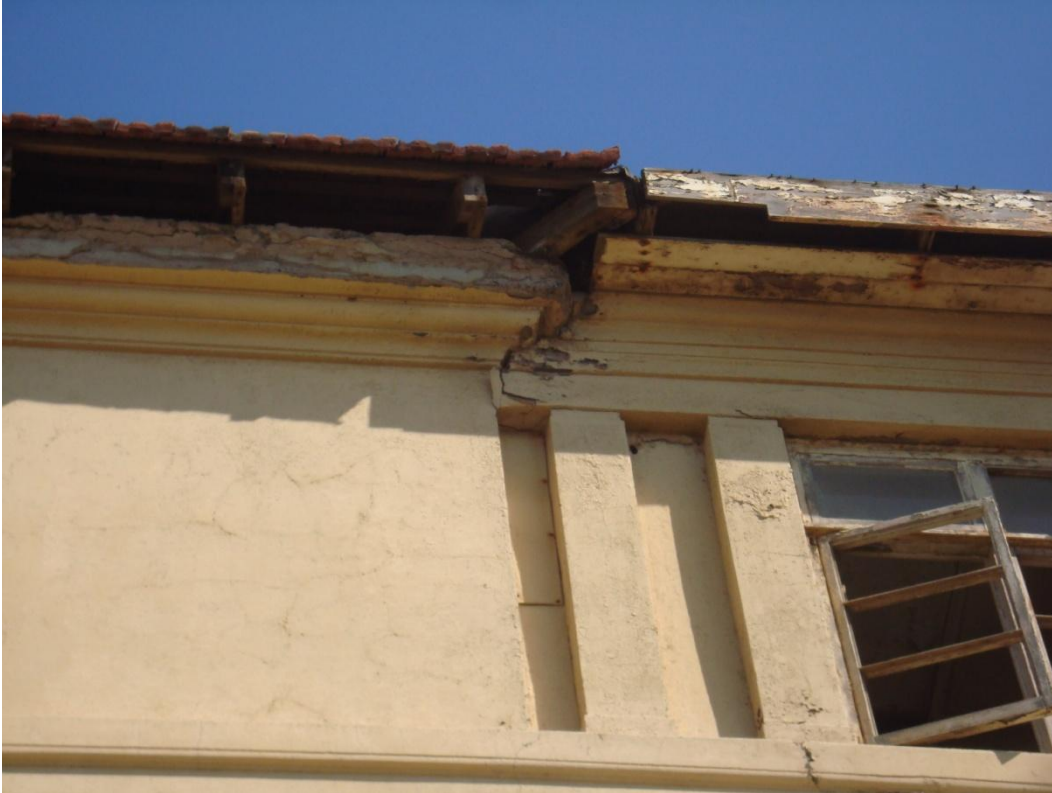
Figure 4 Roof ring beam on East facade

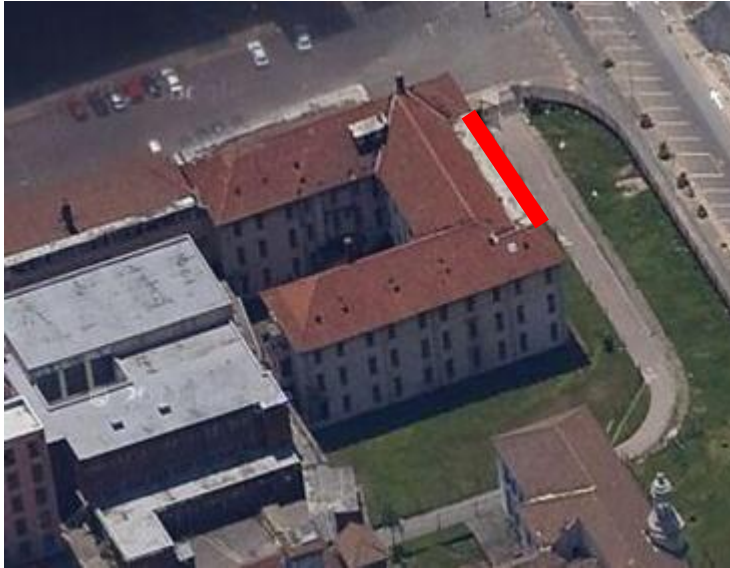
From examining the structure it could be possible that the structure above the East veranda was not part of the original building as shown in Figure 5.

Figure 5 Possible addition of structure not in original building marked in red
