ADDENDUM TO THE MARITIME HERITAGE FIELD SURVEY FOR DURBAN OIL IMPORT PIPELINE OF 12 MAY 2019

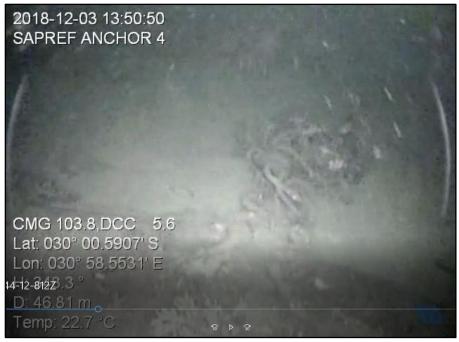
Figure 2: Metal plating is visible, with thickened edges (yellow) as well as standing rigging (blue)

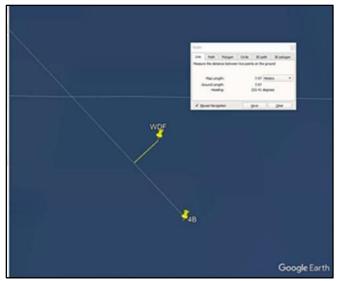
Figure 5: Close-up of anchor chain 4 and plotted MUCH resource (SAPREF)

Using the SHP file from the geophysical report (SBM_Nov18_Anchor_Chains.shp) and the GPS co-ordinates from the ROV footage (above) I notice that there is only a 12 m distance between the anchor chain and the wreck. However, it is beyond the anchor point for the chain.

- 1. The wreck is more than likely the John Bull II due to:
 - The small size of the visible wreck
 - The metal plating
 - The rigging visible
 - The light anchor chain, suitable to a smaller vessel
 - The location of the wreckage
- 2. If it is the *John Bull*, it has little historical significance at this moment in time. Cognisance of its future potential interest must be kept in mind.
- 3. If the anchor point is not going to be relocated, the MUCH resource can probably be avoided.
- 4. The divers and contractors be made aware of the MUCH resource and avoid it. A buoy can be located here during work in order to facilitate avoidance and thus damage to the site.
