## Lindsay Napier architect

02 October 2023

### **ADDITIONAL MOTIVATION : PROPOSED DEMOLITION OF THE CHAPEL AT 96 JABU NDLOVU ST, PIETERMARITZBURG NEW KZN MUSUEM AND ARCHIVES (REVISED) PROPOSAL**

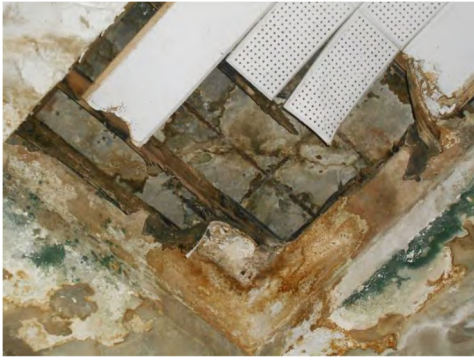
- Severe spalling to the existing suspended concrete slab in various areas was noted - this is as a result of constant moisture ingress into the concrete slab as well as the lack of maintenance to the building.

*Fig.1 Image showing severe spalling(deterioration) to the existing suspended concrete slab.*

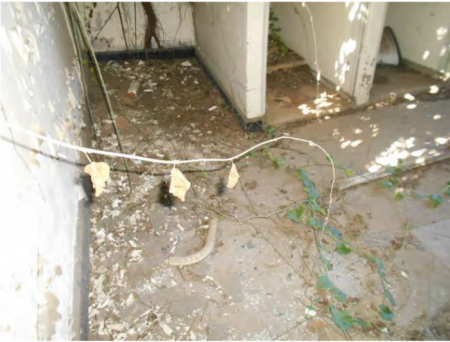
- Severe vegetation growth internally and externally was noted – this is a result of poor maintenance of the building.
- Severe settlement of the existing surface bed within the chapel ablution was noted – this is a result of the movement of the building materials as well as poor maintenance.

*Fig.2 Image showing severe settlement of the existing surface bed slab in the ablutions.*

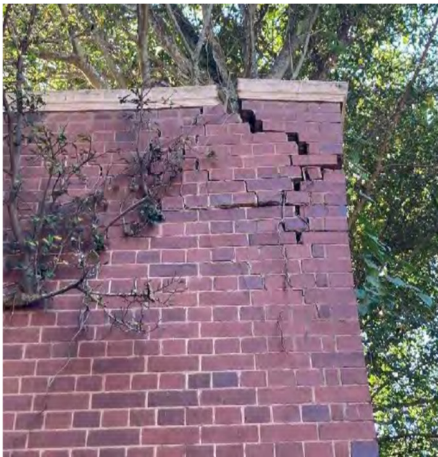
- Severe structural damage to the existing parapet walls at various locations was noted – this is a result of poor maintenance and the impeding vegetation growth.

*Fig.3 Image showing severe structural damage to the existing parapet wall.*

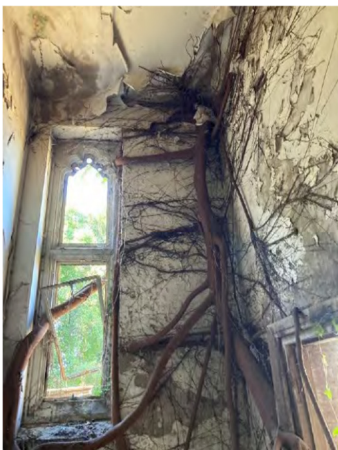
*Fig.4 Image showing severe vegetation growth on the inside of the Chapel.*
