PROPOSED Alterations and Additions to Existing Dwelling - AMAFA APPLICATION
COMPILED BY MARK PILLAY – ST1228

PROPOSED ALTERATIONS AND ADDITIONS TO EXISTING DWELLING
PORTION 146 OF ERF 39 DURBAN NORTH

**2 AVON CRESCENT
DURBAN NORTH**

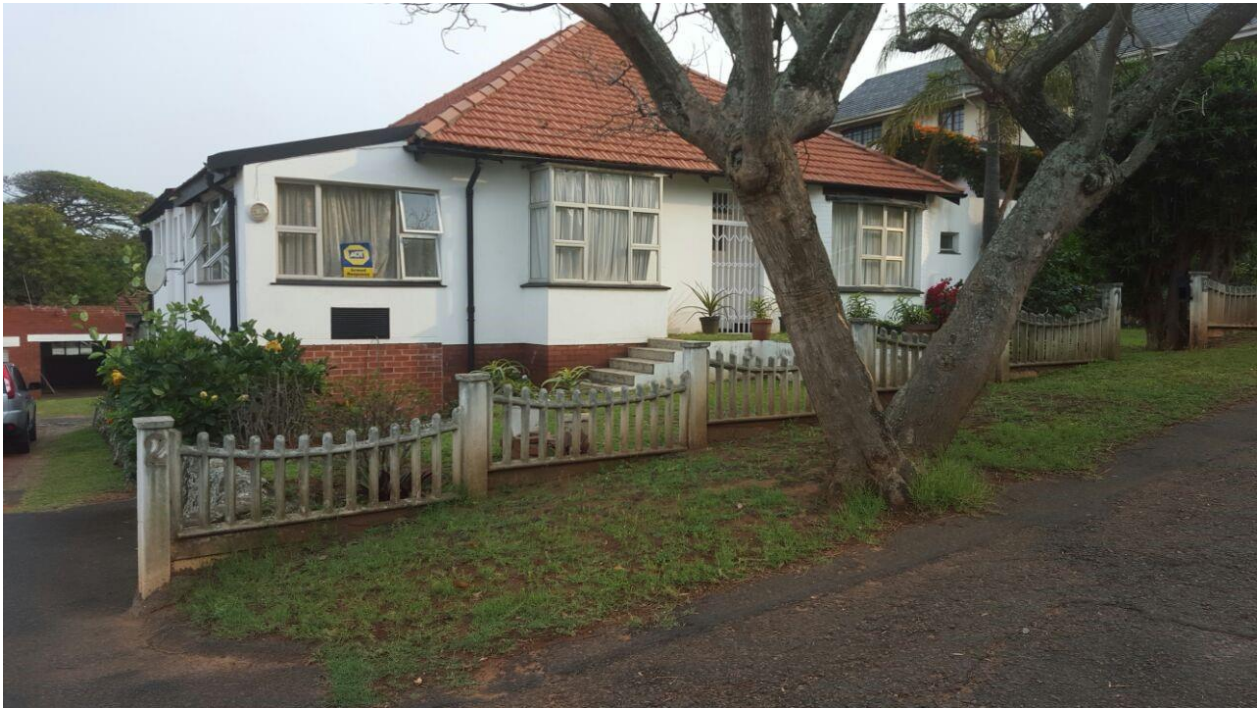
Photo 1 – Street facade

The house has had many hap hazard additions, with the roof structure clearly illustrating this; a very random monopitch roof structure not doing anything for the aesthetics of the house – ie no architectural merit whatsoever.

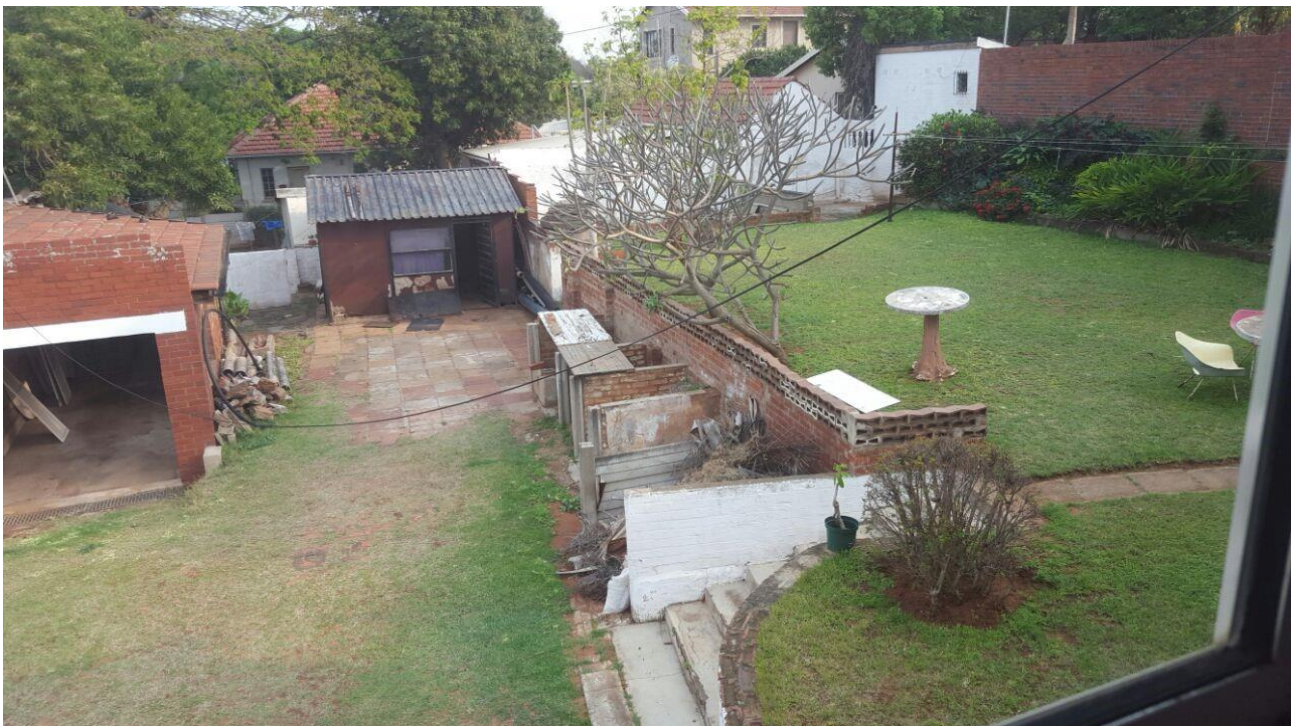
Photo 2 – Back Garden

The back Garden is in a state of disrepair, and the double garage is attracting vagrants to the area, especially with the fact that there is no boundary wall; and so these people can come and go as they please. We had one guy storing avos in the shed (mid Picture) and then selling these!

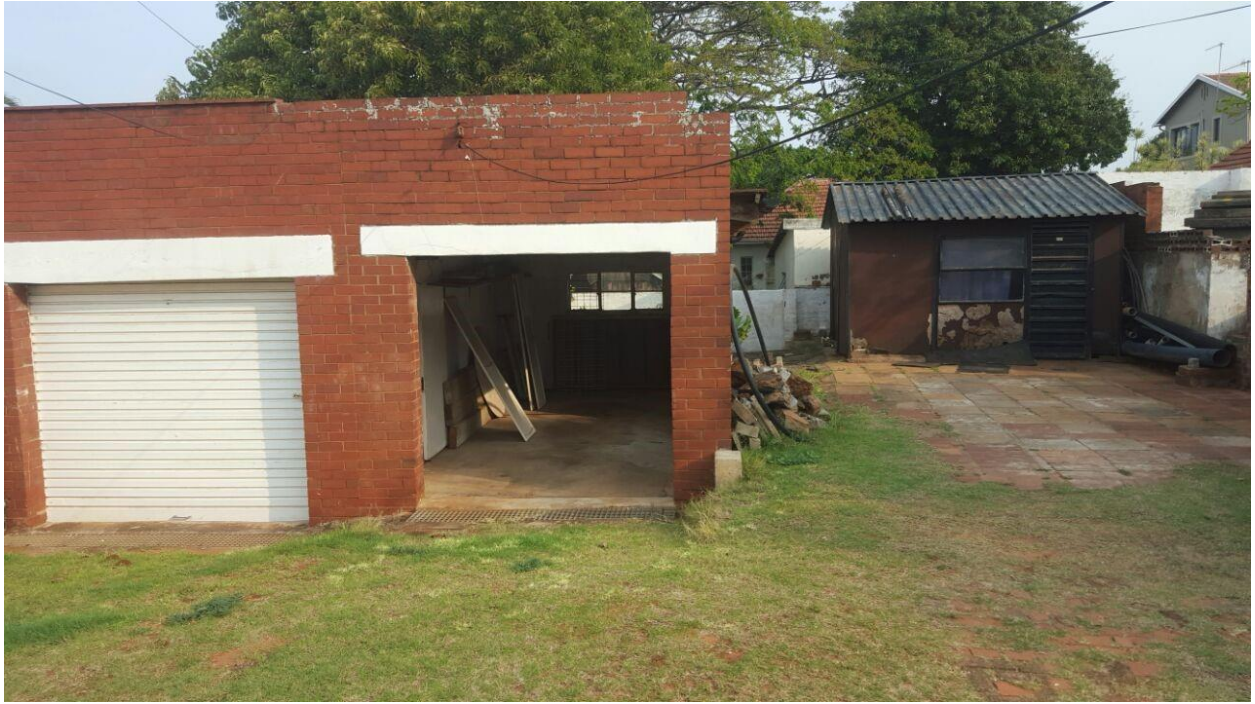
Photo 3 – Double Garage

Double garage is in a state of disrepair, and so this is a perfect place for which vagrants can sleep.

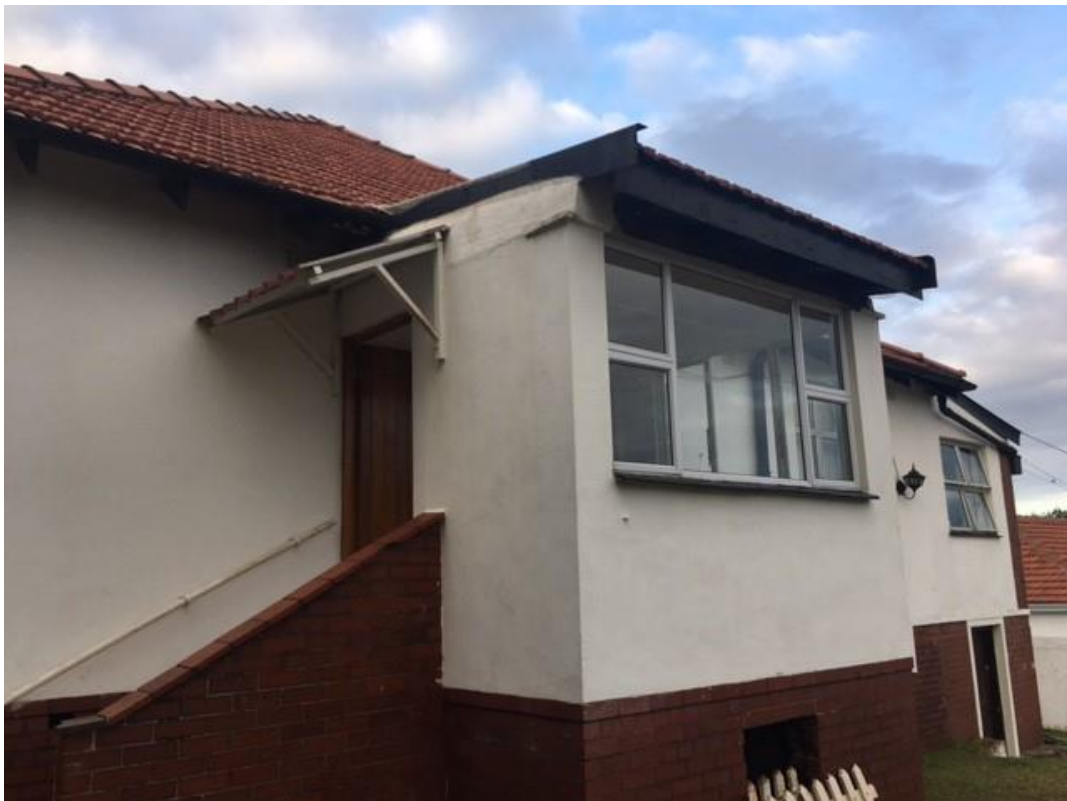
Photo 4 – Rear entry to house into laundry

This is another addition to the house; round the back and is the laundry of the house – another monopitch which has just been tacked onto the façade of the existing house. We have subsequently had a break in into the house and this is where they have smashed the window.

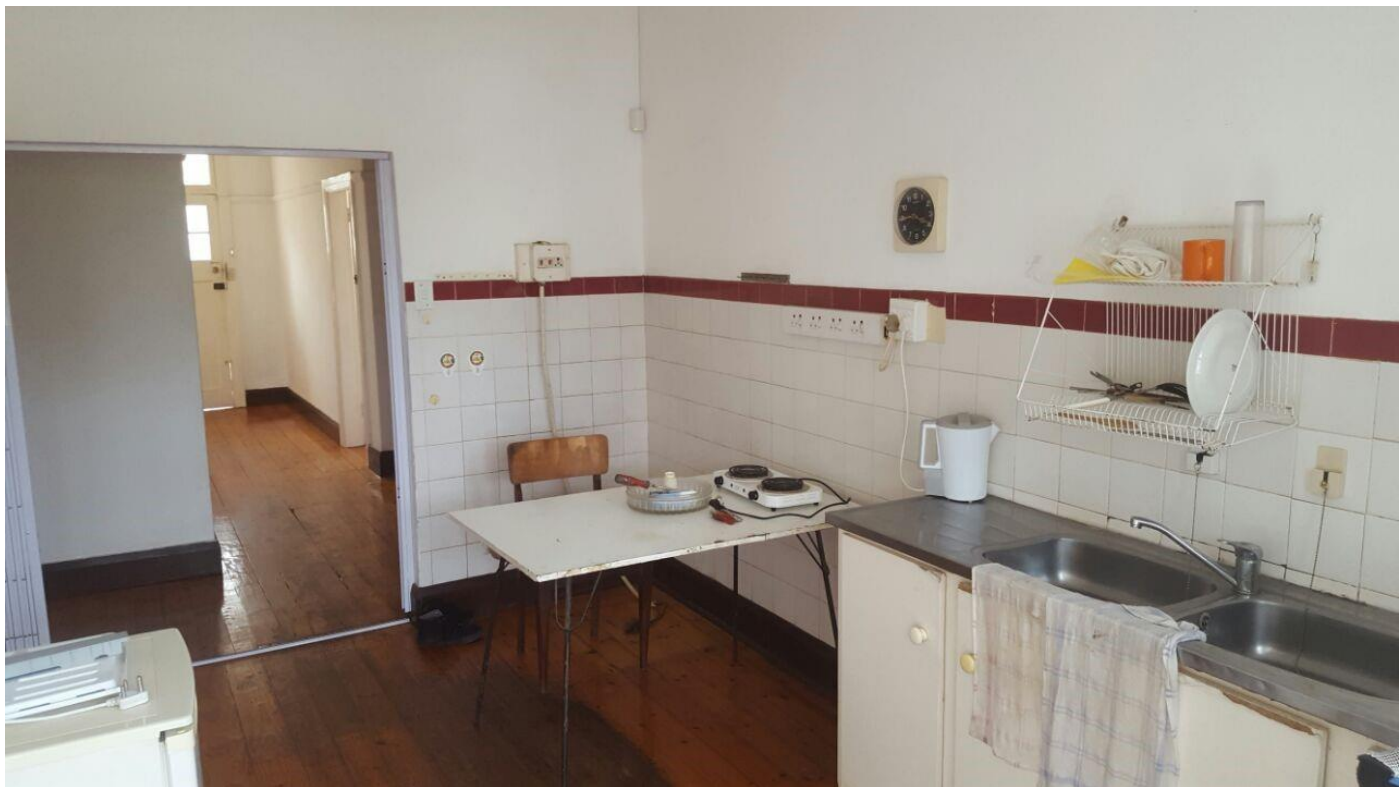
Photo 5 – Existing Kitchen

This is the “kitchen” of the house – again, in an extremely bad state and as one can see, the electrical main to the stove is literally just lying lose on the floor.

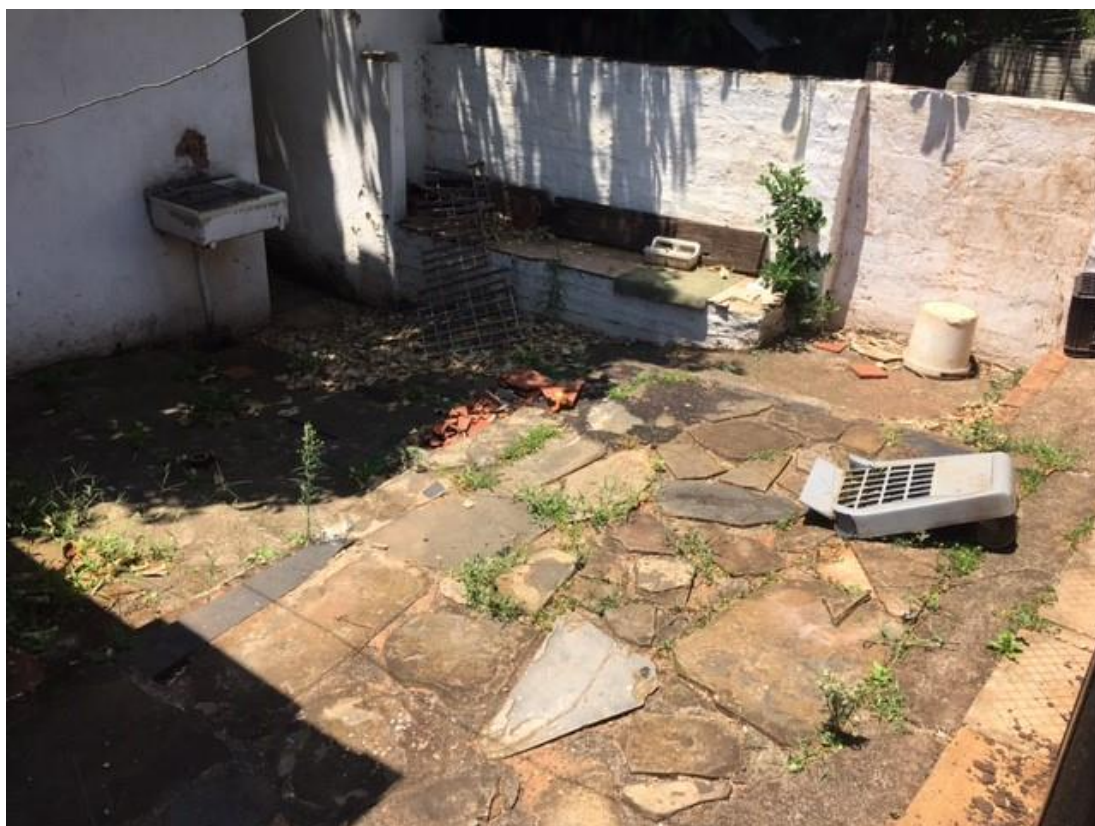
Photo 6 – Behind the Double Garage

Just illustrating the complete lack of maintenance and this is very much concealed from view, and so is attracting vagrants.

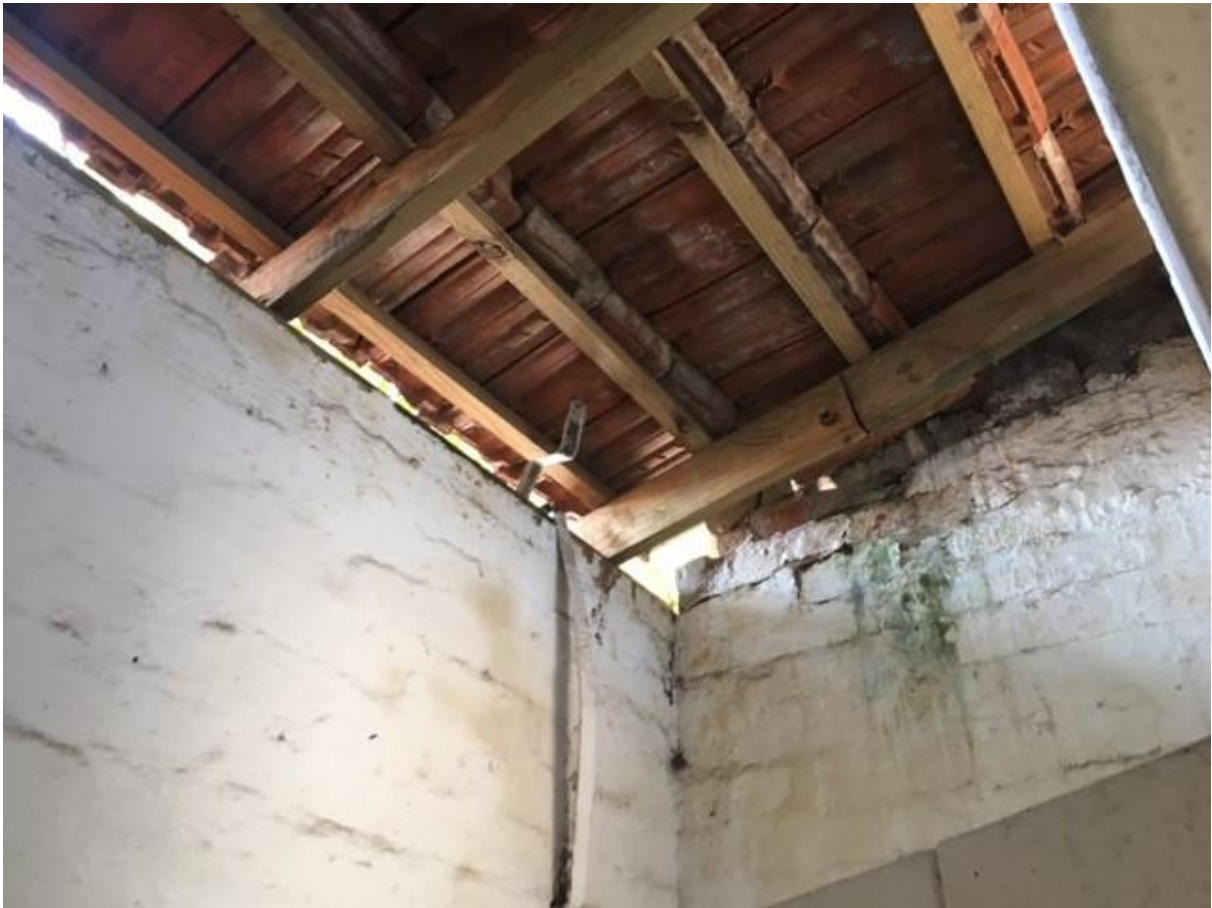
Photo 7 – Roof Structure

Again there has been extremely little maintenance of the place and the roof is in a state of disrepair, and needs to be replaced with urgency. It is bordering on not being structurally sound for occupation.

New Roof: We are proposing to replace the existing roof, as it is currently in a serious state of disrepair.

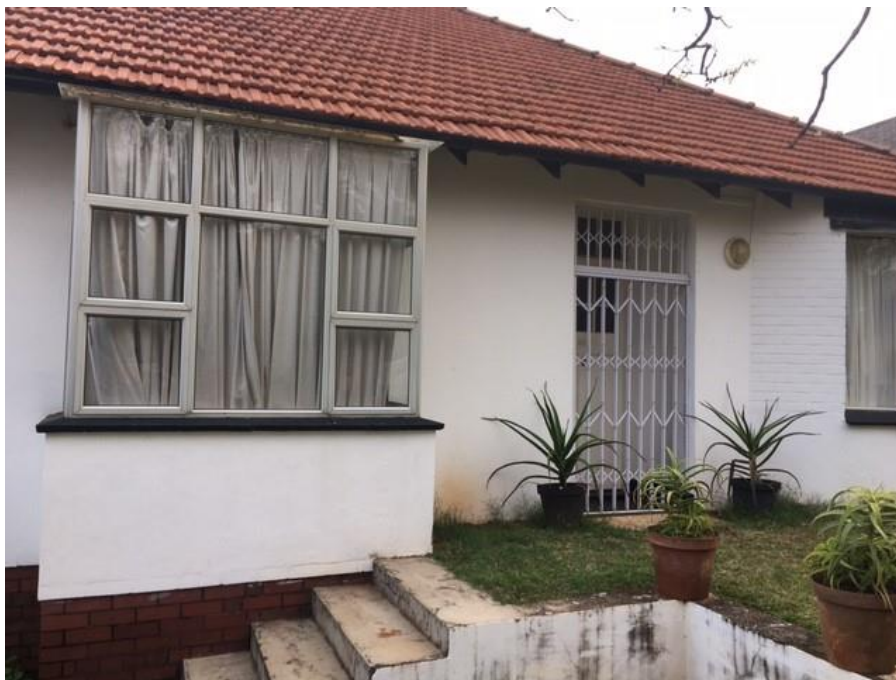
Photo 8 – Main entry to house Showing shocking hap hazard roof additions

As you can see, small additions have been made over the years and the construction methodologies are certainly questionable to say the least! Again, motivation for the roof to be replaced in its entirety.
