REPAIRS & RENOVATIONS TO STANGER SECONDARY SCHOOL:

ANNEXURE 1

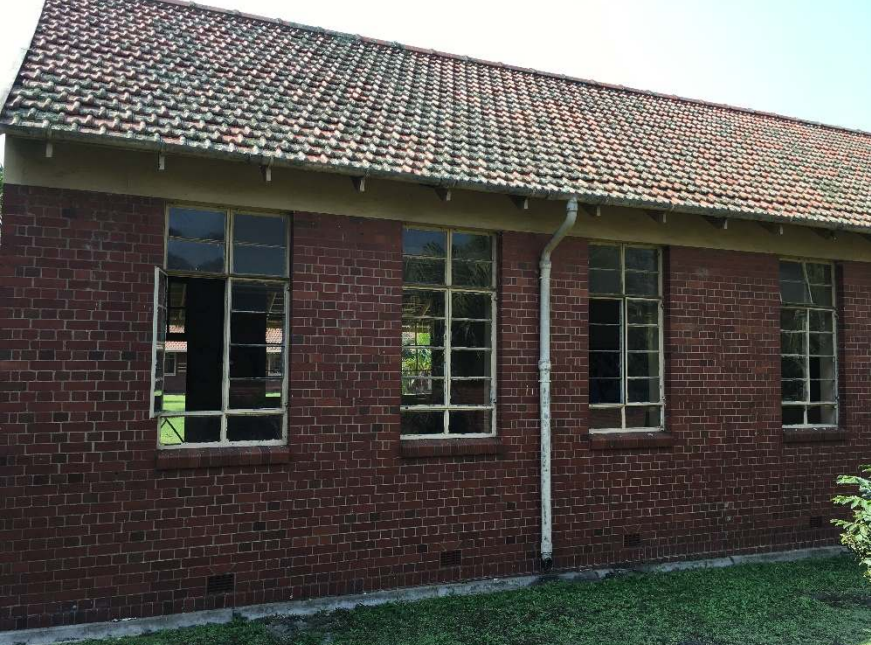
<p>Image 03 – South Elevation 01: Image showing the South corner elevation of the building. Numerous windows and glass panels are broken and will be refurbished and glass replaced.</p>

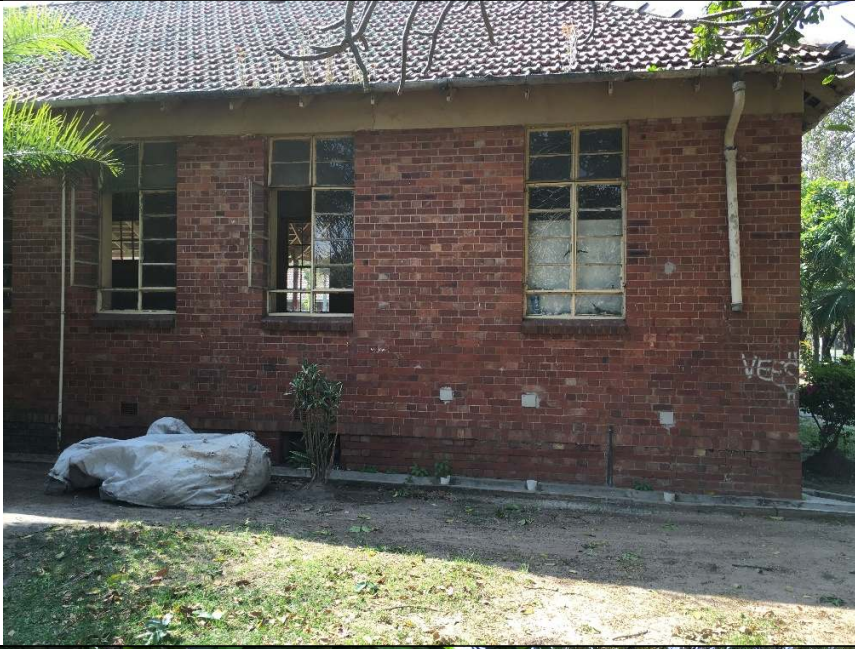
Image 04 – South Elevation 02:

Image showing the damaged rainwater downpipe and graffiti on face brick. Windows and glass panels are broken and will be refurbished and glass replaced.

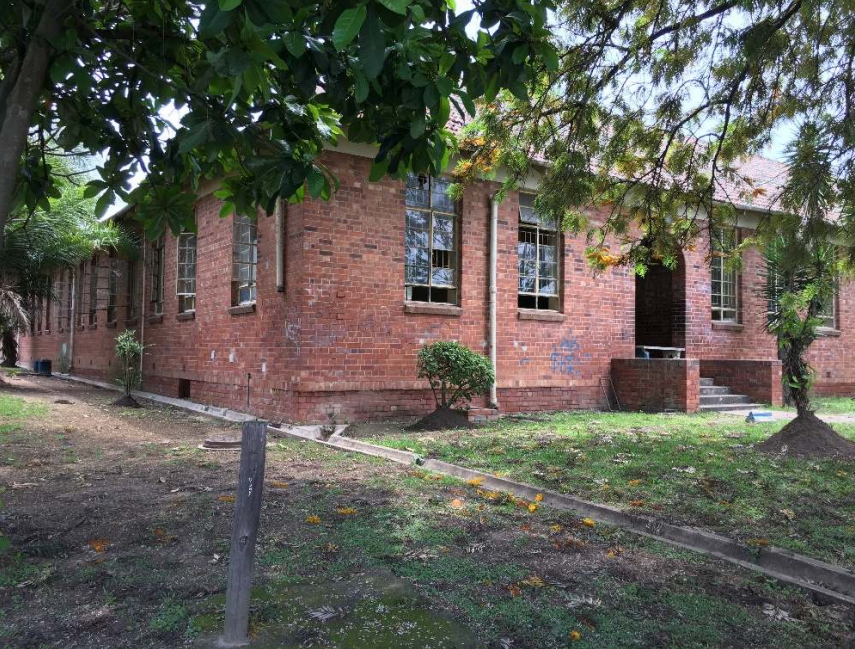
Image 05 – South East Elevation:

Similar to previous image showing the damaged rainwater downpipe and graffiti on face brick. Windows and glass panels are broken and will be refurbished and glass replaced.

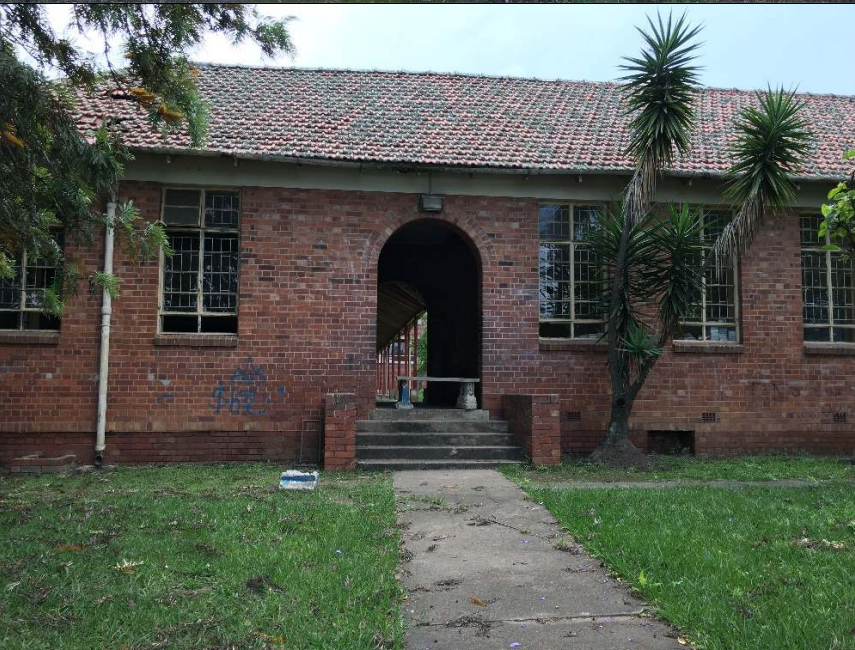
Image 06 – East Elevation 01:

Similar to previous image showing the damaged rainwater downpipe and graffiti on face brick. Windows and glass panels are broken and will be refurbished and glass replaced. The archway is no longer in use and has been temporarily blocked. A new custom made timber door with a fanlight is proposed to close off the archway.

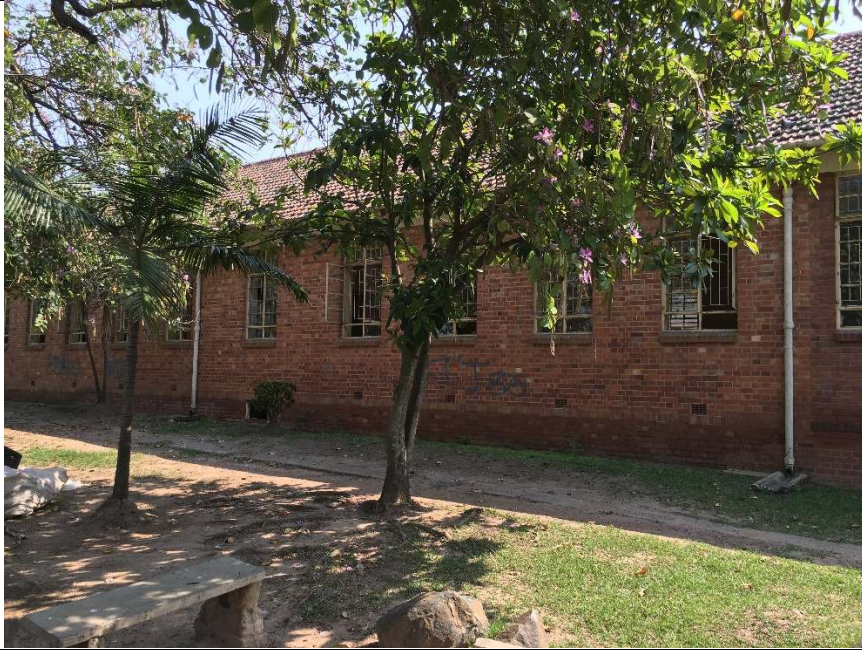
Image 07 – East Elevation 02:

Similar to previous image showing the graffiti on face brick. Windows and glass panels are broken and will be refurbished and glass replaced.

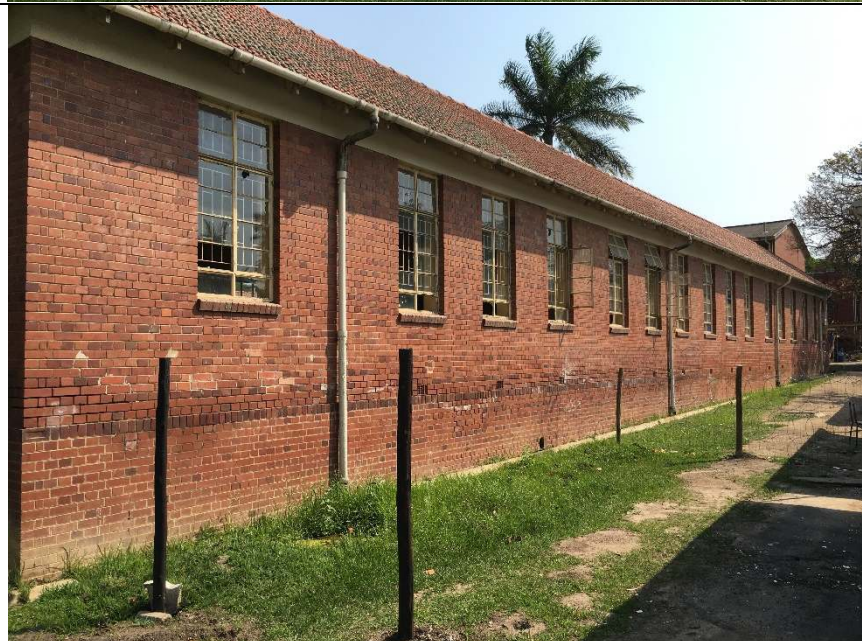
Image 09 – North Elevation:

Image showing the North Elevation of the building and the damp face brick caused from rising damp. During the restoration a DPC waterproofing layer will be added to prevent water from rising.

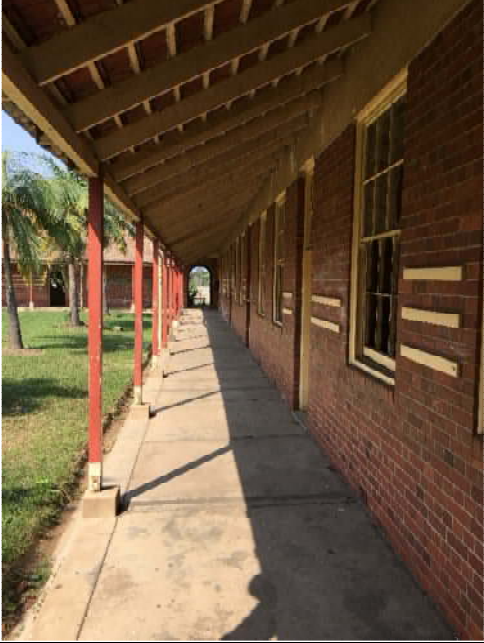
<p>Image 10 – Corridor Perspective: A typical view of the existing corridor. The concrete stub columns are to be removed and replaced with a GMS shoe to restore the original look and feel.</p>

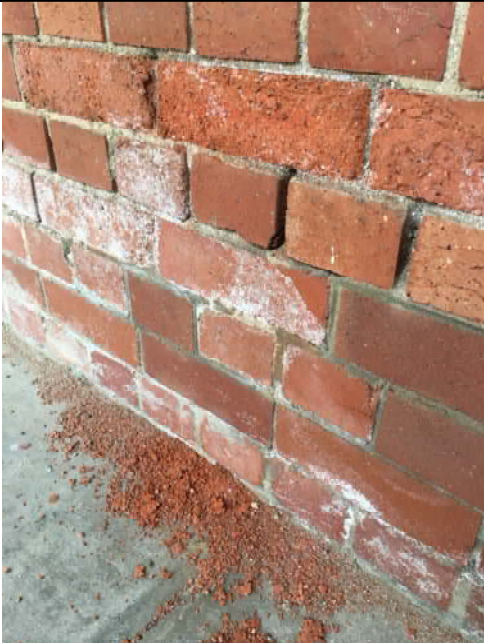
<p>Image 11 – Corridor wall: Image showing the damage raising damp has caused to the brickwork. Damaged bricks to be replaced and DPC waterproofing layer to walls will be added.</p>

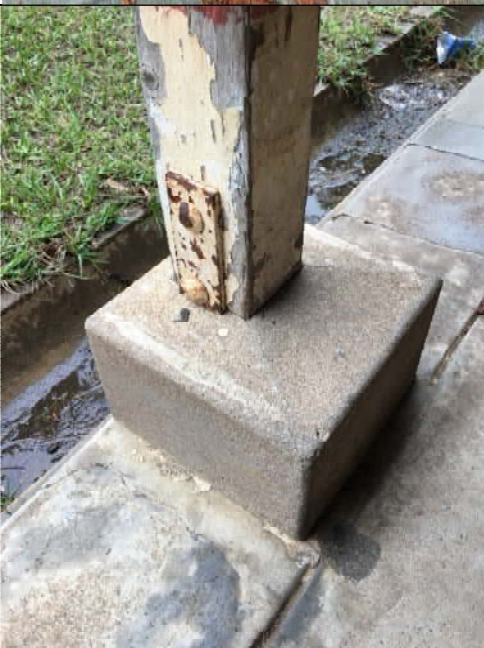
<p>Image 12 – Column footing detail: The concrete stub columns are to be removed and replaced with a GMS shoe to restore the original look and feel.</p>

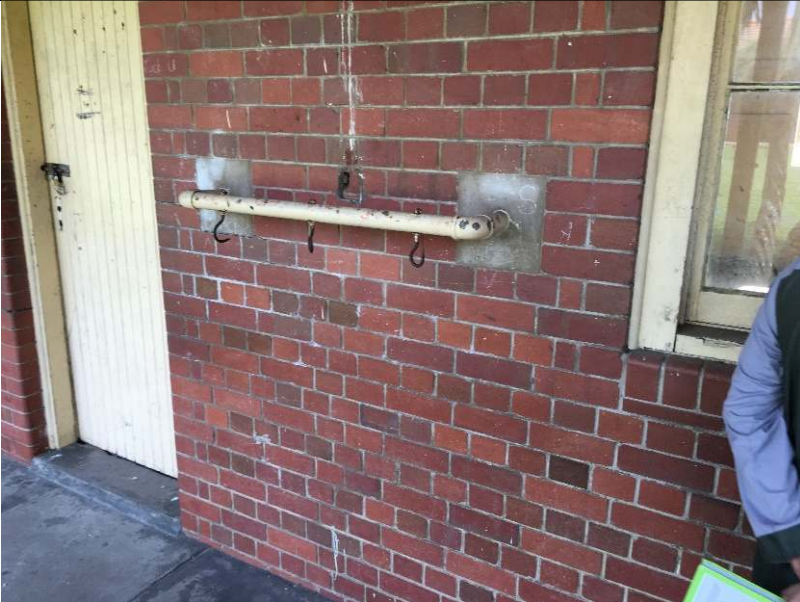
Image 13 – Fire bucket hooks:

Image showing the previous hooks for sand buckets for firefighting. The hooks will be replaced with new hooks and new red buckets with sand will be installed.

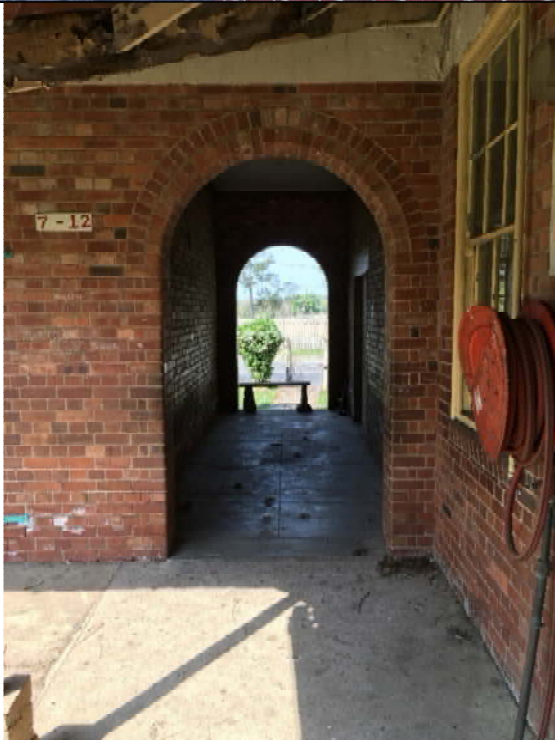
Image 14 – Fire hose reel:

Image showing the damaged existing fire hose reel, ceiling and trusses that will be replaced during restoration.

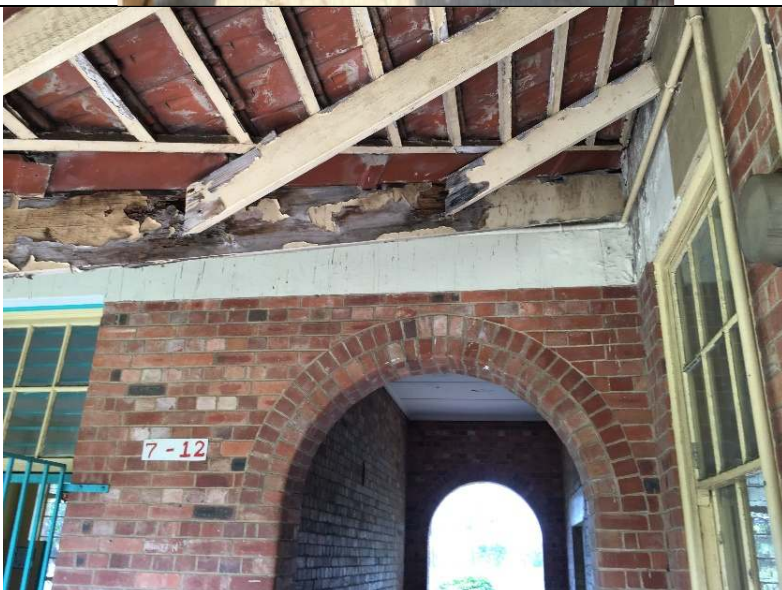
Image 15 – Truss:

Image showing the damaged existing ceiling and trusses that will be replaced during restoration along with a raked ceiling to hide unsightly tile underlay and insulation.

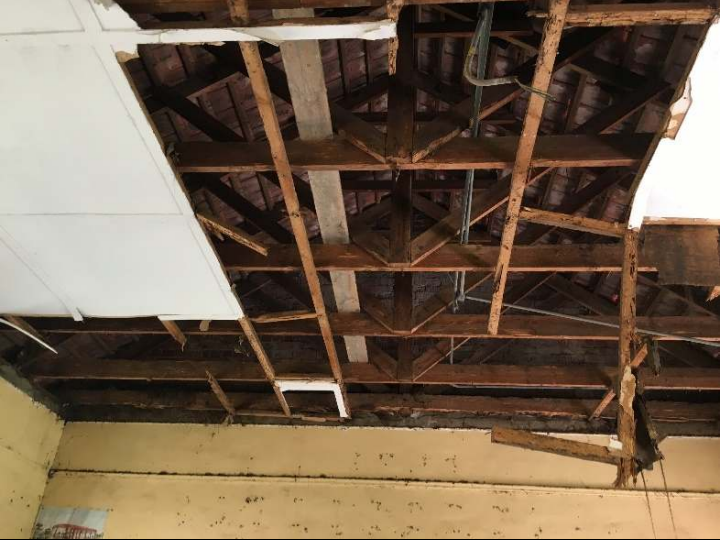
<p>Image 16 – Ceiling 01: Storm damaged existing ceiling and trusses that will be replaced during restoration.</p>

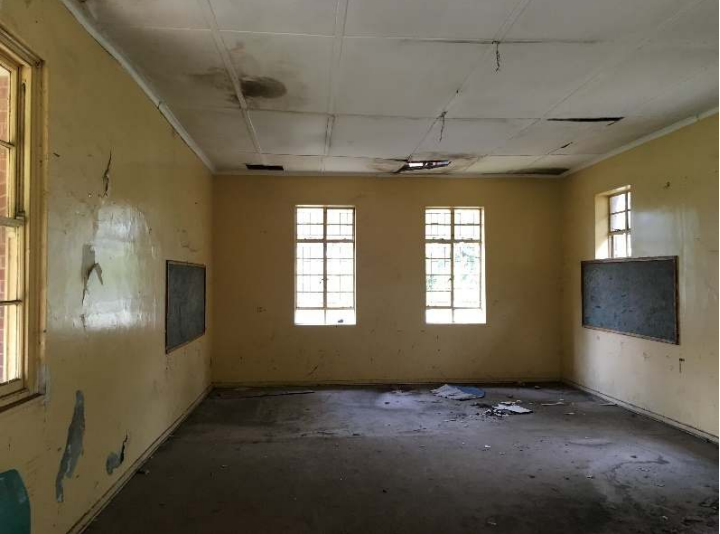
<p>Image 17 – Ceiling 02: Storm damaged existing ceiling that will be replaced during restoration.</p>

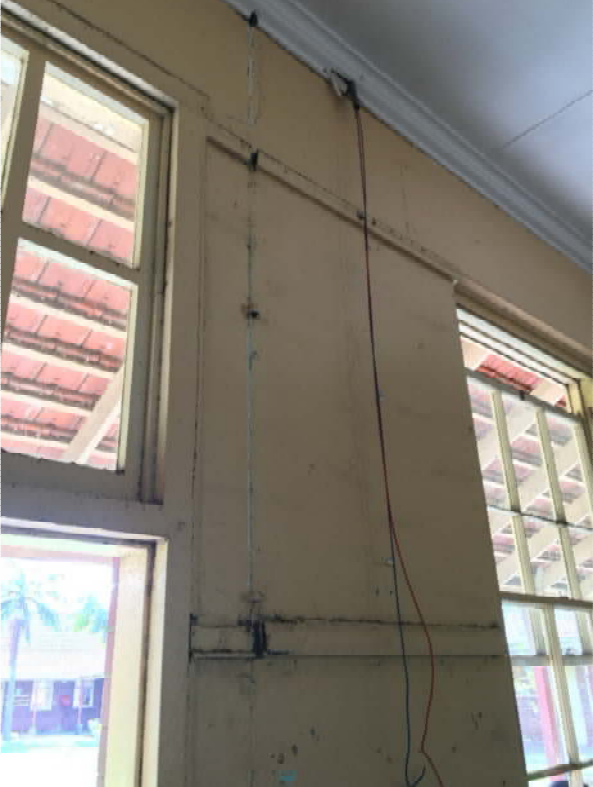
<p>Image 18 – Electrical connections: Image showing door frames, windows and picture and dado rails. Exposed conduits for fans and light switch that has been ripped from the wall. New electrical fittings to be chased into wall and re-plastered to reduce vandalism.</p>
