ANNEXURE 2:
PHOTOGRAPHIC ANALYSIS OF THE EXISTING BUILDING

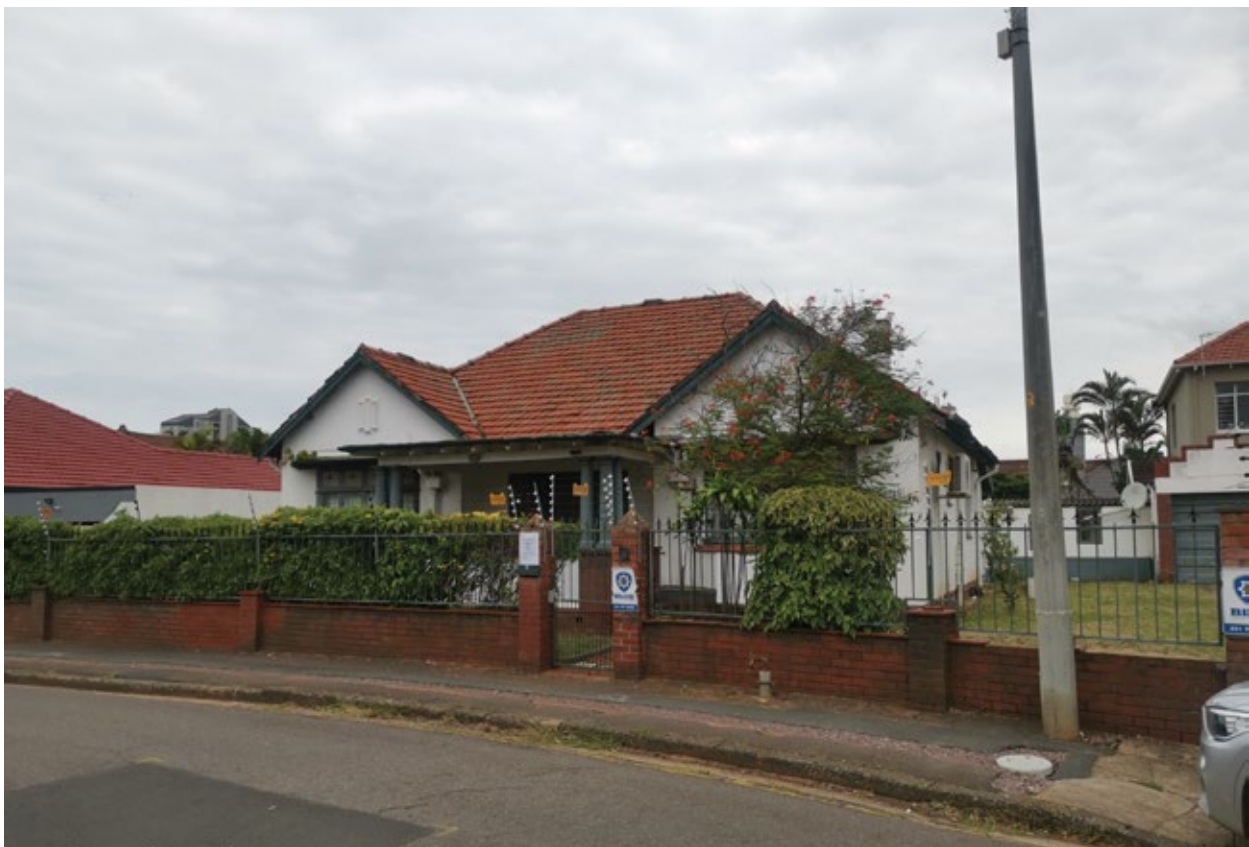
Figure 1. Streetview (Caister Crescent)

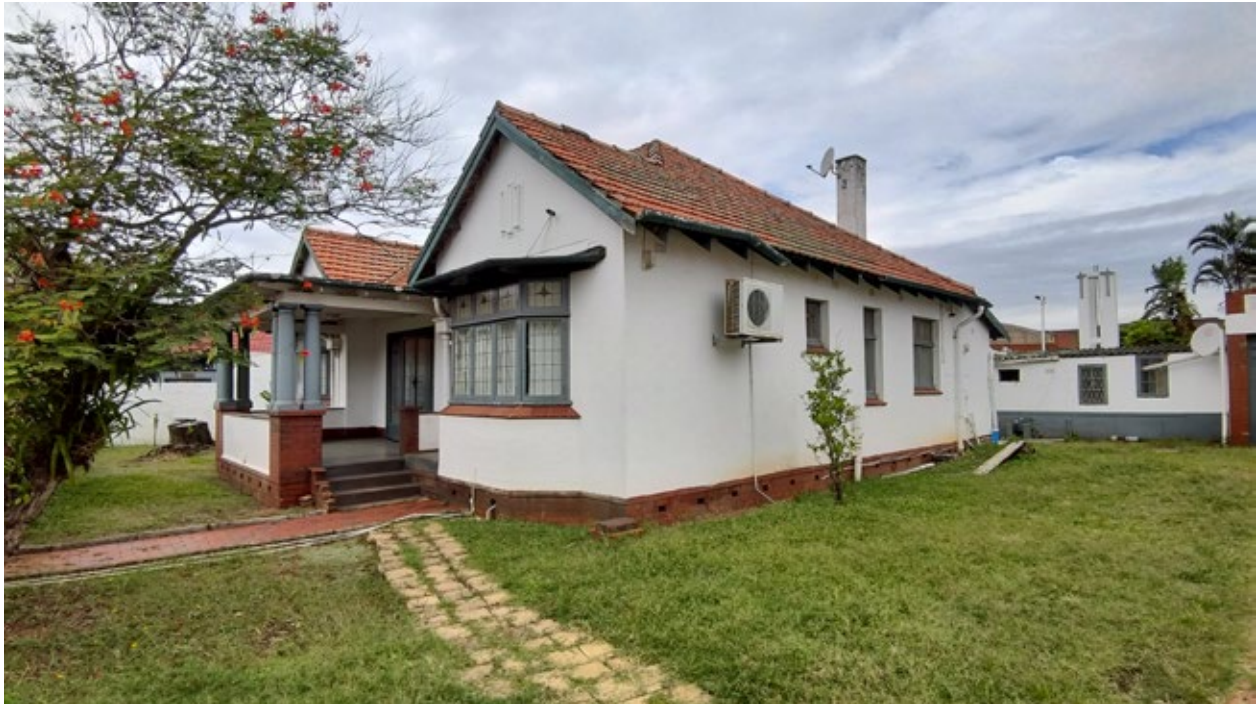
Figure 2. View from Driveway entrance looking at the North East and West Facades. The North-West Facade consists of no architectural elements or features. The North East facade consists of entrance verandah and flanked by windows on either side.

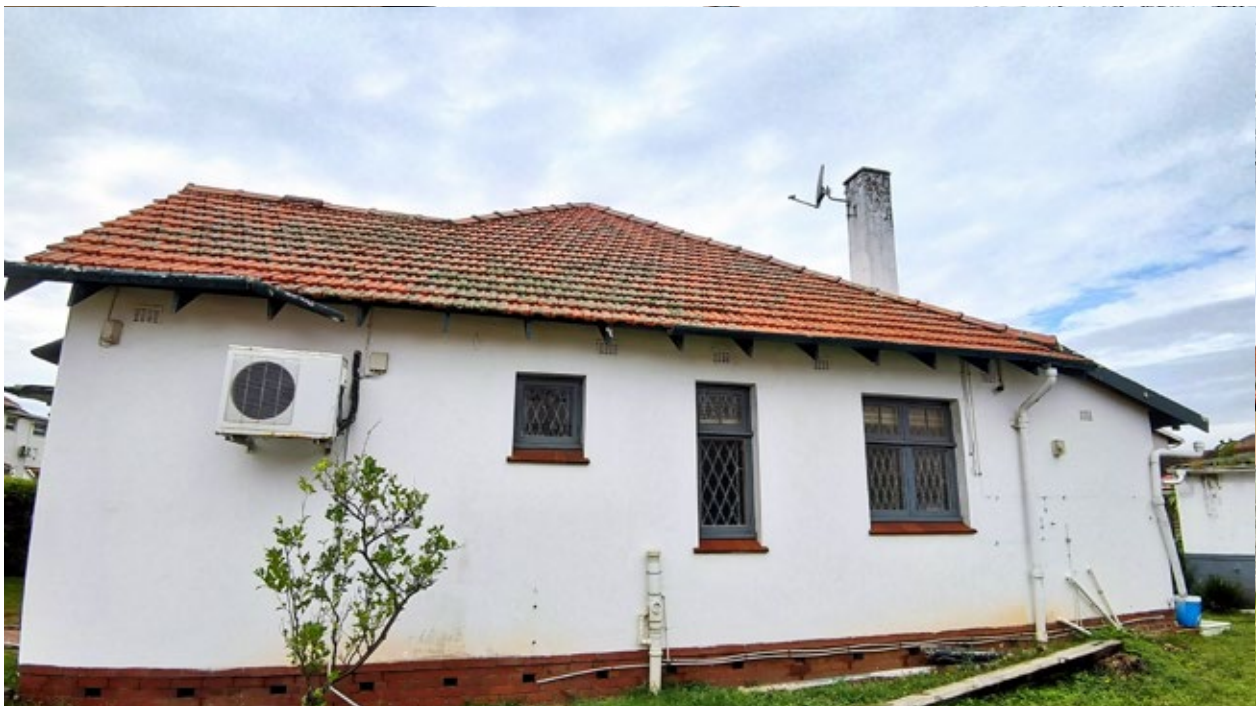
Figure 3. North West Elevation. Red Brick plinth. Smooth Plastered walls. Consists of timber windows. No significant architectural features or elements. Gutters have been damaged. Roof consists of marseille roof tiles

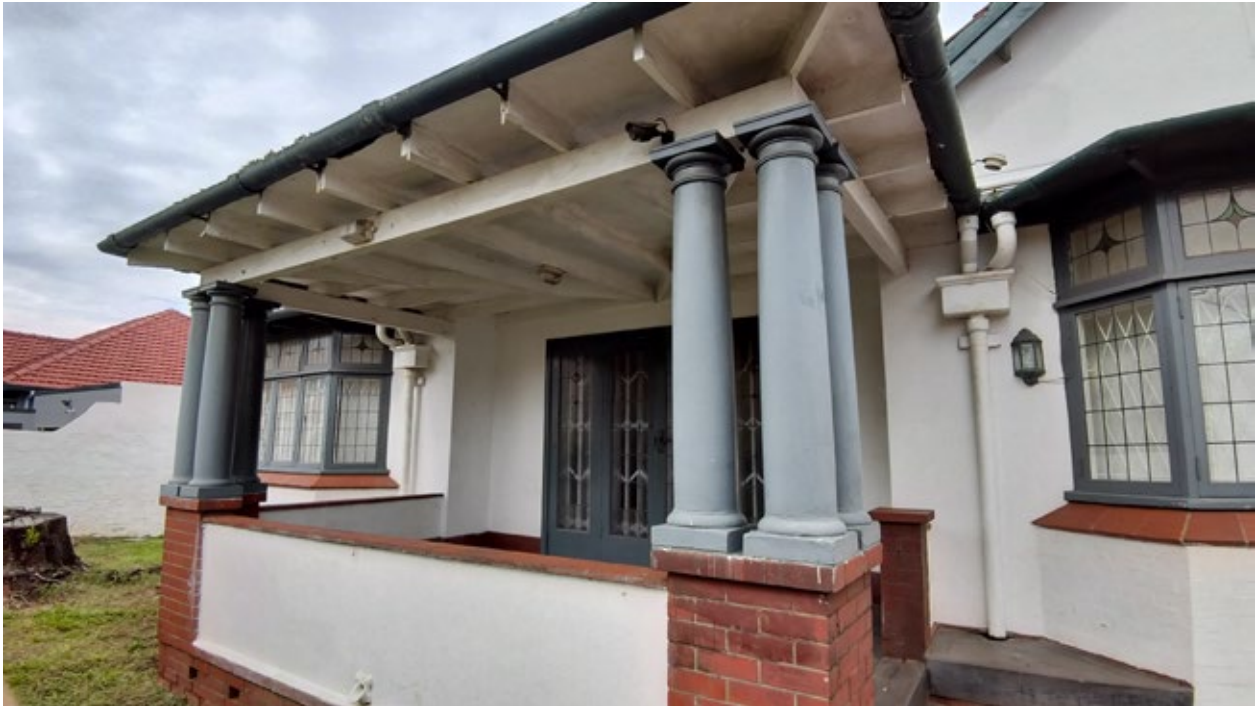
Figure 4. View of Verandah from front garden. Red brick Columns Plinths. Circular columns supporting Verandah roof structure.

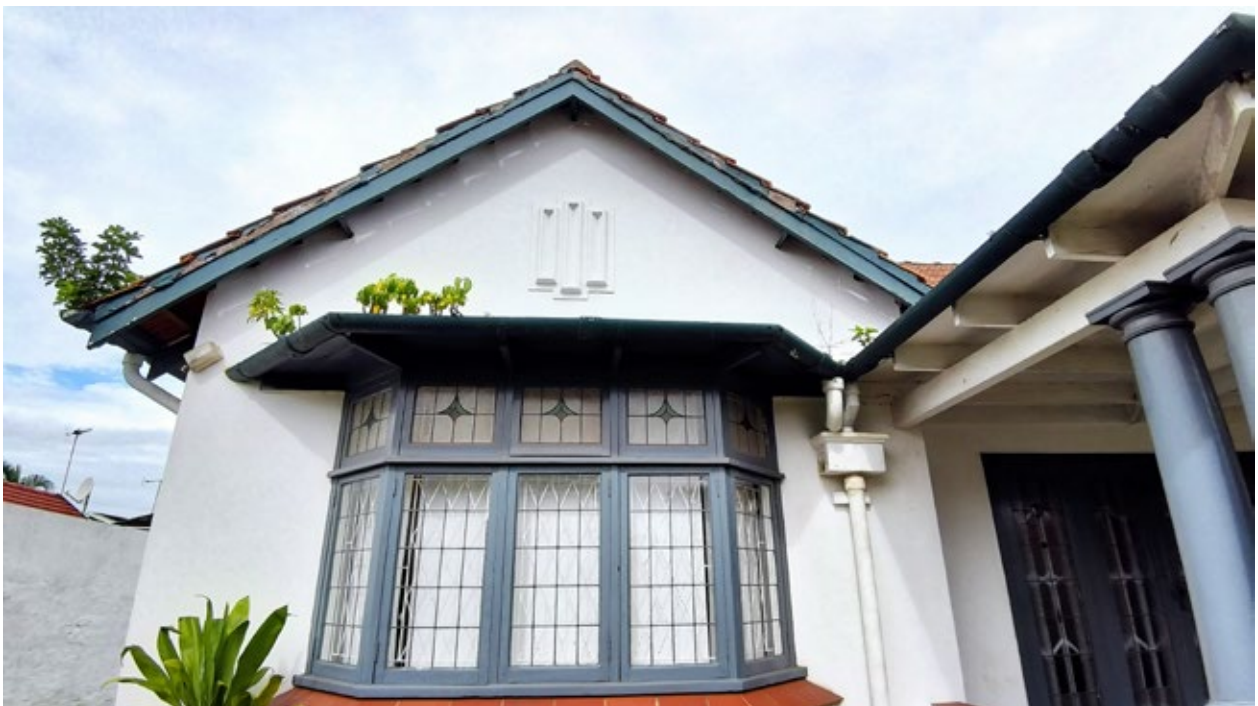
Figure 5. View of the a bay window on the North East Facade. Gable End roof above bay window.

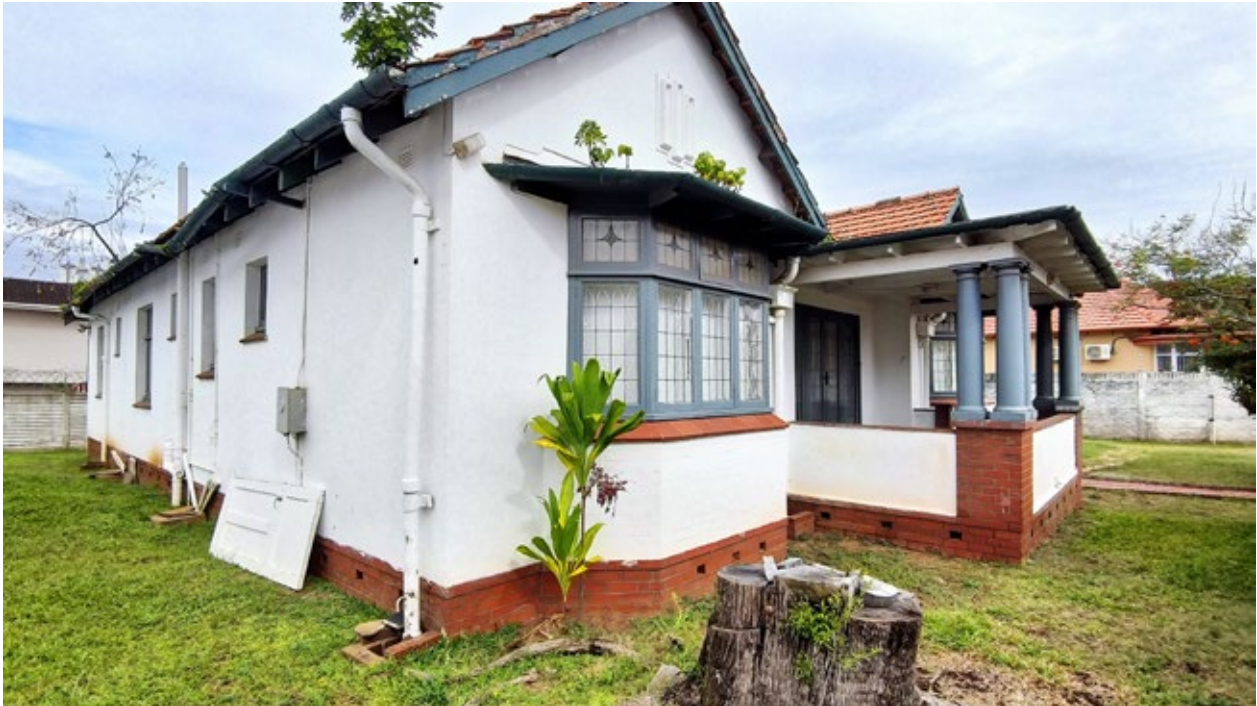
Figure 6. View of existing house from front garden showing the North East and South East facades. Red brick plinths. Smooth plastered walls. Gutters are damaged.

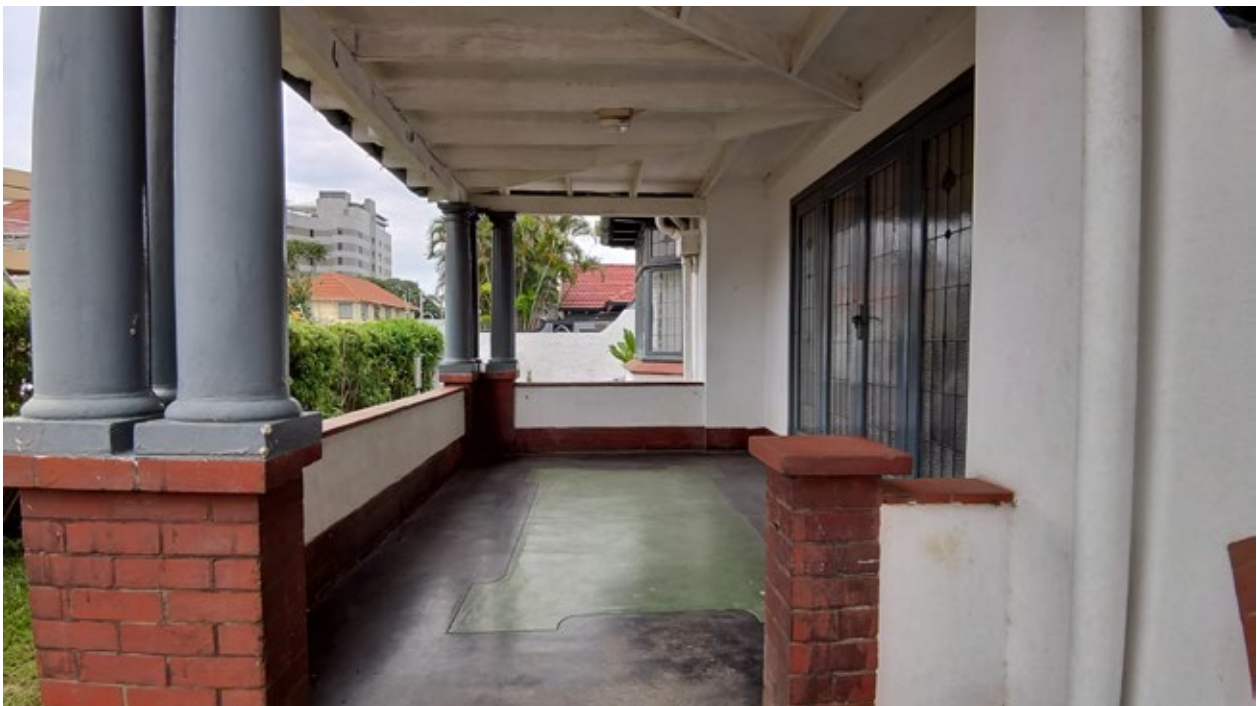
Figure 7. View of entrance verandah. Verandah consists of black and green stoep paint.

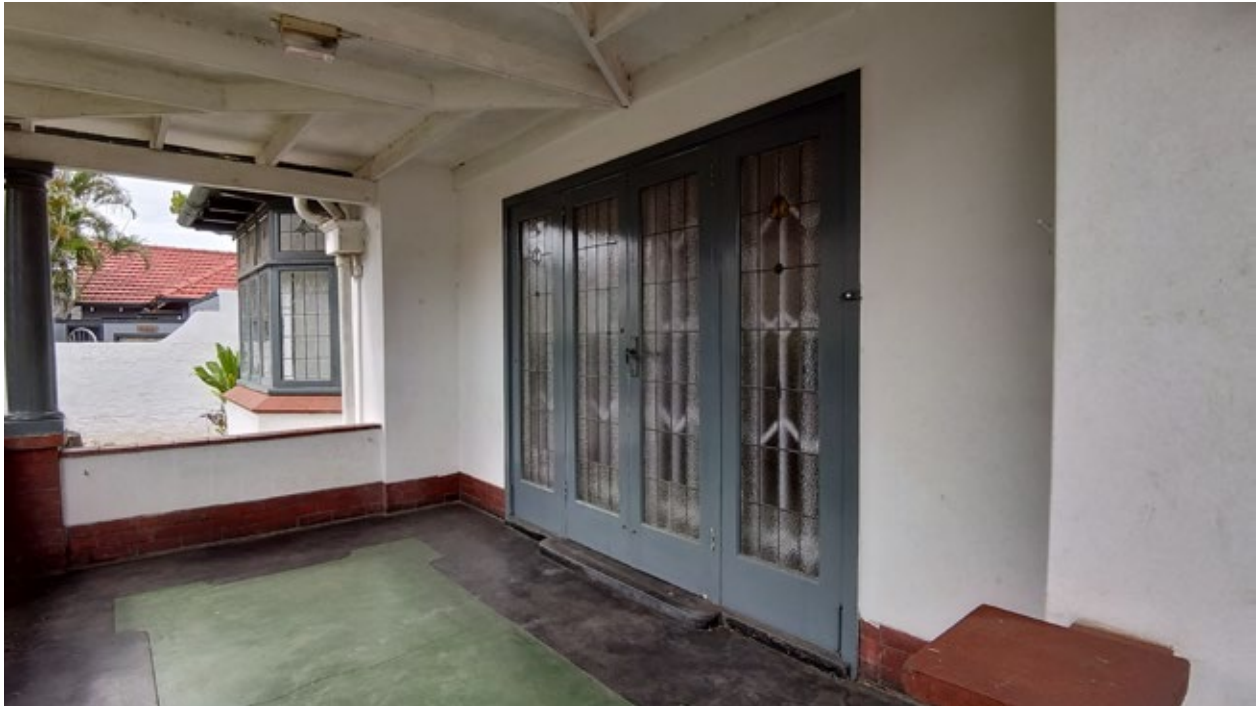
Figure 8. View of entrance verandah. Verandah consists of black and green stoep paint.

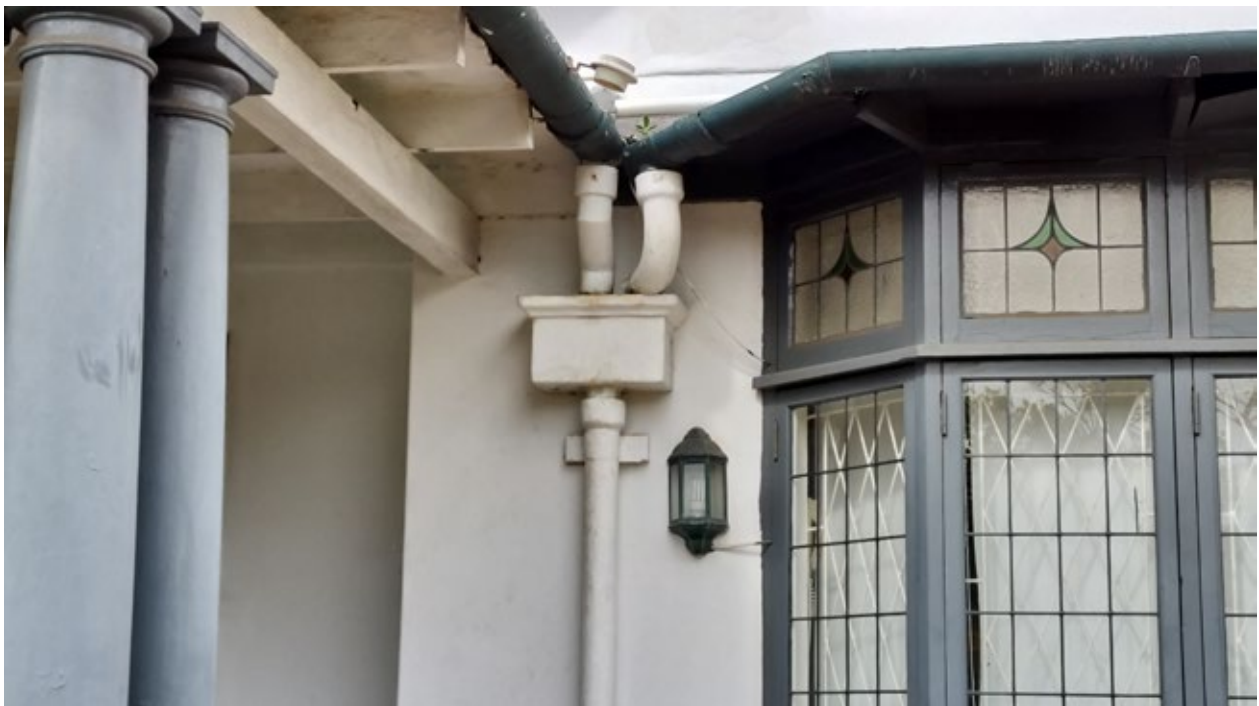
Figure 9. View of the verandah and bay window along the North East Facade. The bay window consists of lead light windows of which portions of the fanlight are stained glass.

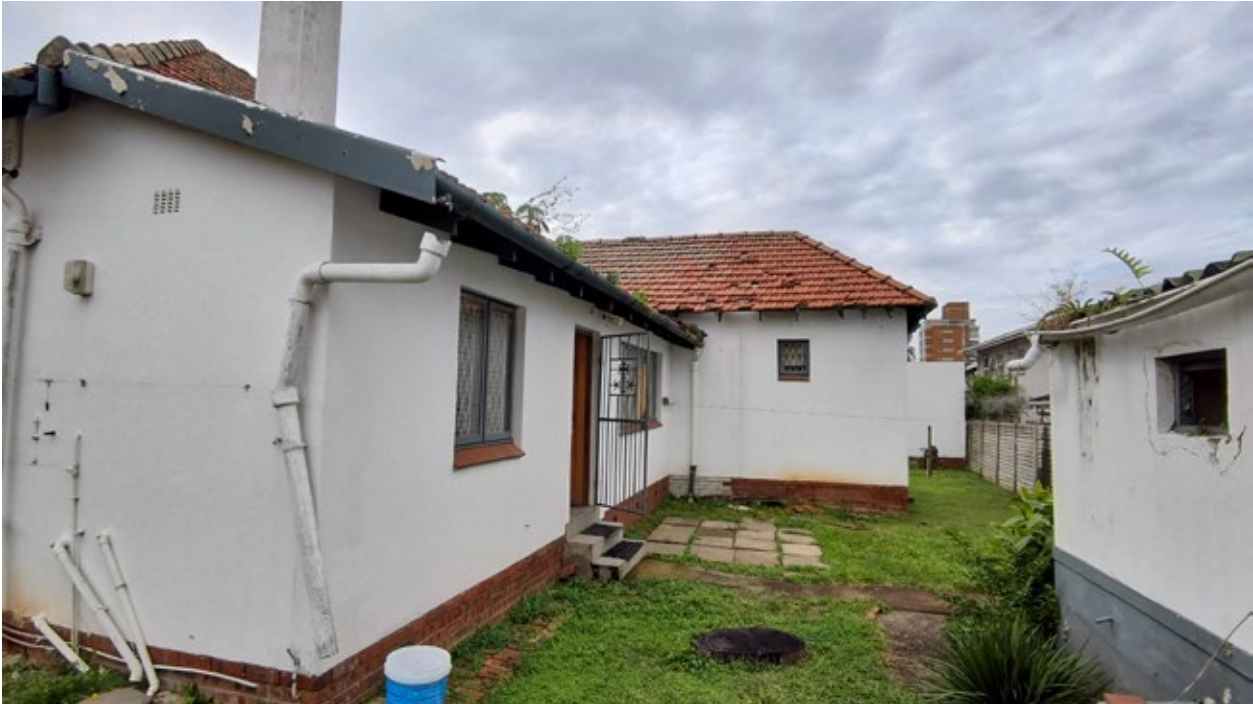
Figure 10. South West Elevation of Main Dwelling with outbuilding on the right hand side. Additions from 1981 were undertaken to this facade and are visible due to the ad hoc manner in which it was undertaken.

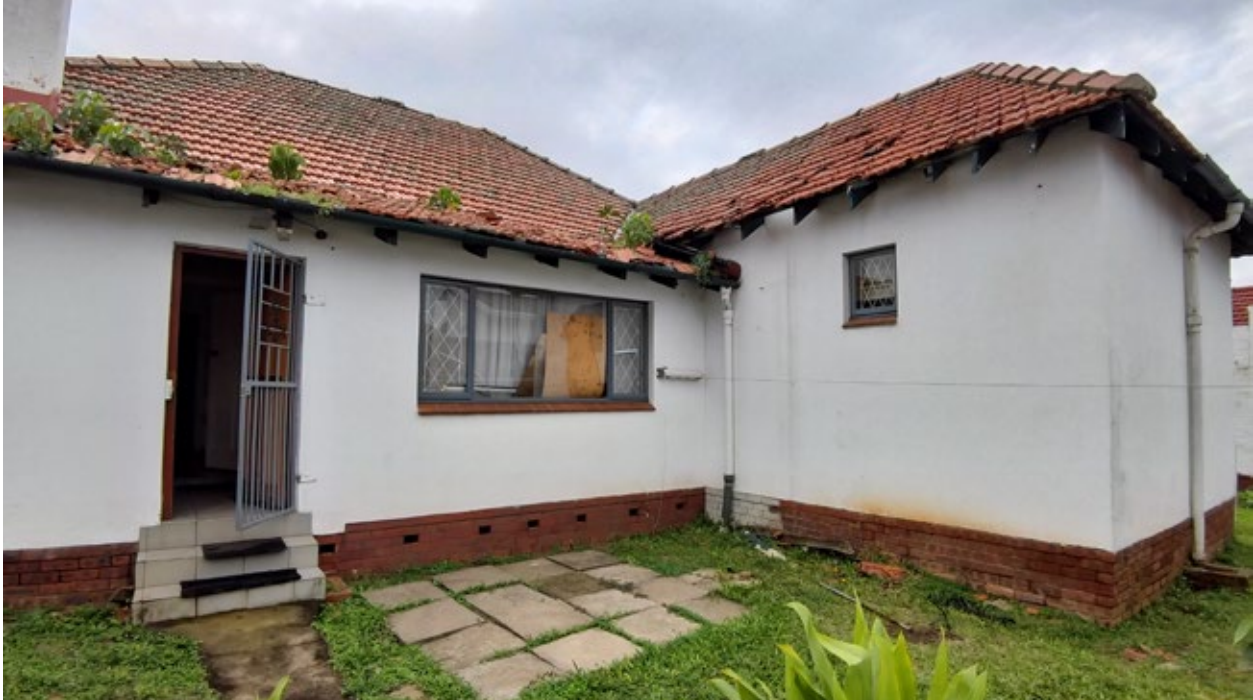
Figure 11. South West Elevation of the main dwelling. The extension to the main house in 1981 resulted in the roof structure having a pitch which is less than 17 degree. This has resulted in leaks through roof tiles. The ad hoc nature of the extension has also resulted in some awkward roof junctions.

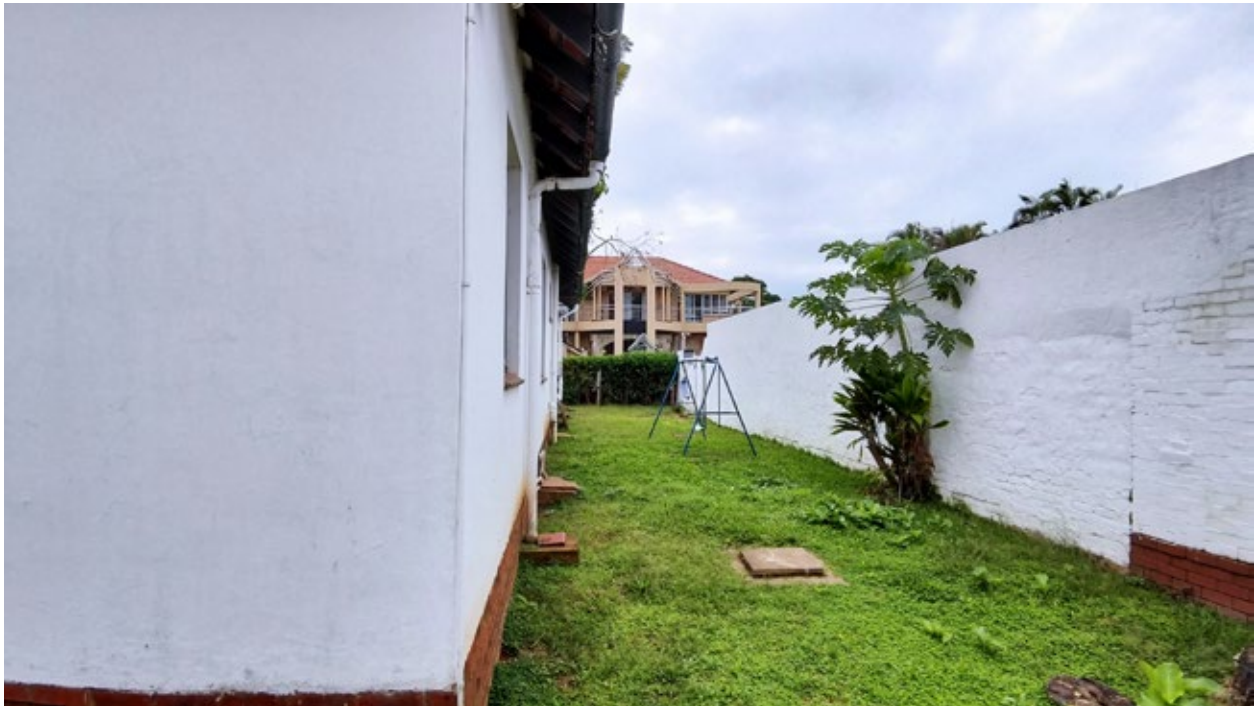
Figure 12. View the side of the dwelling. No architectural features or elements present.

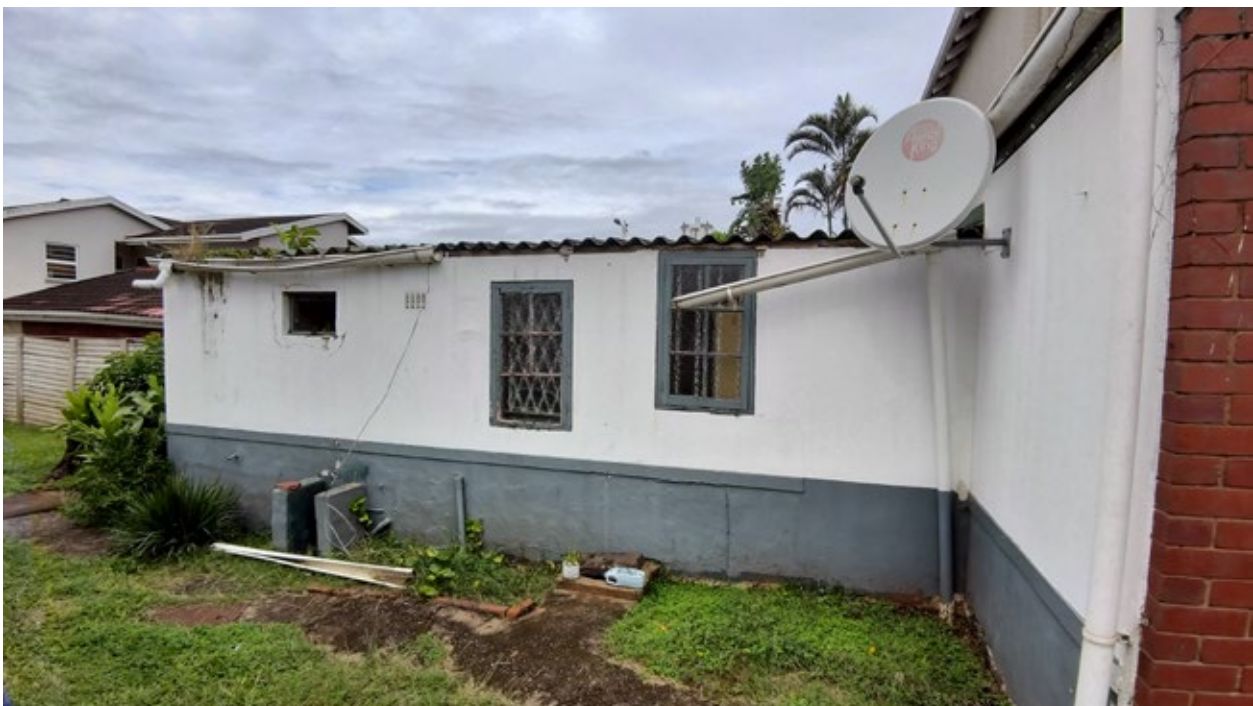
Figure 13. View of the outbuilding. Additions and Alterations were undertaken in 1981. Gutters have been badly damaged. Major cracking around small window. Plastered plinth is very reflects poor workmanship.

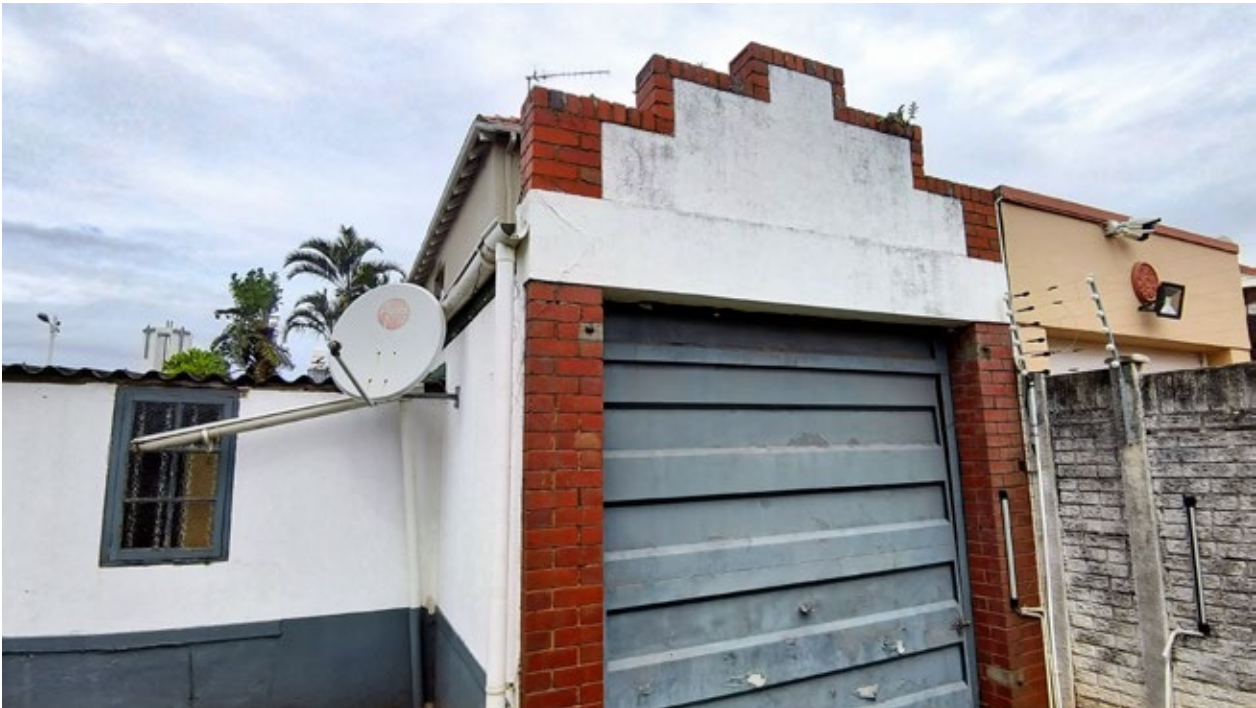
Figure 14. View of single garage from driveway. Consists of the red brick and plasters walls

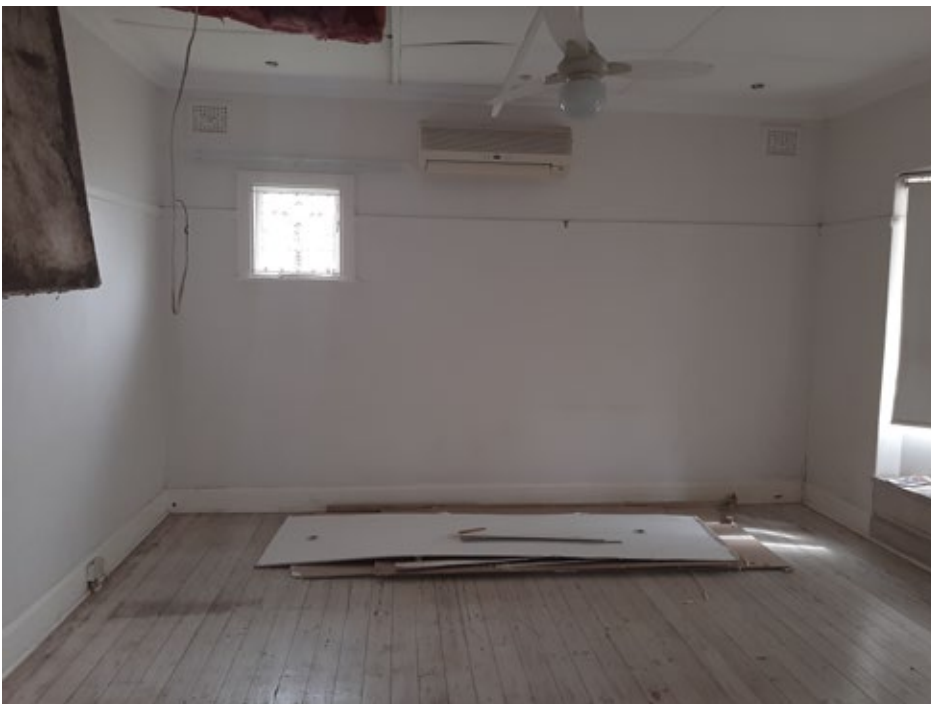
Figure 15. Internal view of the dining area. Painted timber suspended floors. Picture rails and a bay window.

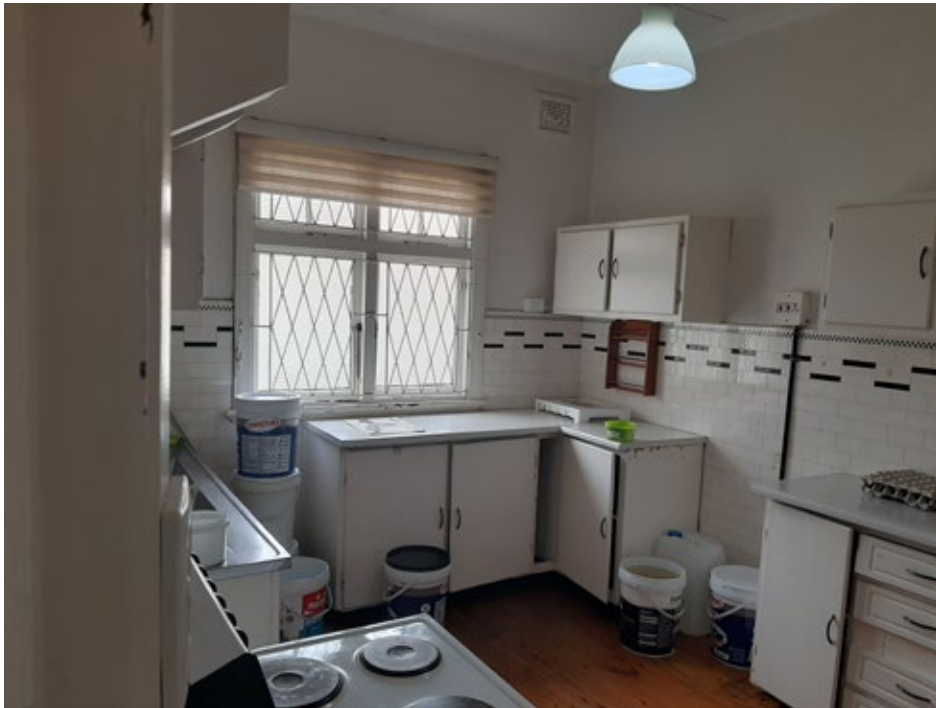
Figure 16. Internal View of kitchen. Timber suspended floors

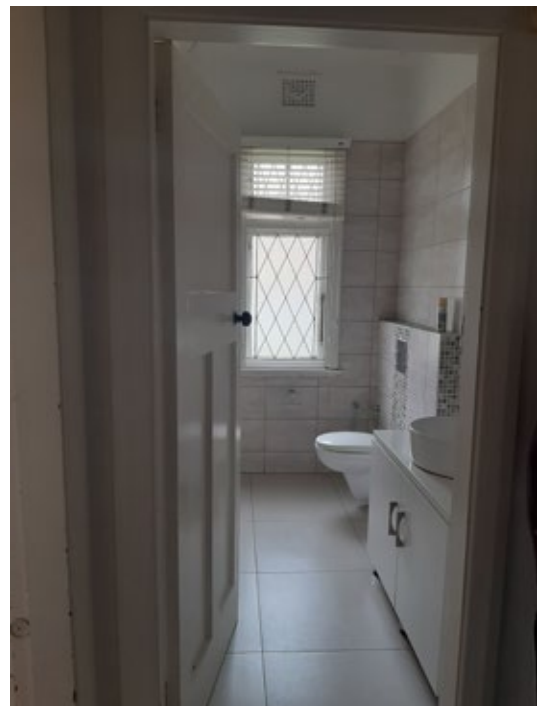
Figure 18. Internal view of bathroom.
Has been recently revamped to a
modern finish

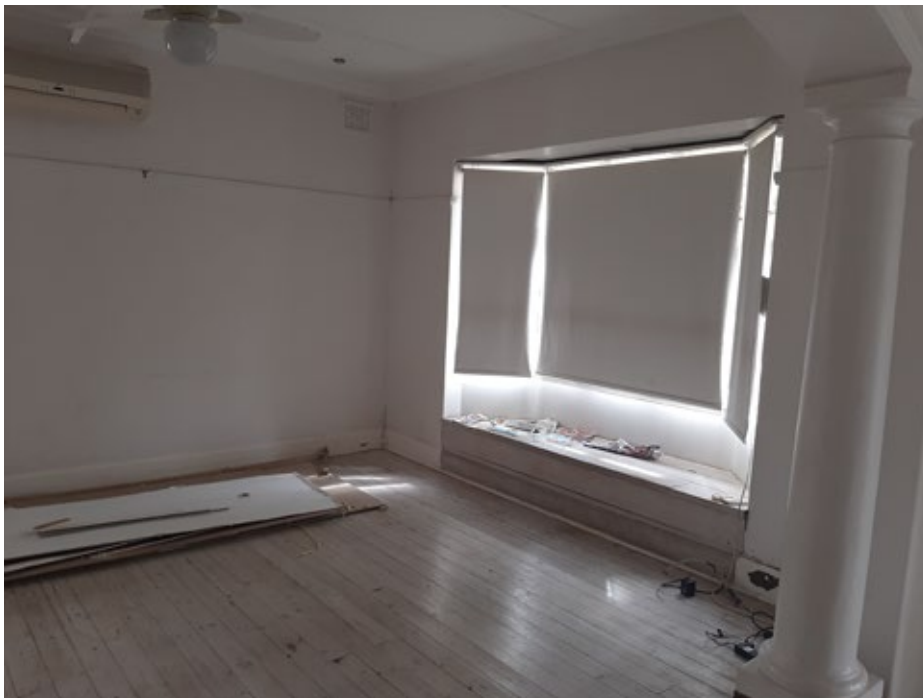
Figure 20. Internal view of the dining area. Painted timber suspended floors. Picture rails and a bay window.

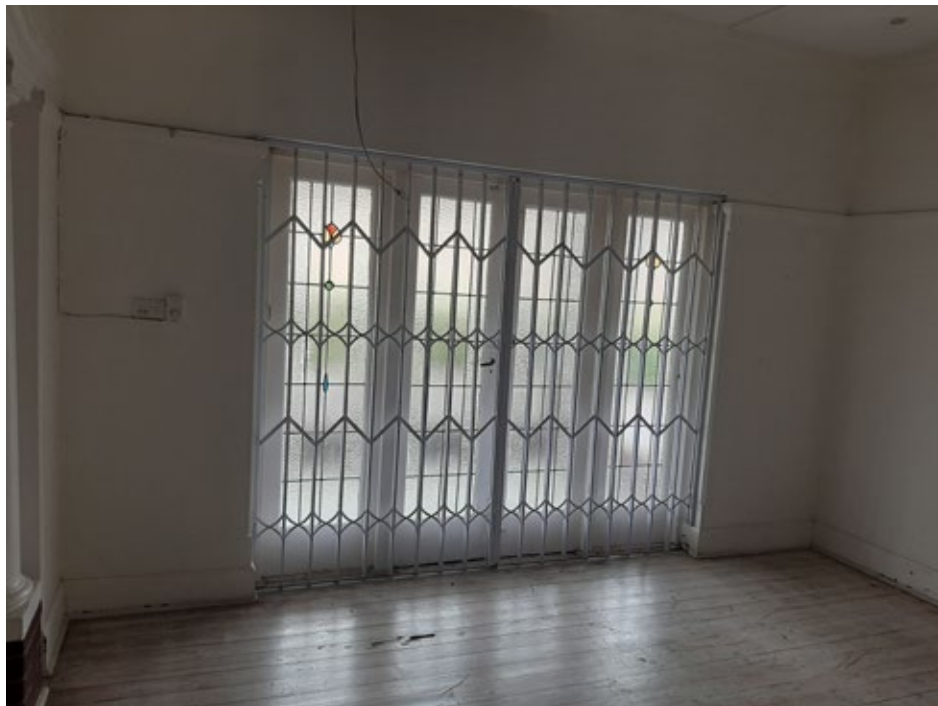
Figure 21. Internal view of lounge area. Painted timber suspended floors. Picture rails

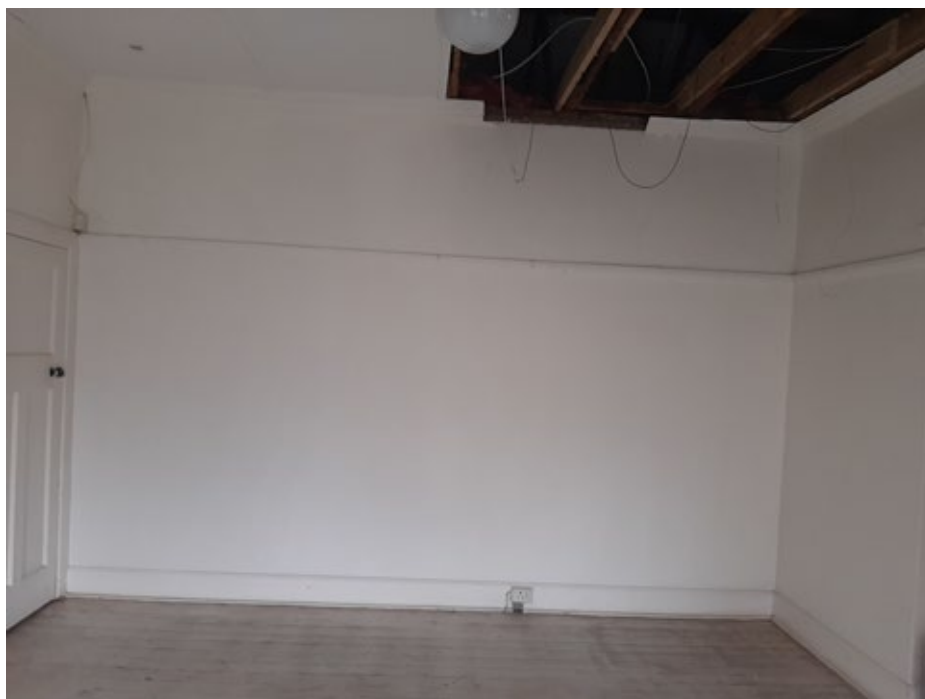
Figure 22. Internal view of bedroom. Contains picture rails. Ceiling has been removed to inspect roof trusses. Borer infestation confirmed and trusses in bad condition.

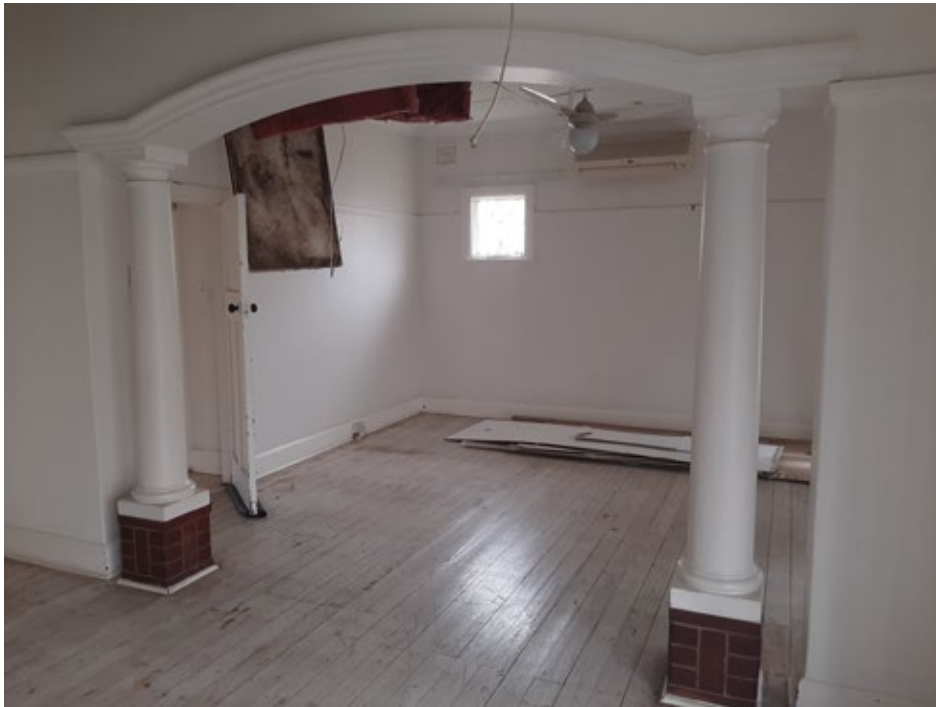
Figure 23. Internal view of lounge area. Painted timber suspended floors. Picture rails. Arched entrance to dining area framed by circular columns on red brick plinths.

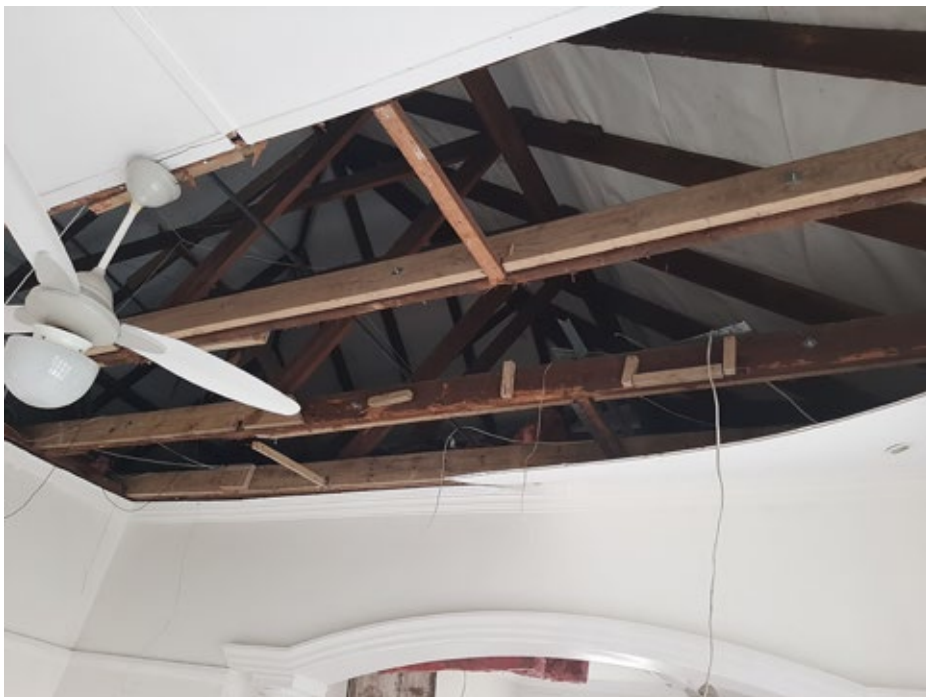
Figure 24. Internal view of lounge. Ceiling has been removed to inspect roof trusses. Borer infestation confirmed and trusses in bad condition. Repairs have previously undertaken

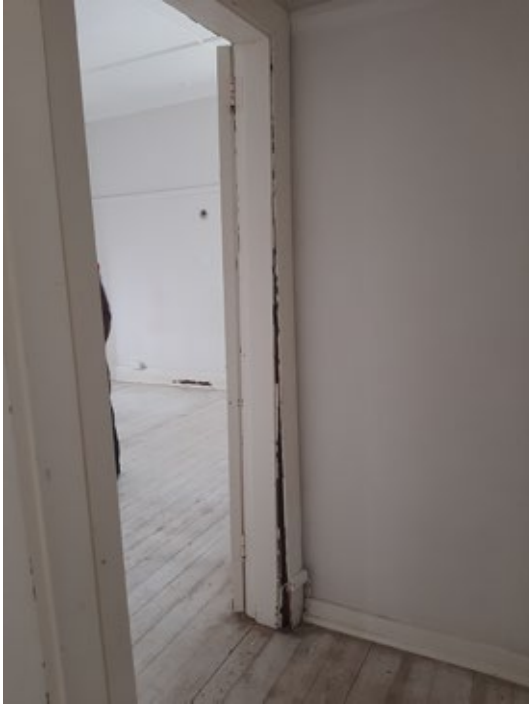
Figure 25. Internal view of passage showing borer infested door frame

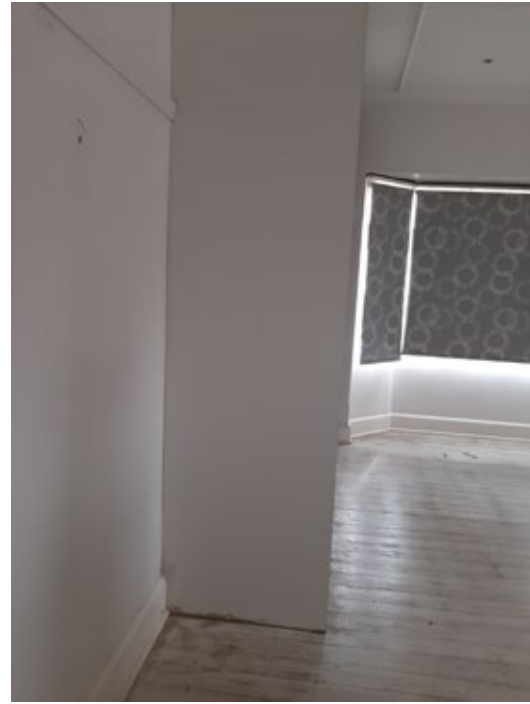
Figure 26. Internal view of main bedroom. Picture rails were not matched in areas where extensions were undertaken

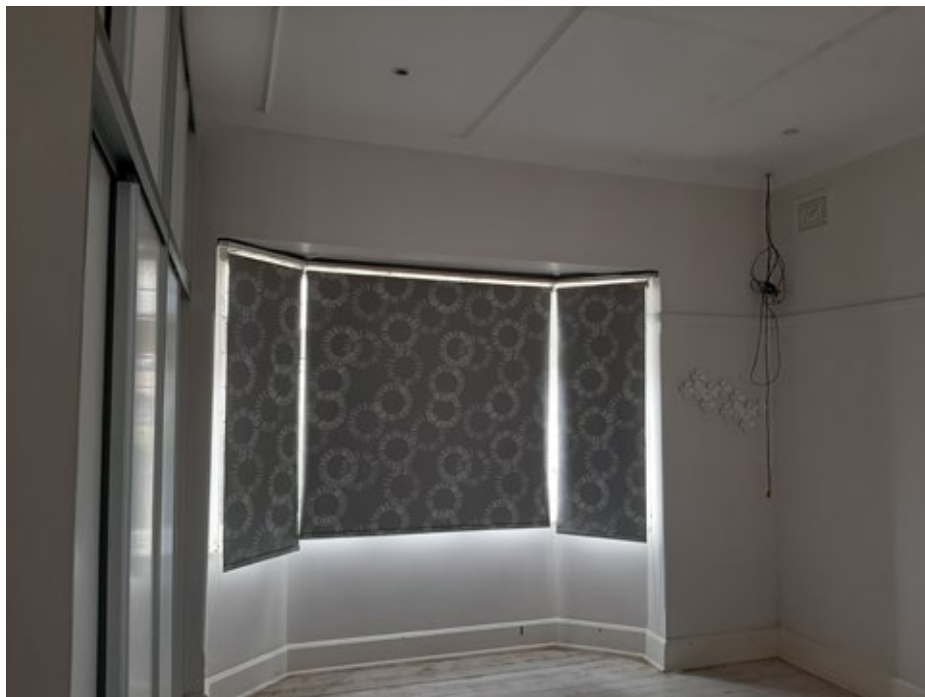
Figure 27. Internal view of main bedroom. Bay Window. Painted suspended timber floors

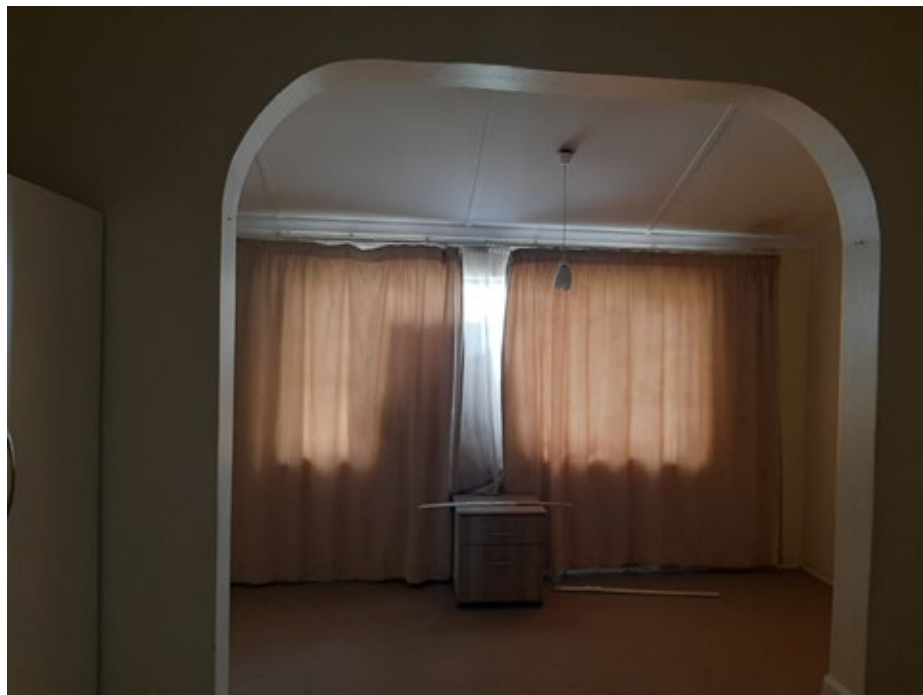
Figure 29. View of bedroom. This was the new bedroom that was extended in 1981.

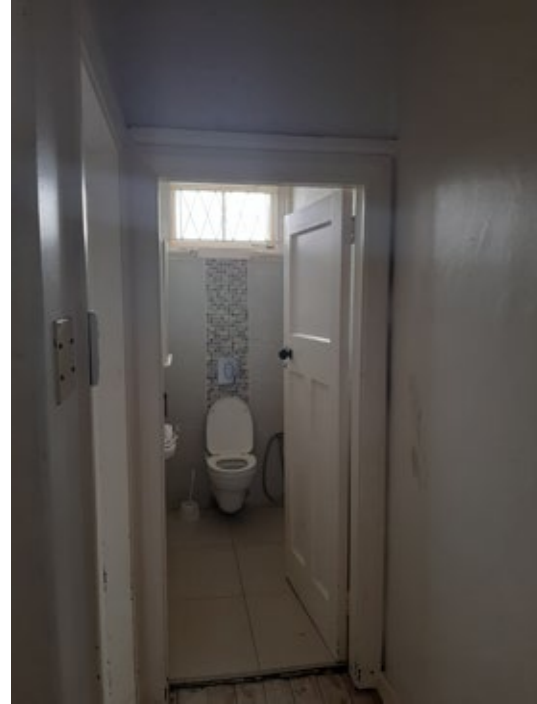
Figure 31. Internal view of wc. Has been recently revamped to a modern finish

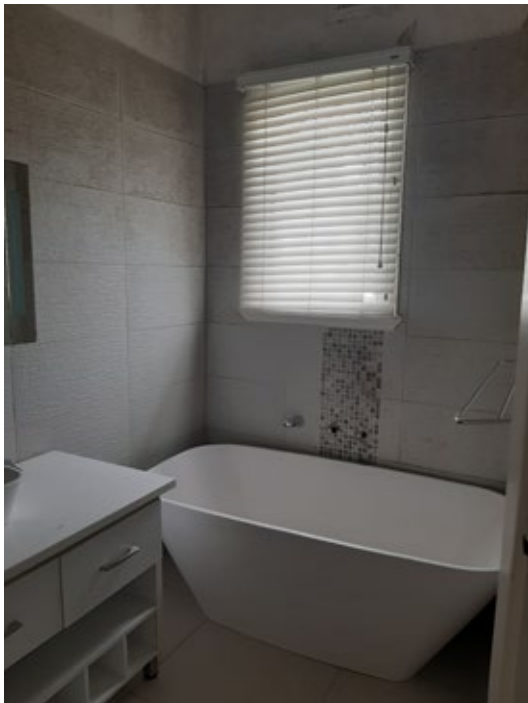
Figure 18. Internal view of bathroom. Has been recently revamped to a modern finish

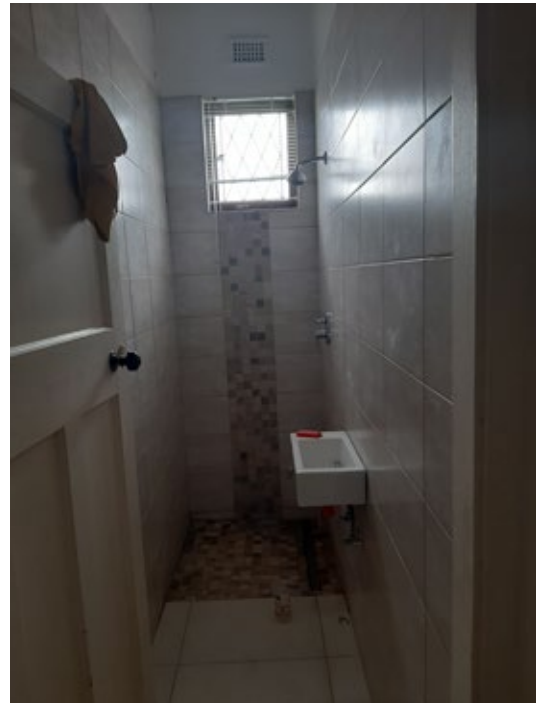
Figure 18. Internal view of shower. Has been recently revamped to a modern finish

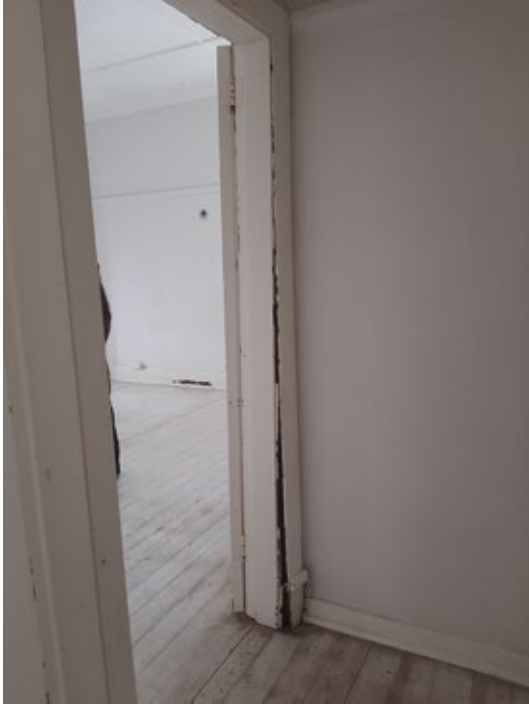
Figure 25. Internal view of passage showing borer infested door frame

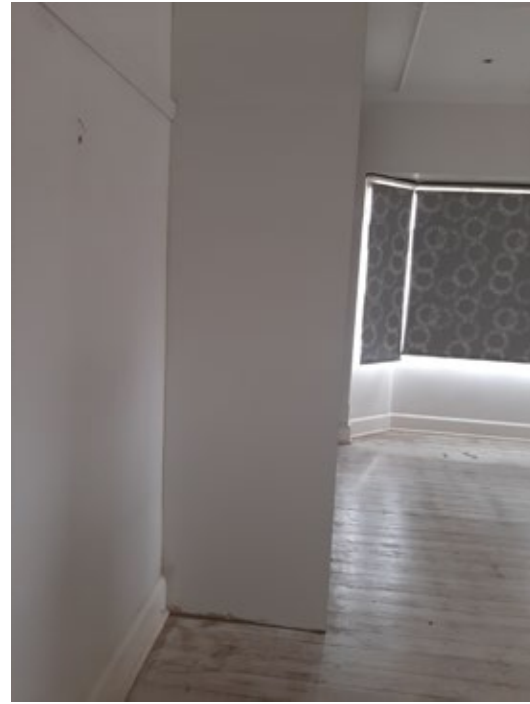
Figure 26. Internal view of main bedroom. Picture rails were not matched in areas where extensions were undertaken

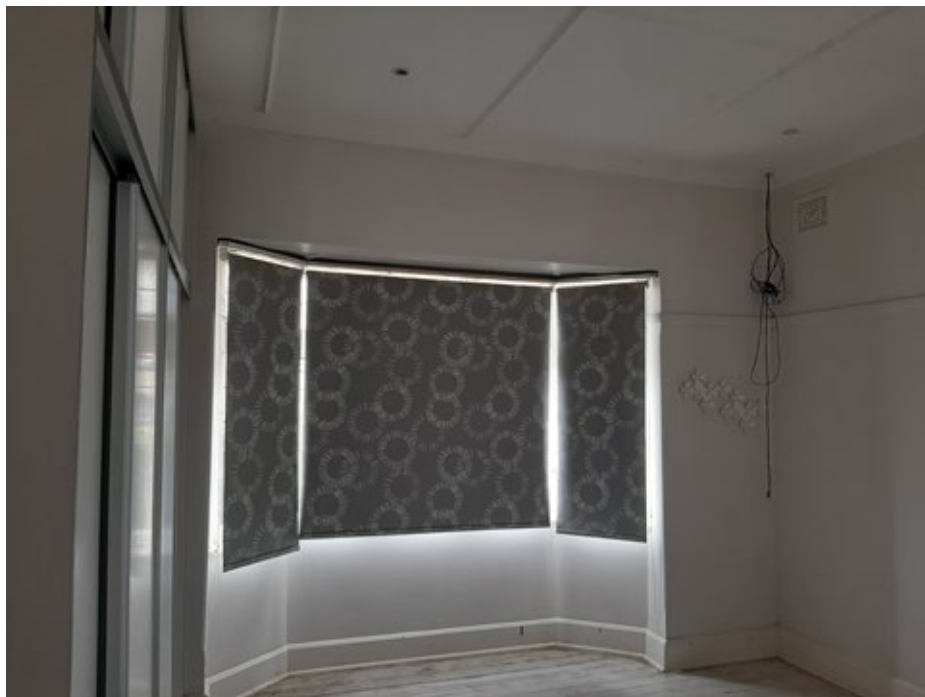
Figure 27. Internal view of main bedroom. Bay Window. Painted suspended timber floors
