ANNEXURE 2:
PHOTOGRAPHIC ANALYSIS OF THE EXISTING BUILDING

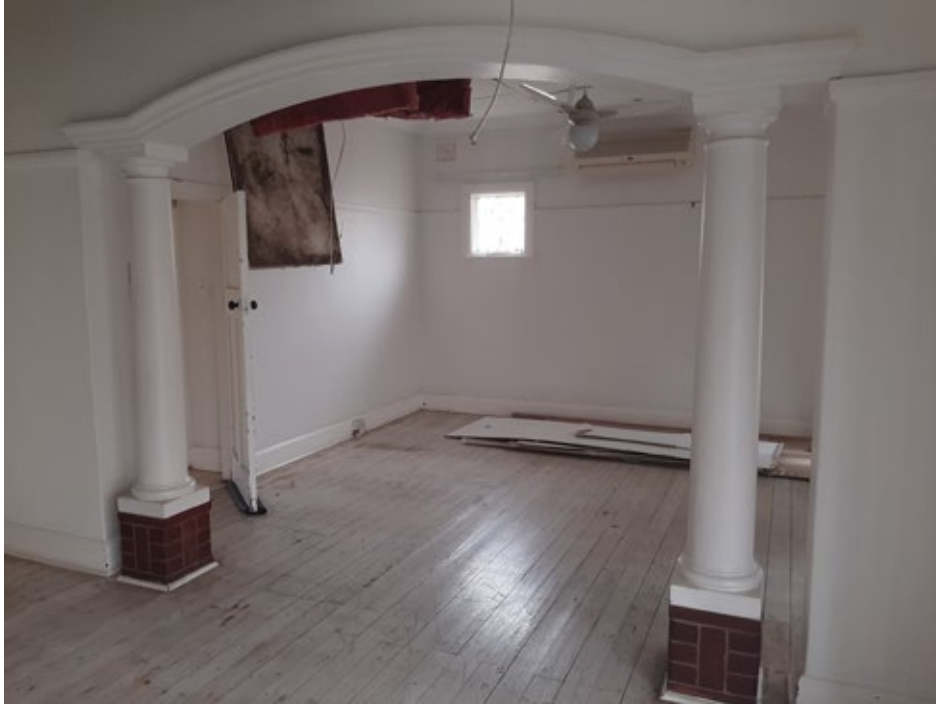
Figure 23. Internal view of lounge area. Painted timber suspended floors. Picture rails. Arched entrance to dining are framed by circular columns on red brick plinths.

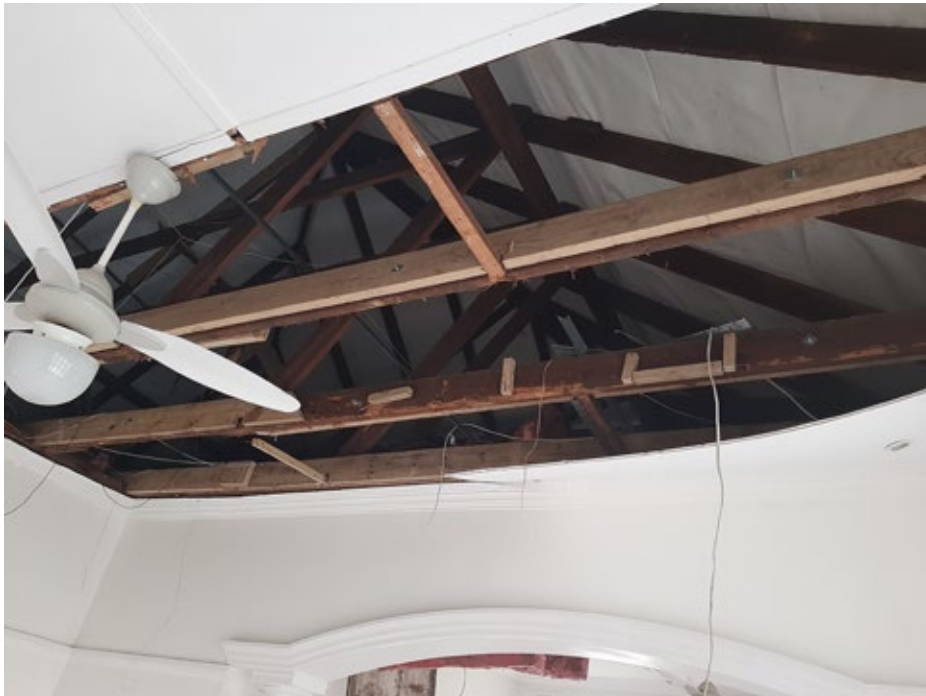
Figure 24. Internal view of lounge. Ceiling has been removed to inspect roof trusses. Borer infestation confirmed and trusses in bad condition. Repairs have previously undertaken
