Reference No: DJH059-R01

REVIEW OF DAM SAFETY RISK AND PROPOSED REMEDIAL WORK ASSOCIATED WITH CATEGORY 3 NGODWANA DAM, MBOMBELA

Ngodwana Dam is a 41 m high zoned earthfill Category III Dam. The dam is located on a tributary of the Elands River, Mpumalanga Province, directly upstream from the N4 highway and the Ngodwana Paper Mill, 40 km from Mbombela. The layout of the dam is shown in **Figure 1**.

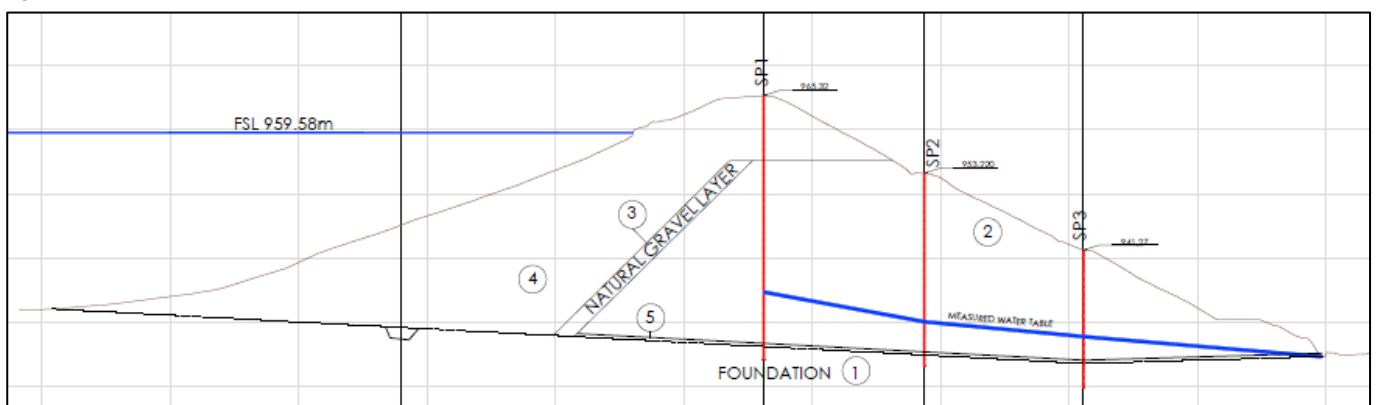
Figure 2: Embankment internal zoning

- The natural gravel inclined chimney drain may not comply with all filter criteria such as permeability (free-draining), collapsibility (cohesionless) and adequate protection of the base core material.
- The gravel strip drains are only for conveying seepage water from the chimney to the toe drain and do not provide continues protection to the foundation and shell zone as a filter blanket drain would have done.

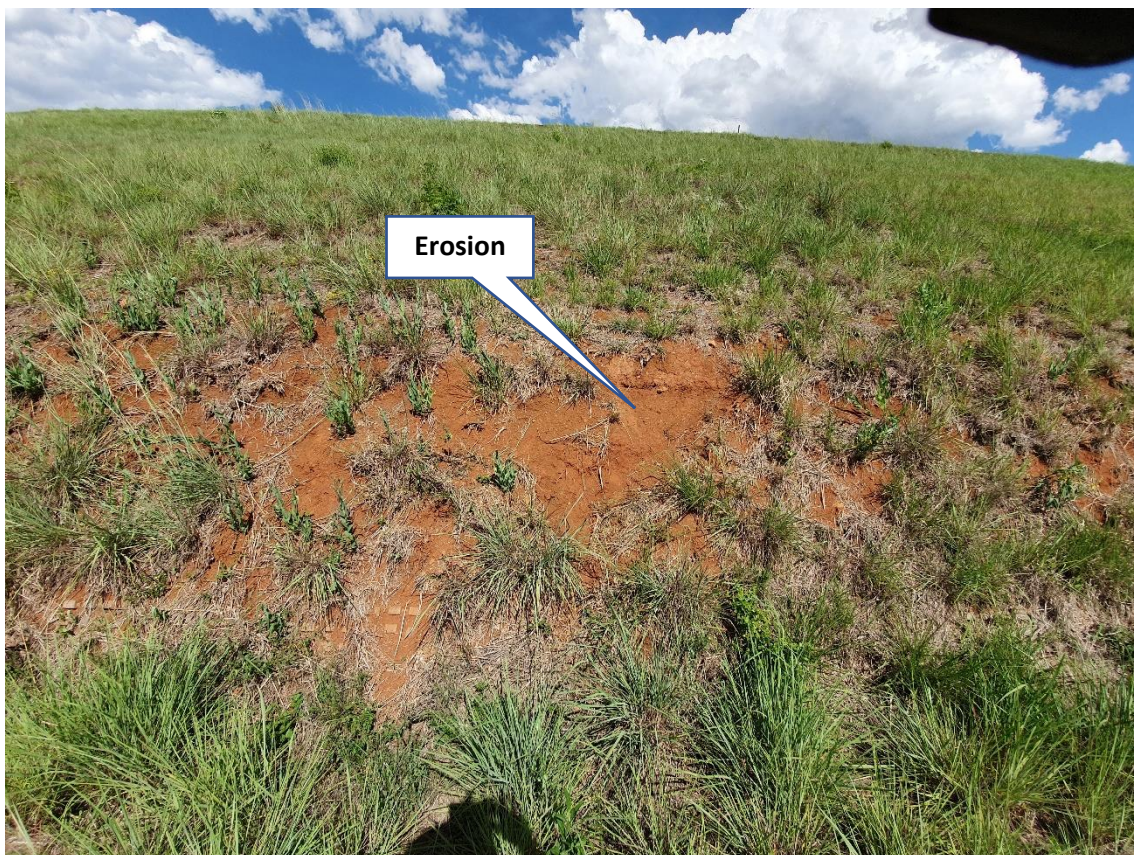
Photo 6: Downstream face erosion on steeper slope section typically above berm drain (19 November 2019). Note reddish clayey sand embankment material exposed.

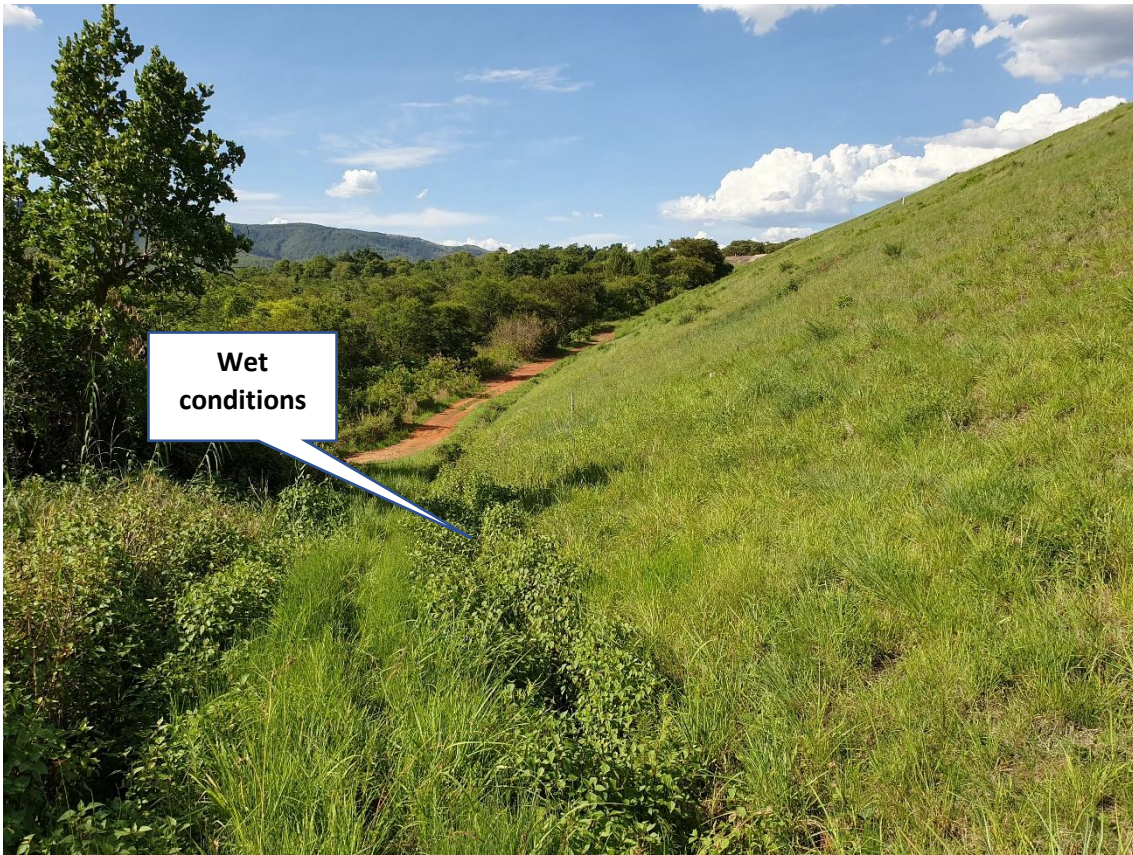
surface within the embankment. This is also the area where the wet area on the lower downstream face had been observed. The high observed phreatic surface indicate that the natural gravel layer does not effectively draw-down the phreatic surface. Saturated conditions exist below the phreatic surface leading to lower shear strength for embankment materials.

Photo 7: Downstream toe on lower left flank (19 November 2019). Note wet conditions which could be attributed to high phreatic surface within embankment.

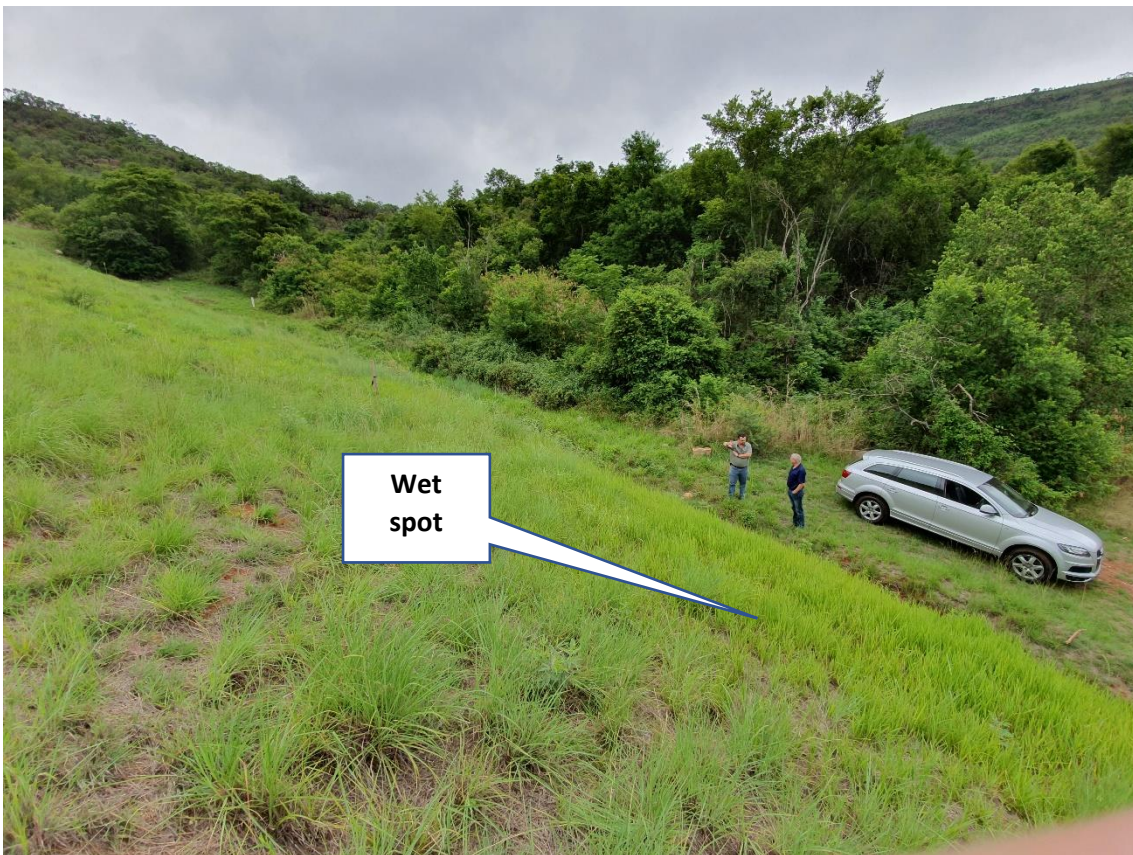
Photo 8: Downstream toe on lower left flank (20 November 2019). Note wet spot referred to in previous reports.

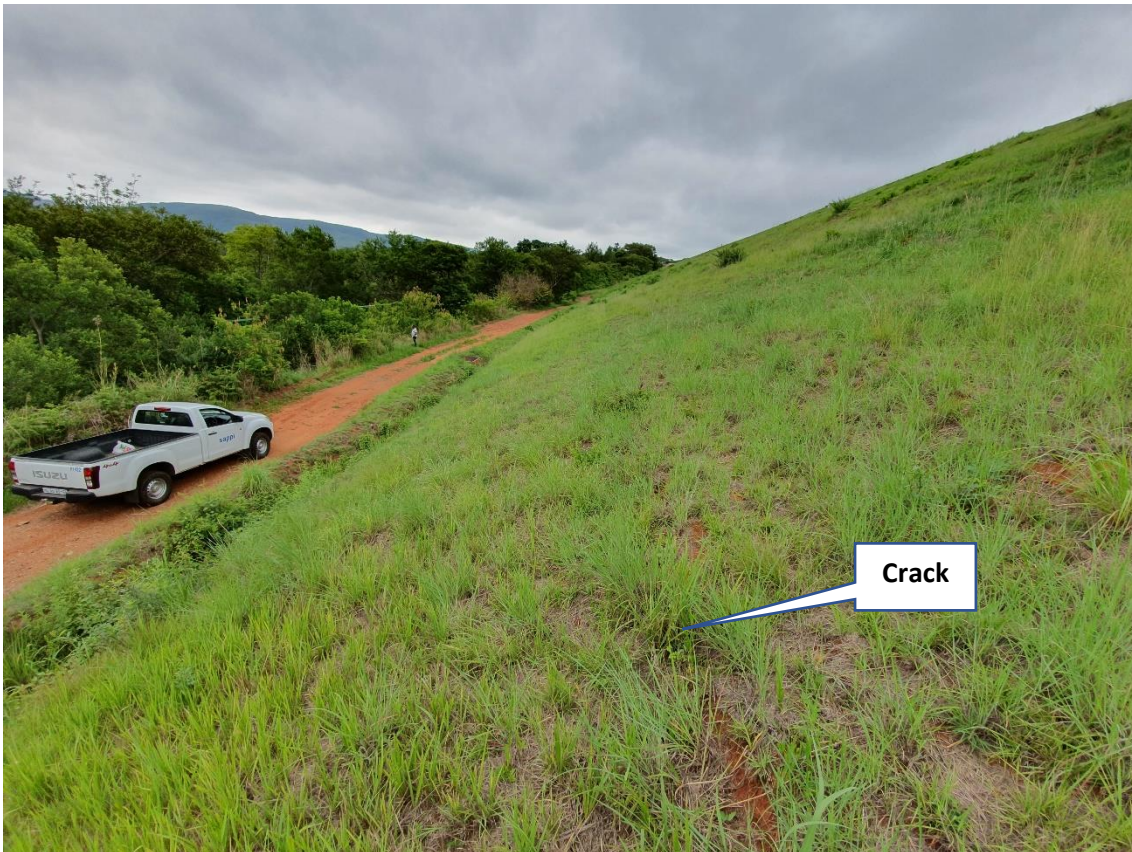
Photo 9: Downstream face from left flank (20 November 2019). Note longitudinal crack likely caused by surface slip movement.

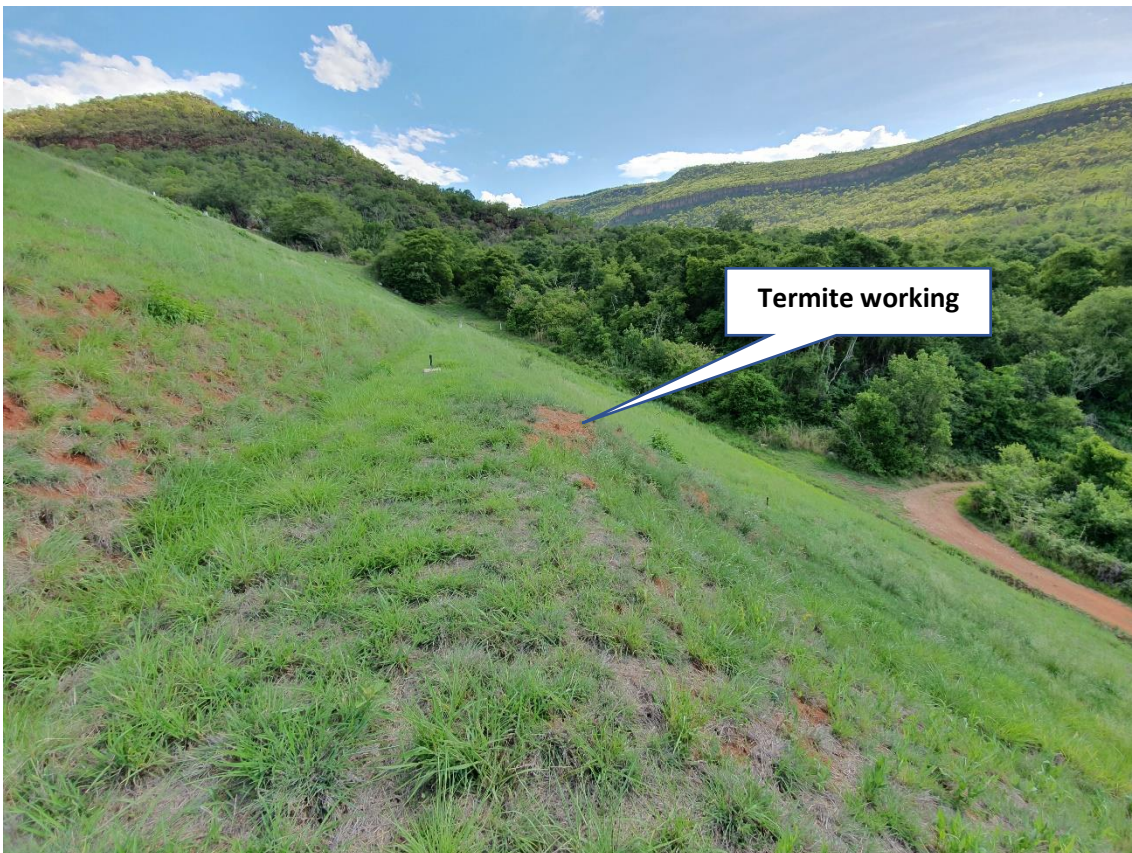
Photo 10: Lower berm on downstream face towards left flank (19 November 2019). Note dormant termite working.

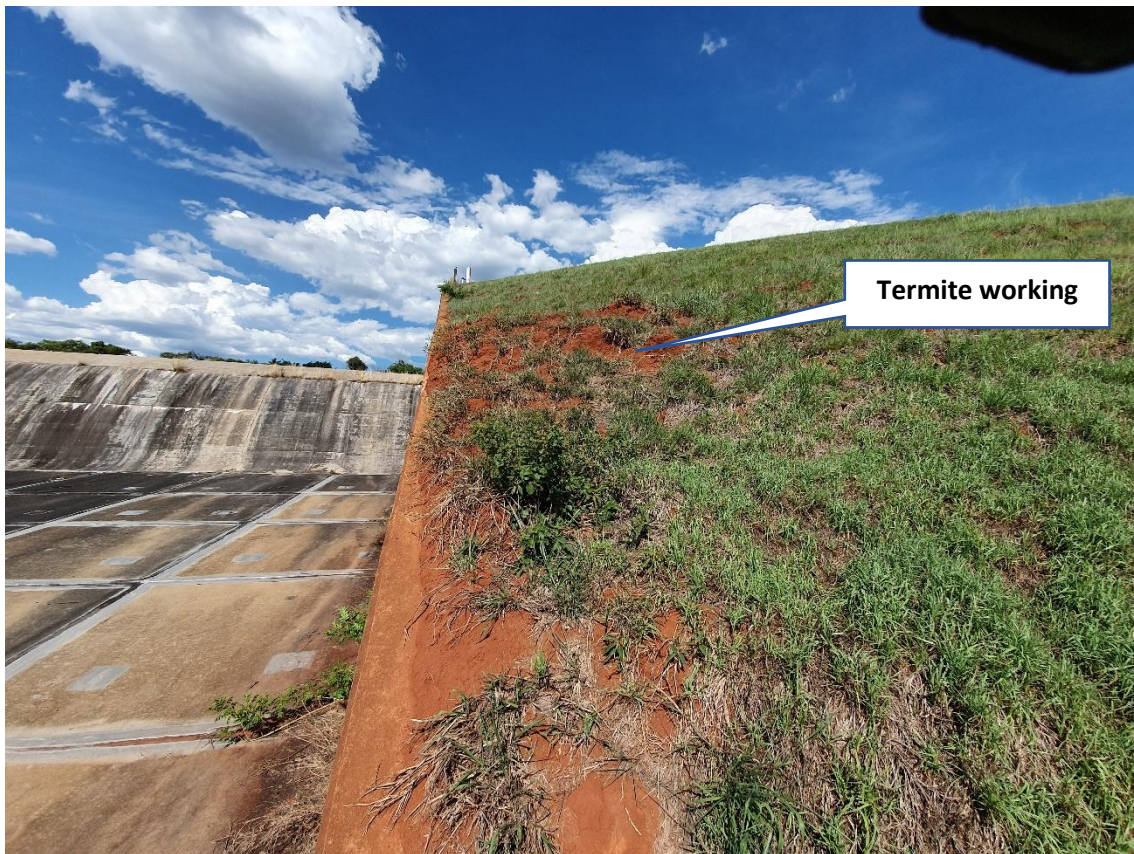
Photo 11: Spillway left retaining wall contact with embankment (19 November 2019). Note dormant termite working. Also note no safety handrail.

- Remedial work to the breaching section downstream face local slip (Photos 18 & 19) and possible raising of the breaching section as it is no longer considered a necessary emergency spillway.
- Repair of outlet conduit joints where water with muddy material is leaking out.
- Spillway joint sealant replacement (Photos 15 & 16).
- Removal of trees along spillway discharge channel training walls and repair of joint (Photo 17).
- Provide safety handrails alongside the spillway retaining walls (Photo 11).
- Reservoir rim stability assessment.

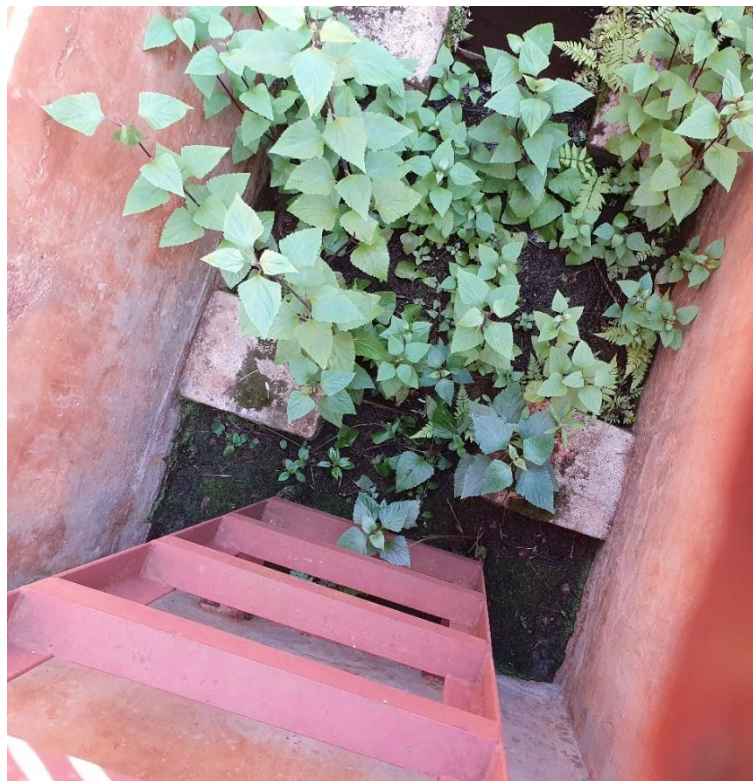
Photo 12: V-notch weirs in chamber at embankment toe to measure seepage flow from sub-soil drains (19 November 2019). Note overgrown state and sediment which will influence accuracy of readings.

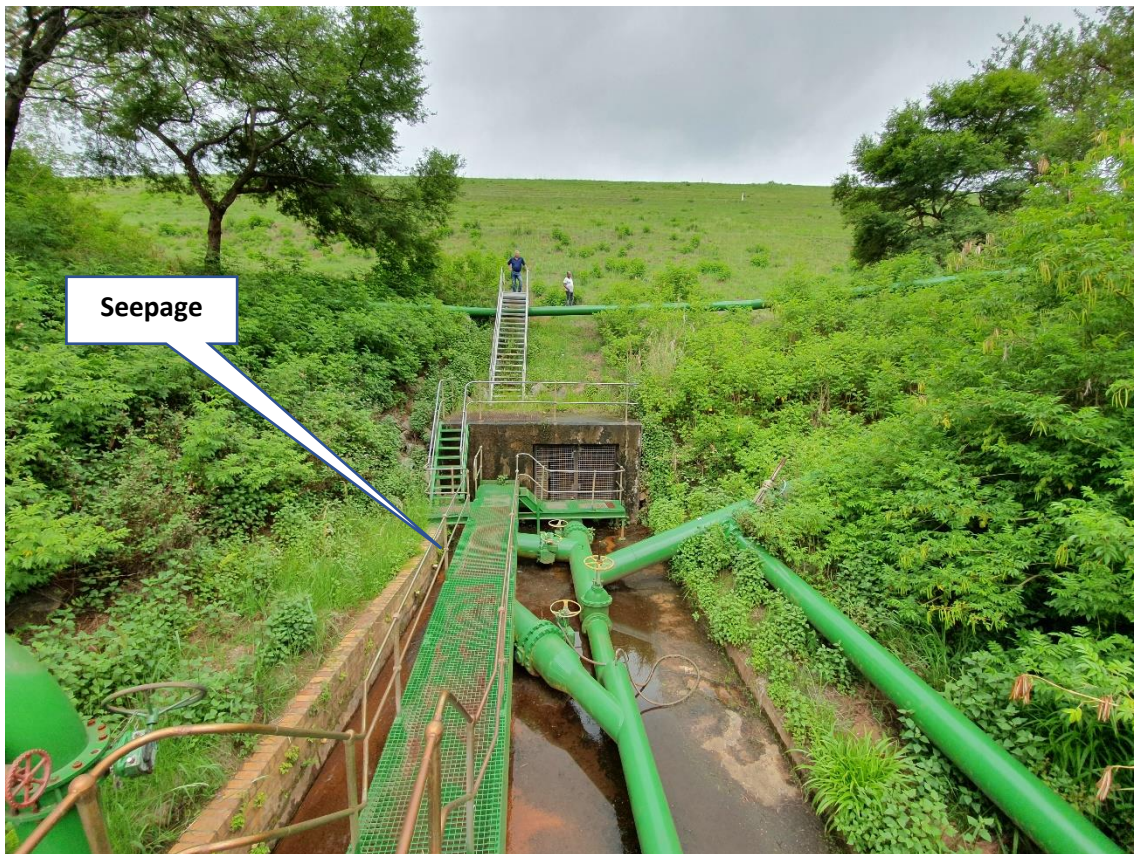
Photo 13: Outlet conduit exit at embankment toe (20 November 2019). Seepage was noted emanating from sides of conduit monitored at v-notch weirs.

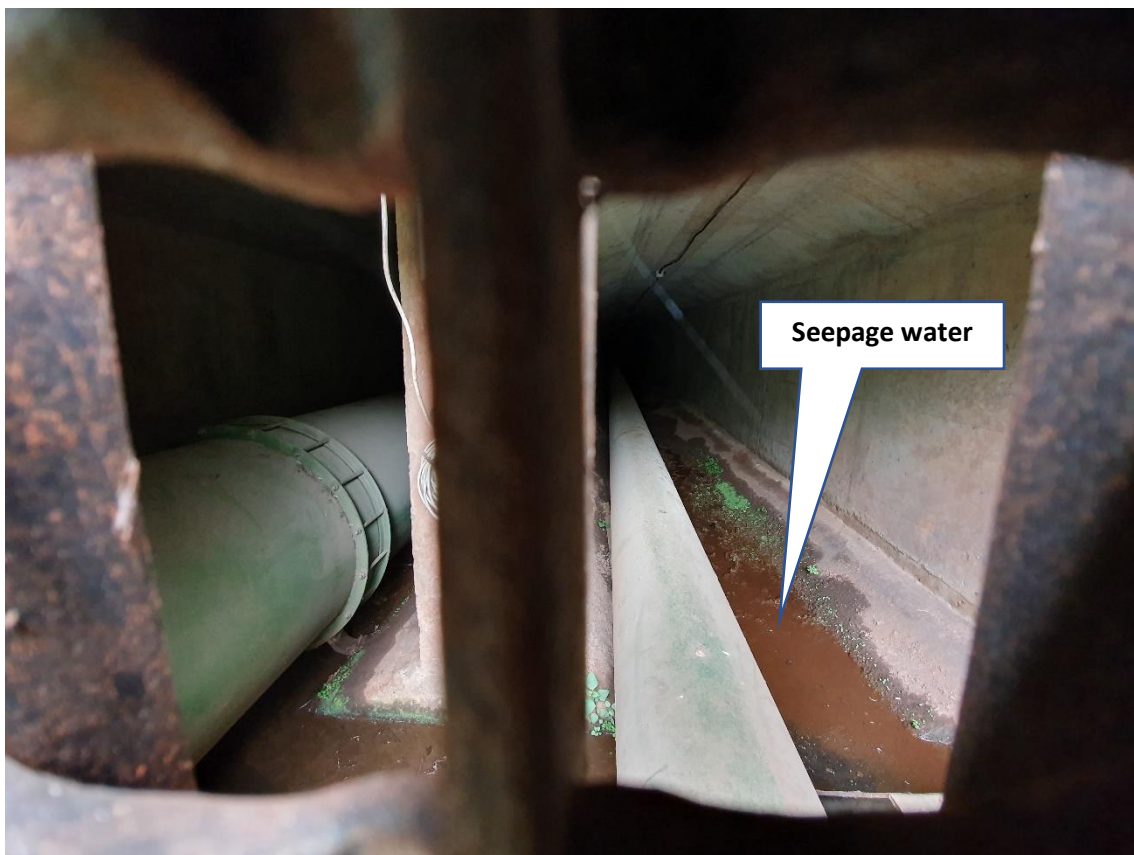
Photo 14: Double barrel outlet conduit (20 November 2019). Note seepage water with clayey deposits.

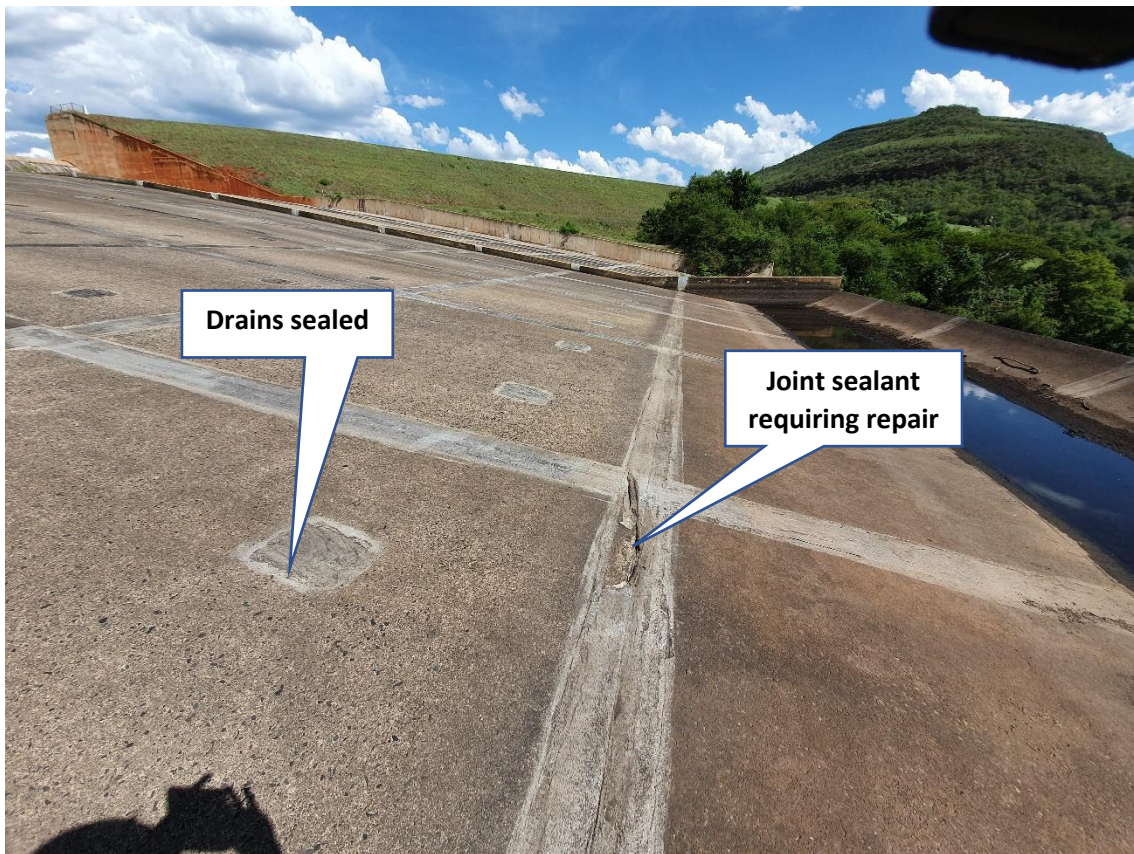
Photo 15: Spillway lining joint sealant requiring repair (19 November 2019). Note lining drains also sealed.

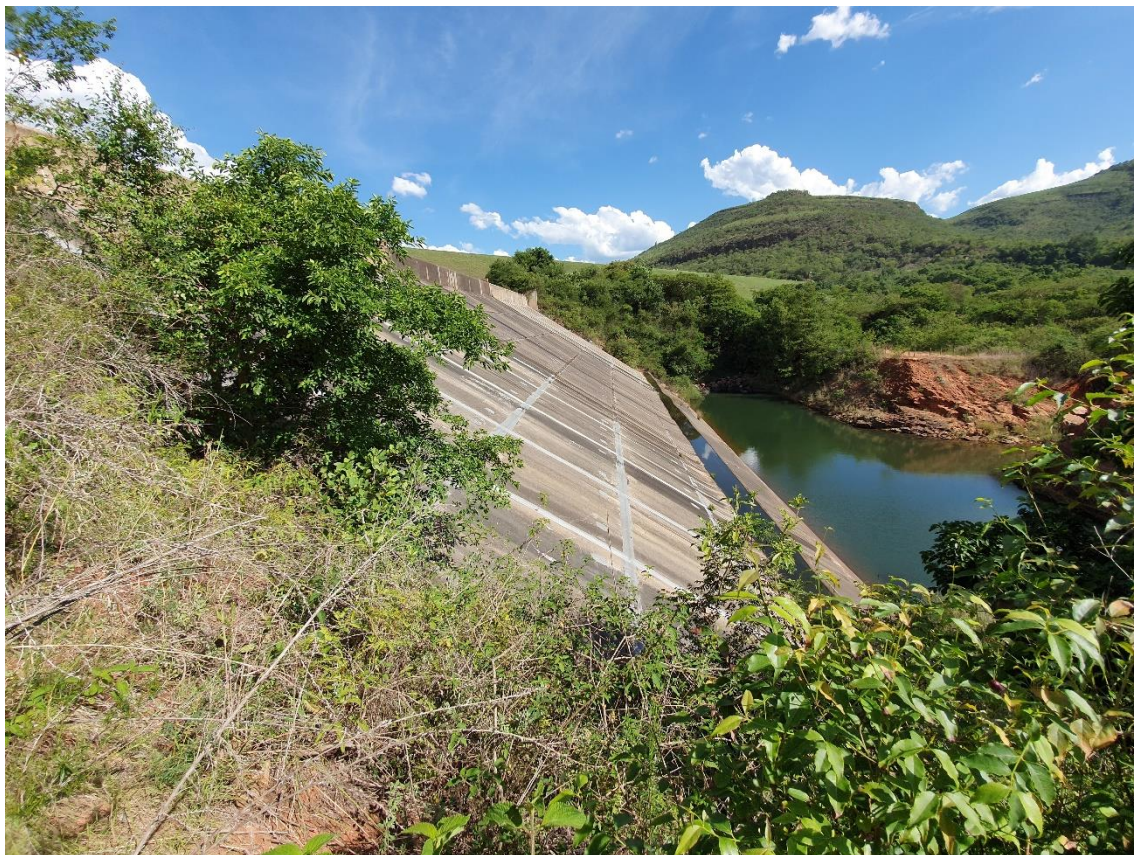
Photo 16: Spillway lower lining steep section (19 November 2019). Joint sealant also requiring repair.

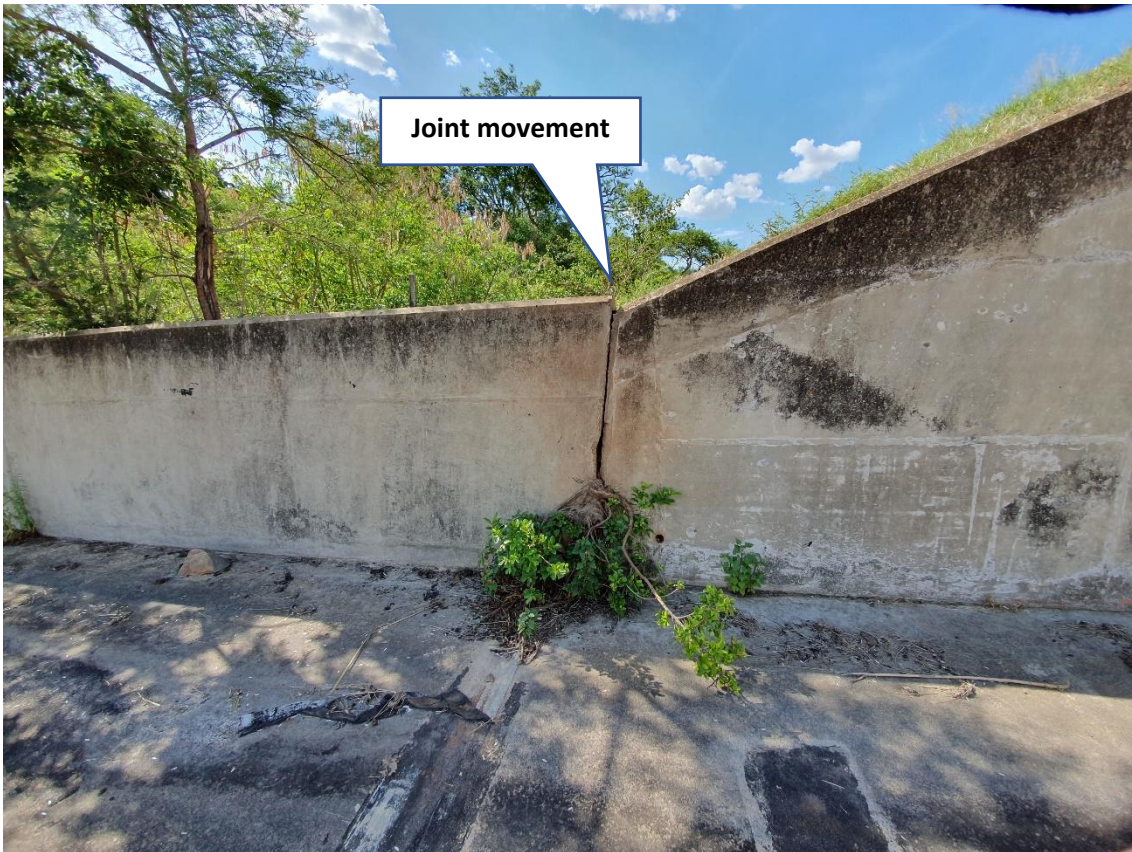
Photo 17: Spillway right training wall joint movement likely caused by tree roots (19 November 2019).

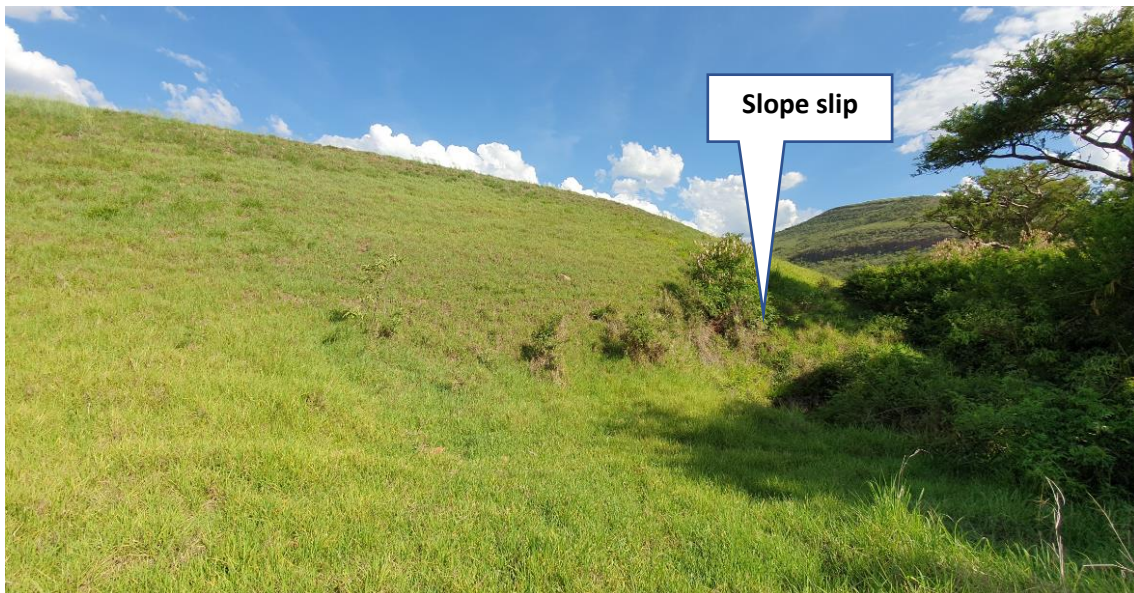
Photo 18: Downstream face of breaching section (fuseplug embankment) on right flank showing local slip (19 November 2019).

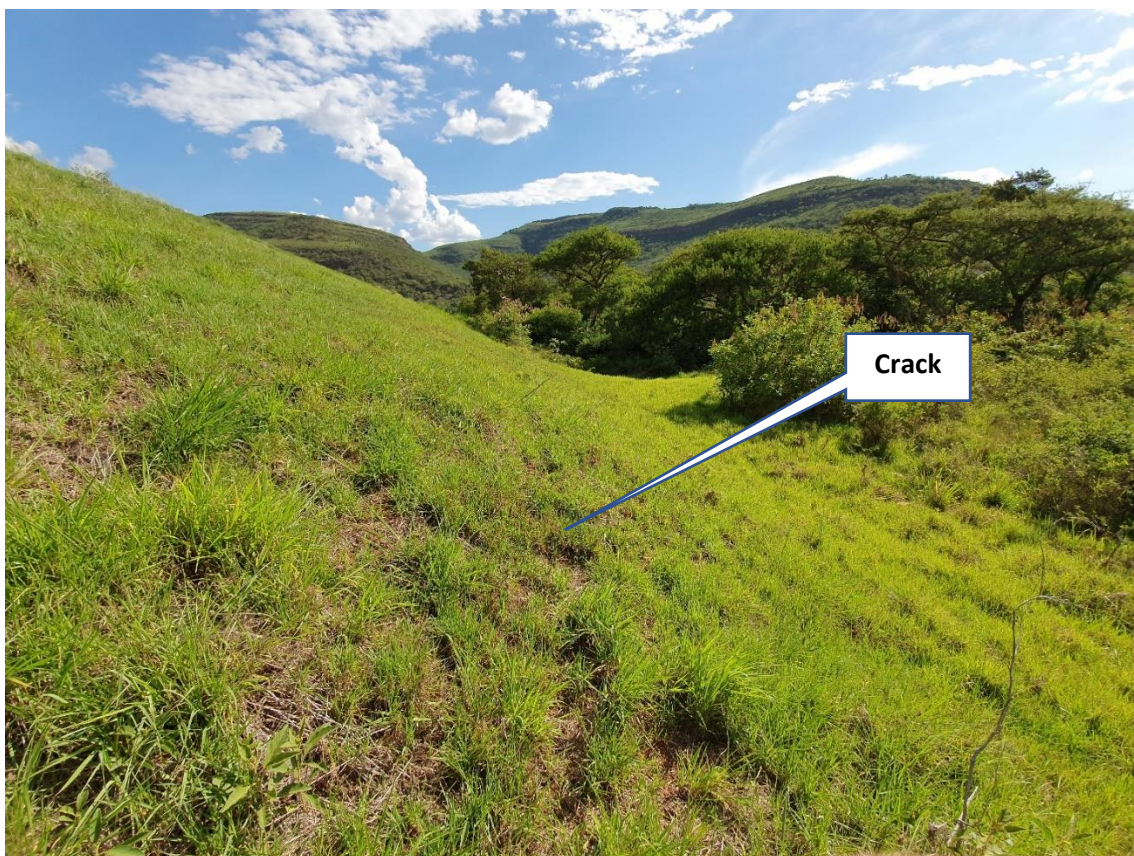
Photo 19: Breaching section downstream face towards left flank (19 November 2019). Note longitudinal crack likely caused by surface slip movement.
