Client: **Ngodwana Mill - SAPPI Paper and Paper Packaging
SAPPI Southern Africa Ltd**

Project Description: **2019 ANNUAL DAM SAFETY INSPECTION**

Date: **30 September 2019**

NGODWANA DAM ANNUAL DAM SAFETY REPORT 30 September 2019

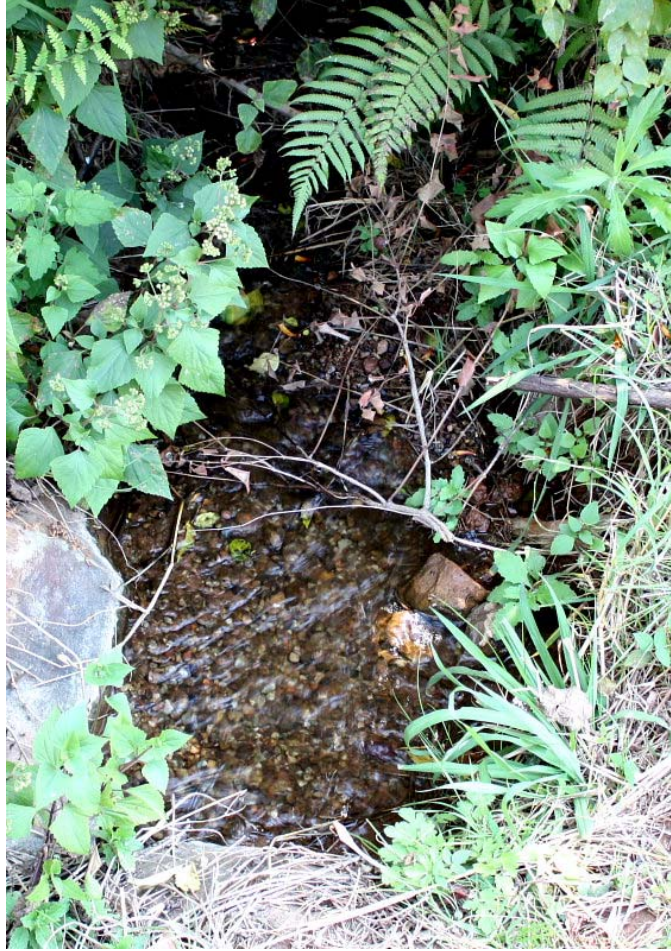
Flow in a small stream originating from downstream of the dam on the left (west) flank is not being measured, but seems to be fairly constant throughout the year (see **Plate G8**). Earlier water tests have shown that this water does not originate from the dam.

Plate G8. Seepage in stream on left flank

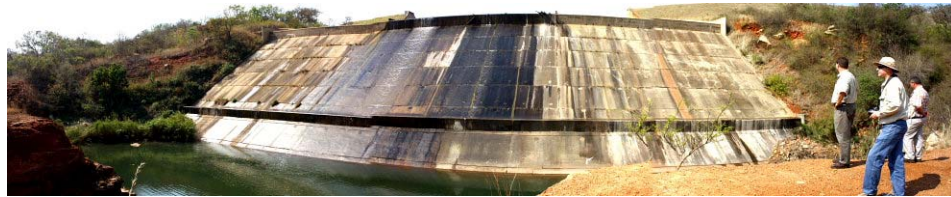
The spillway chute appears to be in good condition with no major signs of displacement or cracking (see **Plate G9**). During February 2009, one of the largest recorded floods of about 500m³/s passed over the spillway. However, based on a comparison of photographs taken in 2003 and during the present visit, the plunge pool and the narrow exit channel in weak rock had not been eroded (see **Plate G10**). However, due to the limited capacity of the discharge channel, major flooding of the area downstream of the dam will occur when larger floods are passed.

Plate G9. View of spillway. Note that curved appearance is due to "photo stitching".

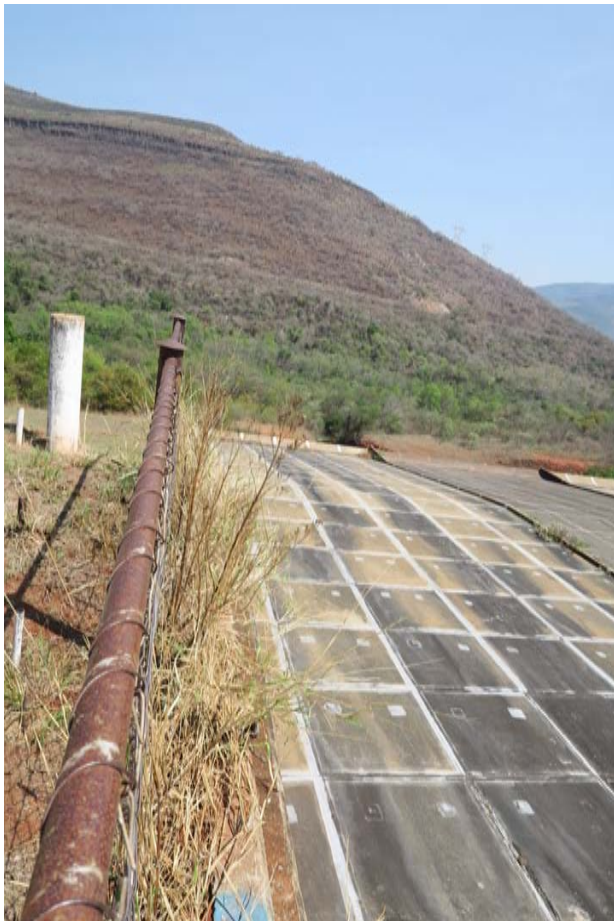
PLATE 6:- Spillway return channel and “bandaging” of joints

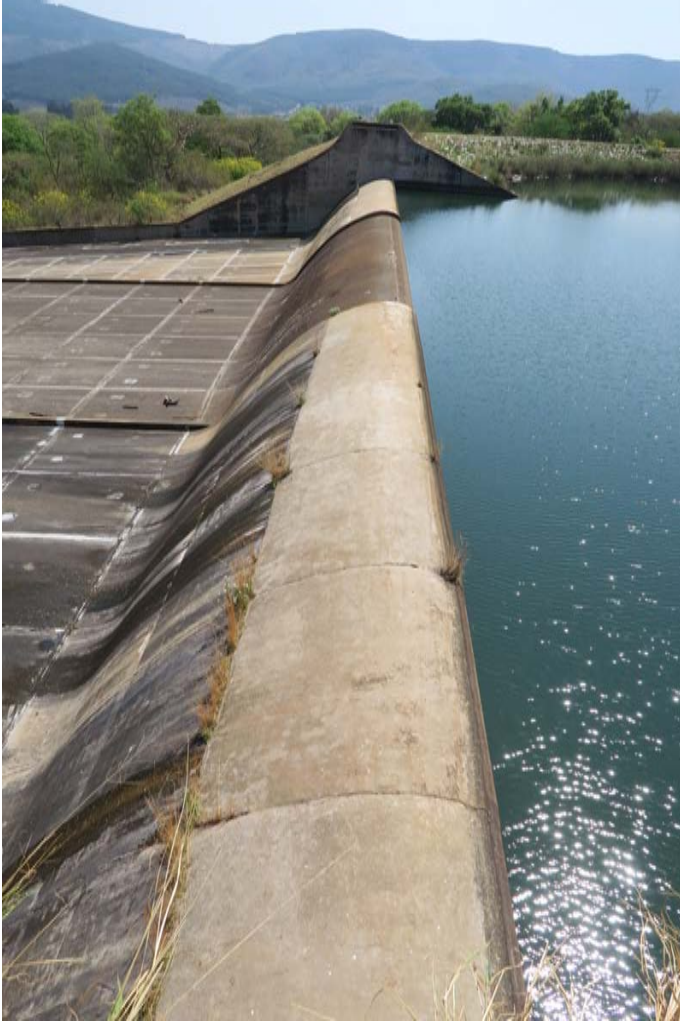
PLATE 9:- Spillway OGEE control structure - grass growing in construction joints

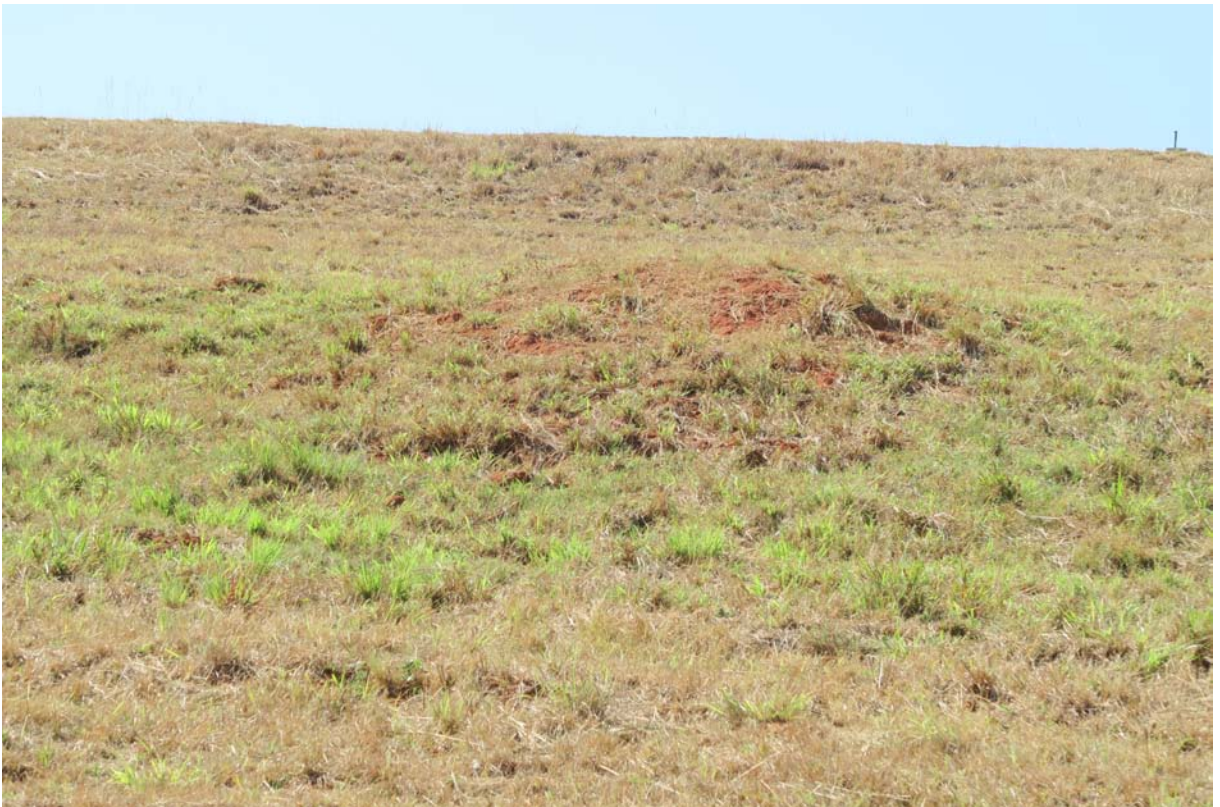
PLATE 10:- Termite nest (now dormant) on riverbed section SP4-7

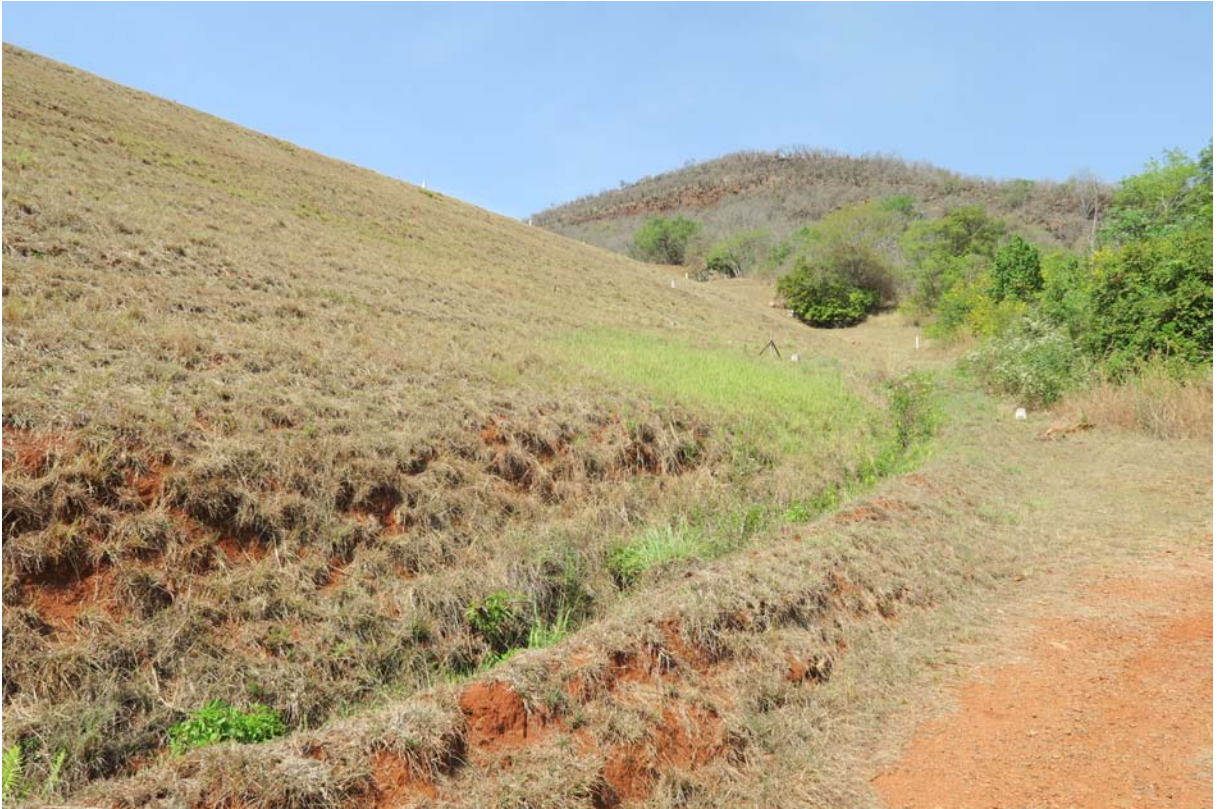
PLATE 11:- Wet spot (green grass) near bottom of embankment at left flank

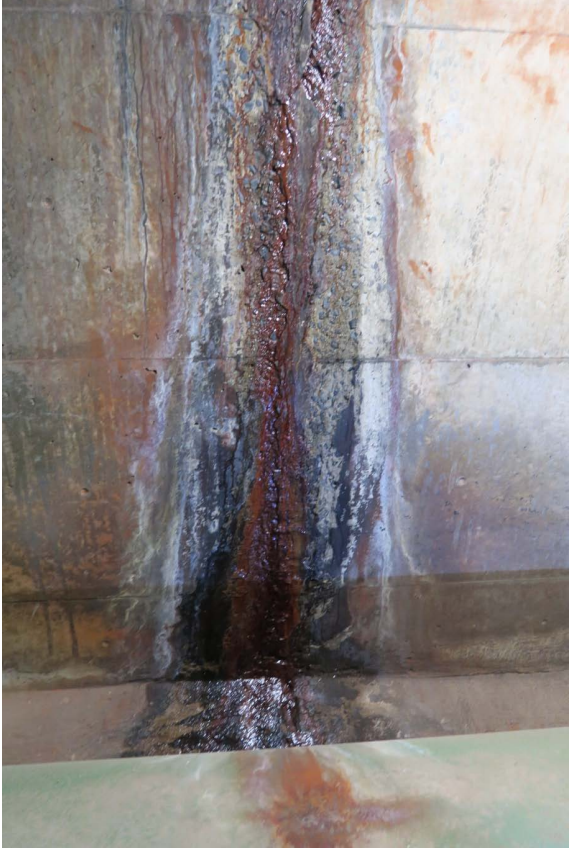
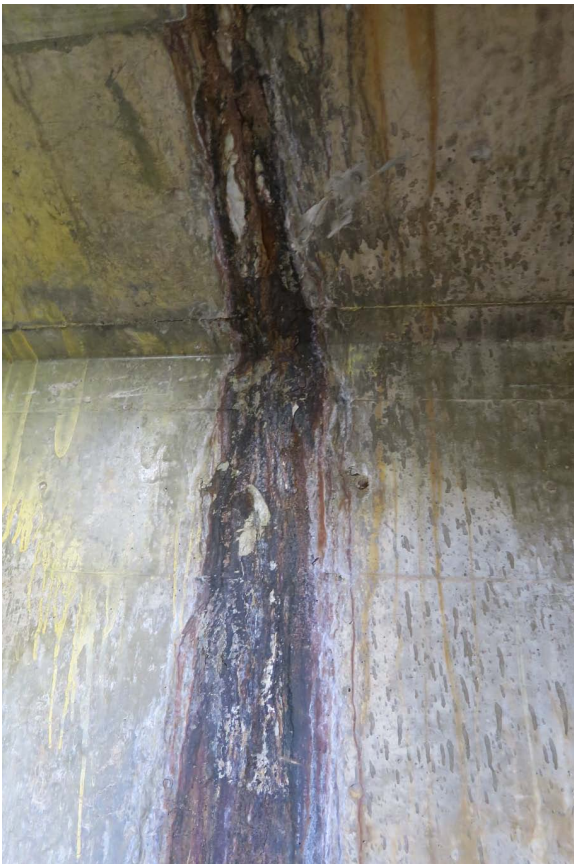
PLATE 13:- Embankment material seeping into outlet conduit at CH 106 (as measured from inside face of outlet tower in downstream direction).

PLATE 14:- material seeping into outlet conduit at CH 106 (as measured from inside face of outlet tower in downstream direction).

- iii. annual monitoring of dam wall deflections through precision survey of deflection beacons;
 - iv. the embankment material leakage as well as the water seepage through the construction joints of the outlet conduit should be carefully monitored;

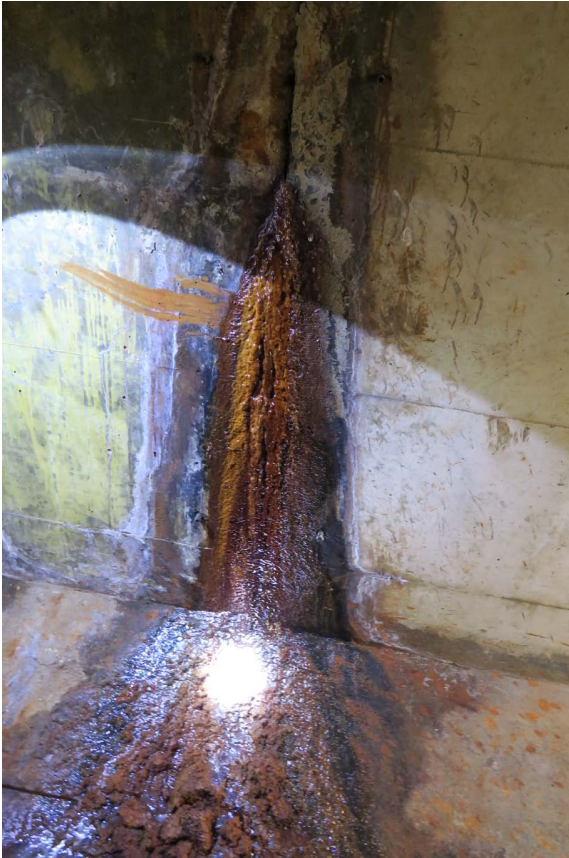
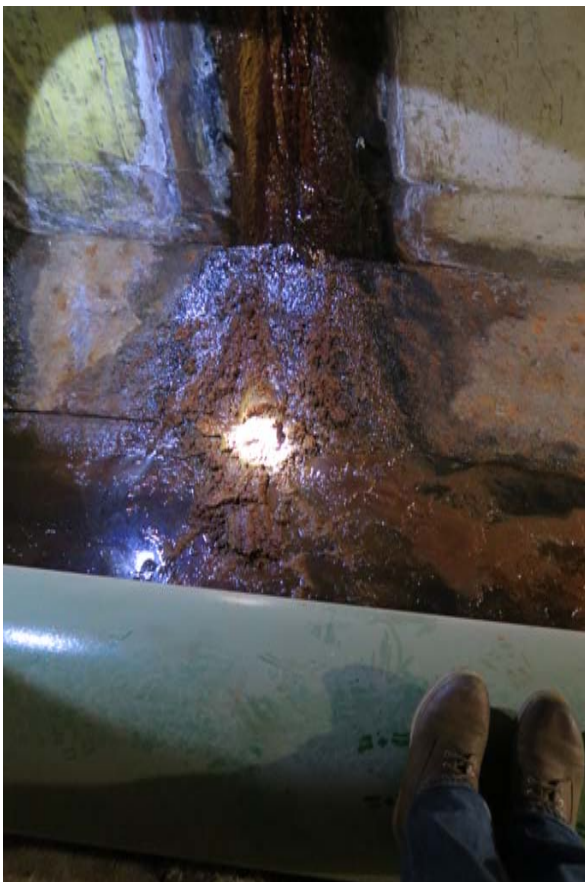
PLATE 15:- material seeping into outlet conduit at CH 63 (as measured from inside face of outlet tower in downstream direction).

PLATE 16:- material seeping into outlet conduit at CH 63 (as measured from inside face of outlet tower in downstream direction).

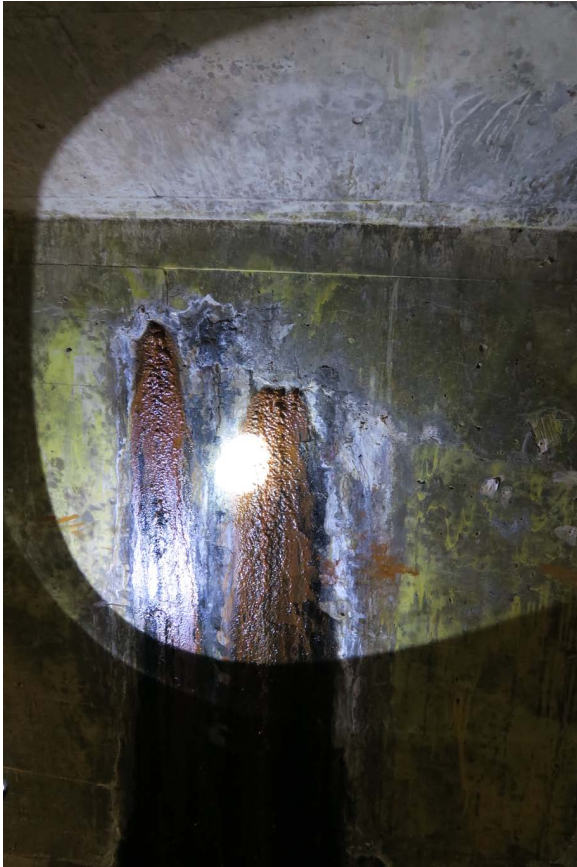
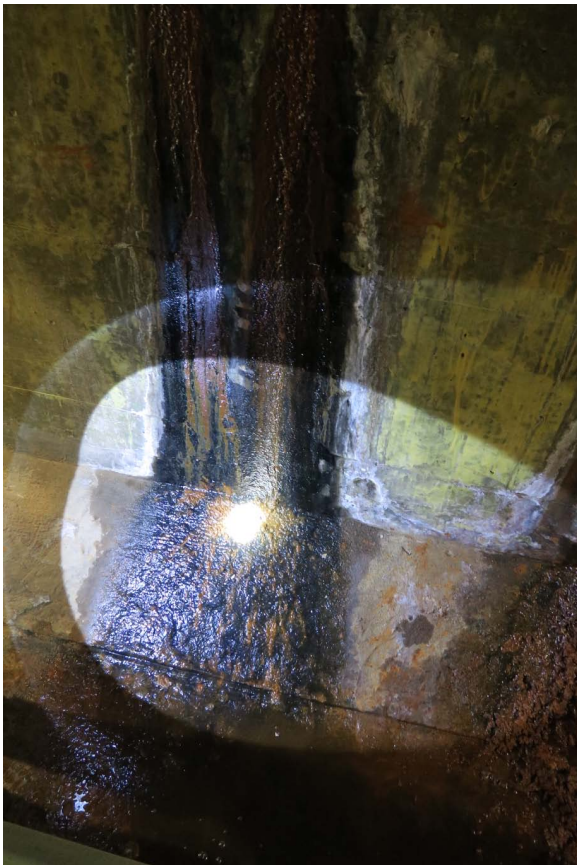
PLATE 17:- material seeping into outlet conduit at CH 62 (as measured from inside face of outlet tower in downstream direction).

PLATE 18:- material seeping into outlet conduit at CH 62 (as measured from inside face of outlet tower in downstream direction).

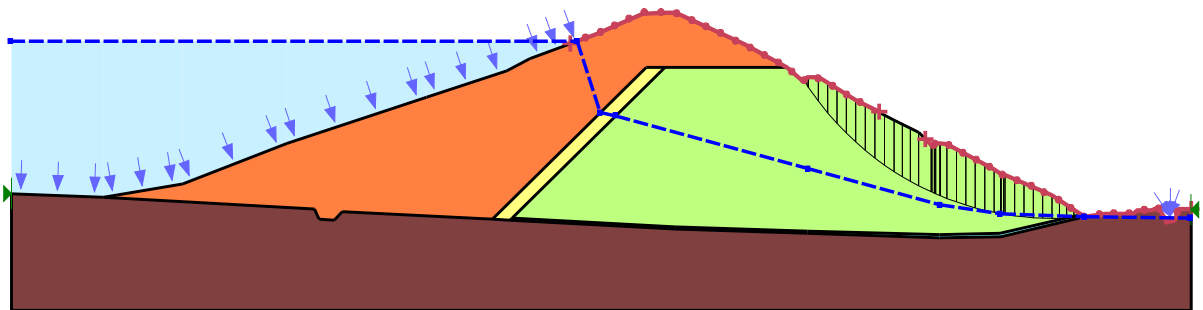
1.175

Riverbed Section Downstream Slope Stability: Scenario 4

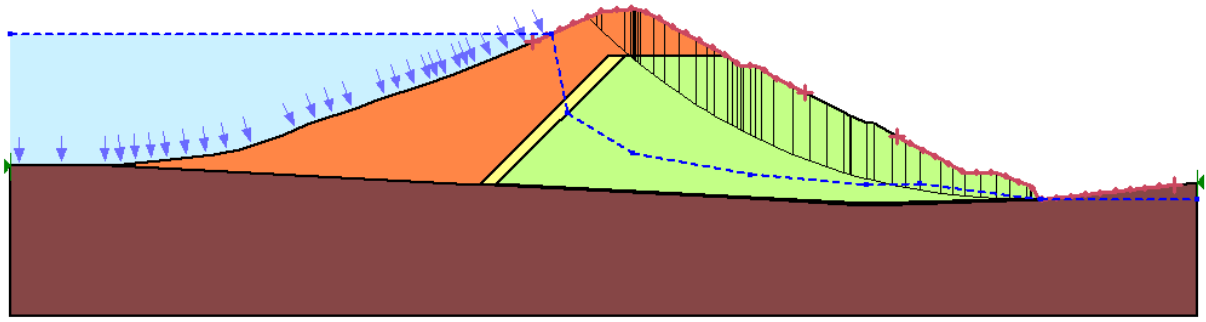
1.193

Culvert Section Downstream Slope Stability: Scenario 4
