Client: **SAPPI Southern Africa Ltd - Ngodwana Mill**
Ref #: **Order # PO 2105-052852**
Project Description: **NGODWANA DAM – SAFETY INSPECTION**
Date: **9 September 2016**

**NGODWANA DAM
COMPULSORY 7-YEARLY DAM SAFETY REPORT
9 September 2016**

Title: **SAPPI Southern Africa Ltd - Ngodwana Mill**
Order # PO PO 2105-052852
Ngodwana Dam:- Compulsory 7-Yearly Dam Safety
Report – 9 September 2016

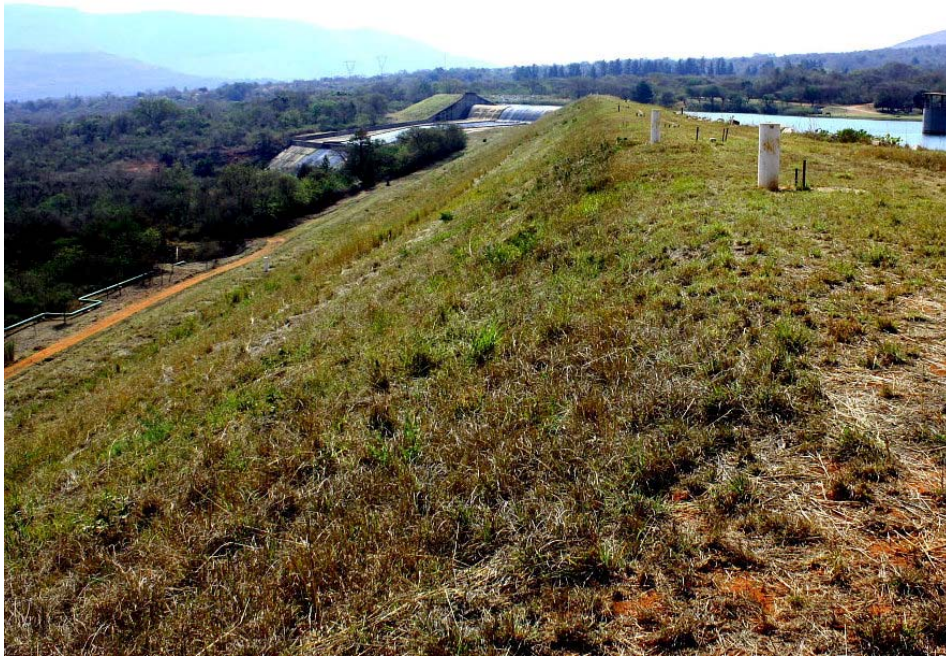
The site visit of 27 August 2009 included an inspection of the left flank, the dam crest, the upstream and downstream slopes (including the “wet area” on the downstream slope), the seepage measuring points, the outlet culvert, the spillway chute, the return channel and the breaching section. Available records of seepage and deflection measurements were reviewed. Inspection of the structure was greatly facilitated by the high standard of maintenance (see **Plate G1**).

Plate G1. View of dam wall from left abutment.

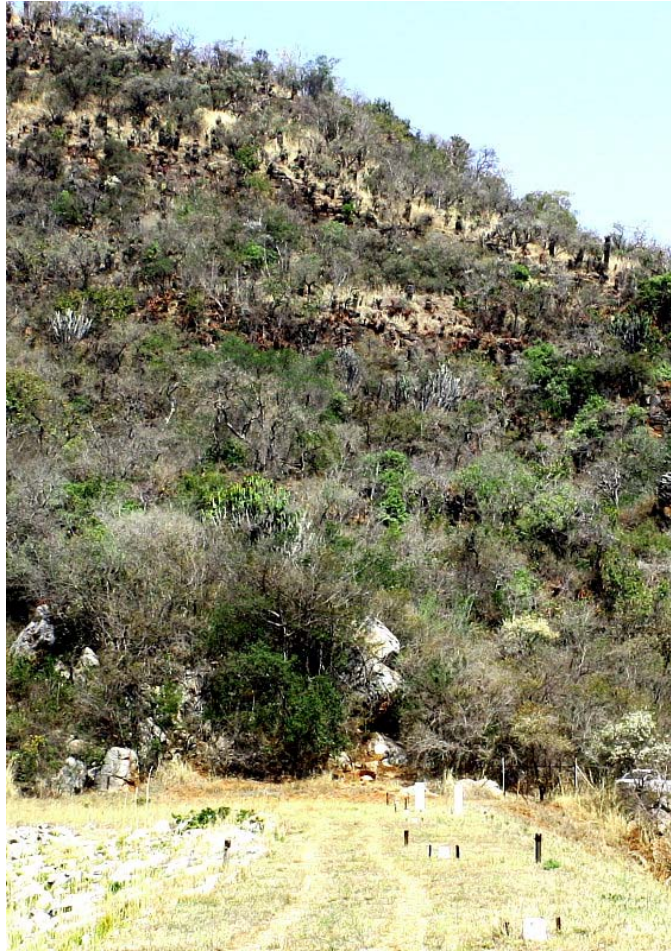
In the first safety inspection report, it was noted that the Fixed Reference Beacon B0 above crest level on the left abutment was located on a colluvial boulder that might be subject to movement (see **Plate G2**). Sappi reported that an additional beacon was installed higher up along the flank, but from surface indications, it appears that the new beacon may also be situated on colluvium.

Plate G2. Beacon on left abutment.

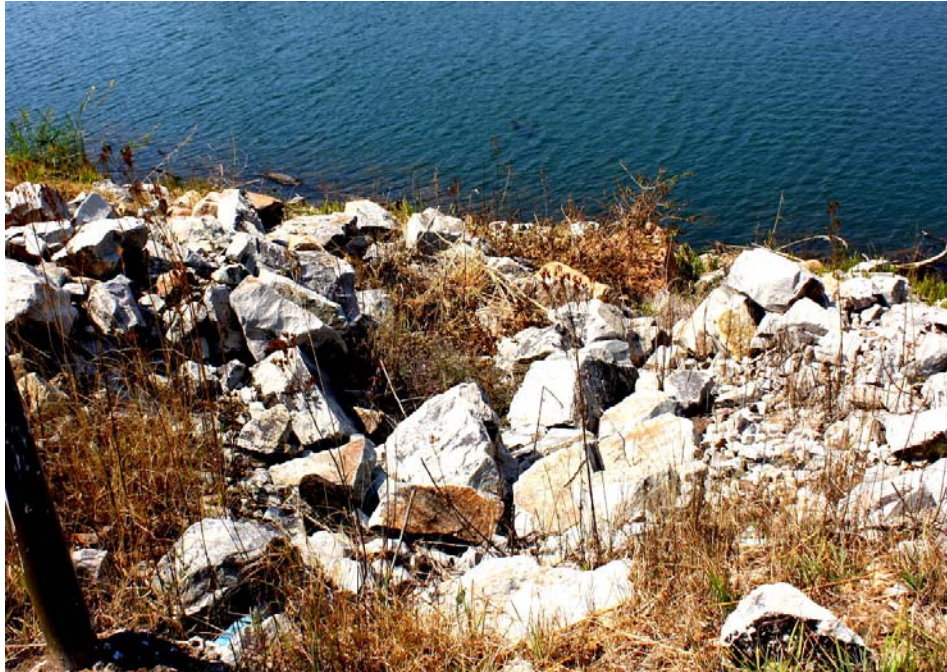
Rip-rap on the upstream slope is generally in a good condition and the rock blocks show no signs of weathering. In one area near the dam crest, there is a shallow trench in the rip-rap where blocks had been removed (see **Plate G3**). This area must be restored.

Plate G3. Trench on upstream face.

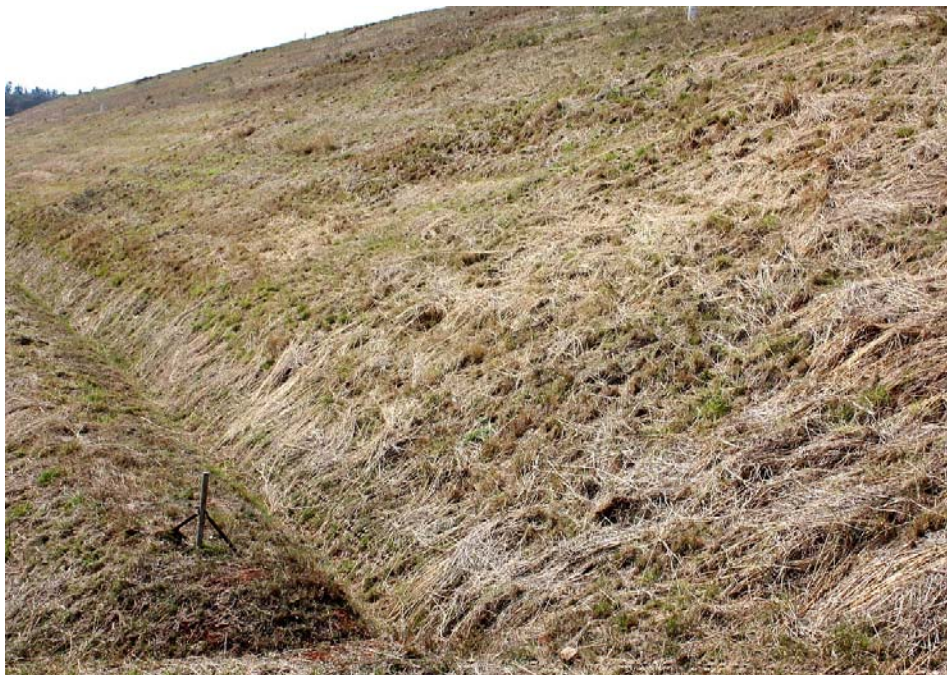
The “wet” area that was reported on in previous reports is still visible (see **Plate G4**), but it has not increased in size and appears to be much drier than before. This is reassuring since the dam was at FSL. No significant movements have been recorded by the Monitoring Beacons installed in 2009 (see **Plate G5**).

Plate G4. “Wet” area on downstream face also showing left flank (west) surface drain.

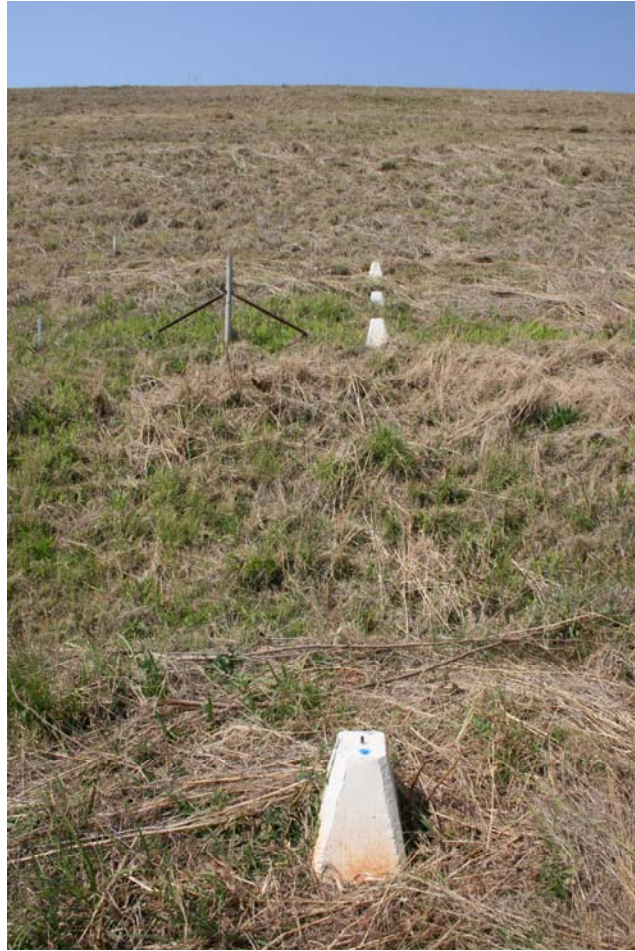
Plate G5. Beacons WD2 – WD5 across "wet area".

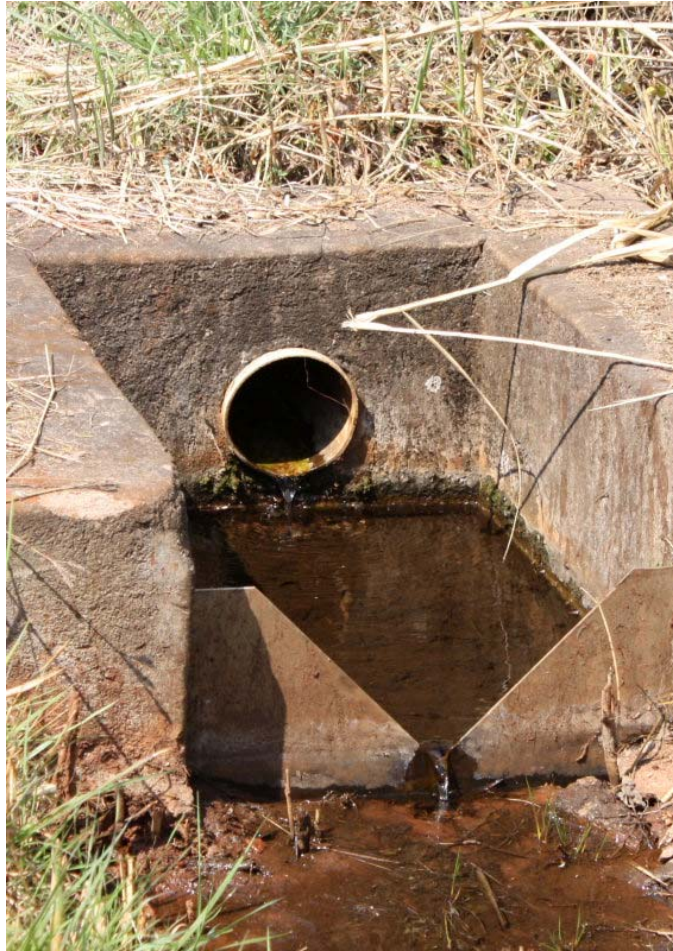
Plate G6. V-notch for Toe Drain East and West.

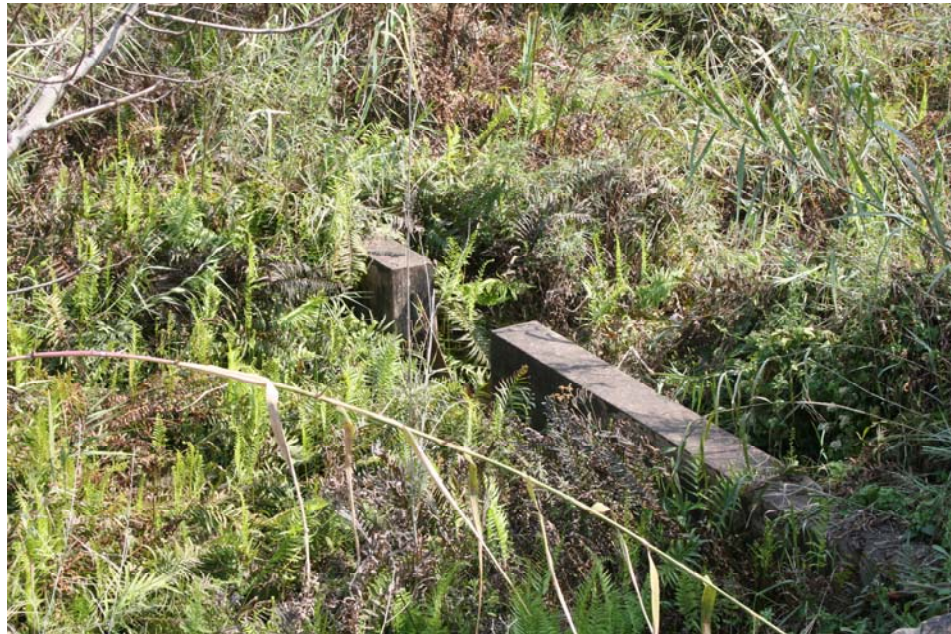
Plate G7. Weir for measuring "Seepage 1".

A possible problem with the record from Seepage 1 at the weir is that some of the flow may bypass the V-notch by seepage below or around the weir. The decrease in measured flow could be the result of an increase in sub-surface flow due to washing out of fines below the weir.

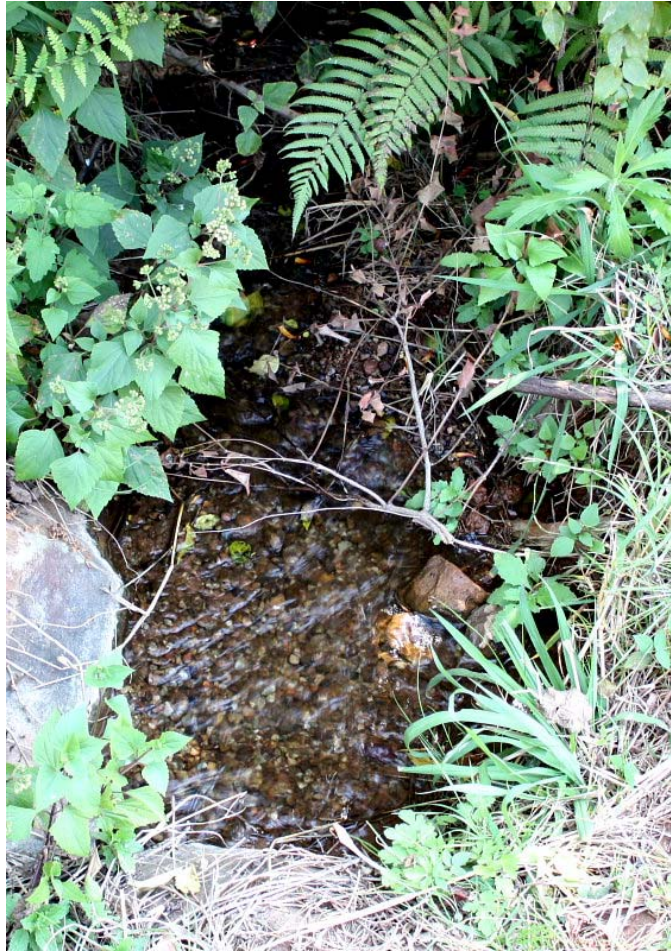
Flow in a small stream originating from downstream of the dam on the left (west) flank is not being measured, but seems to be fairly constant throughout the year (see **Plate G8**). Earlier water tests have shown that this water does not originate from the dam.

Plate G8. Seepage in stream on left flank

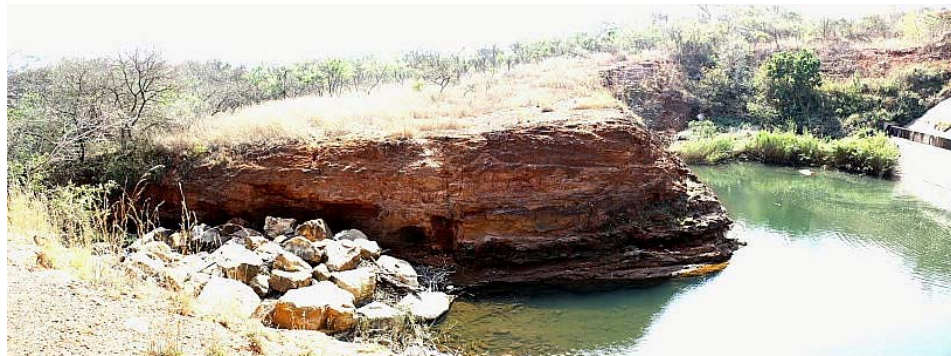
Plate G10. Plunge pool. Note erosion between rock blocks and side of channel.

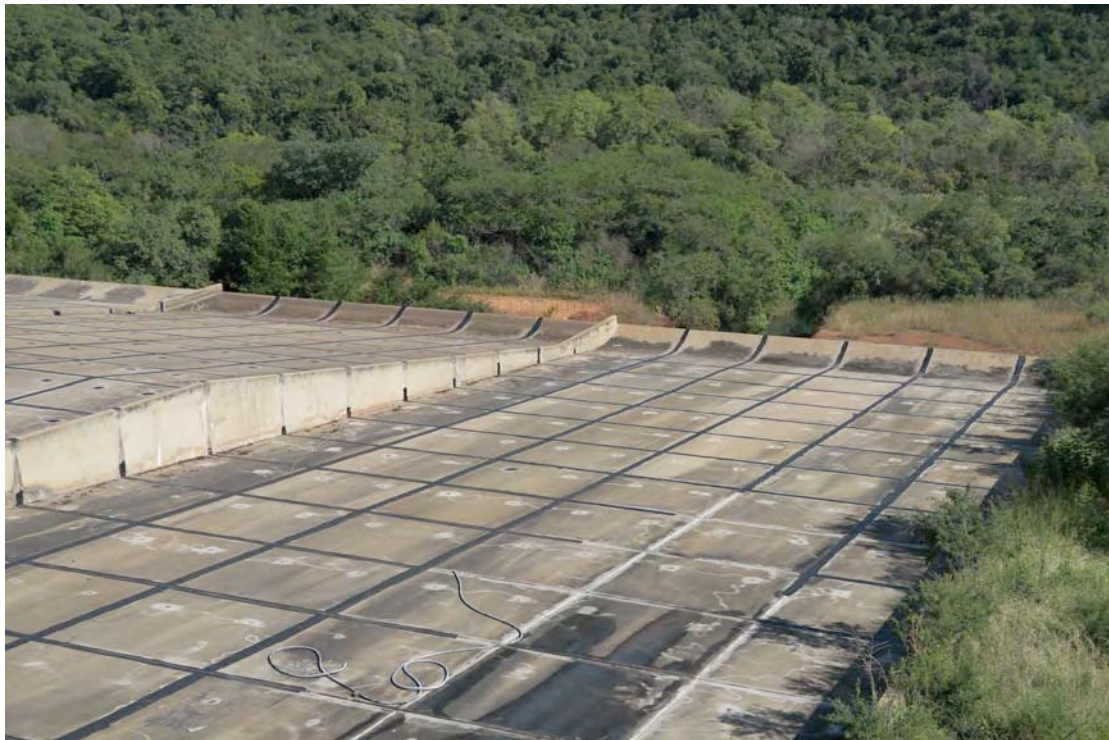
Plate 10:- Service spillway return channel with “kink” and “flip bucket”. Note new repair bandages over construction joints. (2016-05-10)

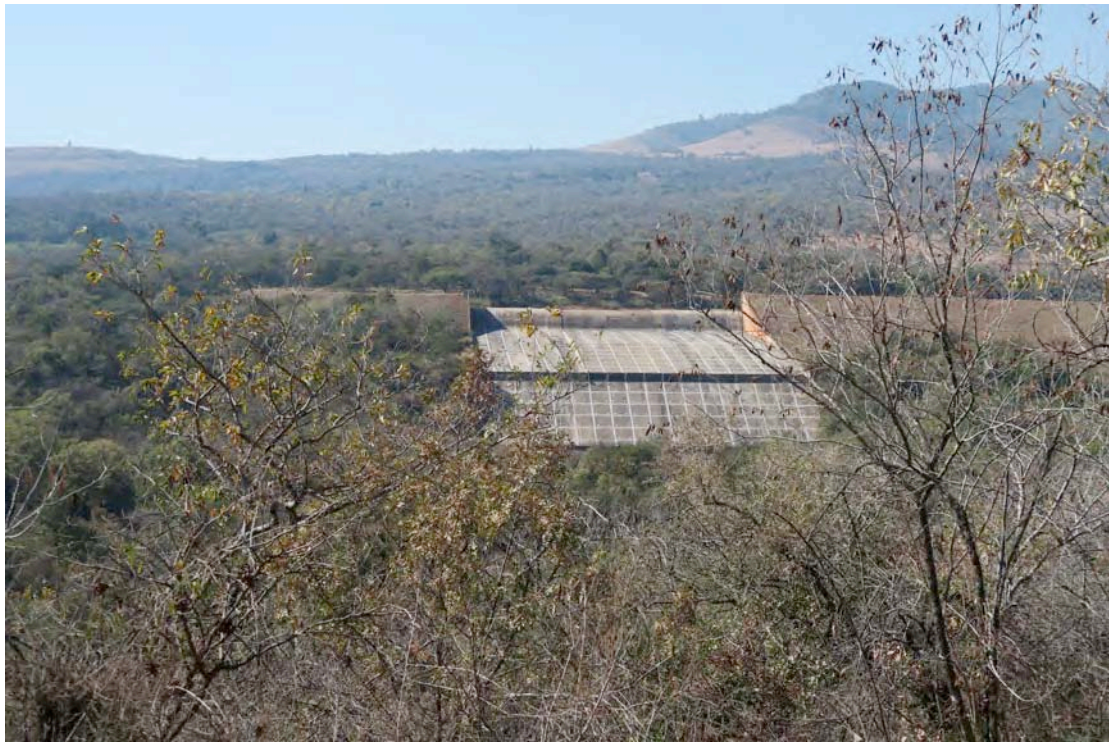
Plate 11:- View of spillway control structure and return channel – Note repair bandages over construction joints (2016-07-12)

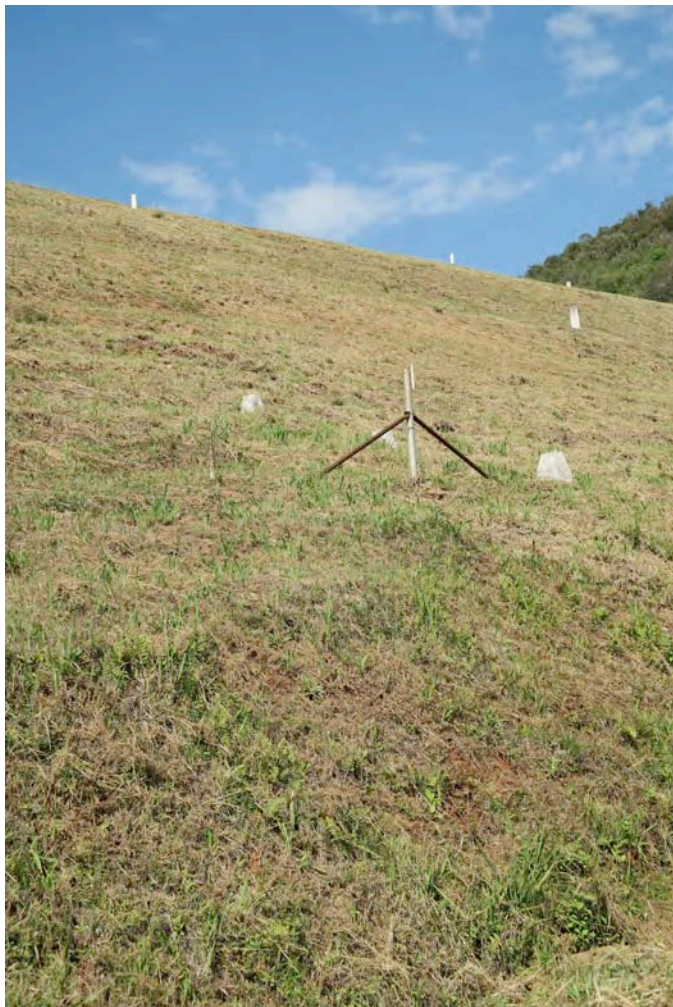
Plate 14:- Survey beacons at “wet spot” on embankment slope near left flank. The “wet spot” was dry at time of inspection. (2016-05-10)

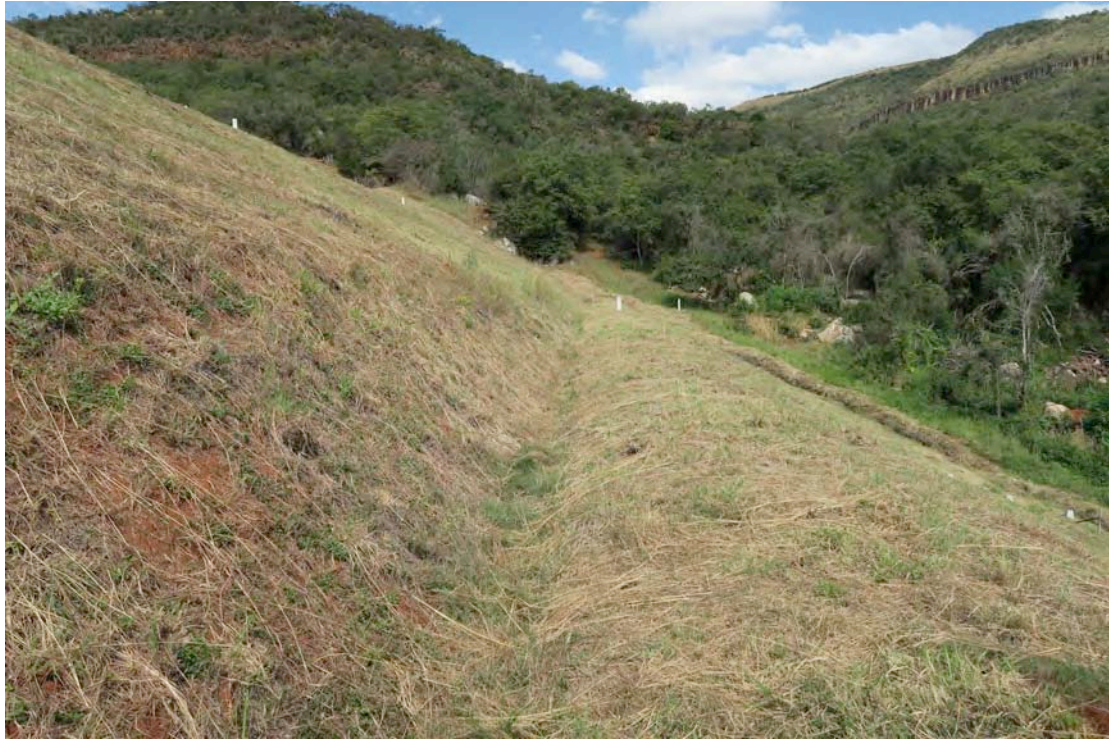
Plate 15:- Survey beacons (top left and bottom right). Faulty piezometers on berm (centre of picture). (2016-05-10)

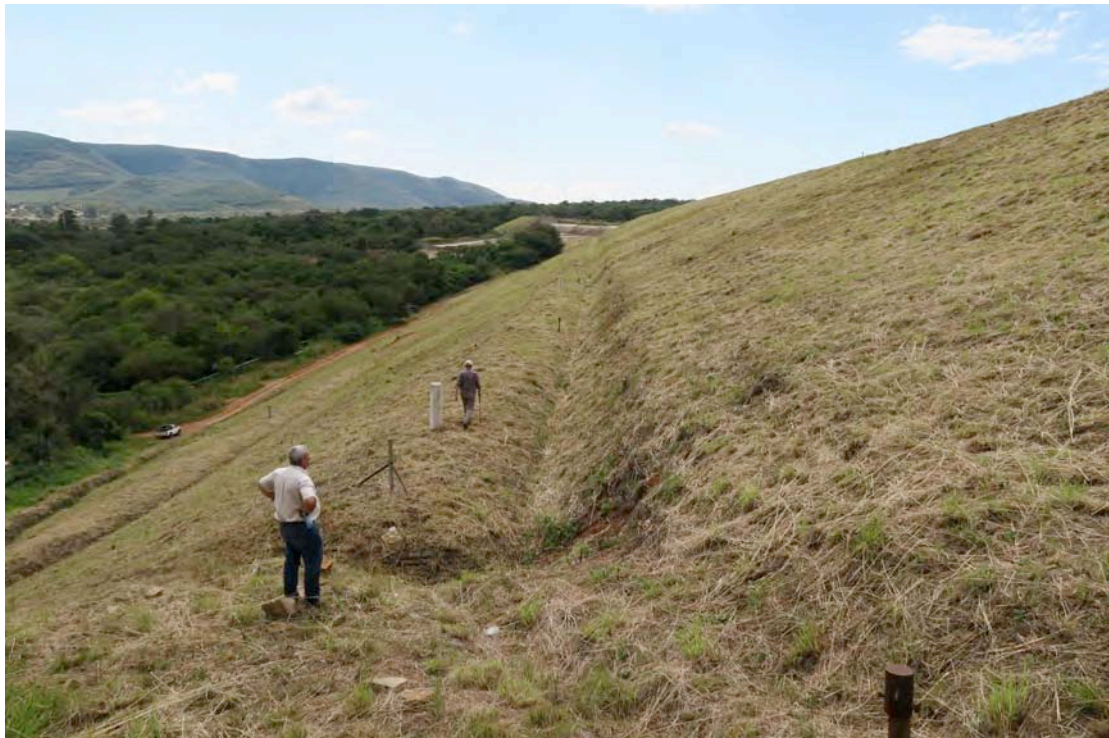
Plate 16:- Faulty piezometers on berm to be replaced with new standpipe piezometers (2016-05-10)

- 2.2 **Drilling & Installation of Standpipe Piezometers:-** This work will be undertaken by a specialised ground engineering contractor, during the financial year that commences in October 2016. Tenders had already been called for and submitted, and recommendations made to SAPPI for the appointment of a suitable contractor.

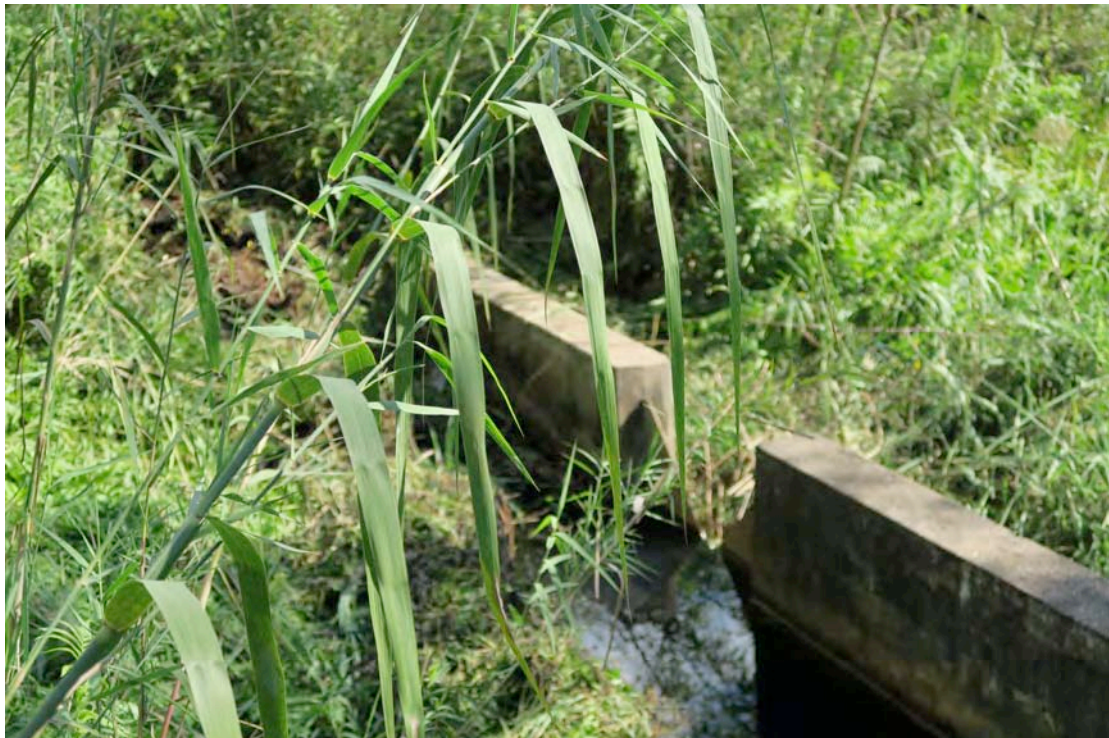
Plate 18:- “Seepage 1” v-notch gauge in old river bed – to be discontinued due to ingress of other seepage, i.e. not from “dam” seepage (2016-05-10)

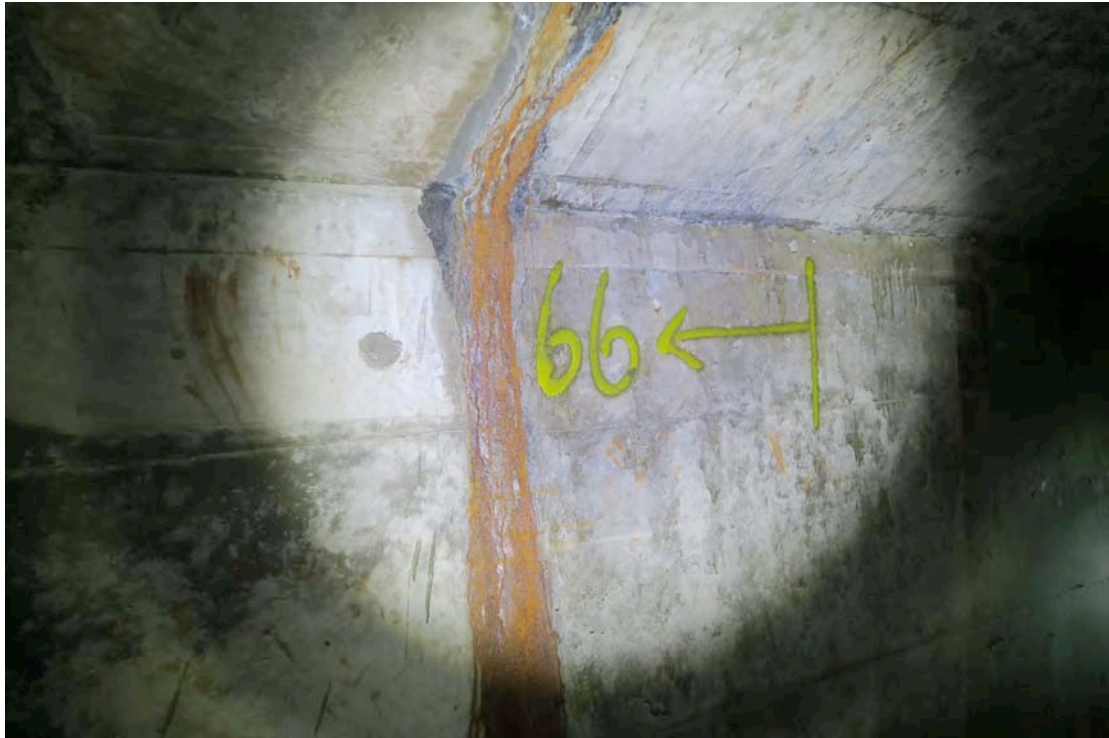
Cracks	None
Leakage	Clay and water seepage through some construction joints of the outlet conduit. See Appendix F – Photographic Record, plates 19 – 23.
Joints	Suspected torn water stops in construction joints of the outlet conduit.
Settlement	Suspected settlement of the outlet conduit responsible for torn water stops in construction

Plate 19:- Outlet conduit:- left-side compartment, right wall, 66 m from intake tower:- seepage of embankment material through construction joint (2016-05-10)

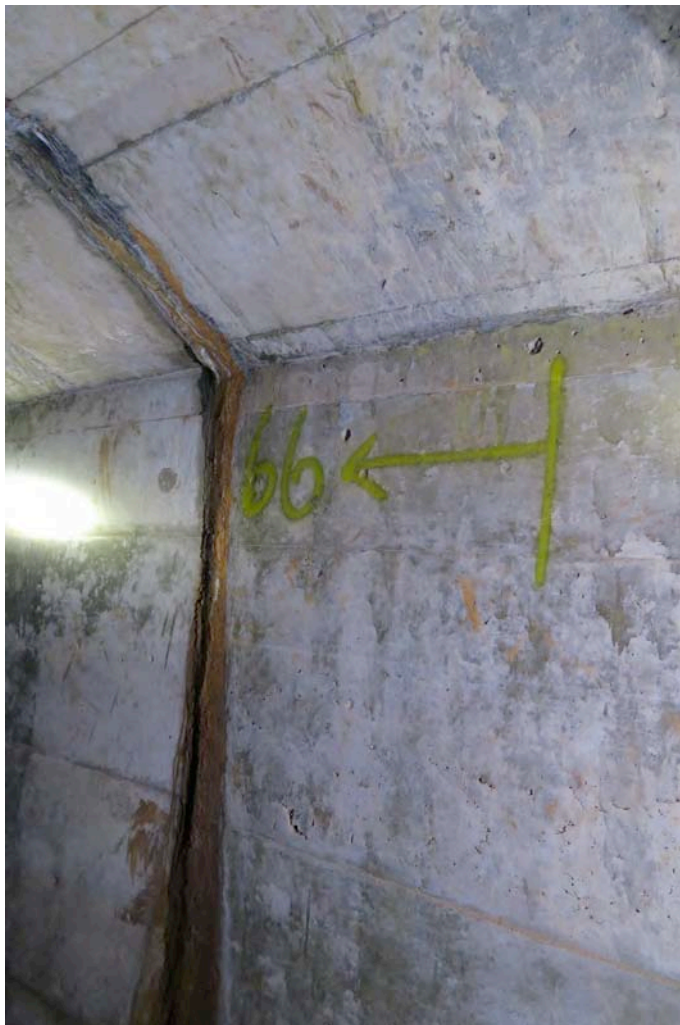
Plate 20:- Ditto as above (2016-07-12)

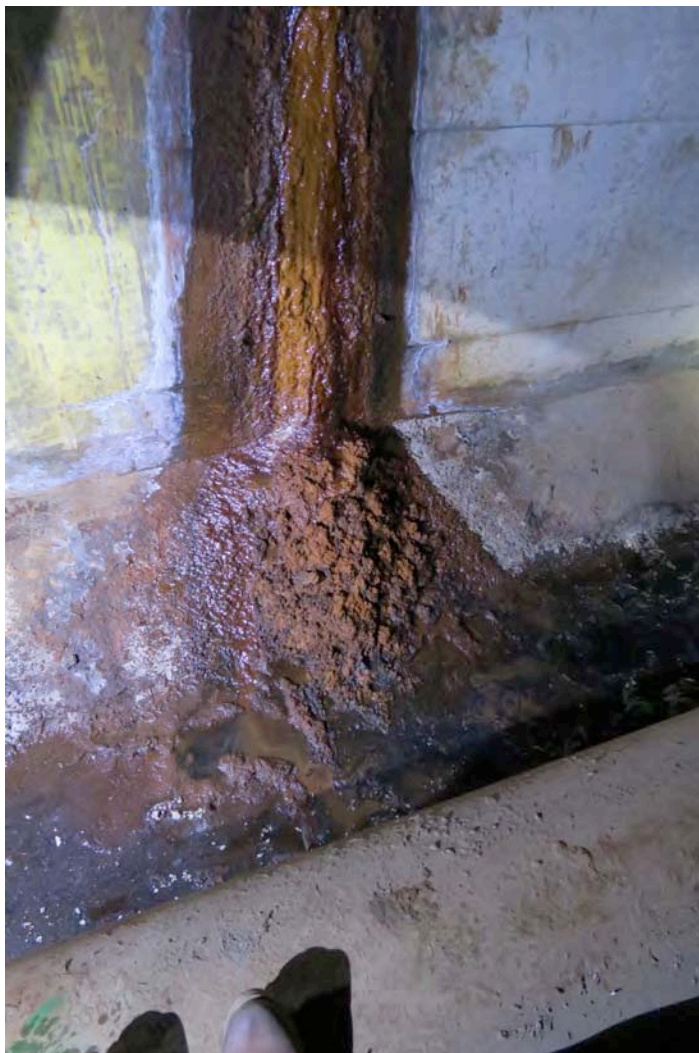
Plate 22:- Outlet conduit:- right-side compartment, right wall, 66 m from intake tower:- seepage of embankment material through construction joint (2016-07-12)

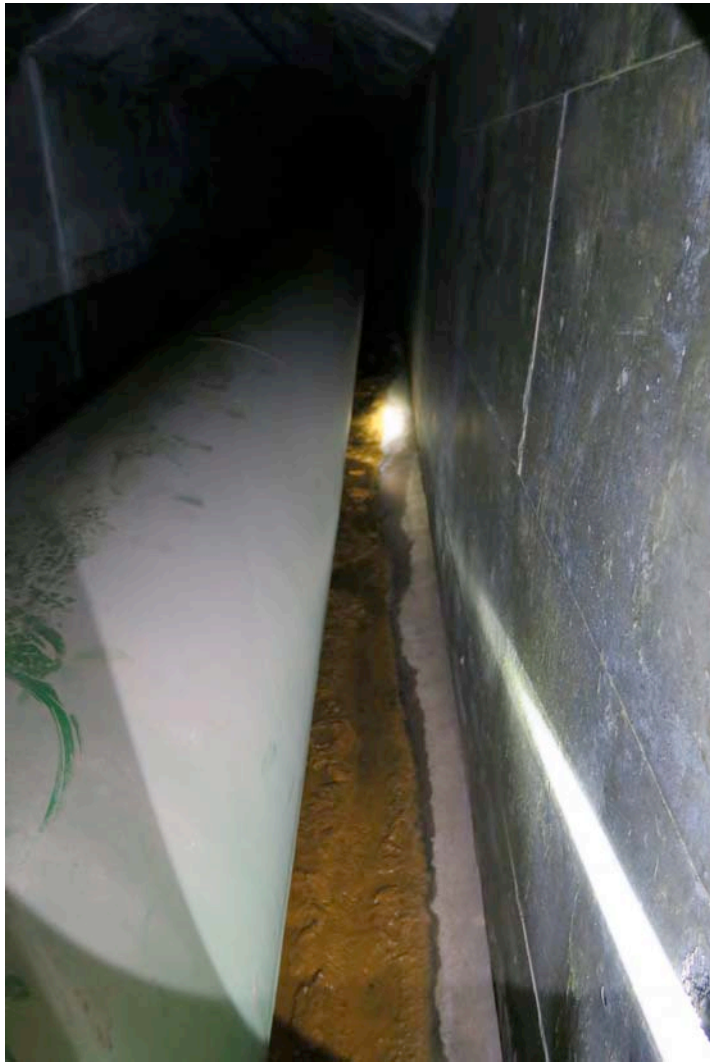
Plate 23:- Outlet conduit:- right-side compartment floor, 66 m from intake tower:- upstream view of seepage of embankment material down the conduit floor (outlet pipe on left and dividing wall on right) (2016-07-12)

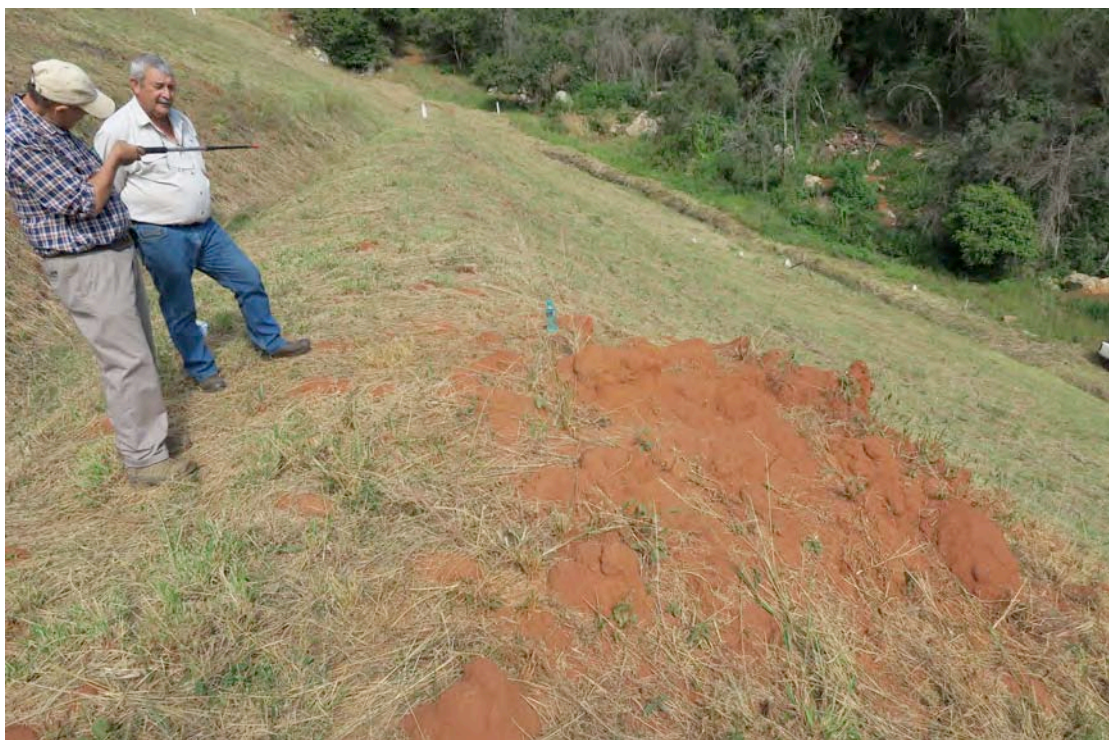
Erosion? Describe	None
Cracks? Describe	None
Burrow Animal Holes? Describe	Termite holes visible along crest.

Plate 24:- Termite activity near left flank upper berm (2016-05-10)

5. **Termite Activity:-** Termite nests on the left flank and termite holes on the dam crest were noted. The active nests will be destroyed.
6. **Spillway:-** The upper section spillway joints had already been cleaned and the joint "bandages" replaced / repaired. The dam level is currently low and the spillway has stopped overflowing, so that it is now dry enough to repair the damaged "joint bandages" in the lower section of the spillway chute. This will be completed before the onset of the 2016-7 rainy season.
