SAPPI NGODWANA MILL

PRELIMINARY ASSESSMENT OF HAUL ROADS FOR SAPPI, NGODWANA DAM REHABILITATION

PROJECT 20828

AUGUST 2020

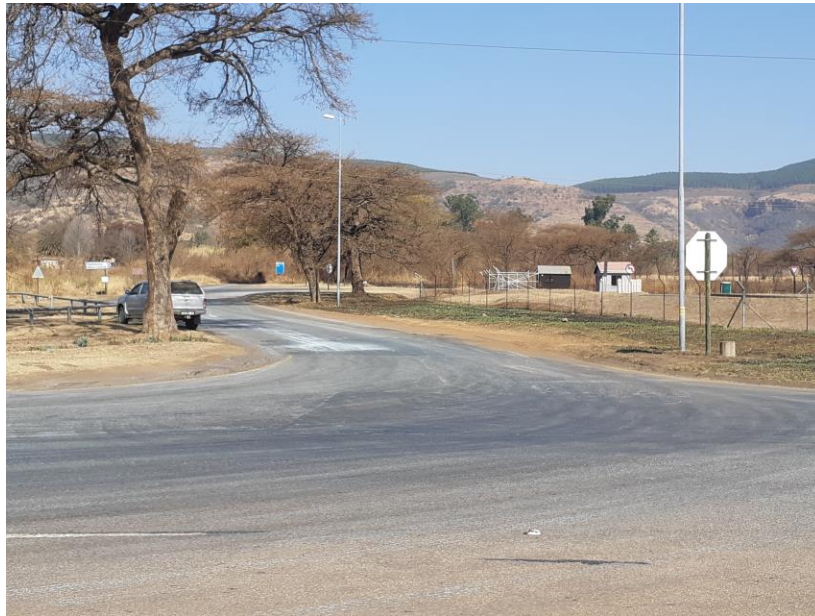
For Route 1 the first section is the existing SAPPI dumpsite access road. This road has a surfaced section of approximately 150m and a gravel section of approximately 1150m. It is generally in a good condition and will require limited upgrading to serve as a haul road. It is however a fact that this section will require some rehabilitation after the haulage due to the expected deterioration of the wearing course during the haul process. The picture below is an indication of the condition of this road: -

The required maintenance will include:

- Roadside maintenance which is mainly restricted to vegetation control;
- Drainage maintenance;
- Surface maintenance;
- Safety aspects;
- Provision of a budget for such maintenance.

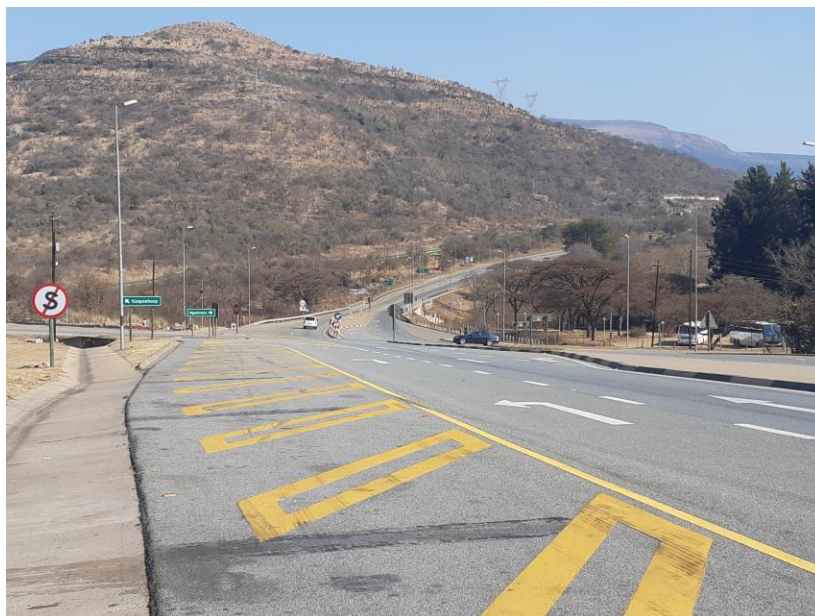
The second section of the route is the N4 section which is serviced by an at-grade intersection of a high standard which provides safe access to and from the dump site access. This 3.2km section stretches to the Kaapsehoop intersection which is also an at-grade intersection of a high standard which provides access to the Kaapsehoop section of this route. The picture below gives a view of this intersection: -

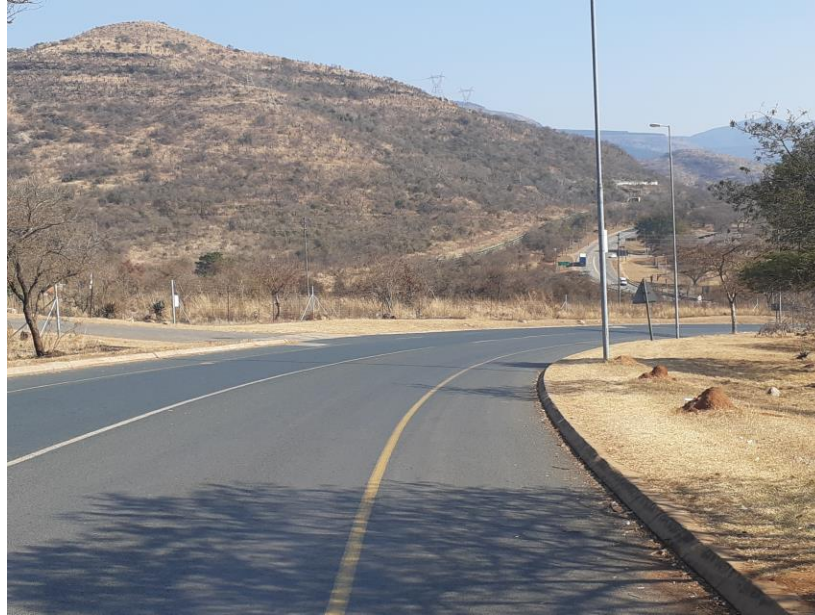
A third section of this route runs along the Kaapsehoop road (D799) for about 200m. This is also a high standard surfaced road, as clearly depicted in the picture below: -

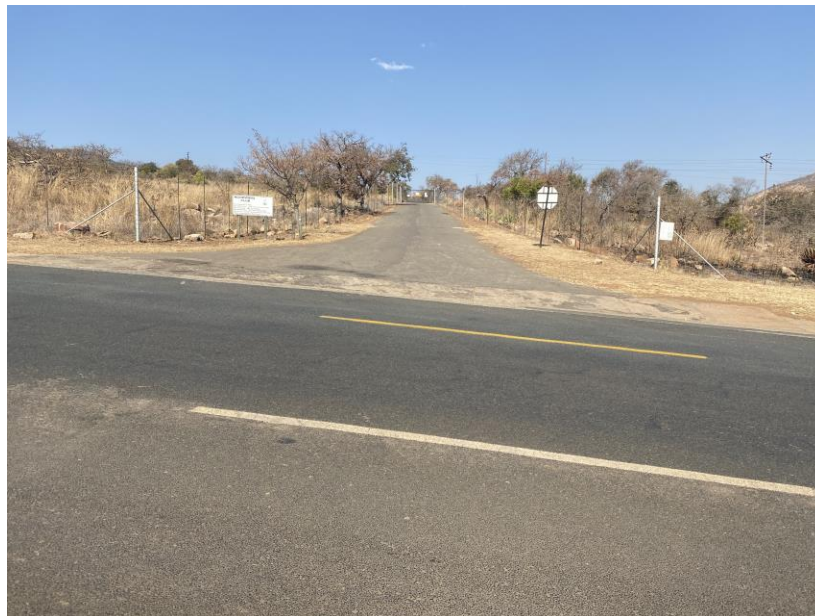
From here the fourth section of the route turns in onto the Ngodwana Dam Access Road at an existing intersection which requires no upgrading. This route is surfaced and provides an all-weather access to the dam. Reservations were expressed by SAPPI if this road will be able to withstand the haulage without any damage and this is therefore assessed in this report. Section four runs up to the access gate at the fishing club, past the proposed stockpile area; approximately 600m along this road. The pictures above and below also show the access: -

Section 4 will in all probability suffer some damage during the haul operations. Although no as-built information is available, this road was never designed for heavy construction traffic and as such the following damage can be expected: -

- Damage to surfacing where turning movement onto and off this section occurs;
- Development of potholes due to the structural design of the road, aged condition of the existing surfacing and the effect of surface water during the haul process;

It is proposed that maintenance be done on this section of road during the construction period by repairing defects in order to maintain trafficability and then to reassess the condition after the dam rehabilitation is completed.

Final repairs can then be affected and re-surfacing of the road can be done to reinstate it to its former condition.

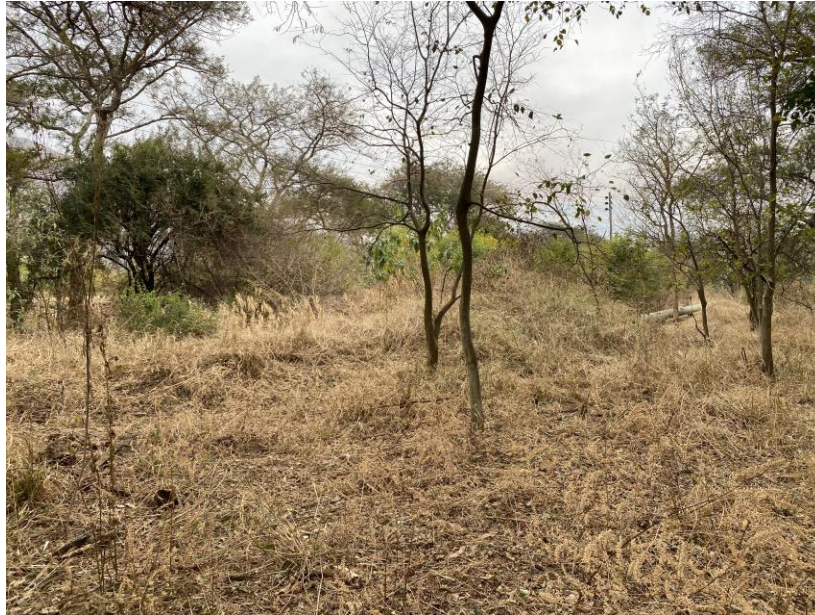
The fifth section of this haul route is the last section up to the construction area of the right flank of the dam. It was pointed out by SAPPI that careful alignment of this section is required to prevent excessive damage to the vegetation and the bulk water supply pipeline in this vicinity, as detailed on the picture below: -

Section 5 will be a temporary 3.9m wide access to the right flank of the construction area, with passing bays and a turnaround area. This section will require a new geometric design, structural design and drainage design with alignment through indigenous vegetation and away from the section of steel pipeline which is located above ground in this area. Once alignment and clearing and grubbing of vegetation and topsoil have been completed, this section will require drainage features like mitre banks and possibly a pipe culvert. Subgrade preparation will include ripping and re-compaction within these alignment parameters. A gravel wearing course of 150mm thickness, which meets the requirements of TRH 20, will be imported from a suitable source and placed on top of the subgrade to abovementioned width and processed to the required geometric standards before being compacted to the density required to provide adequate bearing capacity for the anticipated traffic. It is recommended that the same material from the dumpsite stockpile be blended with ash plant material to be used as wearing course material. This is based on laboratory results which is included in “Annexure B”. Some more testing of the available material will however be required.

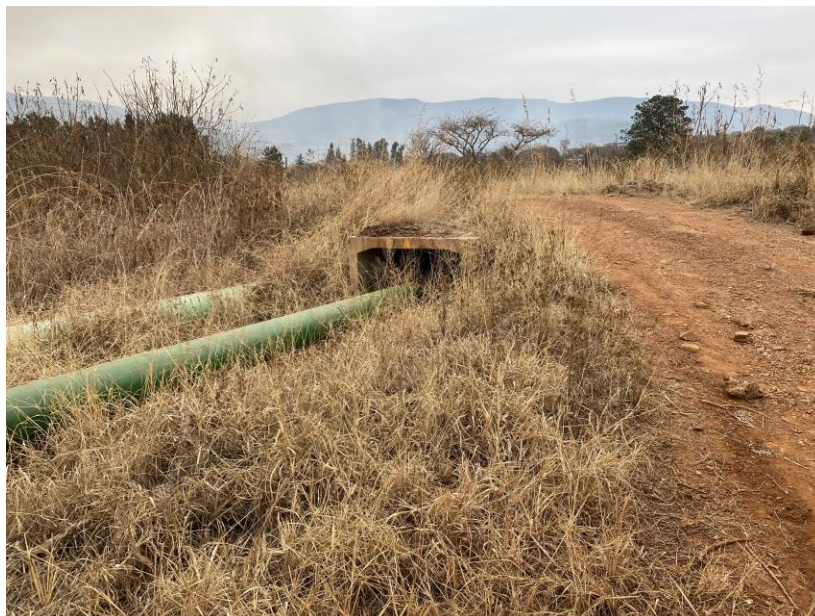
An existing gravel access road, which turns off from section four of this route opposite the stockpile area, (Route 1, Road 6) is earmarked for the access to the contractors’ site office area on the North side of the dam spillway. This route crosses the river pipeline at an existing structure which may require a safety upgrade. This is also a haul road. It will be deliberated / discussed for upgrading and is linked to Section 4 of Route 2. Detail of the pipeline crossings can be seen in the picture below: -

Section 6, the access to the contractors' laydown area and haul road will require upgrades in terms of a widened pipe crossing as well as minor fills around these areas. Some blading of this 3.9m wide route with subgrade preparation along the existing alignment with a new 150mm thick gravel wearing course will be adequate to create an all-weather route for vehicles to reach the parking areas, offices and other temporary facilities required by the contractor and to link up with Route 2, Section 4.

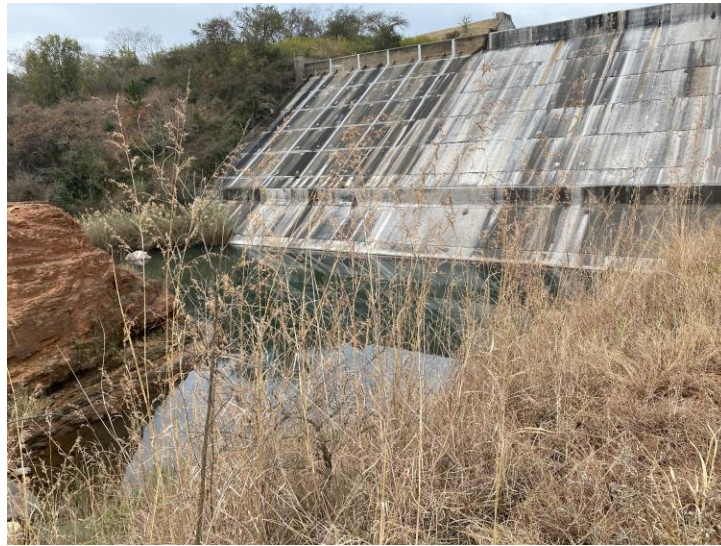
A pedestrian walkway and pedestrian bridge below the spillway will provide access to the construction site from here. This must be done in a way to conserve the area and to serve as an eco-recreation area after construction. A pedestrian bridge can be located at the spot indicated in the picture below: -

A 2m wide walkway from this area to the pedestrian bridge below the spillway will require clearing of vegetation under the trees and some subgrade compaction as well as an all-weather surface to ensure safe walking conditions, with timber handrailing in steep sections. A pedestrian bridge, with a span of approximately 20m which can become a permanent feature, will be constructed below the spillway to provide safe access over the Ngodwana river to the construction site. This bridge should be of steel or timber construction to ensure off-site manufacture and quick erection to facilitate a fast establishment process.

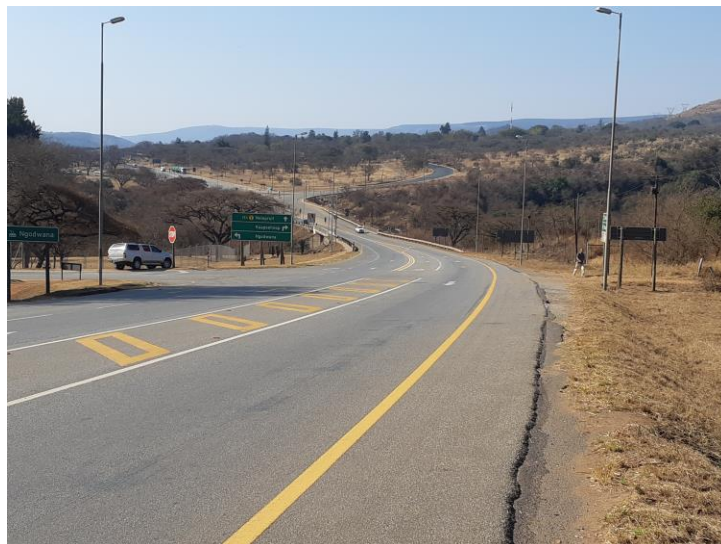
The second section runs from the N4 turn-off to the SAPPI Water Treatment Works up to the stockpiling area at the Water Treatment Works. The access from the N4 to this section will require some upgrading to ensure capacity for queuing of vehicles turning East onto the N4. This required upgrading is discussed in this report. A picture of the access shows the current layout: -

Section 2 access from the N4 requires upgrading of this access from the N4. A proper designed access which meets the requirements of SANRAL as roads authority and TRAC as its concessionaire will be required here. Such access will have to meet the following standards: -

- A T-type junction with maximum of 30° deflection and N4 through alignment;
- Surfaced 7m wide roadway 100m long for queuing and paint markings with kerbing to guide vehicles and a 1.8m gravel shoulder;
- Stop control at point of entrance at 6.25m from N4 edge of road;
- A line of sight from 5m back from the edge of the N4 of at least 300m in both directions;
- A right turn radius of at least 15m;
- Lane width of at least 6.5m at bell mouth;
- Kerb radii of 15m;
- Tapers of 60m to a full lane width of 3.7m wide;
- Drainage by culverts of N4 side drains;

This section up to the Water Treatment Works stockpile area will require re-alignment of horizontal and vertical geometry to meet the abovementioned standards. Clearing and grubbing of this re-aligned section will be required with drainage features such as like side drains and stormwater crossings. The sub-grade preparation of the re-aligned roadway will require ripping and re-compaction. A gravel wearing course of 3.9m width, with gravel shoulders will be constructed with imported gravel material as discussed in paragraph 3.3.1. As mentioned, additional testing of available material will be required to evaluate suitability.

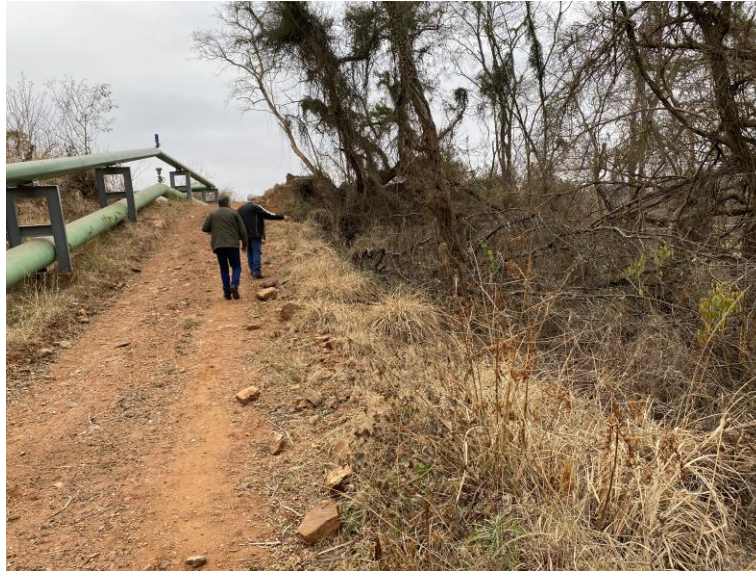
A third section of this route runs from the stockpile area on the N4, along the steel pipeline from the dam which supplies water to the Water Treatment Works, to the proposed new rock toe berm along the main embankment of the dam. This existing section is very narrow with poor horizontal and vertical alignment. It will require some adjustment in this regard and passing bays will have to be established along the route to facilitate passing of construction traffic and to protect the pipeline from construction traffic. From the picture below it is clear how close the pipeline is to the existing road: -

Section 3 follows the route from the stockpile area to the rock toe of the embankment. The existing route from the Water Treatment Works has a limited geometrical alignment which falls outside the safety and geometrical design standards required for a haul road. Although it is not economical to construct deep cuts, high fills or large horizontal curves and obstructions such as the water pipeline and its protection as well as the streambeds are limiting factors it is still recommended that, where possible, 7m wide sections be contemplated for passing purposes and 3.9m wide sections elsewhere. Spacing will be determined by sight distance. It is proposed that a 30km/h geometric design standard be followed and that the construction vehicles expected on this route determine the horizontal alignment minimum standards. In this regard a 25m curve in the roadway should be achieved with 15m as the absolute minimum for low-bed equipment delivery. On the vertical alignment the crest and sag k-values 2 and 5 respectively should be maintained.

Protection of services such as the pipeline will be facilitated with extended culverts at pipeline crossings, berms, barriers and bollards. Drainage will consist of extended culverts and concrete causeways with roadway crossfall as well as mitre banks and berms. Sub-soil drainage may be required on wet sections. This section will require cut to fill operations, rockfill in some areas, sub-grade preparation of re-aligned sections. Imported gravel material of 150mm thickness will be processed into a wearing course along the route. Dump truck manoeuvring areas will be accommodated in the bypass areas.

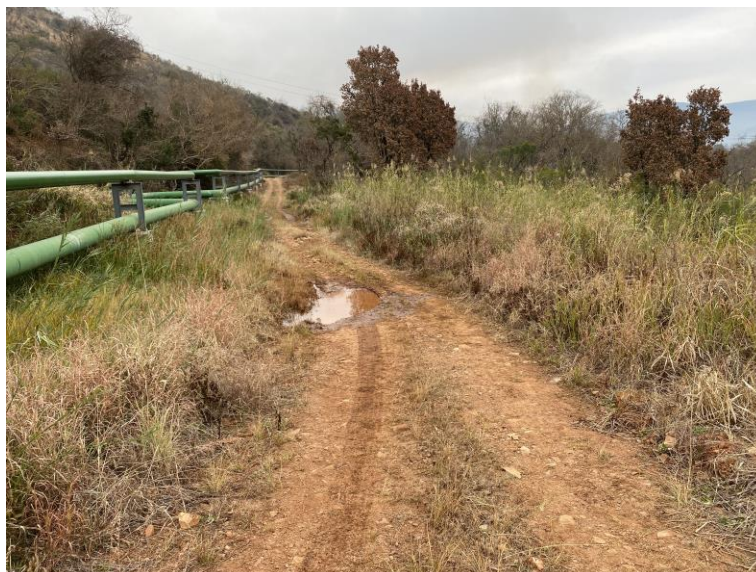
The fourth and last section of this route turns away towards the left flank of the dam in order to reach the final fill level of the rock toe berm where a road along the embankment continues to the laydown area for construction plant and equipment. This area is to be created below the spillway area. Some clearing of alien vegetation will be required for this purpose. A picture of the deviation point: -

Section 4 will require a 3.9m wide section with a completely new alignment in order to reach the points of placement of the material along the rock toe berm. Restricted space at the bottom of this structure between the pipeline and the toe limits the space available to less than 2m, which is not wide enough for trucks to pass. The final level of material placement is also much higher up the embankment and a new road is required to this point. This new haul road is indicated in blue as Route 2, Section 4 on the layout on Figure 1. It follows the route up the groin of the dam and turns onto the embankment at the existing berm, runs along this berm line along the face of the embankment and then drops down to the plant and equipment laydown area. This route will cross the pipeline at the newly constructed culvert before running uphill to the groin area. Fills will be used to create this route. Once past the equipment laydown area this road will cross the Ngodwana river below the spillway area at a stream crossing before linking with Route 1, Section 6. Geotechnical conditions will determine if the stream
