**Report to Umsunguli Project Management on a Geotechnical Investigation  
carried out for the Proposed Mount Verde Development, Hilton,  
KwaZulu-Natal**

**Project No.: 22-037R01**

**Date Issued: June 2022**

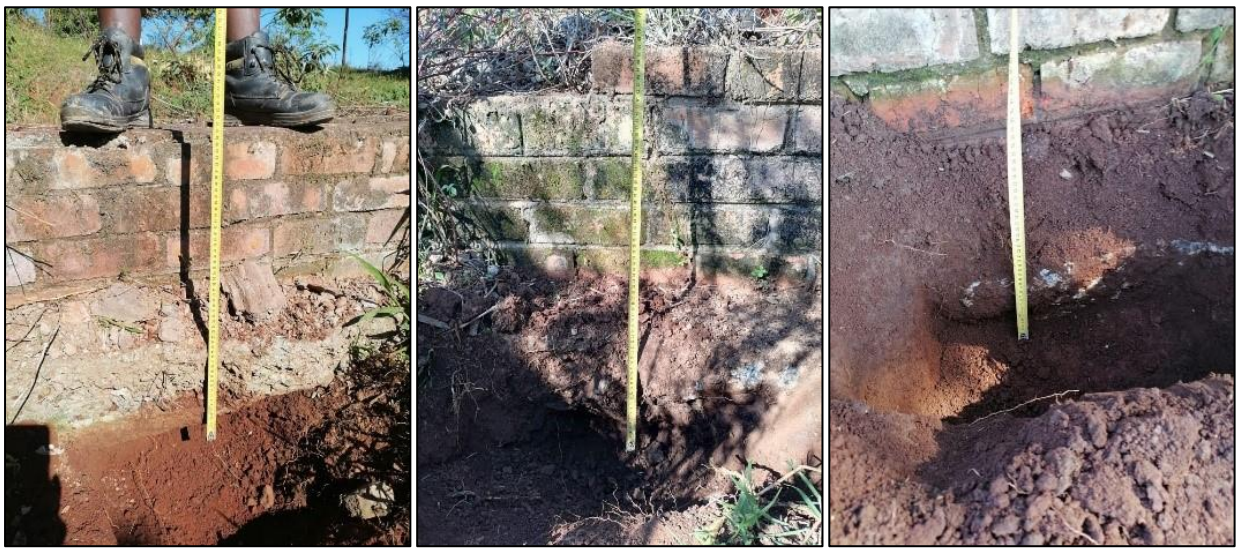
House	Footing Depth below existing ground level (mm)	Inferred Footing Width / thickness(mm)
1	280	600 / 160
2	270	<600 / 150
3	330	600 / 200
4	300	<600 / 130
5	250	600 / 200
6	330	<600 / 200
7	300	600 / 150
8	400	<600 / 160

**Plates 17 to 19: Foundations of partially demolished Farm Houses - Forest Village area**

The existing foundations which have been left in place after the superstructures have been demolished are not considered suitable for re-use, unless the Structural Engineer is able to make these compatible with the design requirements for the H1 foundation class indicated above.

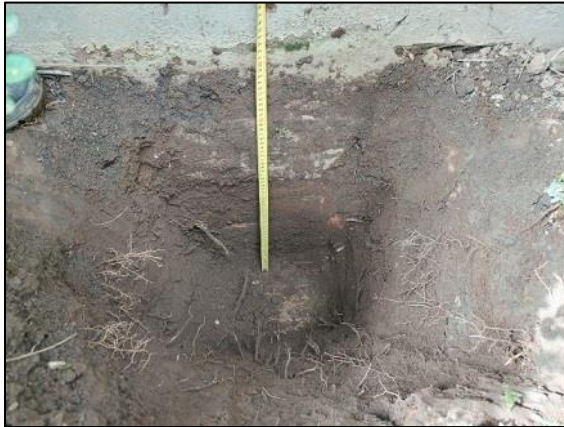
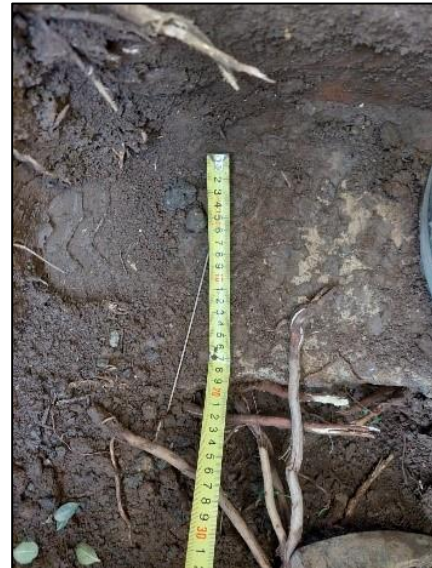
The foundations beneath the existing buildings at the office / workshop area were checked in two places. Generally, these foundations were found to comprise 750mm wide strip footings founded at a depth of 0.70 mbegl.

**Plates 20 & 21: TP W1 & TP W2 showing the foundations measured at the existing workshop area**

The existing foundations in this area appear adequate and no major cracking was evident in the existing buildings.

Foundations for all new buildings should follow the guidelines for NHBC foundation class designated H1 as discussed above.

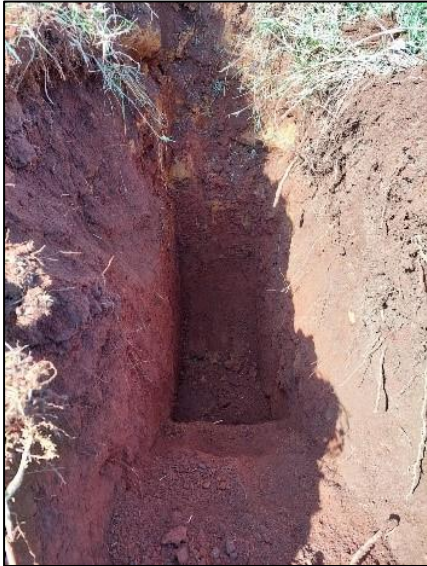
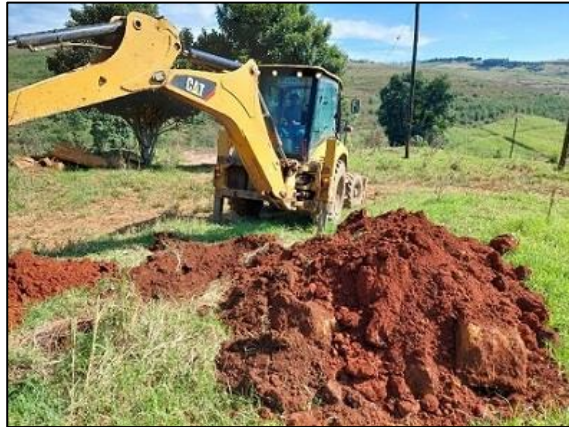
**Plates 22 & 23: Colluvium overlying residual dolerite soils comprising sandy clays with occasional dolerite and sandstone boulders**

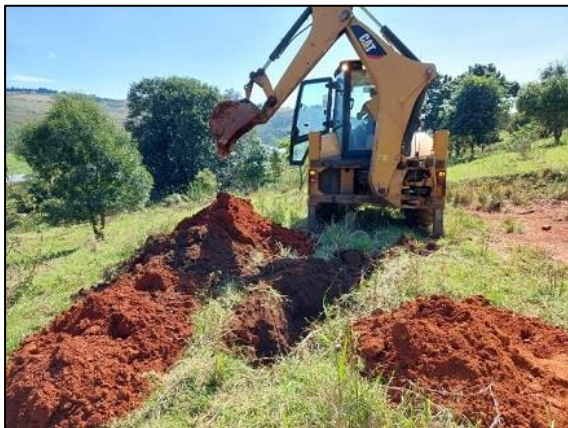
**Plates 24 & 25: Residual Dolerite soils overlying residual sandstone comprising clayey sands**

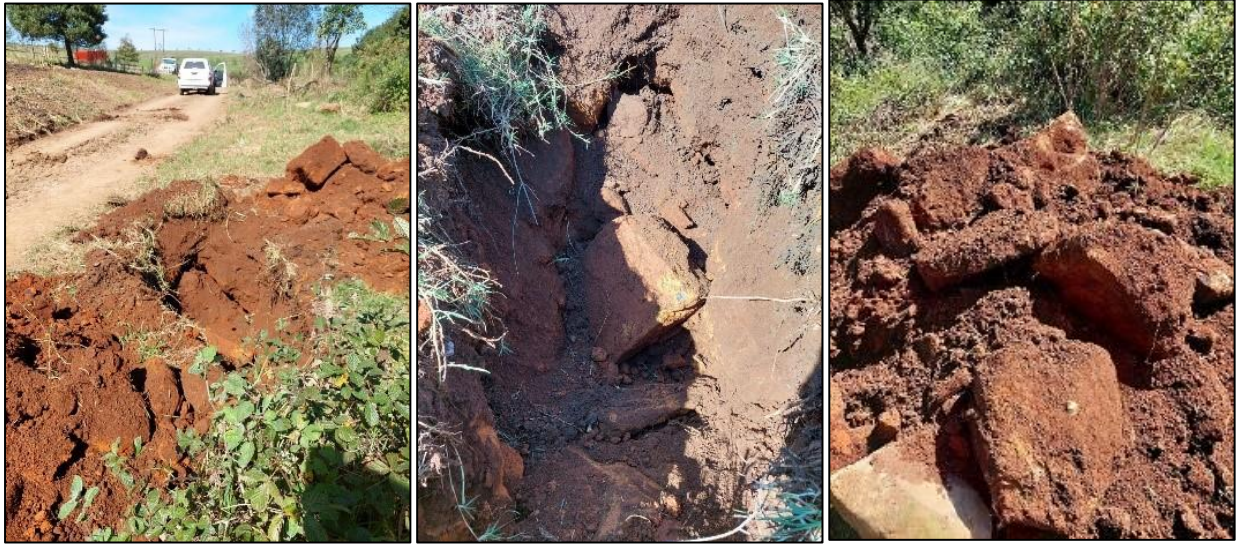
**Plates 26 to 28: TP7 and TP8 excavated along the access road for the Forest Village. These test pits show abundant sandstone boulders in a matrix of clayey sand**
