Date: November 2019

Report number 1911-002MOI-MJ

ROCK ENGINEERING REPORT – SUBSIDENCE RISK

This report was compiled for:
LANGCAREL INVESTMENTS (PTY) LTD
MOOPLAATS COLLIERY

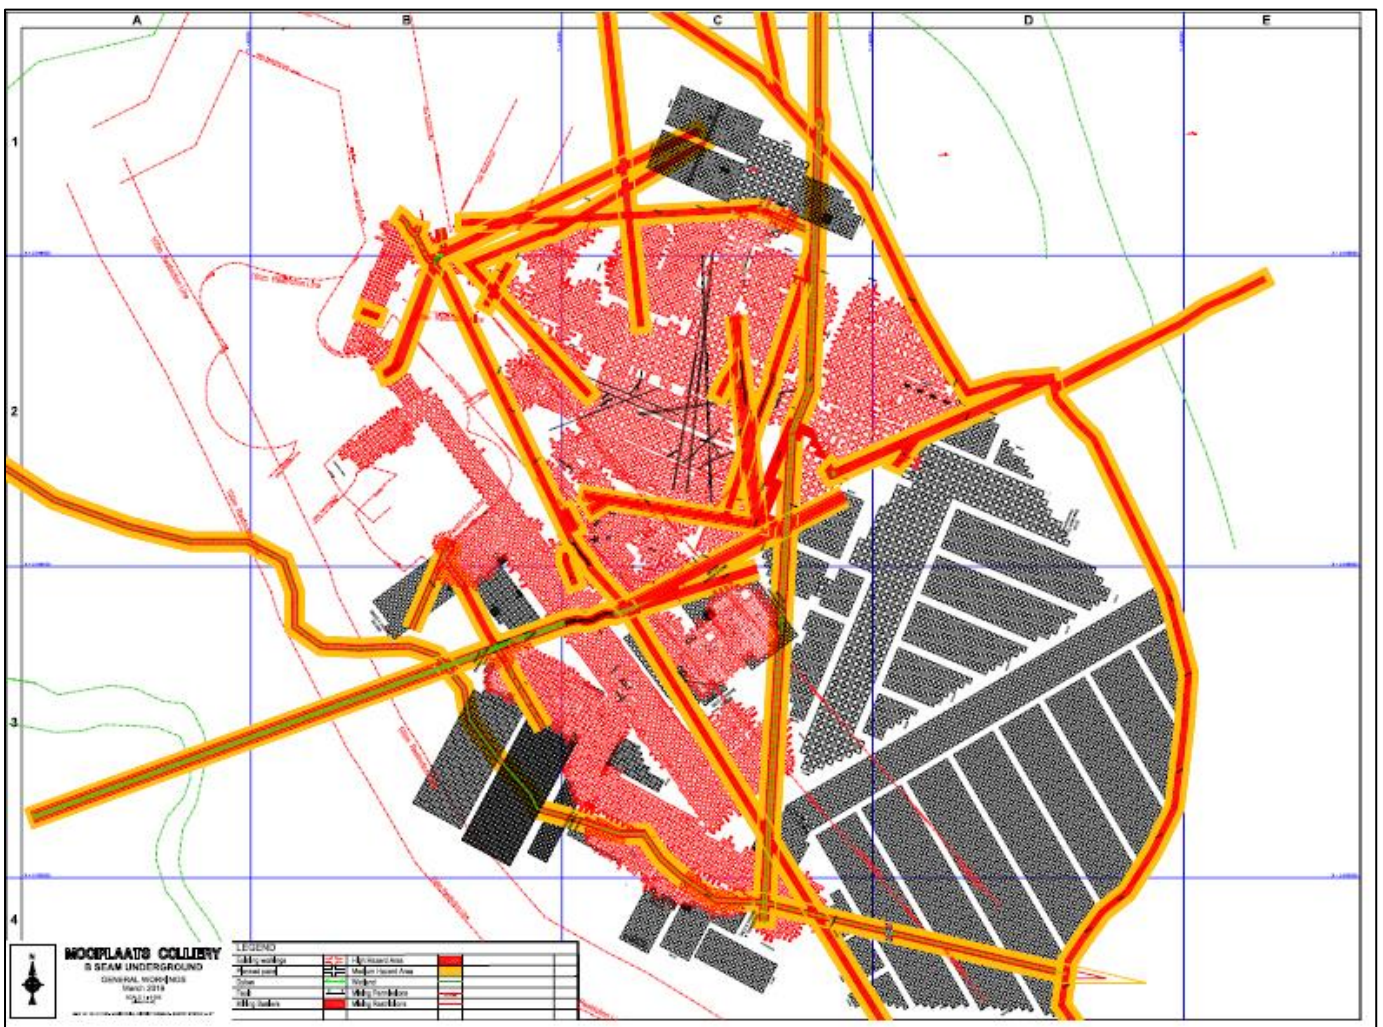
Map illustration of the major geological features within the mining area

A number of dolerite sills have been intersected in boreholes. The sills are, for the most part, concordant but may transgress to differing stratigraphic levels, resulting in displacement of the coal seams. Coal seams occurring in proximity above and below sills are also devolatilised to varying degrees. A number of dolerite dykes have also been recorded in outcrop, boreholes and mine workings. The frequency of dykes is illustrated below in relation to the mine workings in red.

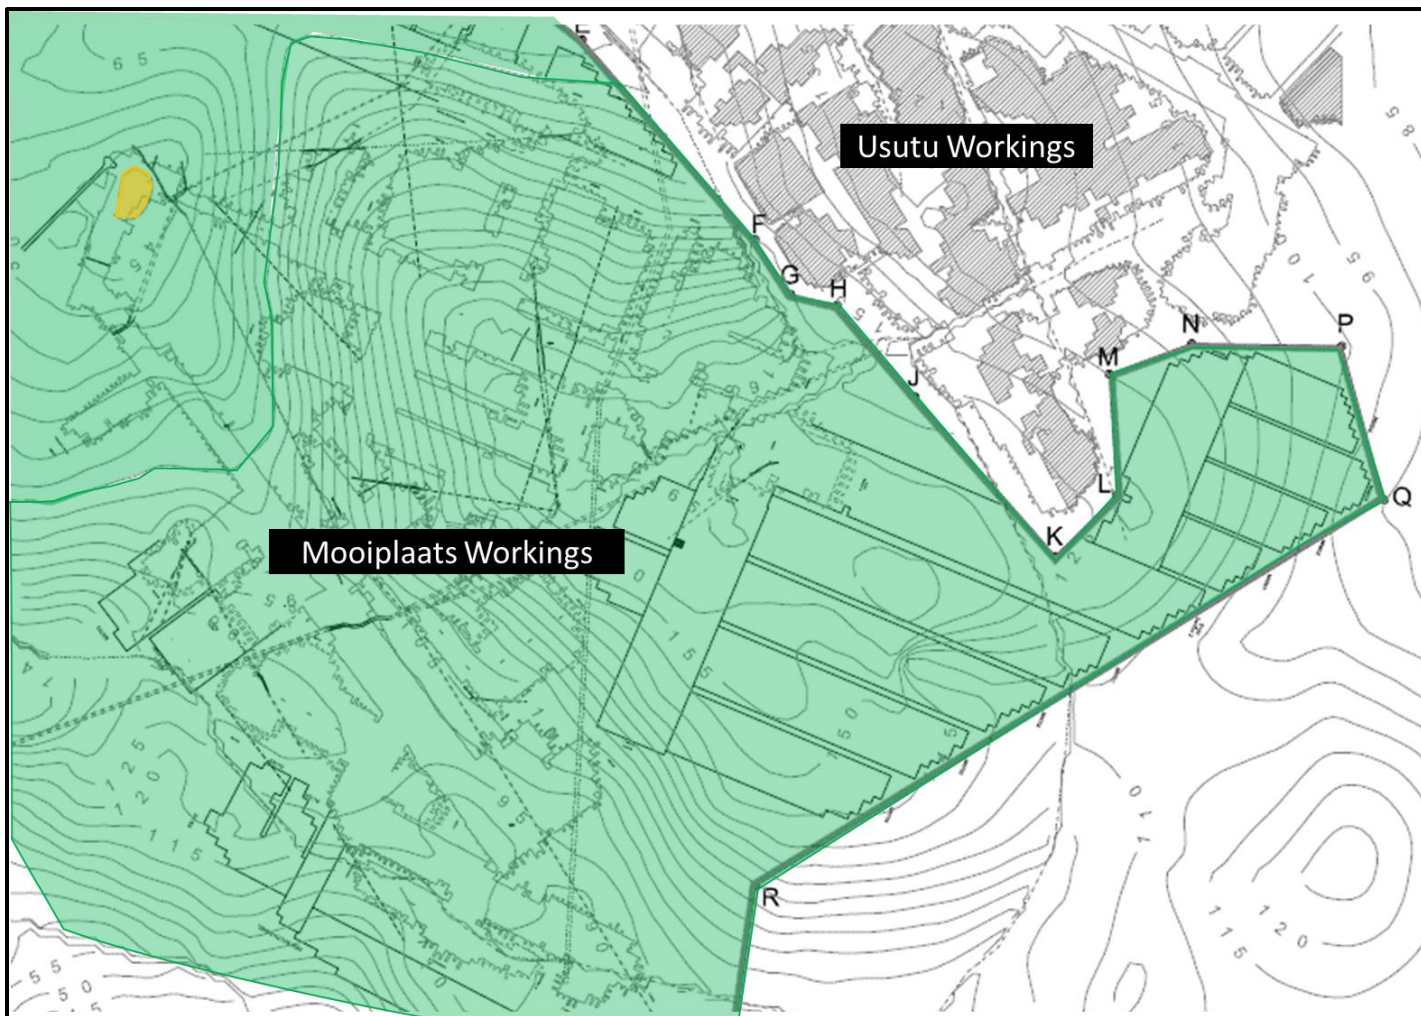
Figure 1: Illustration of the risk assessment outcome - subsidence

Hazards	Hazard Consequences	Initial Risk Value			
		P	S	E	R
Pillar failure – Square pillars (<40m deep)	Pillar failure resulting in large scale catastrophic subsidence occurring unexpectedly.	3	4	5	60
Pillar failure – square pillars (>40m Deep)	Pillar failure resulting in large scale catastrophic subsidence occurring unexpectedly.	2	3	5	30
Pillar failure – long pillars	Pillar failure resulting in large scale catastrophic subsidence occurring unexpectedly.	2	3	5	30
Roof failure – intersections	Roof failure in intersections resulting in sinkholes and other forms of subsidence.	2	3	5	30
Roof failure - bords	Roof failure in bords resulting in sinkholes and other forms of subsidence.	1	3	5	15

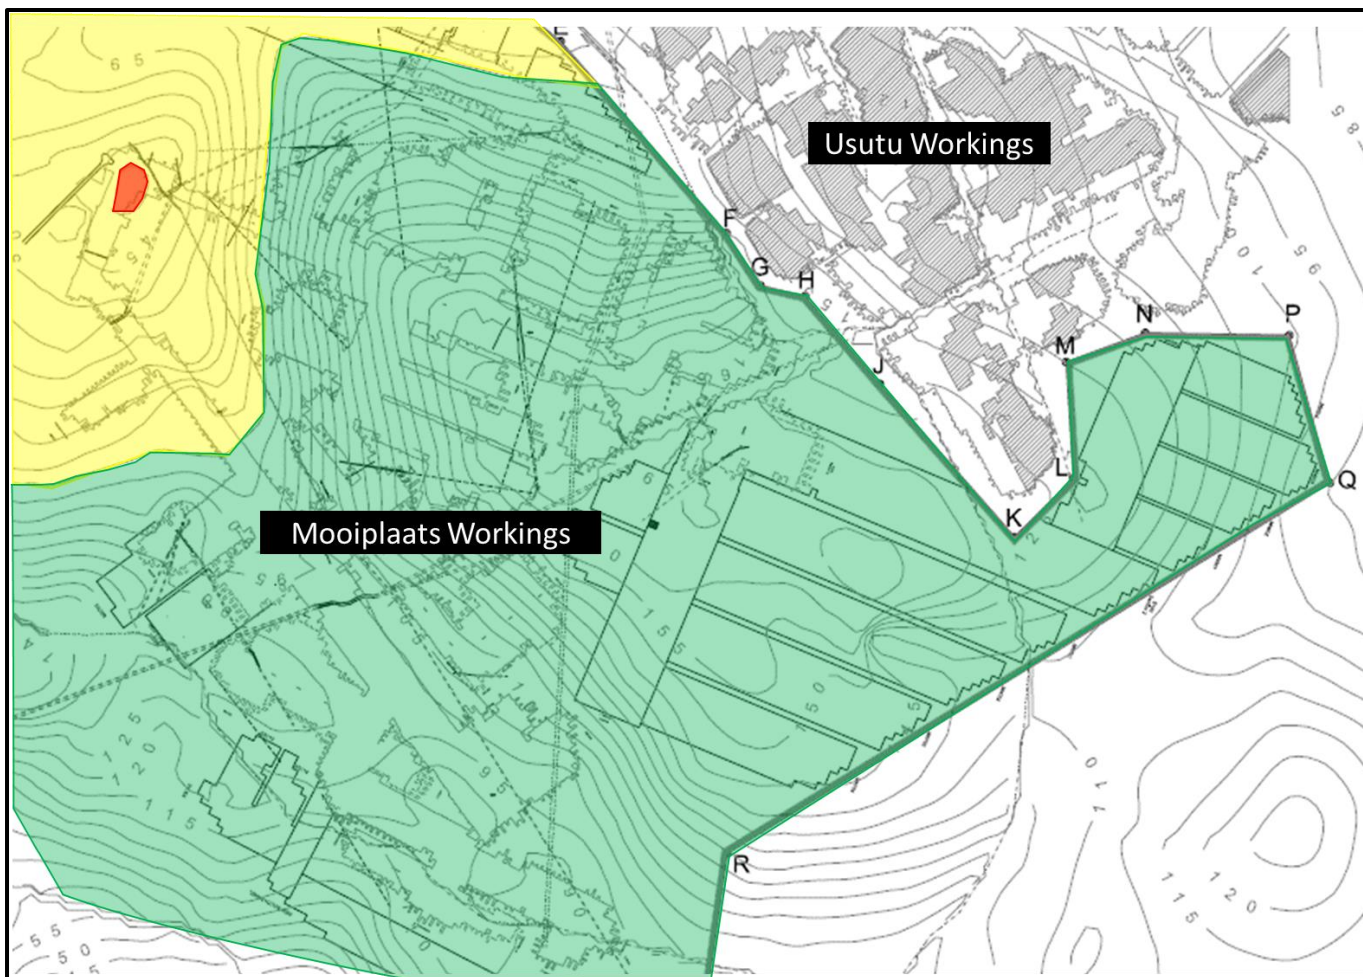
Figure 1: Illustration of the areas more prone to subsidence

Although subsidence is unlikely to occur it cannot be excluded over the long term, it is for this reason that areas more prone to subsidence was identified based on the levels discussed below and illustrated in Figure 2.

Levels	Description
Green	The mining area is situated well below surface (>80m), pillars are stable, no secondary extraction has been conducted and the overall roof composition consists of predominantly “good” rock. Subsidence will only occur in the event of large scale pillar failure.
Yellow	The mining area is situated 40m to 80m below surface, pillars are stable, no secondary extraction has been conducted and the overall roof composition consists of predominantly “good” rock. Subsidence will only occur in the event of pillar failure and will be in the range of 80% of the mining height.

Red

The mining area is situated below 40m from surface, pillars are stable, no secondary extraction has been conducted and the overall roof composition is considered weathered. Subsidence can occur as a result of pillar and roof failure. All types of subsidence can be expected in these areas in the event of roof or pillar failure and will be in the range of 80% of the mining height.

- A proper industry accepted pillar design must be accepted and followed at the mine, developed by a rock engineering practitioner.
- Barrier pillars must be included into the pillar design of the mining area and panel widths should be limited with respect to the critical mining span.

- Underground assessments to monitor adherence to designed dimensions. The Mine Manager must implement disciplinary measures in cases where the mine dimensions was not adhered to.
- Mining in areas less than 40m deep should not be attempted beneath areas where subsidence is unwanted, such as below critical surface structures.
- In areas where subsidence is likely backfilling methods can be implemented to decrease the effect of subsidence. Site specific recommendations must be conducted by the rock engineering practitioner in such an event.
