SHAKAVILLE LANDFILL

Site photos taken on the 20th September 2017 and 18th October 2017

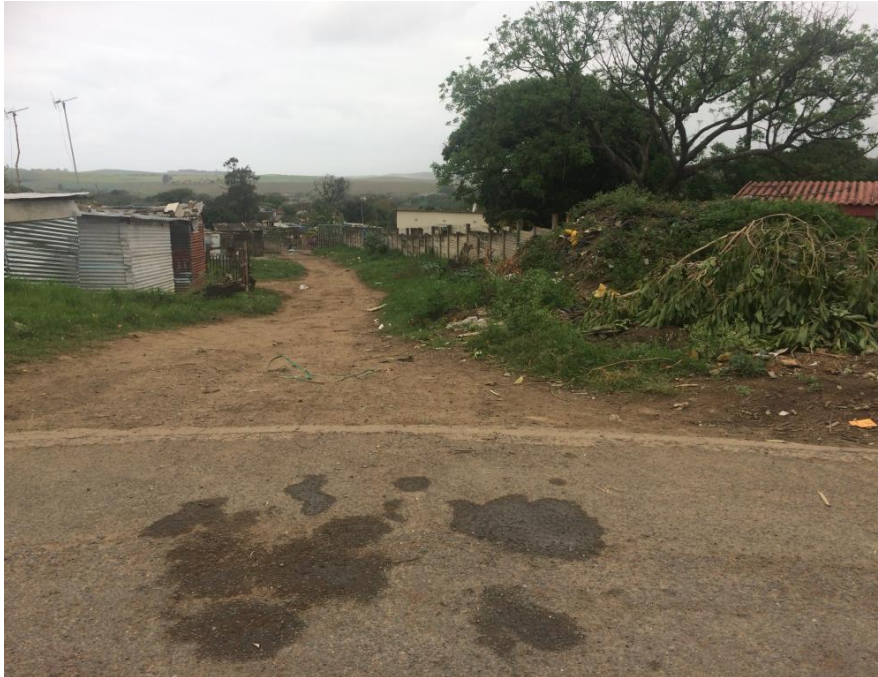
Figure 1: View towards the south east site showing the gravel road providing access to the site entrance form Mbozambo Street

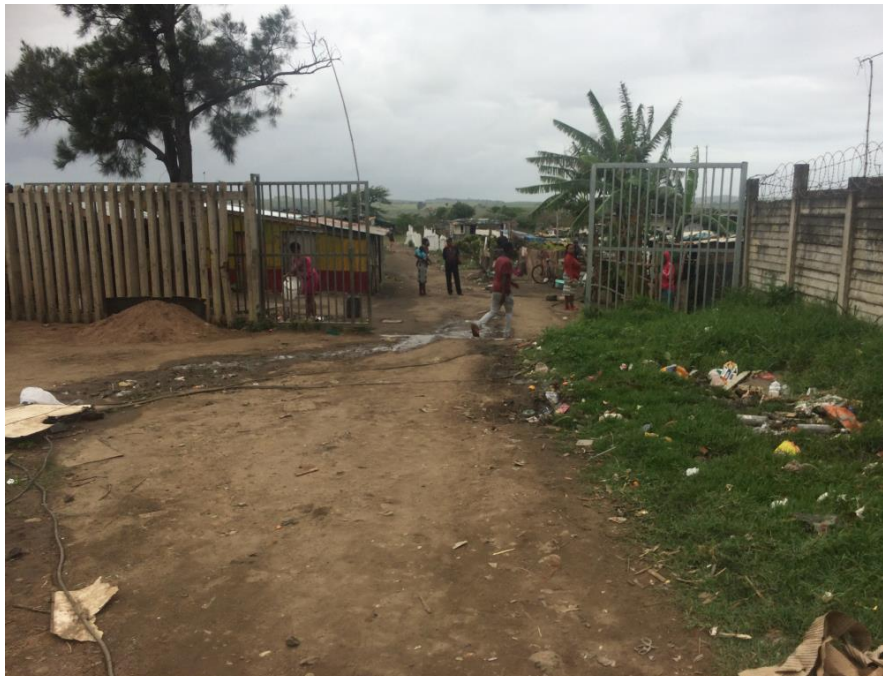
Figure 2: View towards the site gate

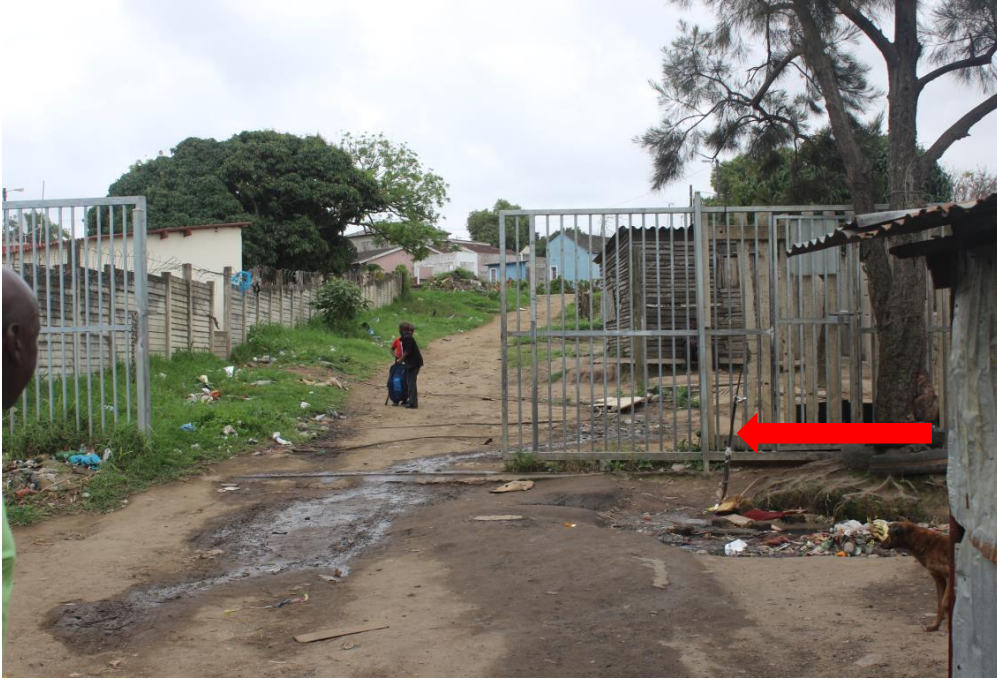
Figure 3: View towards the north east showing the site entrance and the tap (red arrow)

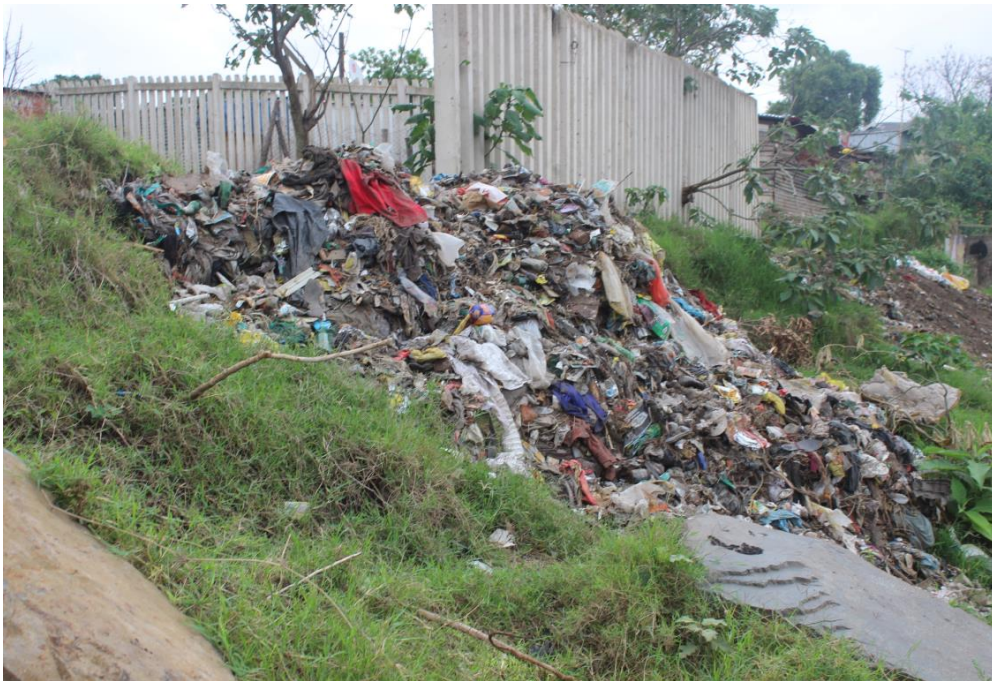
Figure 4: Waste body on the north-eastern section of the site close to the gate and within the riparian area of a tributary of the Mbozamo River

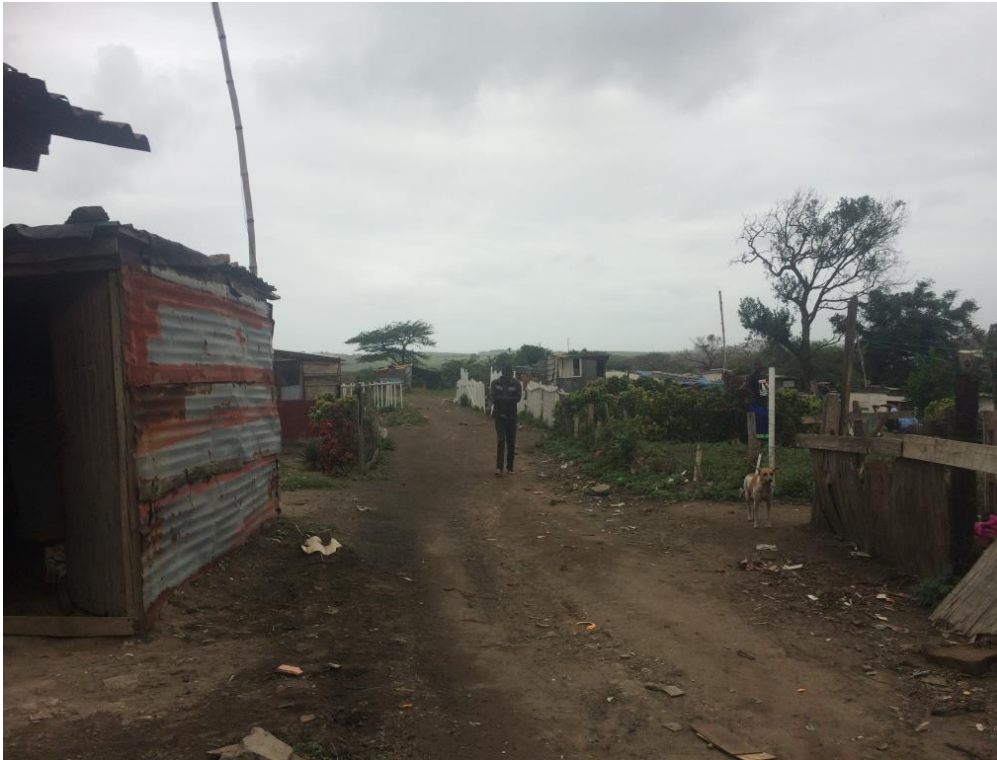
Figure 5: Main access road within the landfill boundaries

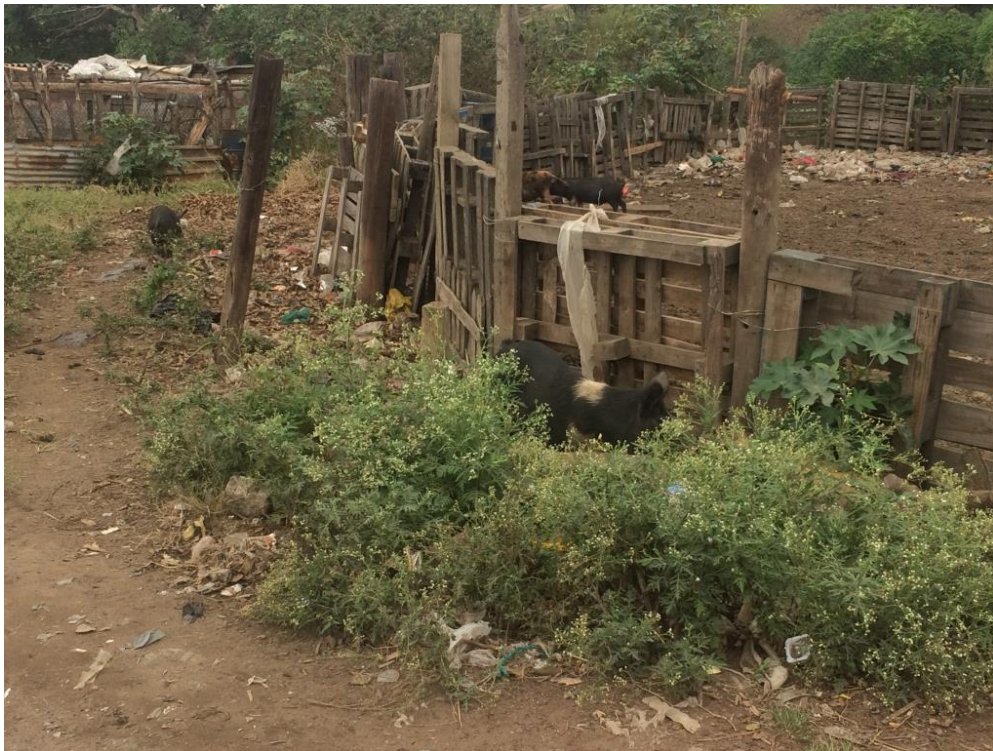
Figure 6: Pigsty noted within the landfill boundaries

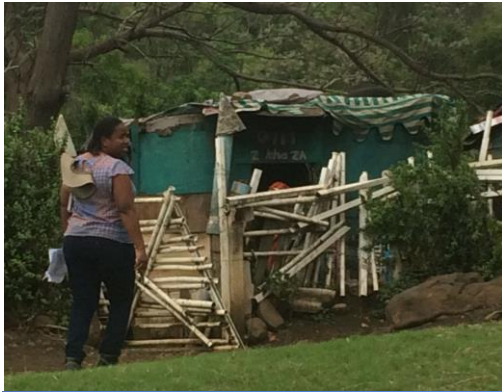
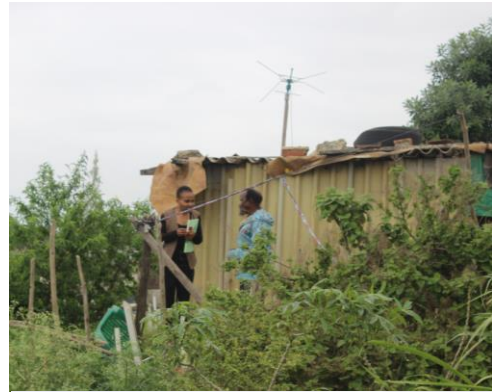
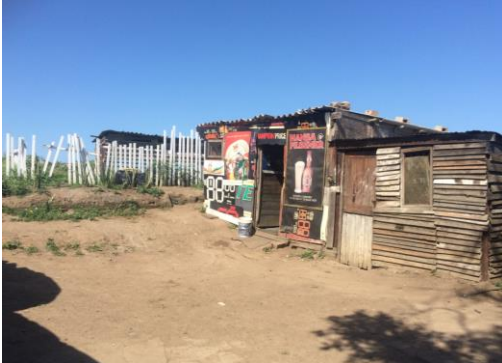
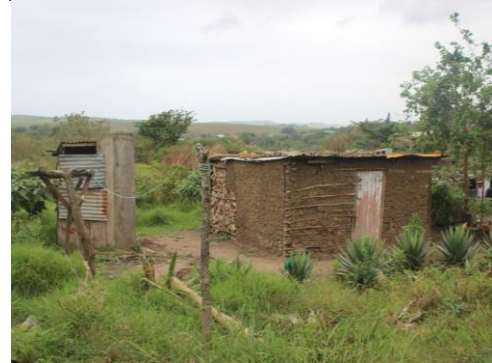
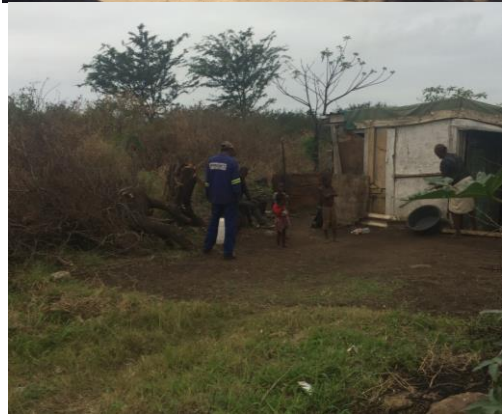
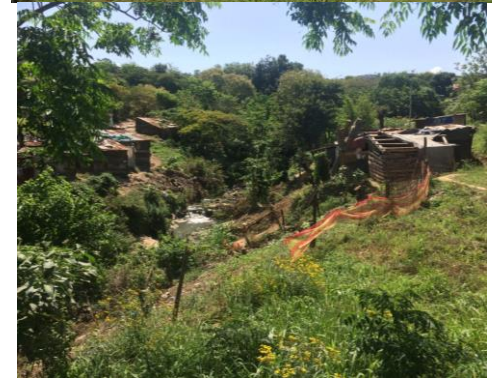
Figure 7: Informal Housing structures on site

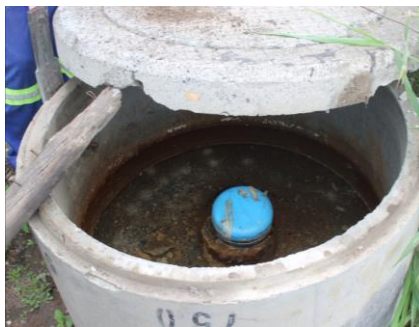
Figure 8: Monitoring borehole protected by a manhole

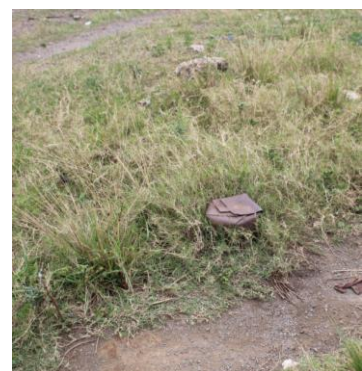
Figure 9: Capped manhole without additional protection

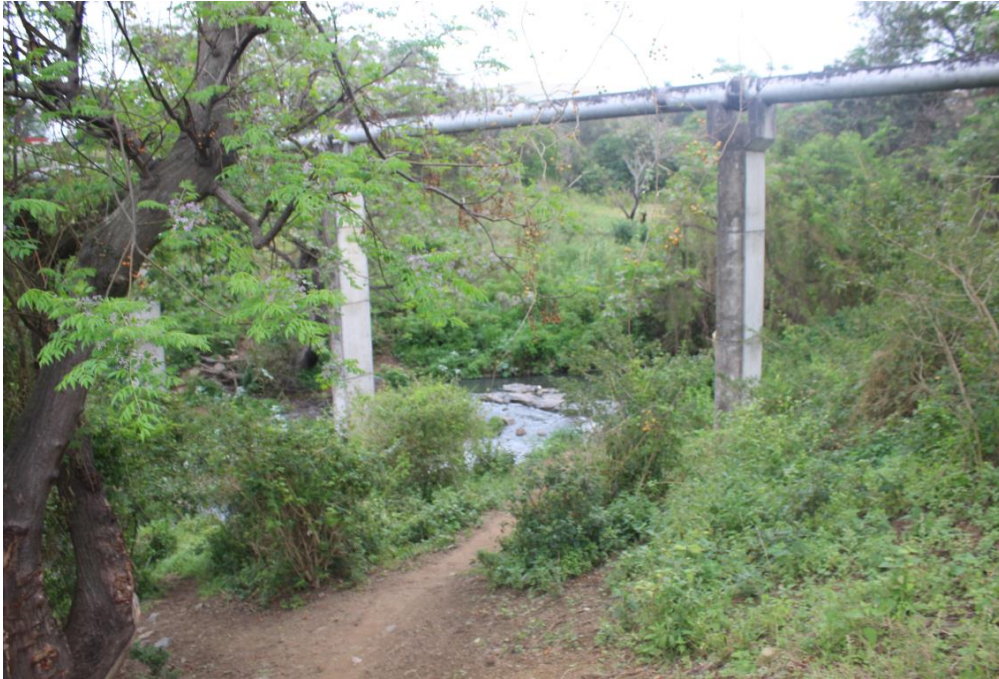
Figure 10: Sewerline traversing the site and crossing a tributary of the Mbozamo River

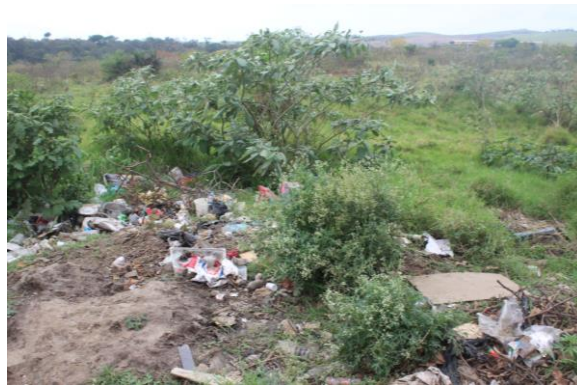
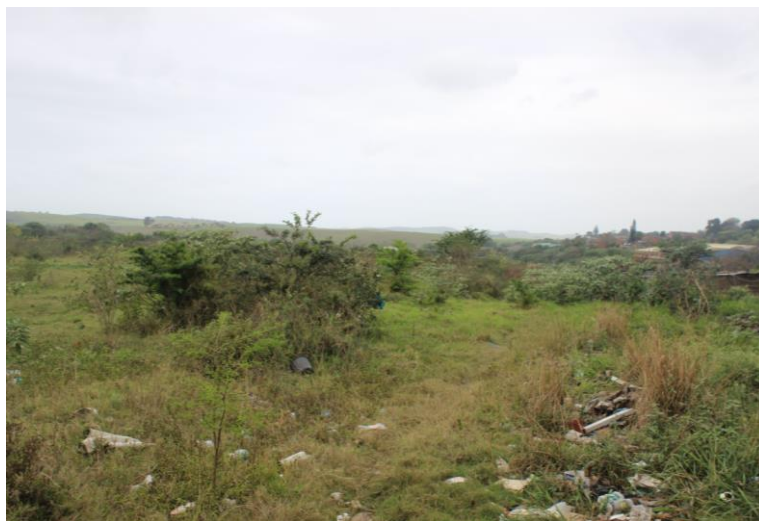
Figure 11: An example of one of the pockets of waste disposal

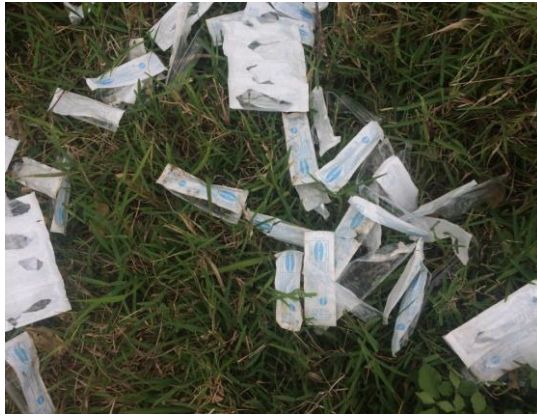
Figure 12: Empty syringe packaging
