UMZIMKHULU LANDFILL

Site photos taken on the 21st September 2017 unless otherwise indicated

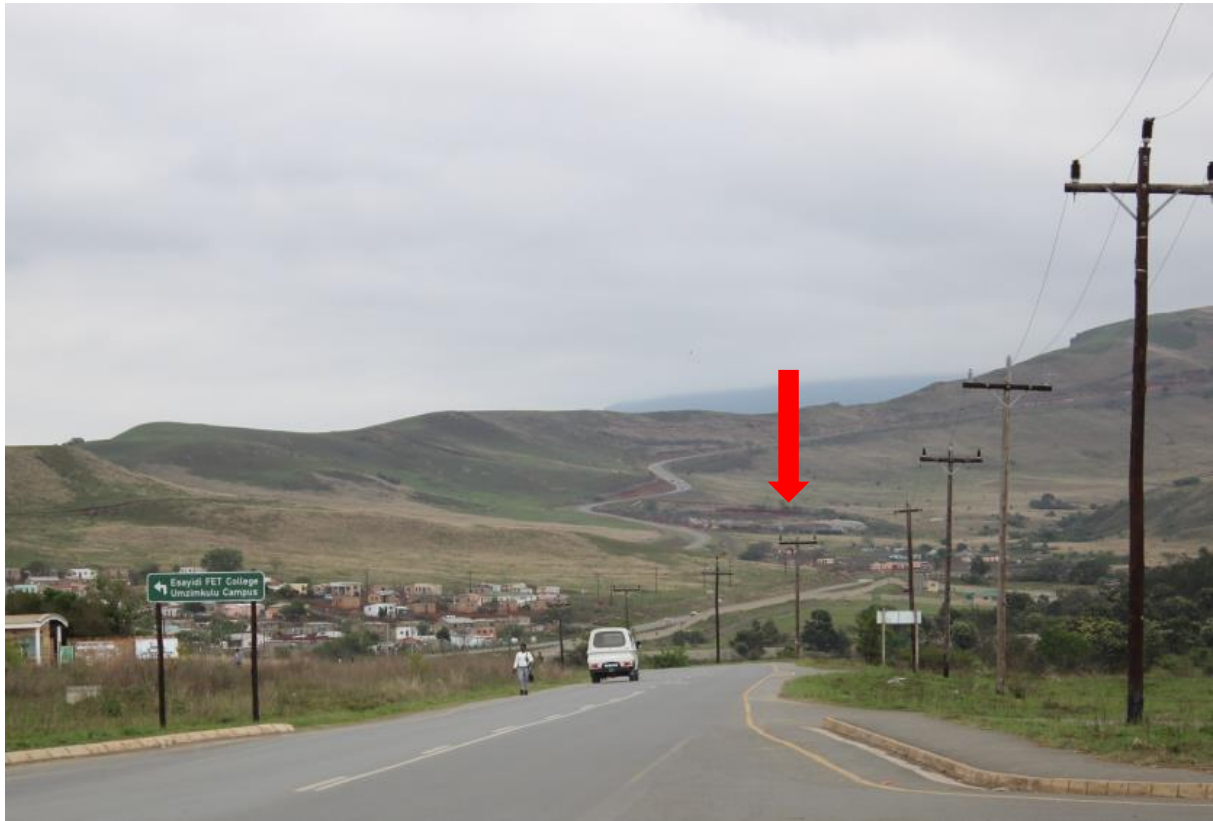
Figure 1: View towards the west showing the location of the landfill in relation to the P601 and the rolling hills (20 October 2017)

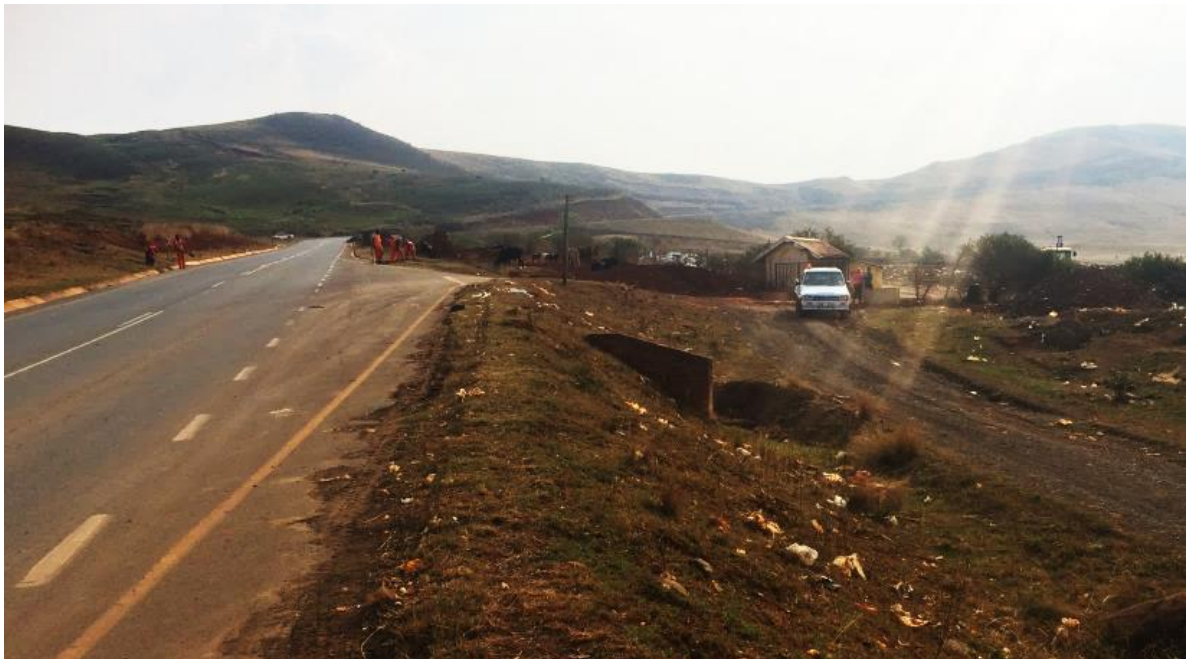
Figure 2: View towards the west showing the entrance to the site in relation to the P601 road to Franklin

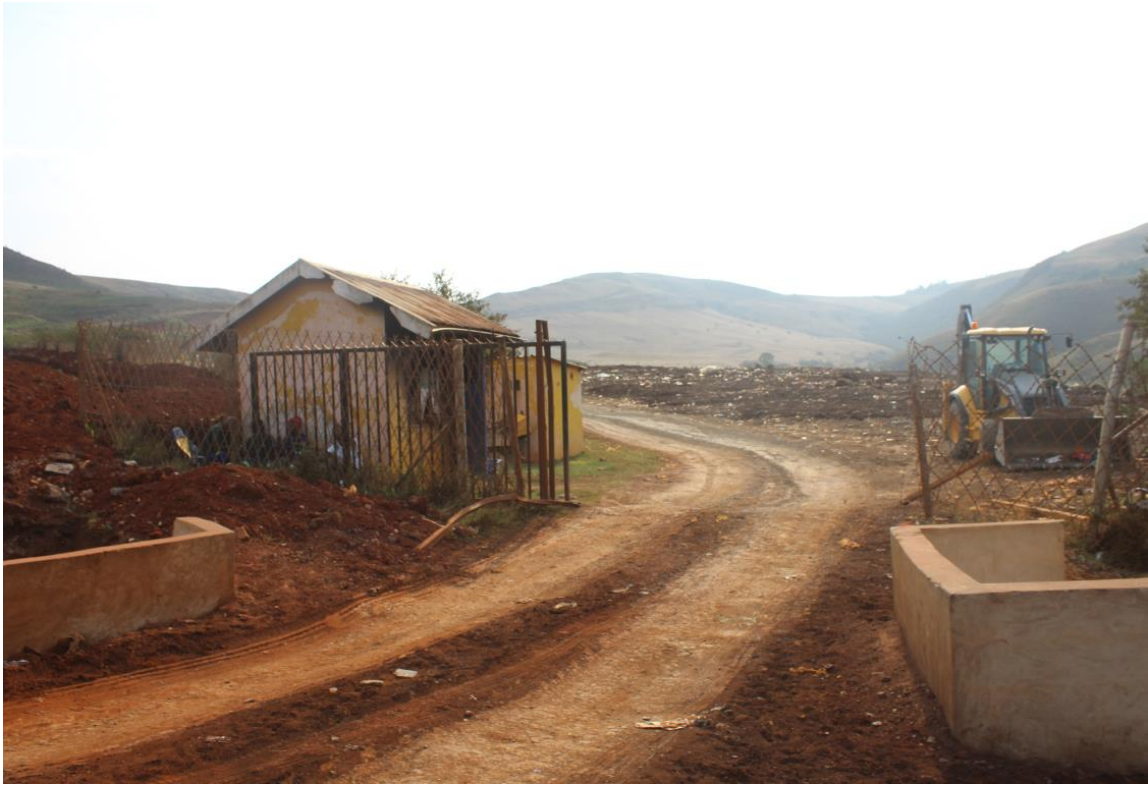
Figure 3: Site entrance with the guardhouse in the foreground

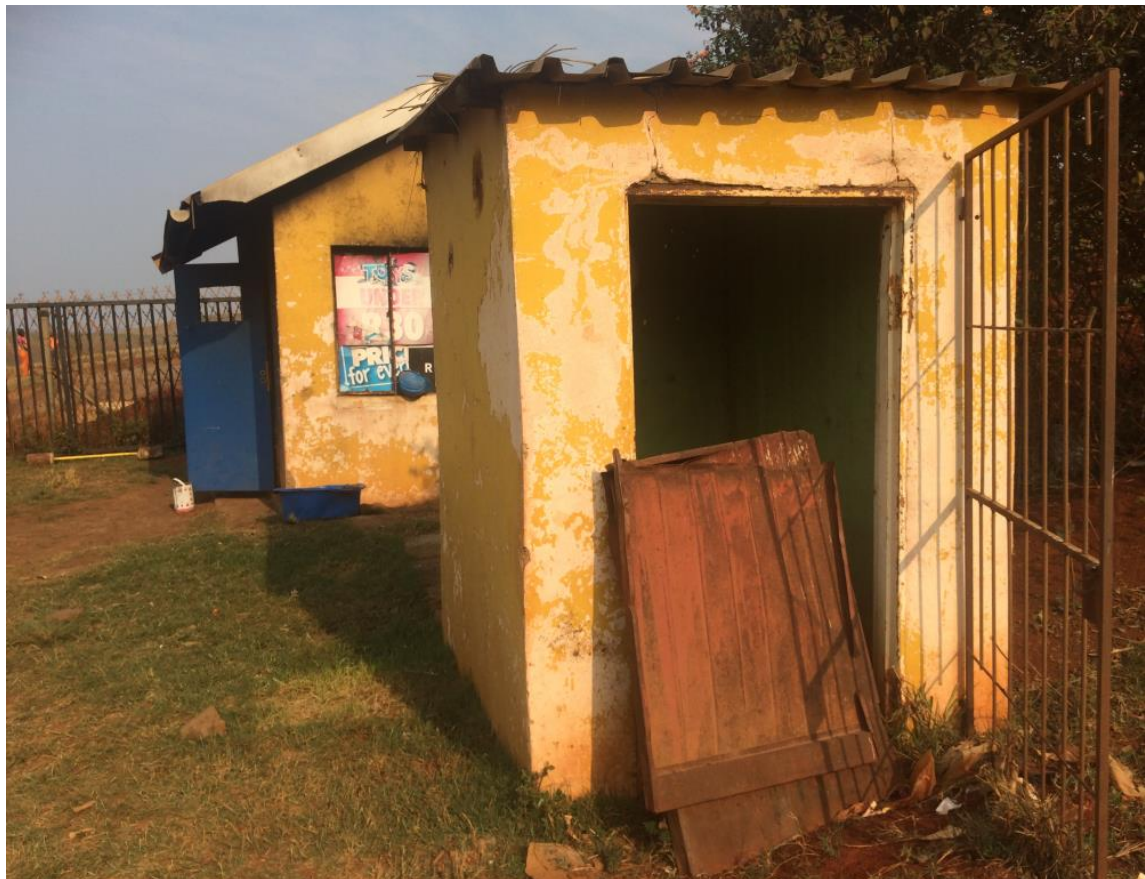
Figure 4: Site toilet in the foreground and the guardhouse in the background

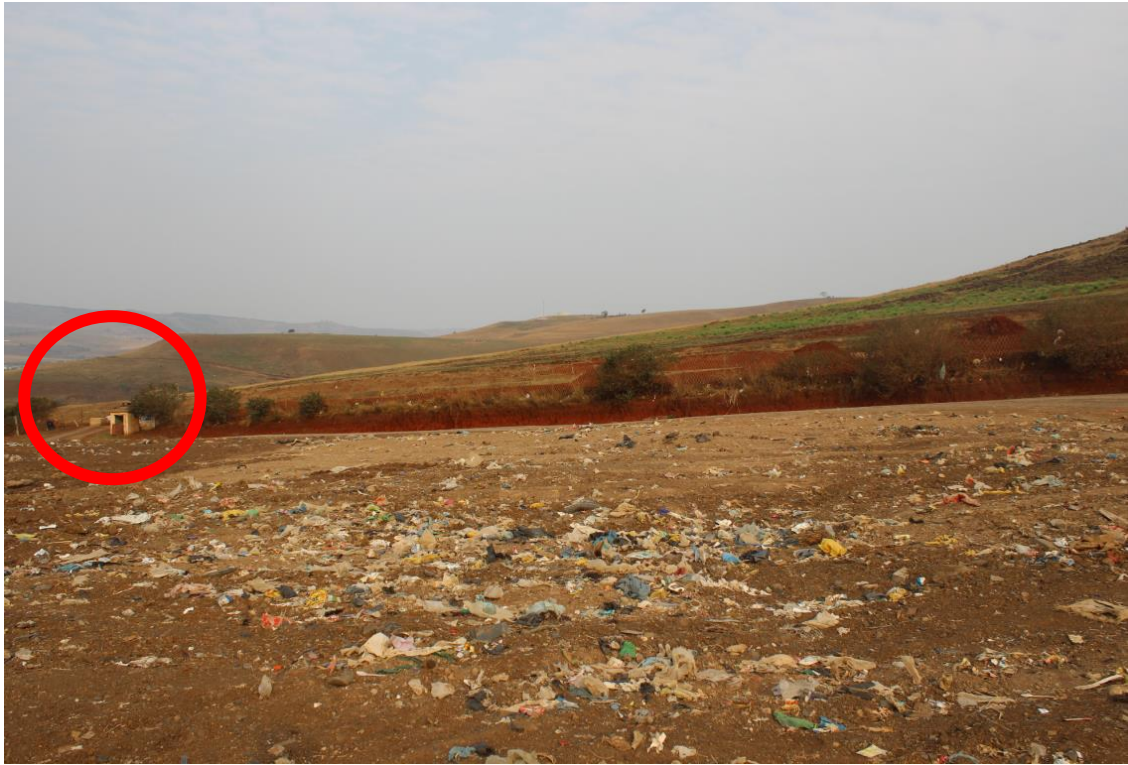
Figure 5: View towards the south east showing the site entrance (red circle)

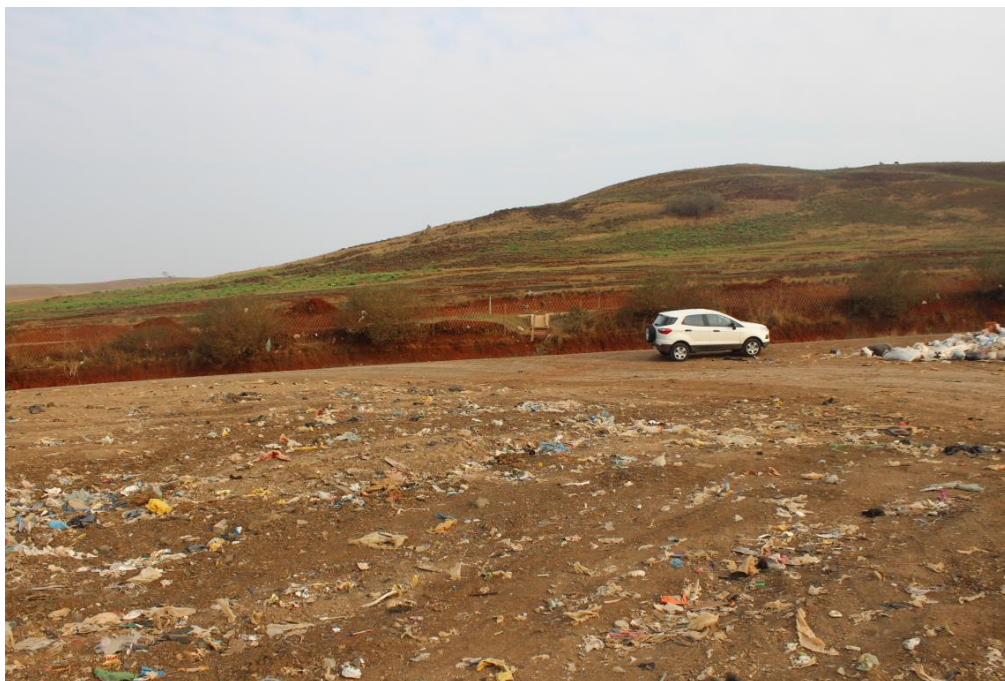
Figure 6: View towards the south showing the compacted waste in the foreground and the fence and the P601 in the background

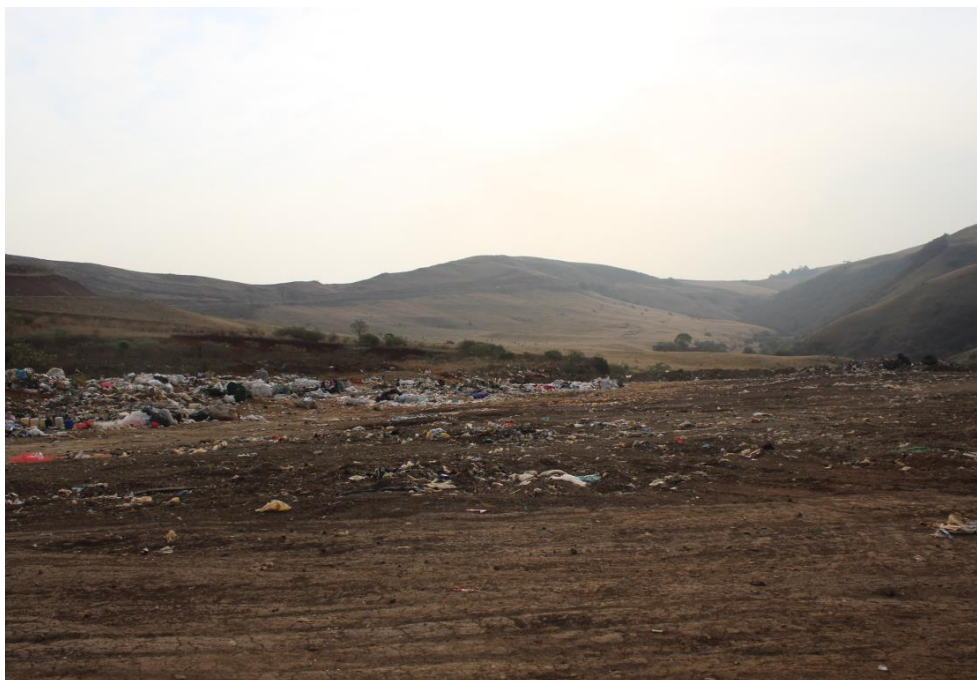
Figure 7: View towards the north west showing the waste on site showing uncompacted waste on the left and compacted waste on the right

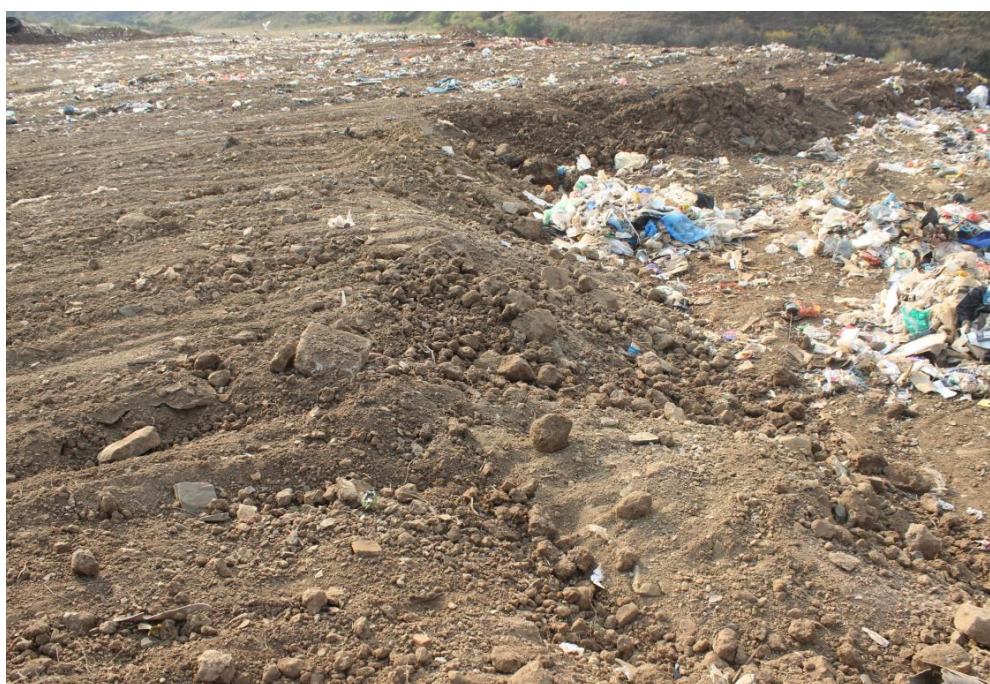
Figure 8: Waste capping efforts

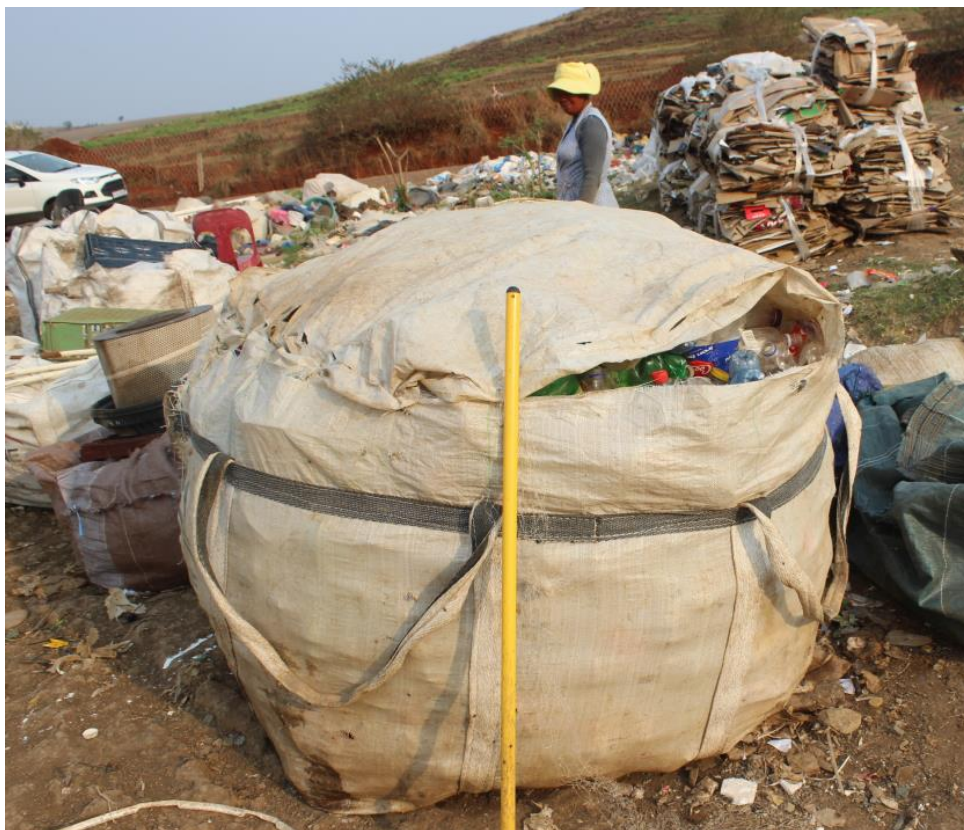
Figure 9: Examples of recyclables reclaimed from the landfill. Note the large bag filled with plastic bottles in the foreground and the cardboard boxes in the background

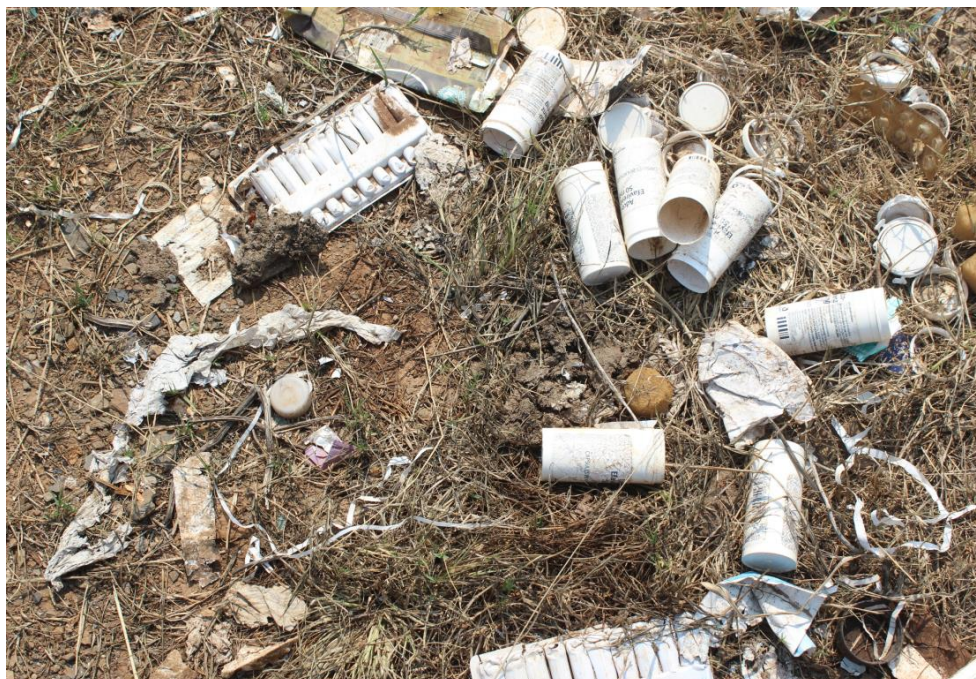
Figure 10: Empty tablet containers

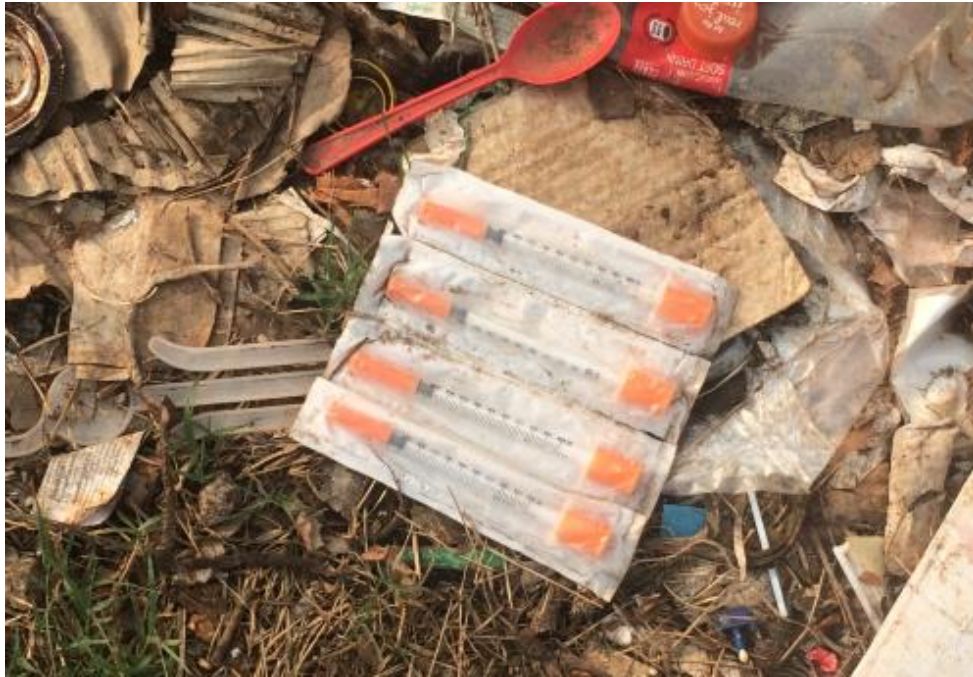
Figure 11: Insulin Syringes

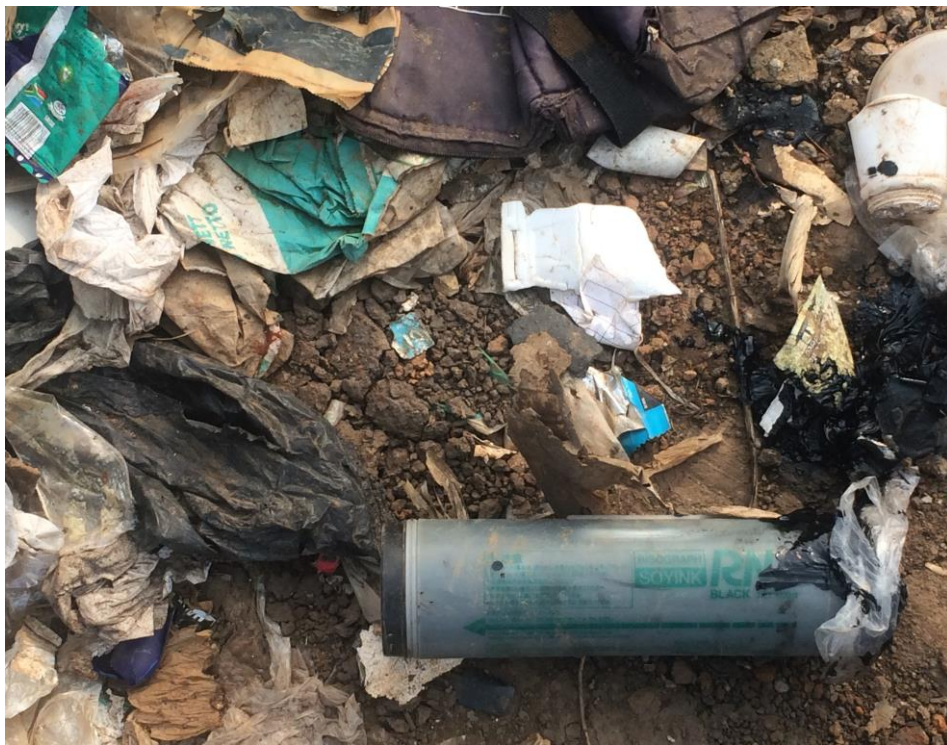
Figure 12: Ink container spilling excess ink on the ground

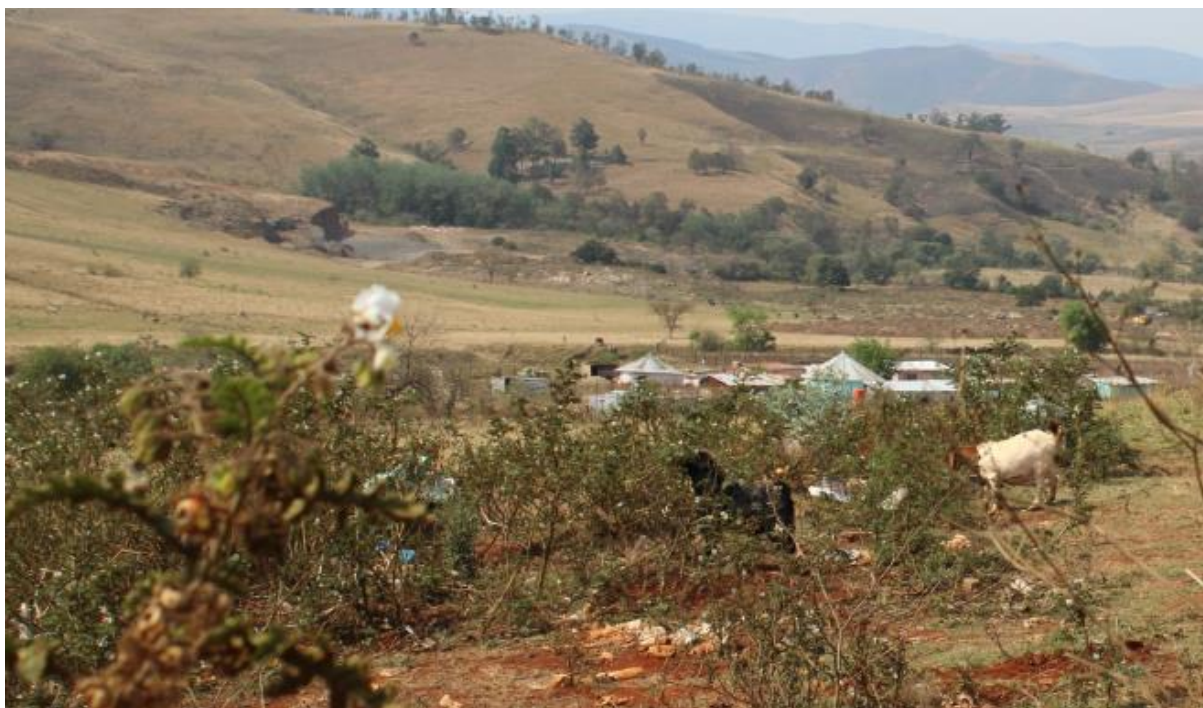
Figure 13: Goats feeding on plants immediately outside the landfill entrance

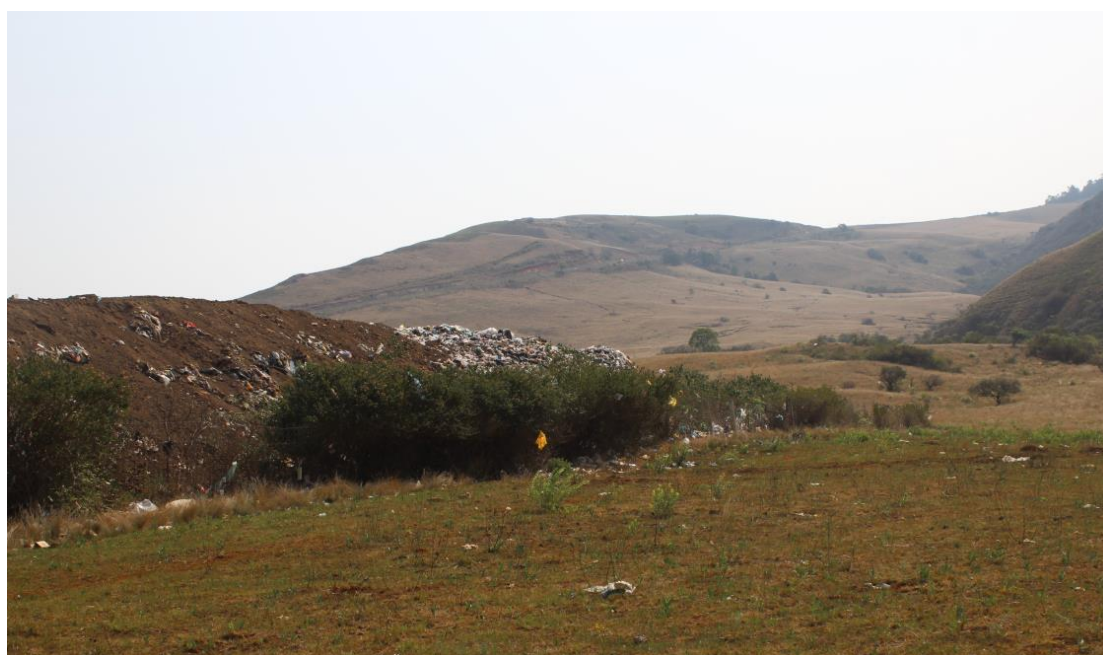
Figure 14: View towards the north west showing windblown litter in the foreground and the waste body in the background

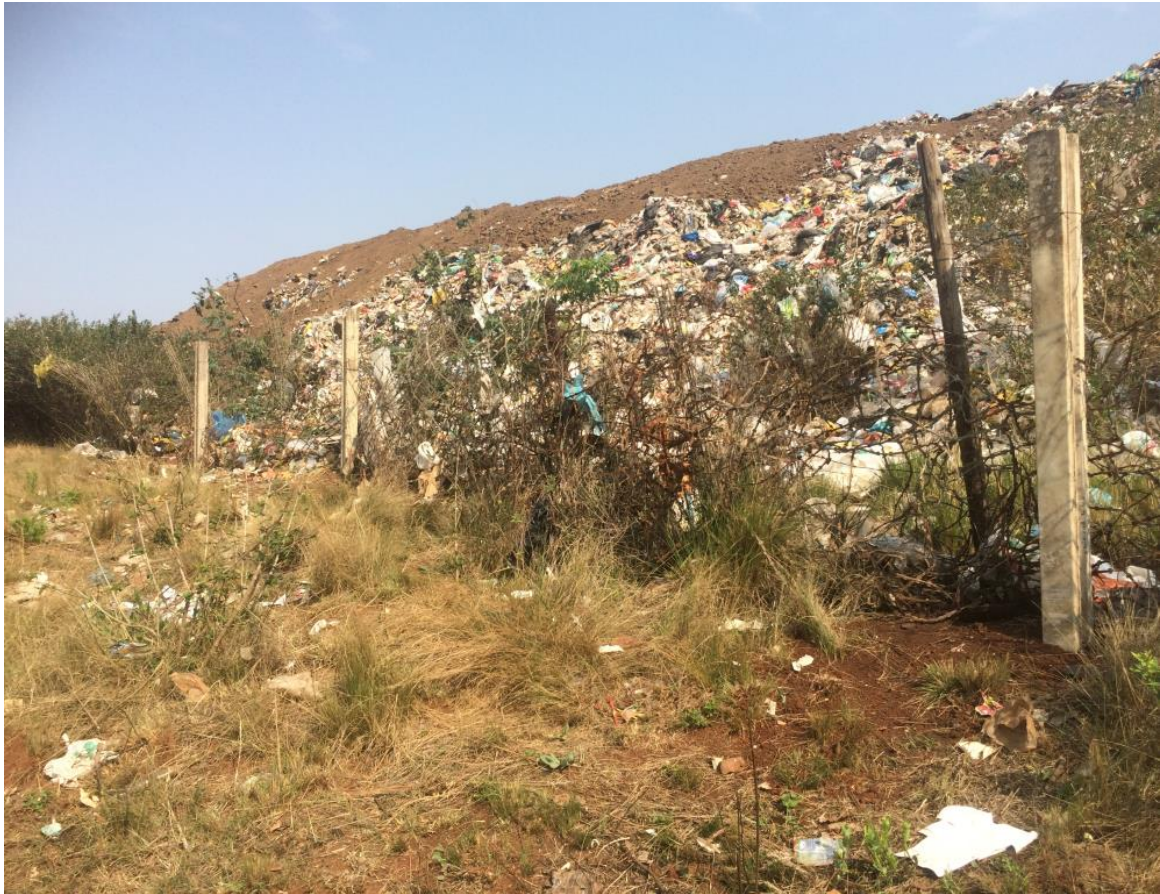
Figure 15: Close up of the waste body viewed from the northern boundaries of the landfill. Note the poor state of the fence

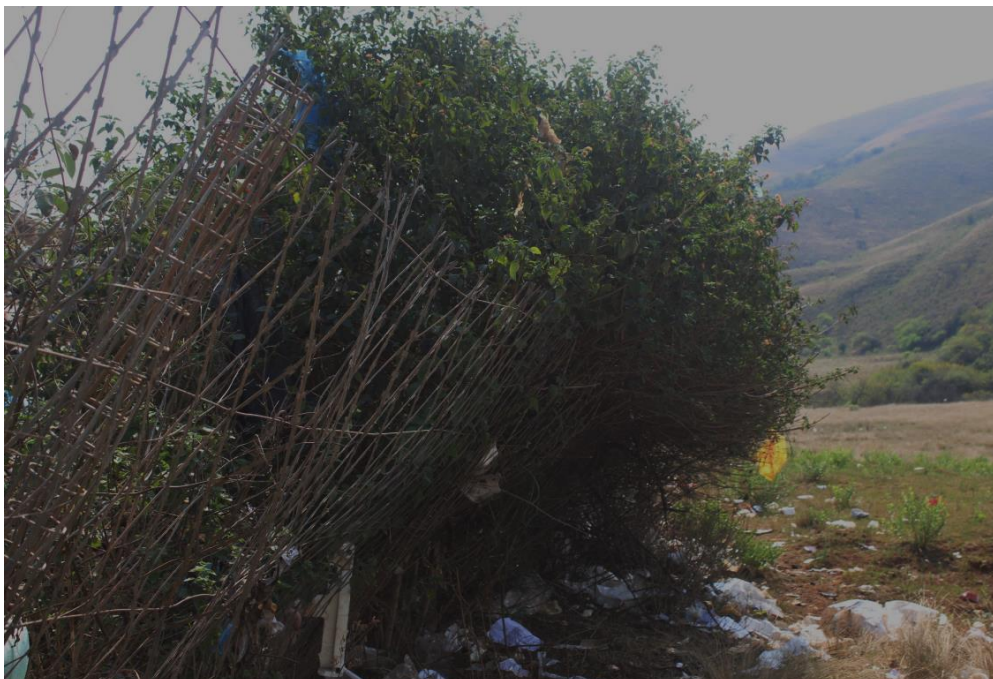
Figure 16: Slanted fence due to the weight of the waste body pushing against shrubs to the fence

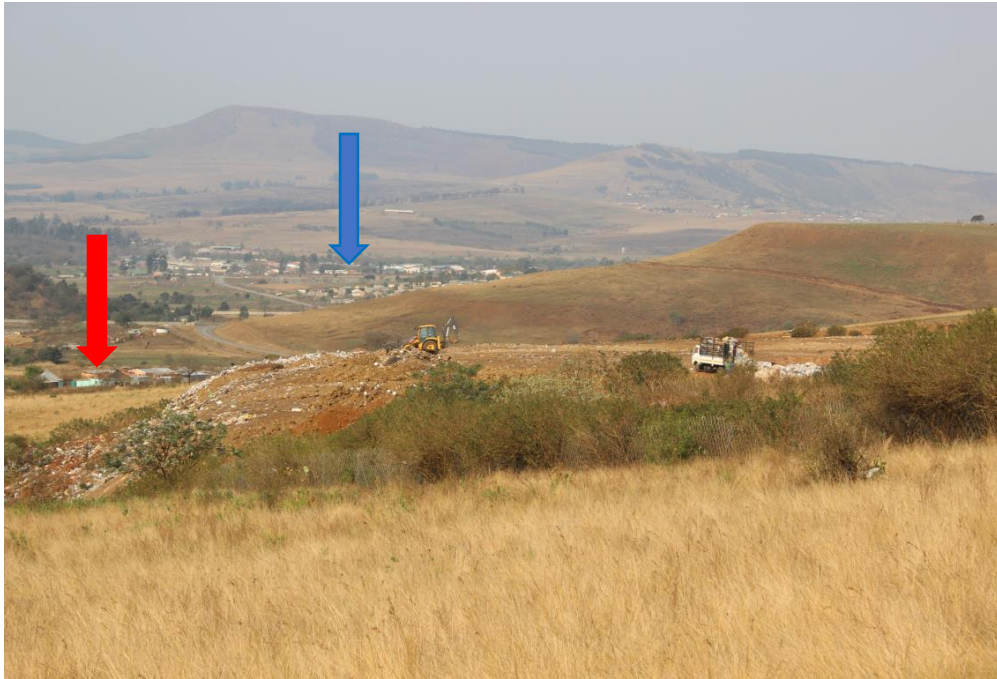
Figure 17: View towards the east towards showing the landfill in the foreground, Mankofu Village in the middle (red arrow) and uMzimkhulu CBD in the background (blue arrow)
