# Report on Geotechnical and Geohydrological Investigations for the Proposed Decommissioning (Closure) of a Waste Landfill at Utrecht, eMadlangeni Local Municipality, KwaZulu-Natal Province

16 November 2017

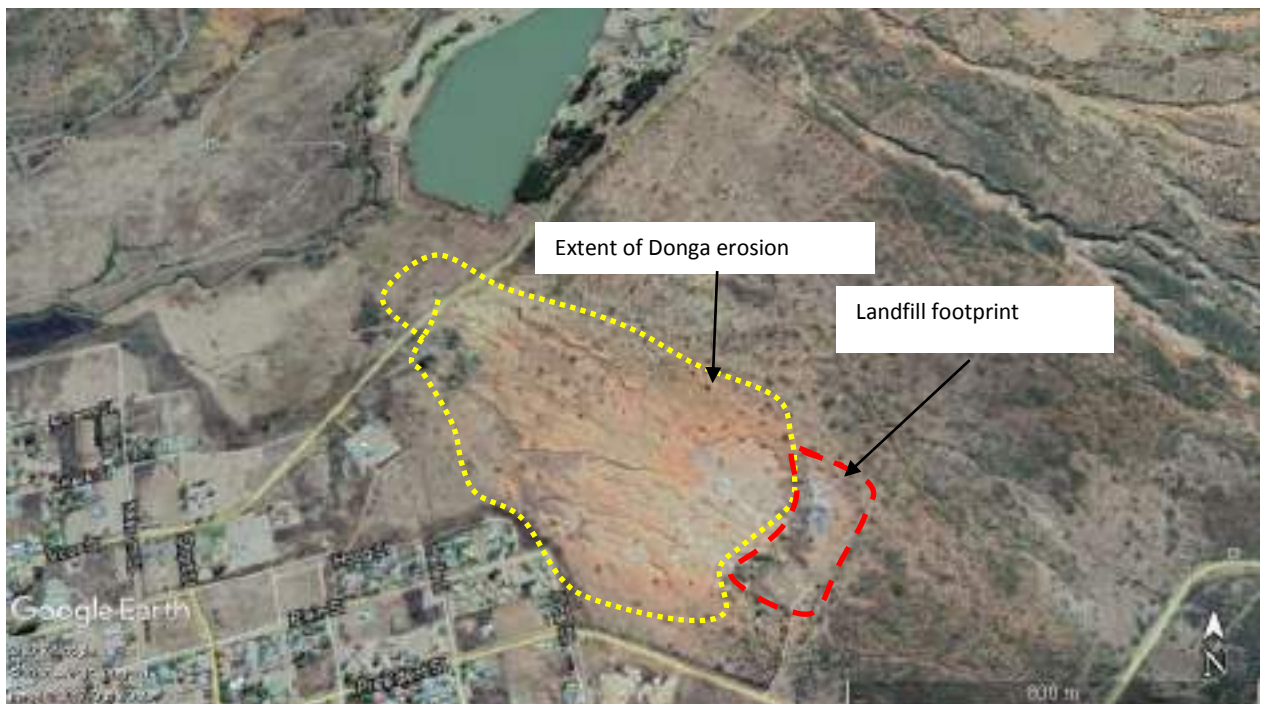
A hallmark of the local topography in the vicinity of the landfill is active serious sheet erosion resulting in the formation of dongas (gulleys) where is a large bare patch of veld with a hard surface and low amounts of organic material, making plant growth virtually impossible. These dongas have formed when flowing water cuts a channel into the soil (Figure 2). Where ground falls away, a donga head forms that gradually works its way upstream, widening and deepening the donga. The water and soil run-off direction are to the NW direction via non-perennial streams/rivulets or surface drainage features, downslope towards the nearby (~1.5km) river and dam water resources.

Figure 2: Extent of donga erosion with direction of water and sediment flow in the NW direction. Location of surface water bodies in the area (river and dam).

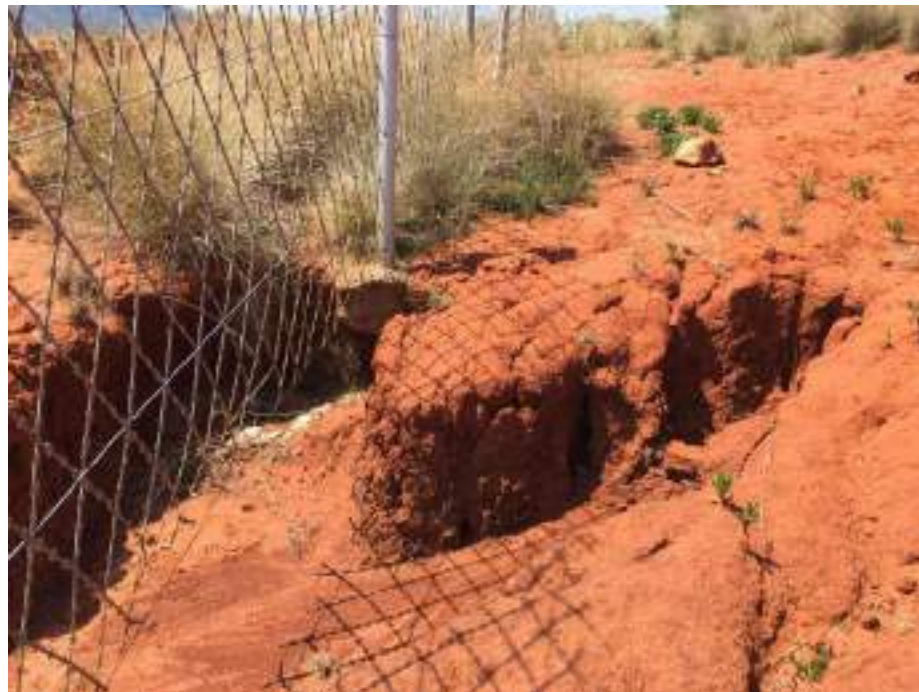
The KwaZulu-Natal Geohazards Database (Richards and Grow, 2003) currently identifies no record (Figure 7) of slope failures of whatever type within the Amajuba area. The absence of an historical record for a particular type of geohazard is a significant disadvantage to analysis and assessment. The potential for slope instability – which could be either earthquake-, rainstorm- or flood-triggered – could exist in parts of Amajuba because of the deep incision of the major rivers or stream, and local steep slopes between the flood plains and the surrounding plateau areas. Locally at Utrecht at the landfill site, the area has active donga erosion as can be seen on Figure 2 and Figure 8.

Figure 8: Active erosion of the residual soil as shown by erosion of the western boundary fence post foundation.

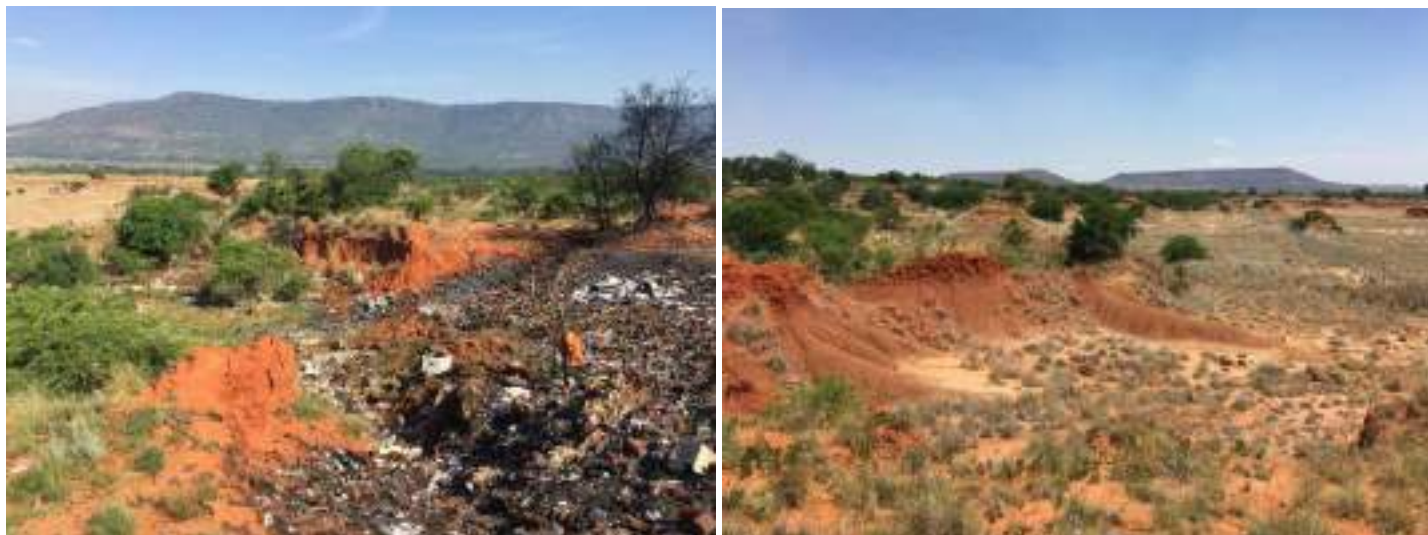
The inception date of the landfill is unknown, but it seems to be at least 10-15 years old. The topographic landscape (Figure 11) of low-lying donga compartments (in between the remaining ridges of red soil) seems to have been the natural attraction for this to have been used as a dumping site since inception. The municipality makes use of the existing dongas caused by soil erosion in the area. These are backfilled and banked to minimise storm water runoff. The use of dongas for waste disposal needs to be carefully considered. This is especially true when considering ground and surface water pollution, as runoff from the donga contaminated with leachate could be a source of pollution.

Figure 11: Waste material being deposited between the donga valleys (left). On the right is donga erosion exposing deeply (3-4m deep) incised and weathered in-situ soil. Donga erosion is on the southern fence boundary portion of the landfill where dumping is yet to reach.

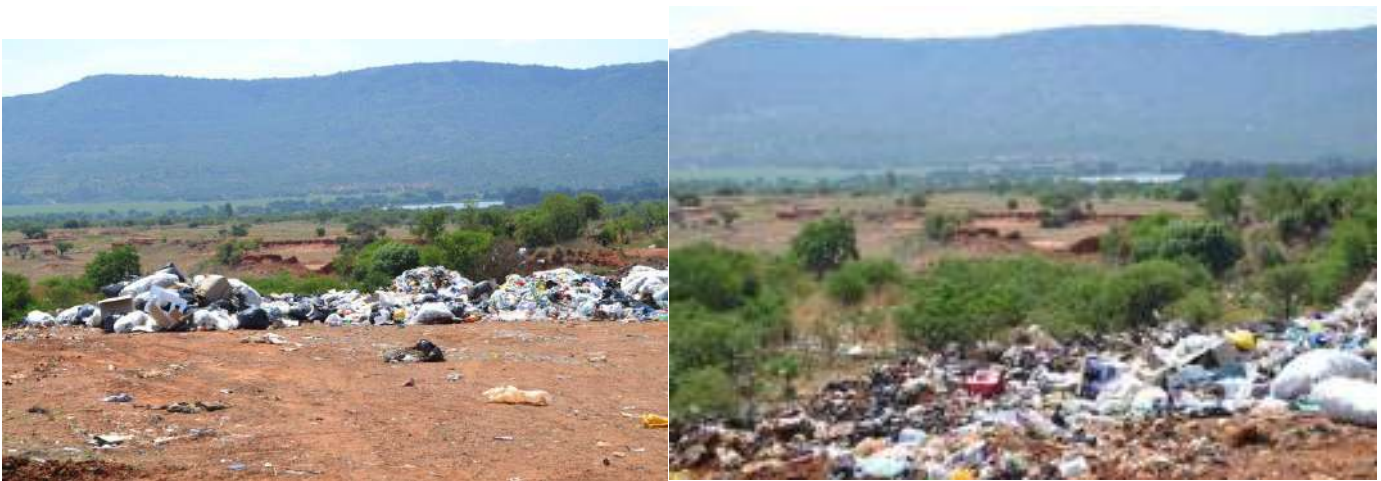
The frequency of capping (to prevent / reduce the nuisance of windblown litter and odours) is unknown. Some parts of the waste body are still exposed (see Figure 12). Vegetation (seasonal grasses and weeds) covers portions of the landfill's crest and side slopes. The current poor application of cover material has created areas with exposed waste leading to the possibility of horizontal leachate seepage or run-off downslope towards the river and dam.

Figure 12: View towards the northwest direction of surface water (and possible leachate run-off)) flow through the donga valleys and non-perennial streams. On left (foreground) is evidence of waste cover with top soil, while on right is uncompact and uncovered waste next to a vegetated section of the landfill yet to be dumped.

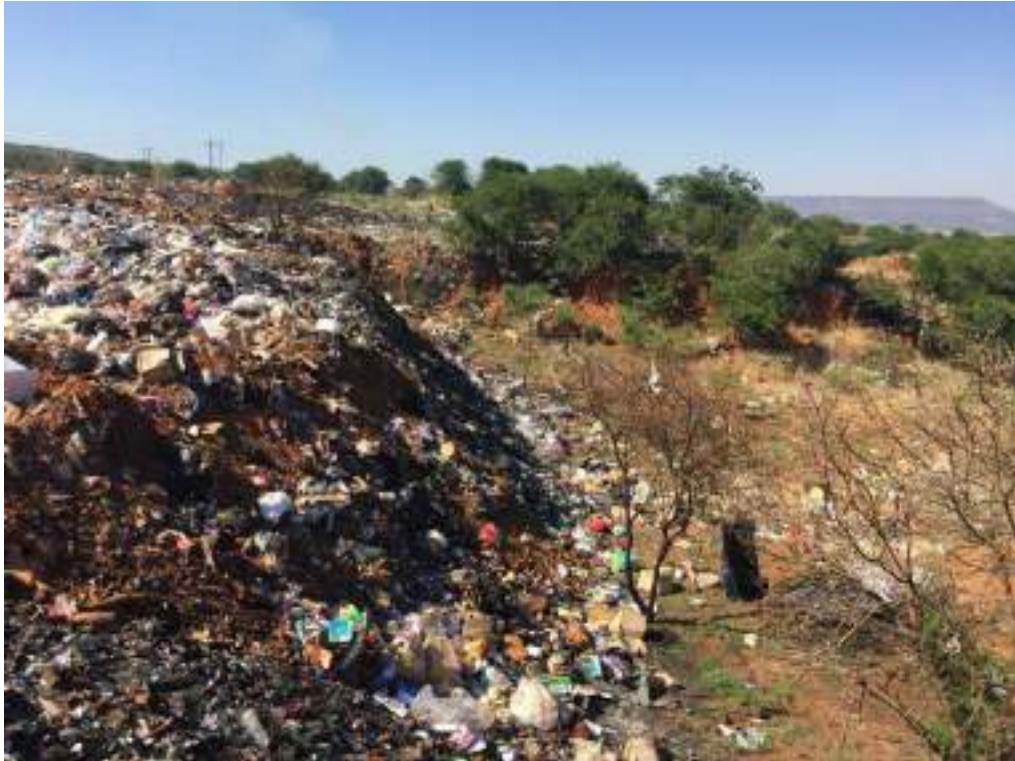
From the site walkover and investigations, the side slopes of the landfill currently appear stable even though not covered (Figure 14). No other warning signs of local or larger scale slope failures such as tension cracks or bulging of slope faces were observed at the site. No notable erosion channels were observed on the landfill itself other than as reflected on the western portion of the landfill where waste filling has not occurred yet. There is general absence of vegetation as part of rehabilitation on the vertical slopes other than overgrown alien vegetation in some places. In the unlikely event that the waste body is deeply saturated, the risk of internal slope failure may present itself.

Figure 14: An example of waste side slope which has not been capped nor rehabilitated by vegetation.

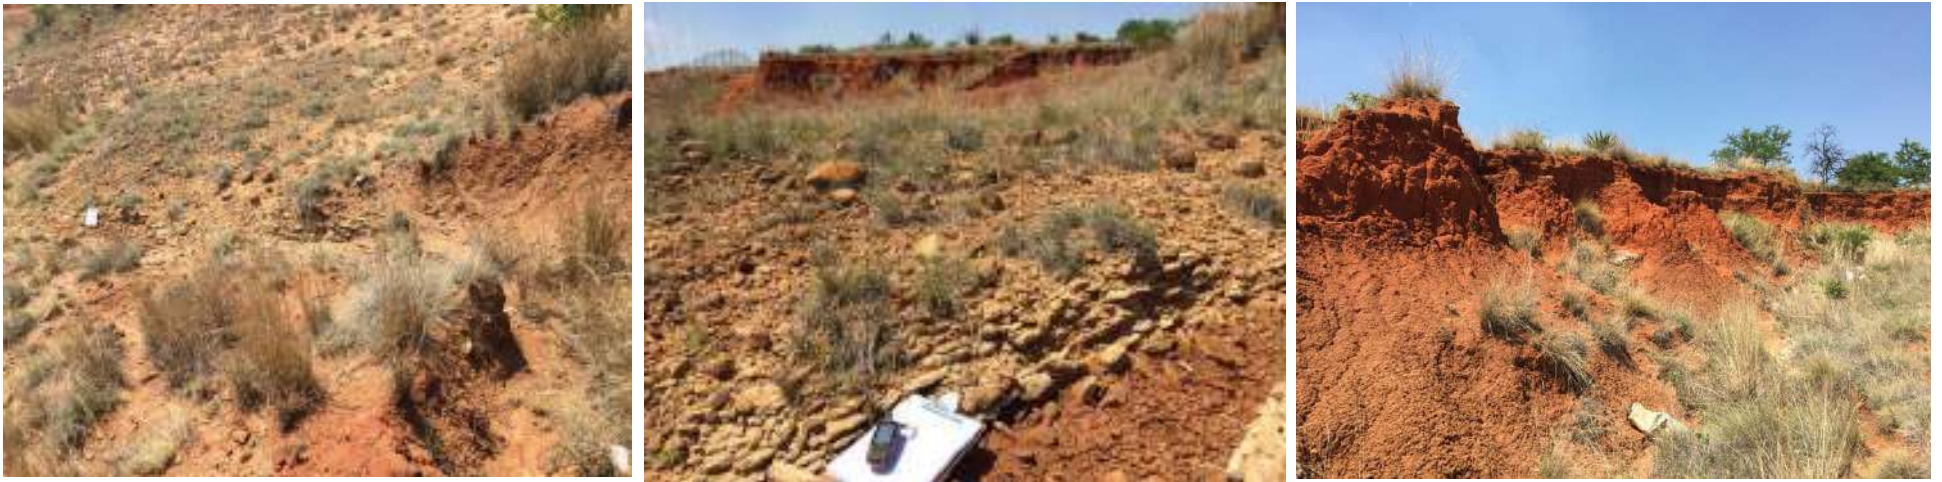
Figure 18: Left and middle - Sandstone exposure along which rivulets or water erosion channels (flowing to the south) have developed. Right - Donga weathering profile showing red residual soil from natural ground level to approximately 3-4m below surface.

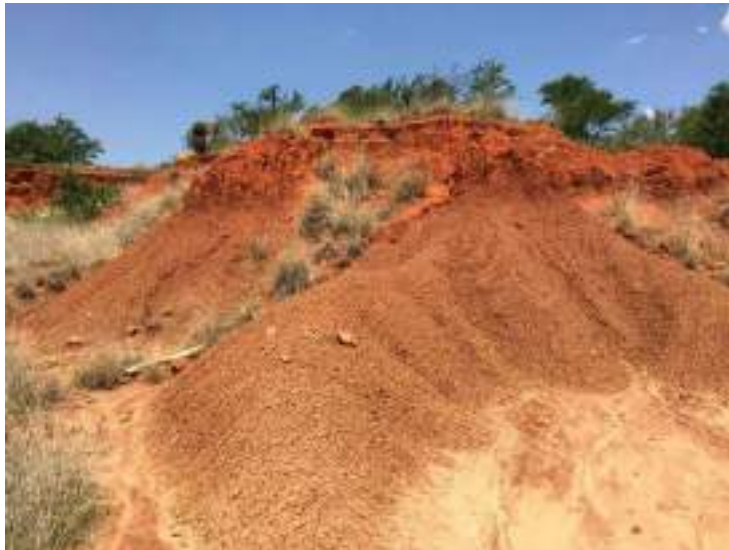
Figure 26: Example of exposed residual soil profile, showing depth extent below surface.

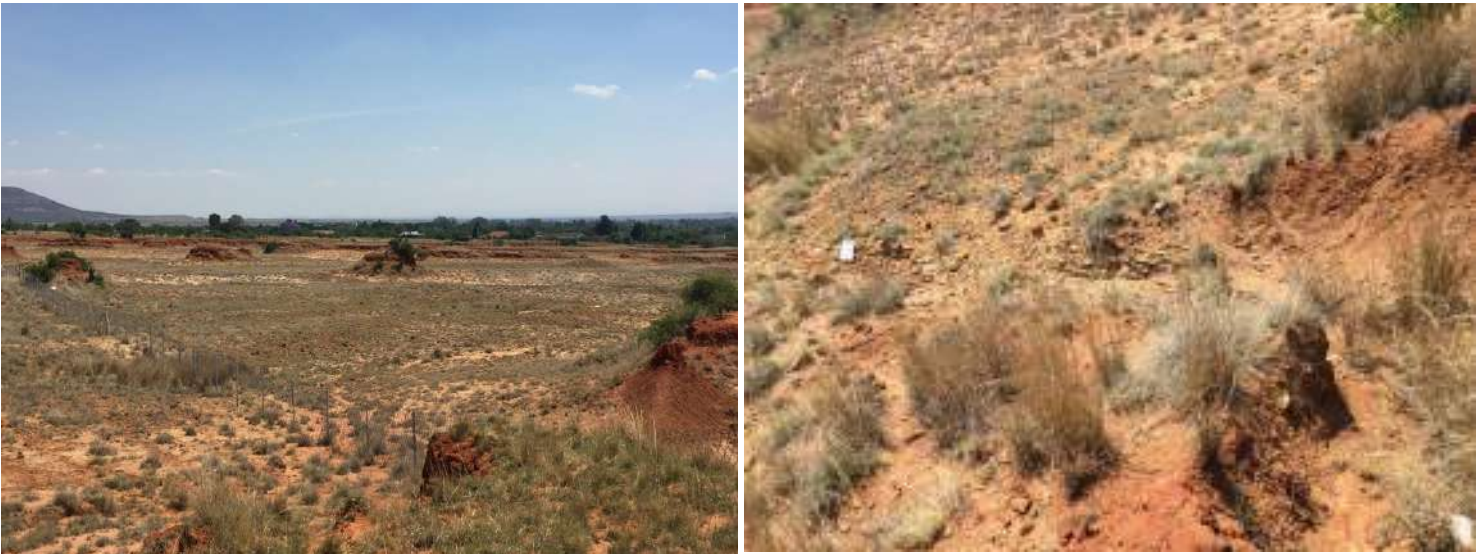
Hydrologically, and considering the dry nature of the area, there are no perennial drainage systems at or in the immediate vicinity of the site. There is no evidence of ponding water bodies on the landfill waste body as well as to the west of the fence boundary. There is also no evidence of any present monitoring (for potential pollution) of the dam and river water resources due to the landfill located up slope.

Figure 27: Sheet erosion valley created by donga erosion looking west of the boundary fence (left). Waterflow channels cutting through in-situ exposed sandstones (right).
