### **WETLAND STATUS QUO REPORT**

# Alluvial Fan Status Quo Report

Baviaanskloof

6/22/2015

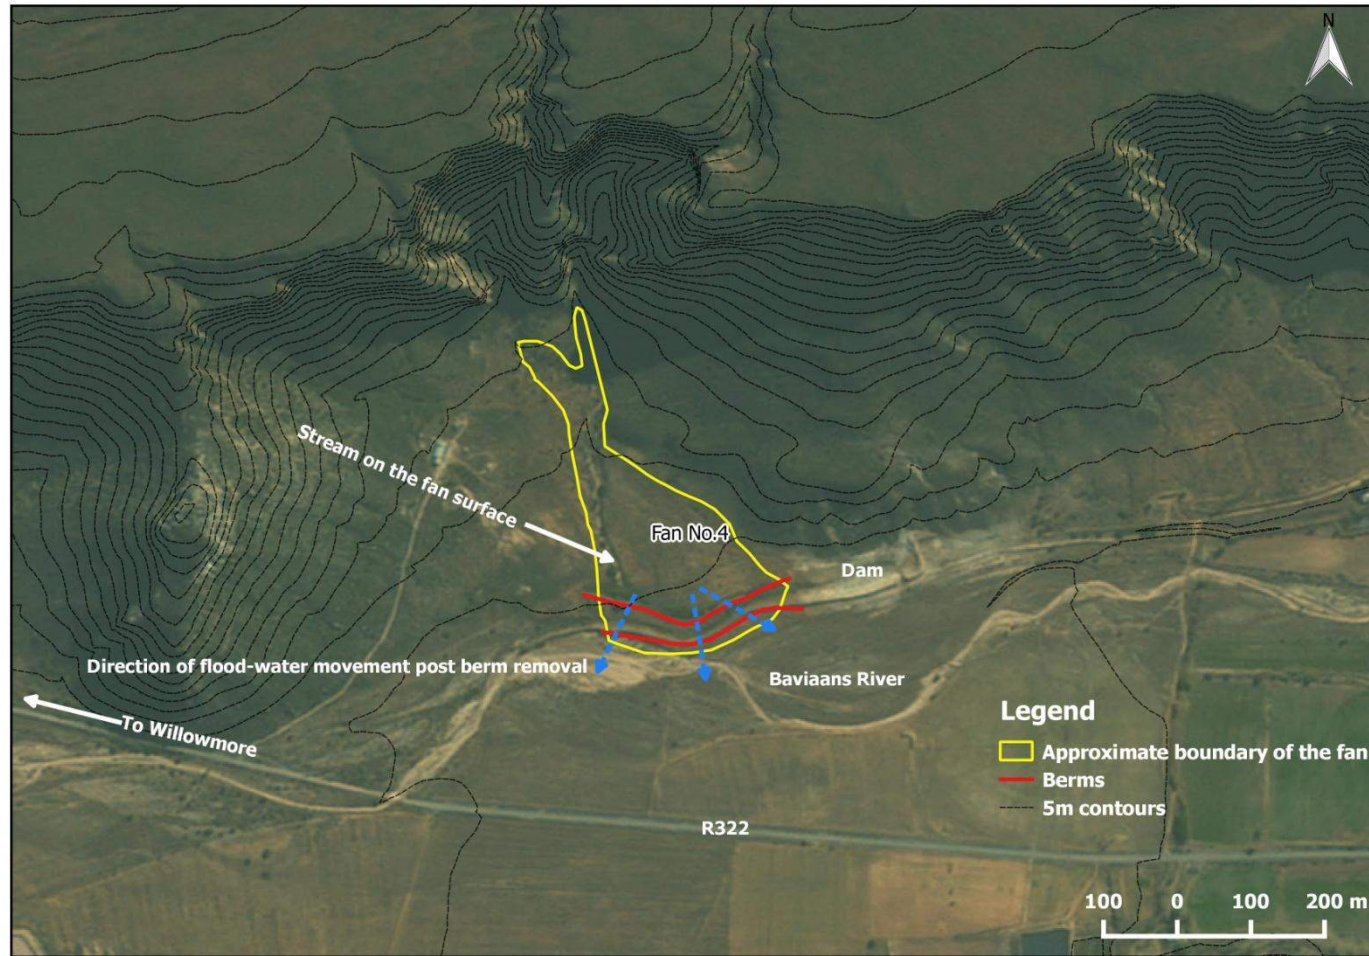
Figure 1 Fan No.4 (L81A-01) overview and impacts

<p>Looking upstream along the ditributary stream on the fan surface</p>
<b>Key impacts</b>	The distal portion of the fan at its junction with the Baviaans River, has been altered. A cut-off berm has been constructed that run along the toe of the fan. Surface flows from the fan are captured by a cut-off berm at its base and the water is lead into an off channel dam (now defunct).

<p>Looking downstream off the fan surface towards the cut-off berm (foreground) and Baviaans River (background) - L81A-01-201-00</p>	<p>Looking downstream along the cut-off berm towards the off-channel dam</p>
<p><b>Intervention points and rationale</b></p>	<p>L81A-01-201-00 Earth works – Removal of segments of the berms visible in Figure 1 to allow for floodwater and sediment to pass into the Baviaans River</p> <p>The berms have disconnected the alluvial fan from the downstream river. The removal or deactivation of the berm will allow sediment and water to reach the river as what would have occurred naturally.</p>	
<p><b>Rehabilitation objectives</b></p>	<p>Reconnect the fan, hydrologically and geomorphically, with the Baviaans River.</p>	
<p><b>Expected outcomes</b></p>	<p>The removal of the berm will allow for the movement of water and sediment from the fan into the Baviaans River.</p>

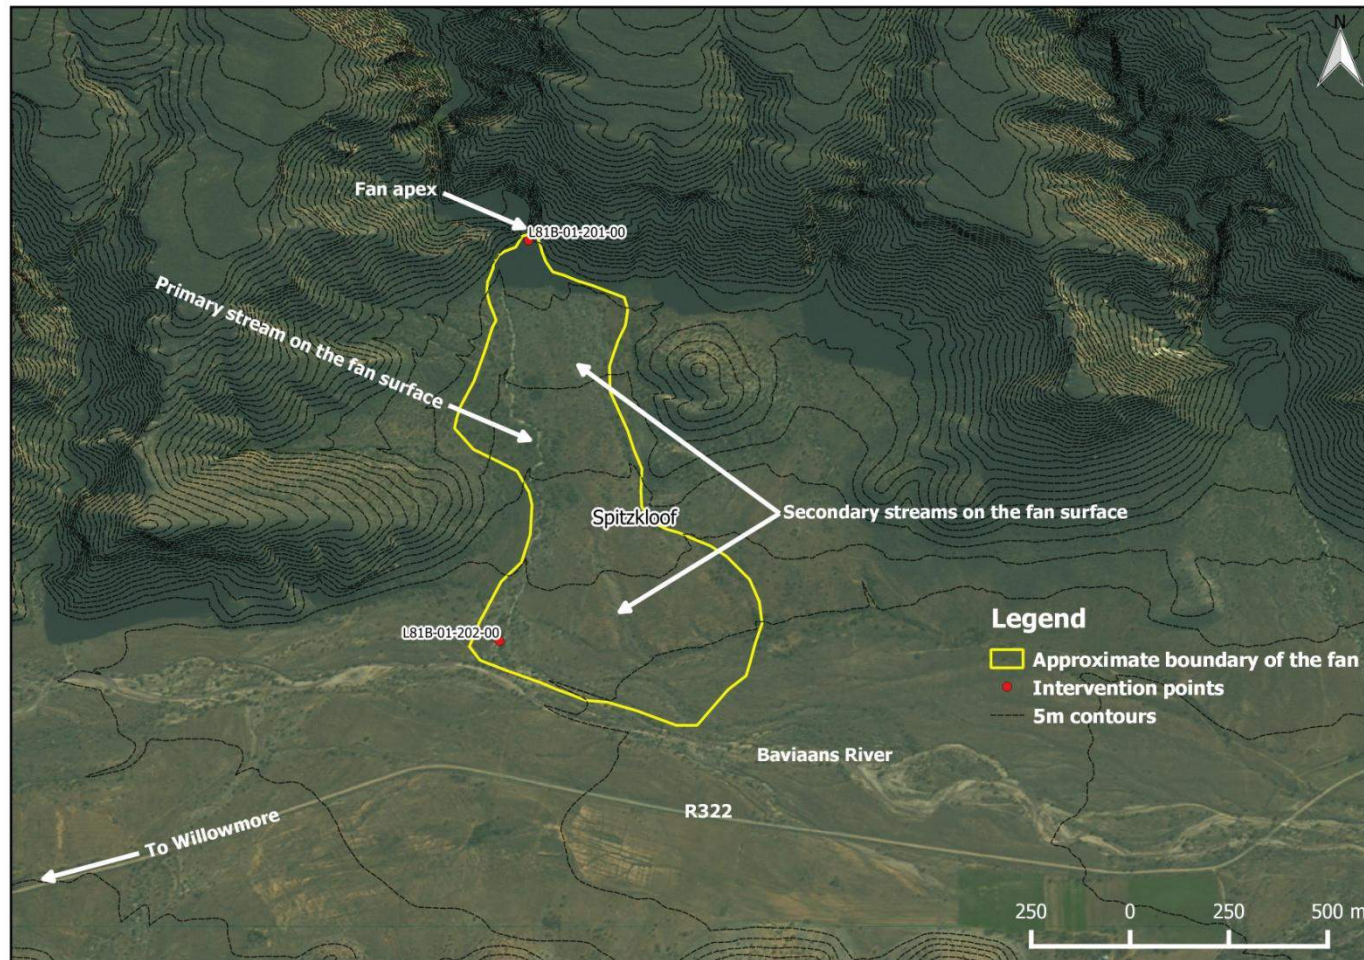
Figure 2 Spitzkloof (L81B-01) overview and impacts

The fan surface and primary stream at the apex of the fan	The primary stream atnd fan surface at the distal end of the fan
<b>Key impacts</b>	<p>The key impacts of the fan:</p> <ul style="list-style-type: none"> <li>• Incision of the trunk stream (Baviaans River) has led to the lowering of the fan base and the incision of the fan along the primary stream.</li> </ul>

<ul style="list-style-type: none"> <li>• The incision of the stream has been aggravated by channel confinement caused by a berm constructed along the edge of the stream channel in the distal section of the fan.</li> <li>• Cultivation of the fan adjacent to the above-mentioned berms.</li> </ul>
<p><b>Photos of impacts</b></p>

<p>The berm that constrains the stream channel along the distal section of the fan. The berm protects now abandoned, cultivated lands on the adjacent fan surface (at intervention point 'L81B-02-201-00)</p>	
<p><b>Intervention points and rationale</b></p>	<p>L81B-01-201-00 – Split the surface flows at the apex of the fan into two channels: the current primary stream channel and a historic channel. The reduction of flows into the primary channel will reduce the stream capacity to carry sediment and thus stop further degradation and encourage aggradation of the channel.</p> <p>L81B-02-201-00 – Remove the berm from the bank of the primary channel. The removal of the berm should allow for the more frequent flooding of the lower part of the fan</p>

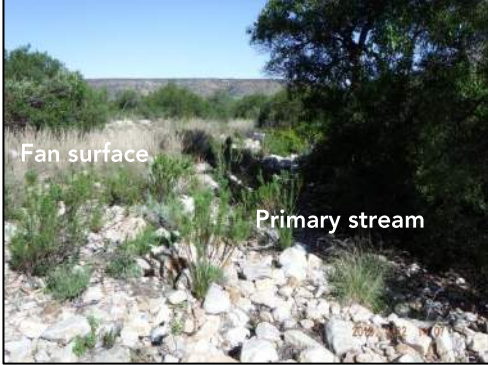
<p>The incised primary channel near the apex of the fan at intervention point L81B-01-201-00.</p>

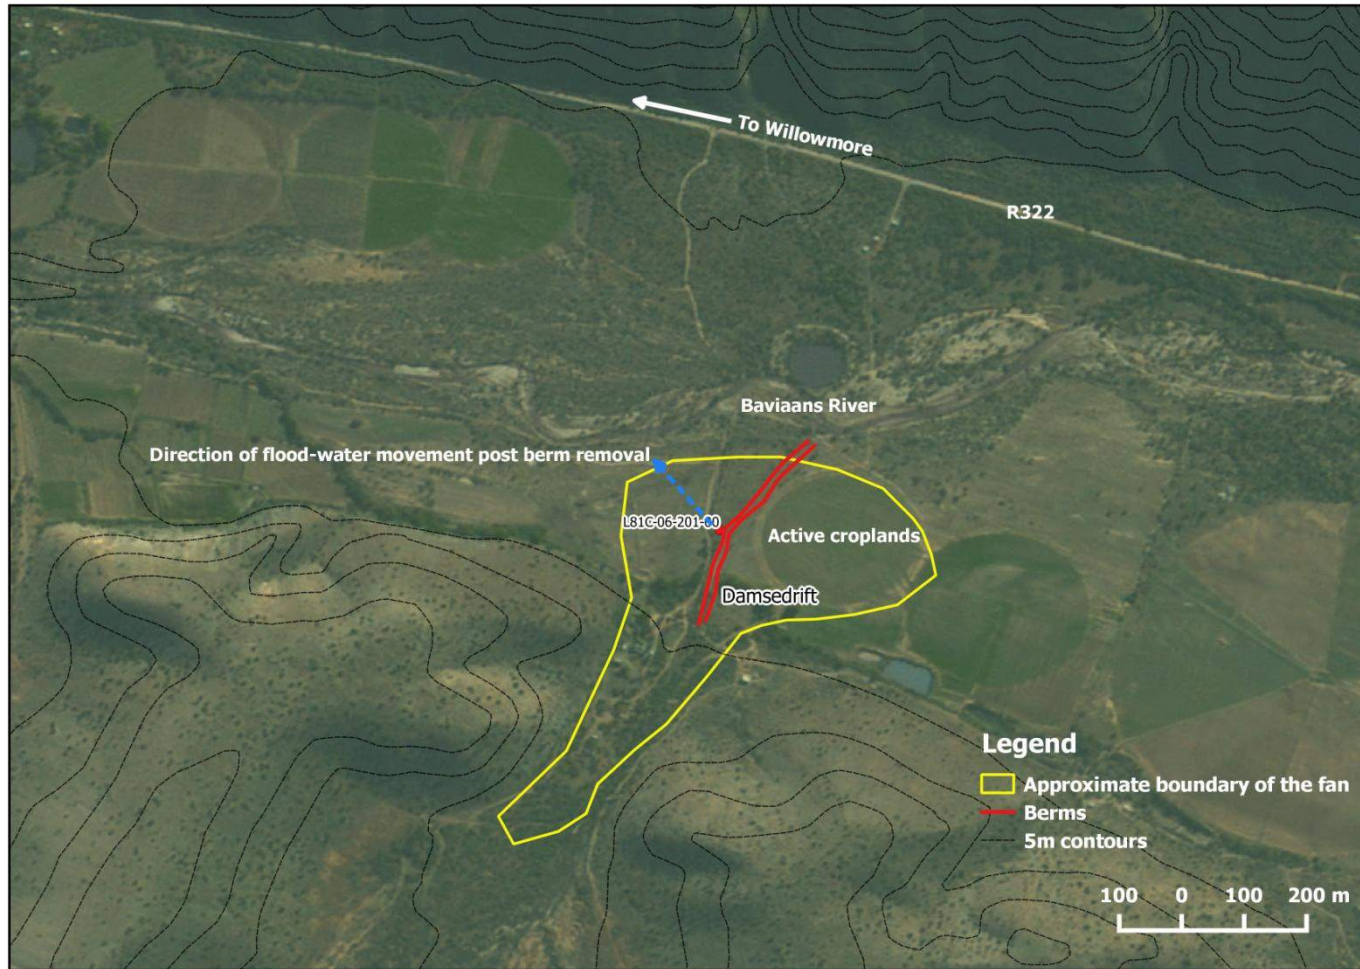
Figure 3 Dam Se Drift (L81C-06) overview and impacts

The primary stream on the fan surface near the fan apex.	The distal section of the fan impacted by berms
<b>Key impacts</b>	The key impacts on the fan:

<ul style="list-style-type: none"> <li>• The stream that flows over the fan has been canalized by the construction of berm on both of its banks.</li> <li>• The berms stop flooding in adjacent cultivated lands.</li> <li>• The fan has and is being used for cultivation.</li> </ul>	
<p><b>Photos of impacts</b></p>

<p>The berms that were constructed to constrain the primary stream on the fan surface to prevent flooding of adjacent cultivated lands at intervention point L81C-06-201-00</p>
<p><b>Intervention points and rationale</b></p>	<p>L81C-06-201-00 – Removal of a section of the left-hand bank berm (looking downstream). The removal of portion of the berm will encourage the flooding of the left-hand (north-western) portion of the fan where the cultivation has been abandoned.</p>	
<p><b>Rehabilitation objectives</b></p>	<p>Reinstate the hydrological and geomorphic processes of the left-hand (north-western) portion of the fan where the cultivation has been abandoned</p>

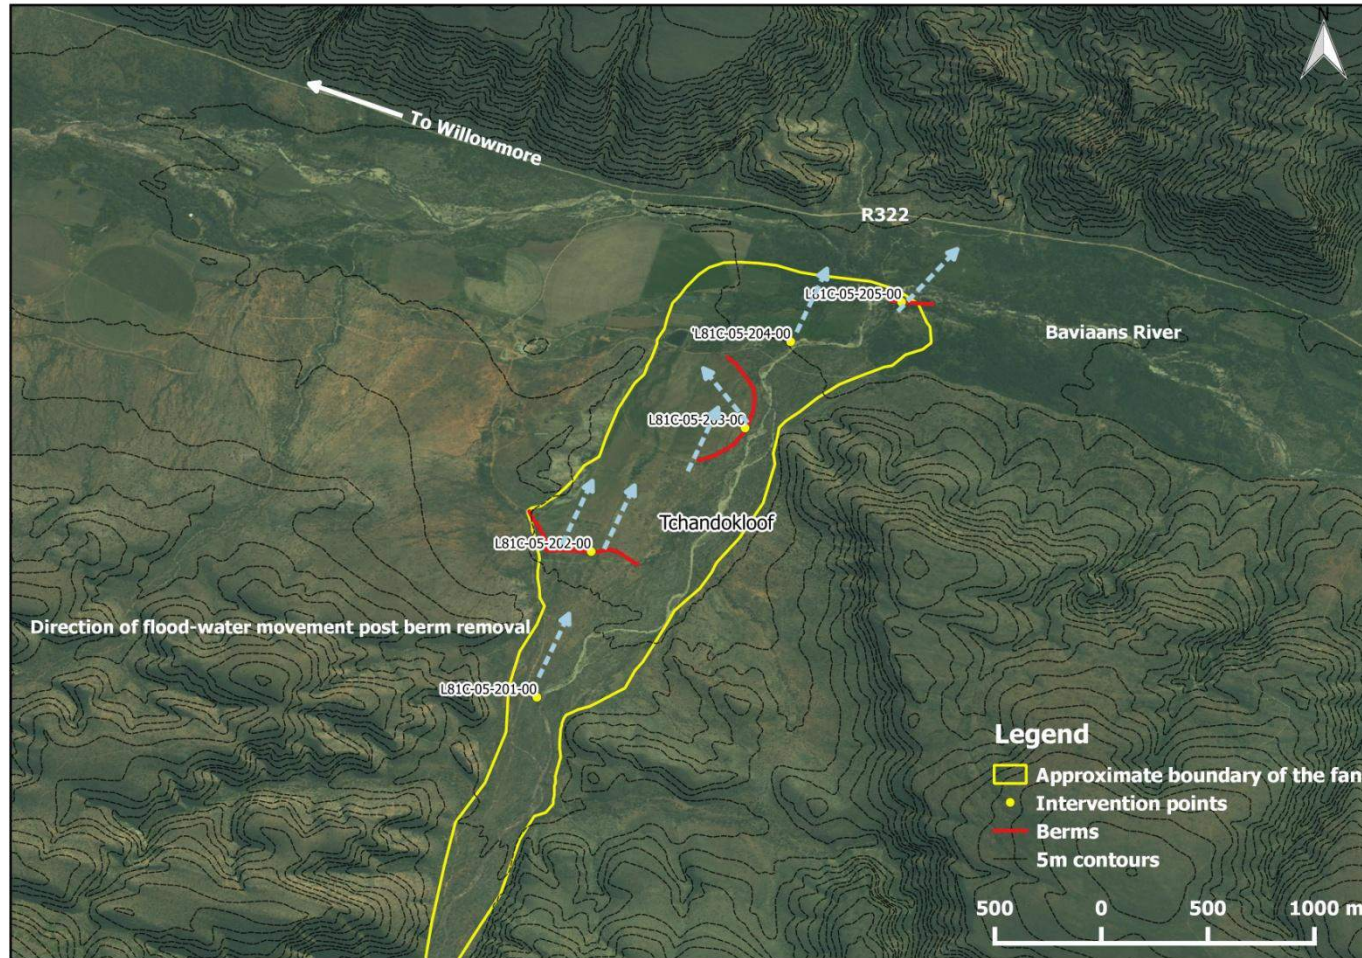
Figure 4 Tchandokloof (L81C-06) overview and impacts

The channel on the proximal reach of the fan near the apex.	The channel on the distal reach of the fan.
<b>Key impacts</b>	<p>The key impacts of the fan:</p> <ul style="list-style-type: none"> <li>• Incision of the trunk stream (Baviaans River) has led to the lowering of the fan base and the incision of the fan along the primary stream.</li> <li>• The incision of the stream has been aggravated by channel confinement caused by berms constructed along the edge of the stream channel in the medial, distal sections of the fan.</li> <li>• Cultivation of the fan adjacent to the above mentioned berms.</li> </ul>

<p>Berm that excludes flooding across the fan at intervention point L81C-05-204-00. See Figure 4.</p>	
<p>Intervention points and rationale</p>	<p><b>L81C-05-201-00</b> – Removal of a berm to allow for natural flooding patterns of the surface of the fan. By allowing for flood waters to escape the channel high up in the fan, it is expected that the ability of the stream to carry its sediment load will be reduced and the stream bed will aggrade along its length. The reduction in the depth of the stream will promote further flooding of the fan surface.</p> <p><b>L81C-05-202-00</b> - Removal of a berm to allow for natural flooding patterns of the surface of the fan.</p> <p><b>L81C-05-203-00</b> - Removal of a berm to allow for natural flooding patterns of the surface of the fan.</p> <p><b>L81C-05-204-00</b> - Removal of a berm to allow for natural flooding patterns of the surface of the fan. This intervention point will also facilitate channel aggradation as described for intervention point L81C-05-201-00.</p> <p><b>L81C-05-205-00</b> - Removal of a berm to allow for natural flooding patterns of the surface of the fan.</p>

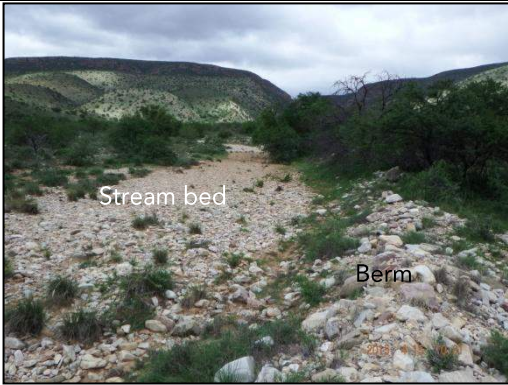
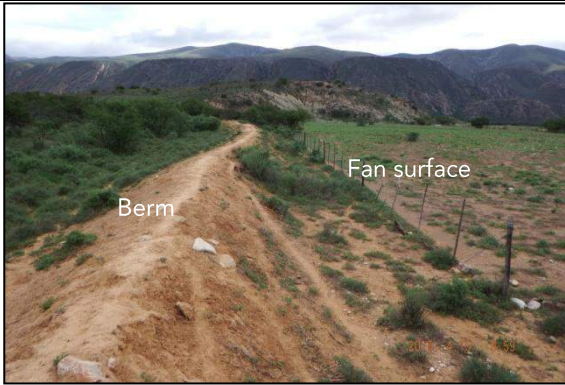
<p>Berm Fan surface</p>
	<p>A berm constraining the primary stream at intervention point L81C-05-201-00. See Figure 4.</p>	<p>Berm that excludes flooding across the fan at intervention point L81C-05-202-00. See Figure 4.</p>

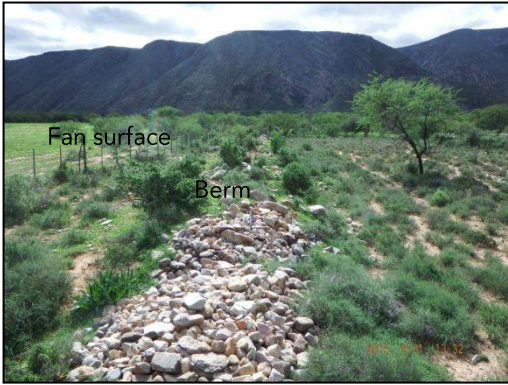
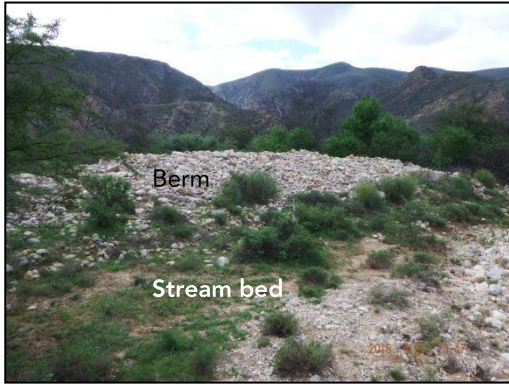
<p>Berm Stream bed</p>
	<p>A berm constraining the primary stream at intervention point L81C-05-203-00. See Figure 4.</p>	<p>A berm constraining the primary stream at intervention point L81C-05-204-00. See Figure 4.</p>

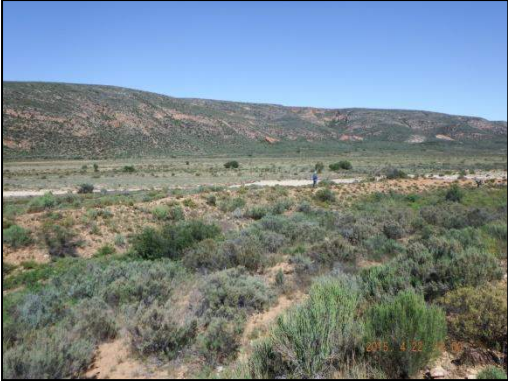
Fan	Location (D°M'S")	Description	Photo
Fan 4	33°31'06.410" S 23°43'09.880" E	A berm at the toe of Fan 4. The berm must be removed to allow the free flow of water to the Baviaans River.

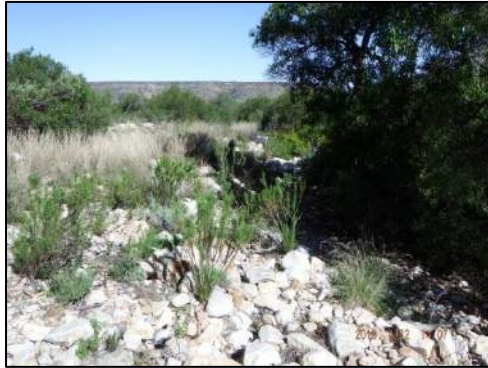
<p><b>Spitzkloof</b></p>	<p>33°30'34.860" N 23°52'33.090" E</p>	<p>The channel at the apex of the Spitzkloof Fan must be partly filled in and a "spillway" created on the left-hand bank of the stream.</p>

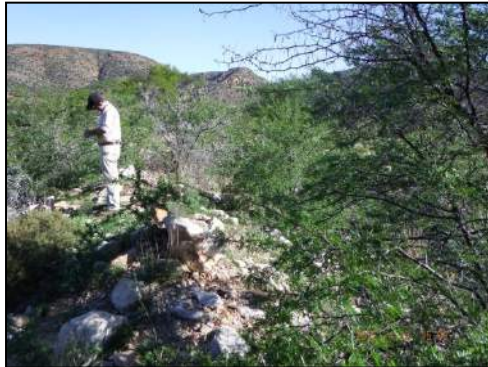
<p>33°31'14.100" N 23°52'30.230" E</p>	<p>A berm on the surface of Spitzkloof Fan that must be removed to allow water to flow over the fan.</p>

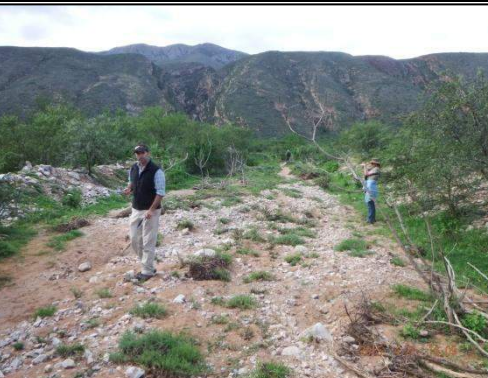
<p><b>Dam Se Drift</b></p>	<p>33°33'35.700" N 24°02'55.850" E</p>	<p>Artificial levy that constrains the stream on Dam Se Drift. Fan to be removed in part.</p>

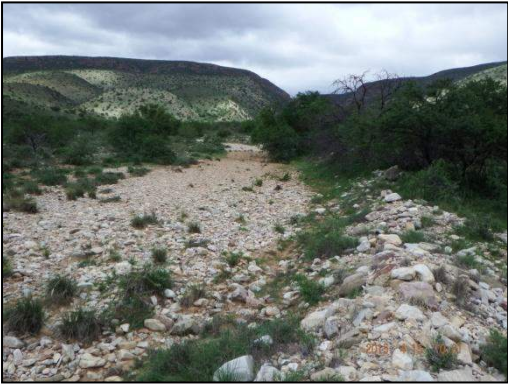
Tchandokloof	<p>33°35'46.230" N 24°06'18.410" E</p>	<p>A berm on the surface of Tchandokloof Fan that must be removed to allow water to flow over the fan.</p>

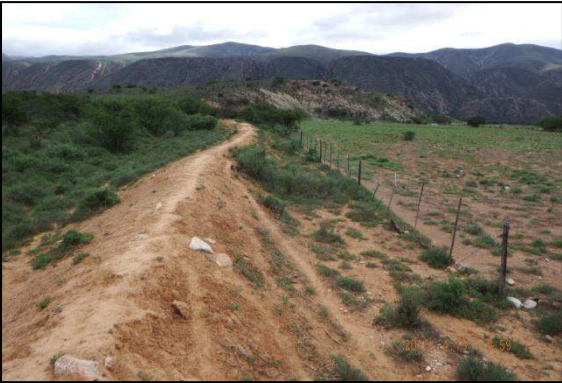
<p>33°35'21.650" N 24°06'36.360" E</p>	<p>A berm on the surface of Tchandokloof Fan that must be removed to allow water to flow over the fan.</p>

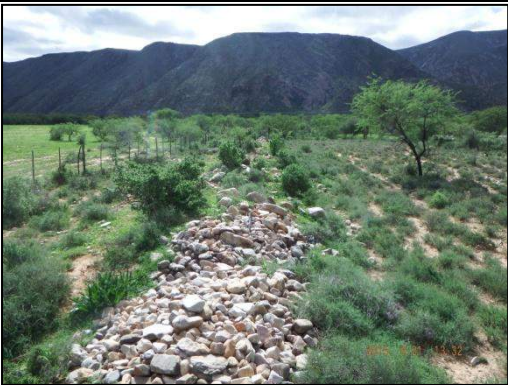
<p>33°35'02.310" S 24°06'50.730" E</p>	<p>A berm on the surface of Tchandokloof Fan that must be removed to allow water to flow over the fan.</p>

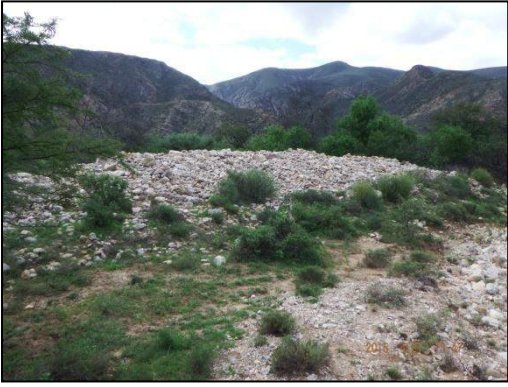
<p>33°34'41.570" N 24°07'04.640" E</p>	<p>A berm at the toe of Tchandokloof fan that must be removed.</p>

<p>33°34'34.070" N 24°07'22.840" E</p>	<p>A berm at the toe of Tchandokloof fan that must be removed.</p>
