LONMIN

Internal Audit

Final Rehabilitation of M5 Opencast Pit

12 March 2015

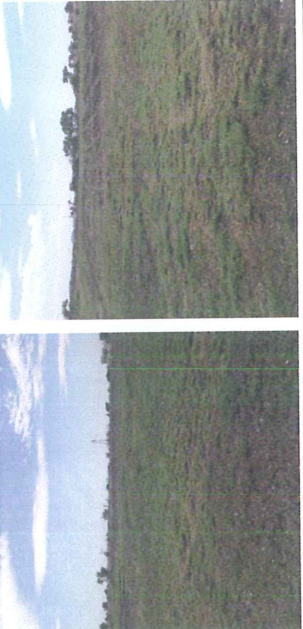
<p>Spread topsoil mounds to fill in where topsoil is insufficient</p>	<p>A large number of turf and small waste rock dumps stockpiles were dotted around the area. The majority of this was turf soils. These were removed as far as possible and relocated to areas where additional topsoil was required. The subsequent areas were adequately levelled out to ensure suitable drainage.</p> <p style="text-align: right;">Completed</p>

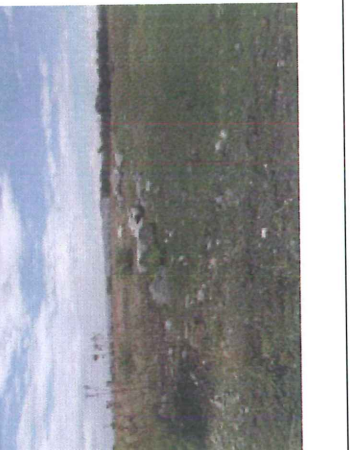
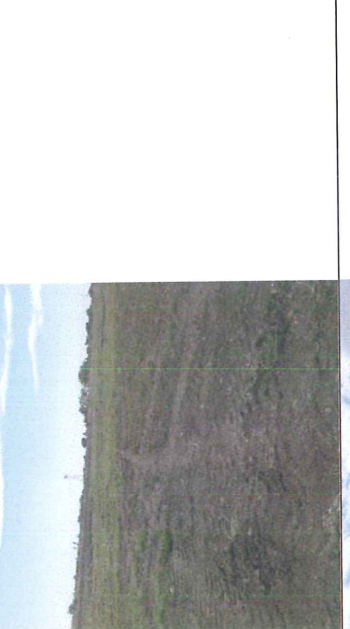
<p>Address the excess boulders left on site</p>	<p>A number of large and small boulders were exposed from the initial rehabilitation done on site. These boulders have all been removed from site and relocated to the grave area.</p> <p style="text-align: right;">Completed</p>

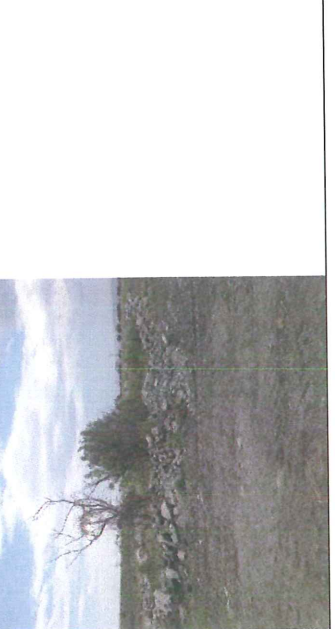
<p>Address demarcation and accessibility by animals, of graves on site</p>	<p>A grave yard is situated on the property adjacent to the pit. The area was previously access controlled and demarcated with a fence. This fence has subsequently been taken and fencing is not a sustainable solution. It was decided, and in agreement with the current lessee, that the boulders be placed around the grave yard.</p> <p style="text-align: right;">Completed</p>
