BLACK ROCK MINE OPERATIONS

NCHWANING AND GLORIA SLIMES STORAGE FACILITIES

DAM BREAK ANALYSIS

February 2020 | 278-BRM-1-RP-900-Rev 0

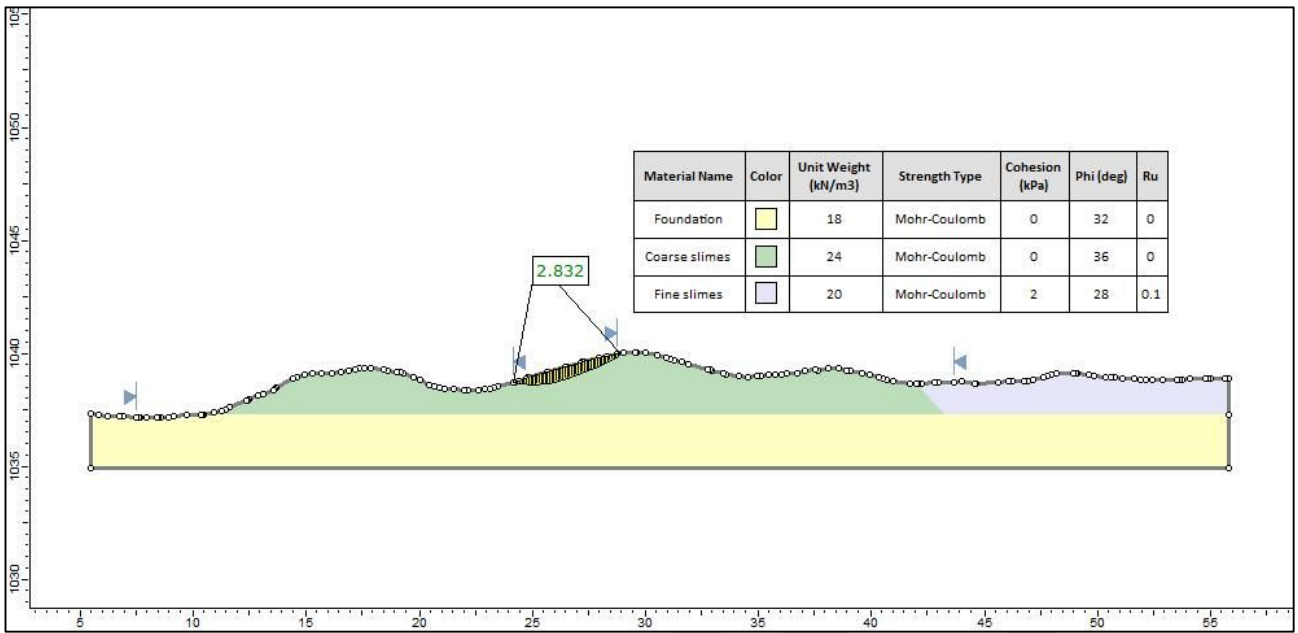
FIGURE 10: SIDE SLOPE STABILITY – GLORIA LARGE UNLINED COMPARTMENT (EAST FLANK – OPPOSITE POOL)

Slimes dam	Section	Factor of safety	Target factor of safety	Satisfactory
Gloria	Large unlined compartment (east flank – opposite pool)	2.832	1.5	Yes
Nchwaning	Compartment 1 (west flank)	1.679	1.5	Yes
	Compartment 1 (south flank)	1.380	1.5	No
	Compartment 2 (south flank)	1.589	1.5	Yes
	Compartment 2 (east flank)	1.772	1.5	Yes
	Compartment 2 (north flank)	1.294	1.5	No
	Compartment 3 (north flank)	1.796	1.5	Yes

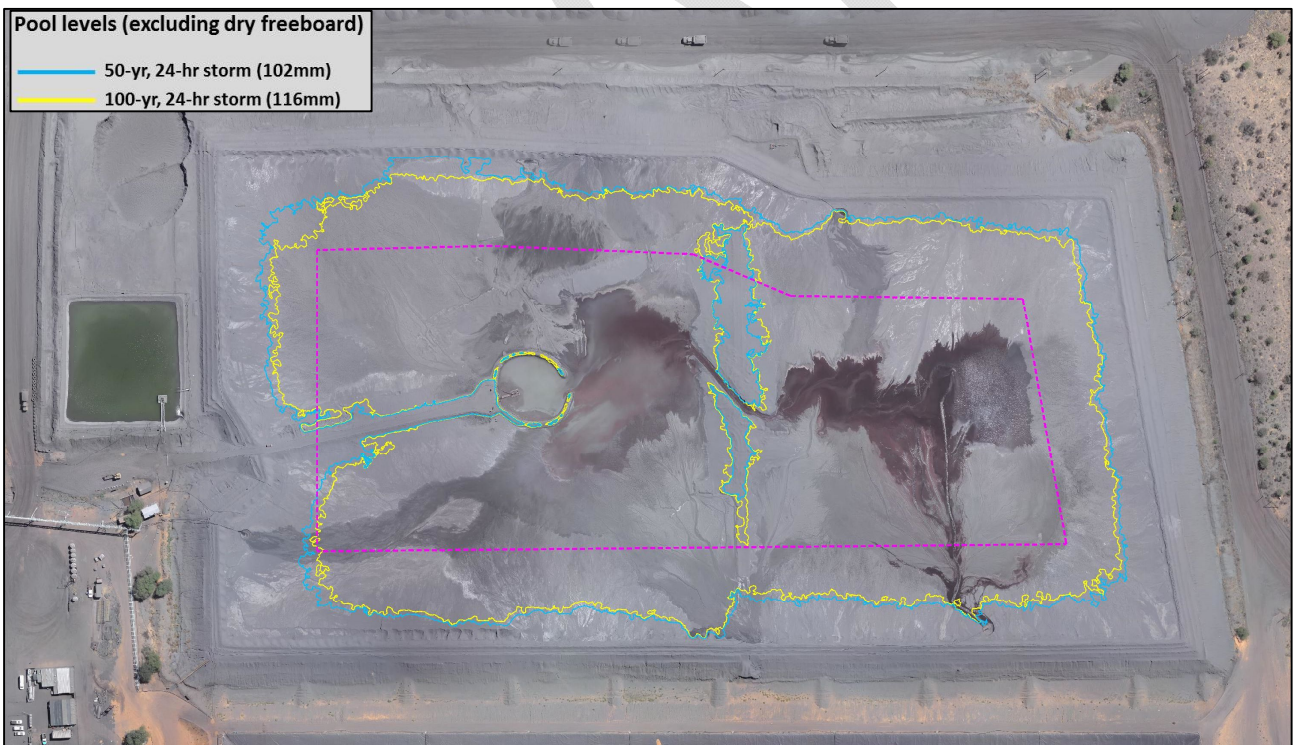
FIGURE 18: LIKELY POOL LOCATIONS AS A RESULT OF EXTREME RAINFALL EVENTS (NCHWANING)

- The existing beach freeboard in the Nchwaning slimes storage facility basin is enough to cater for storm water volumes resulting from the design storms considered.
- The pools from a storms event will extend to within the 50 m perimeter buffer zone.
- There is adequate total freeboard to ensure legal compliance.

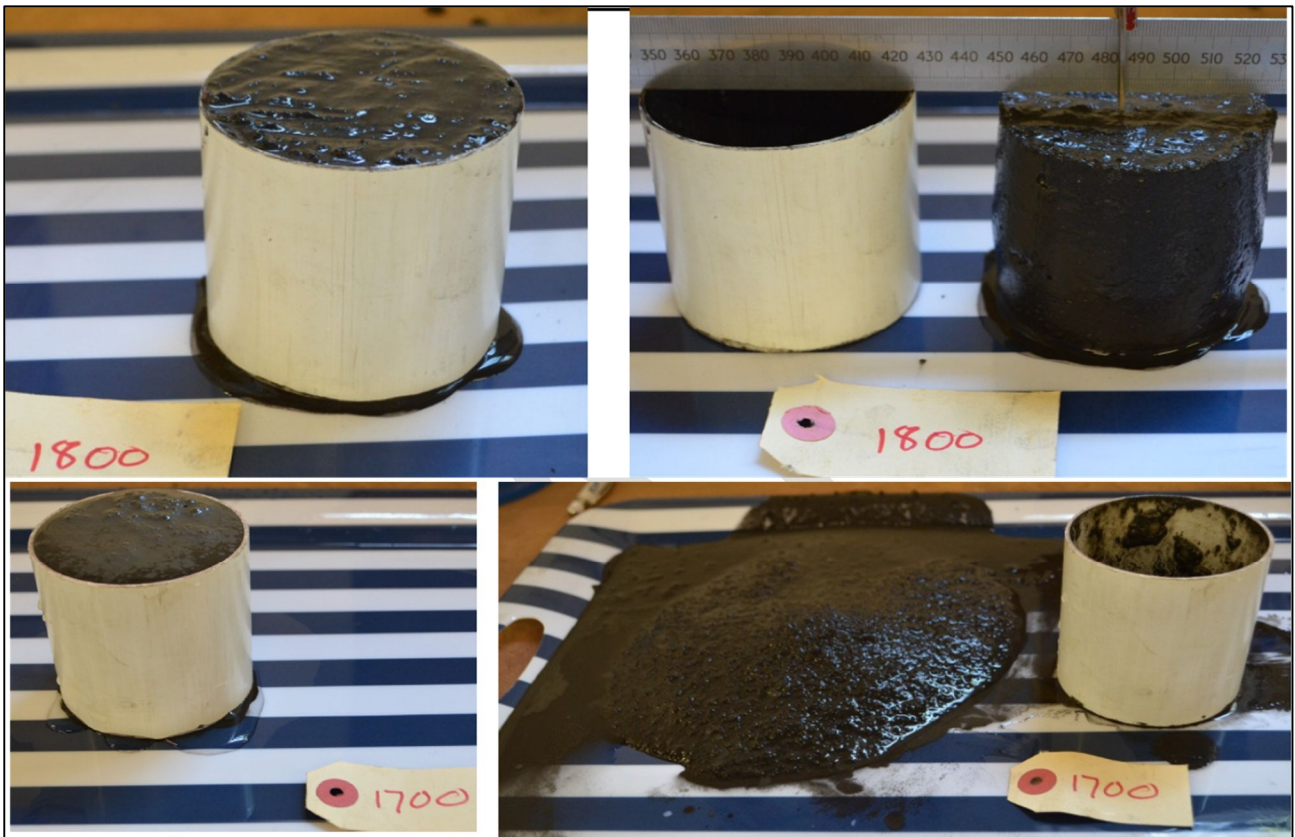
FIGURE 19: BOGER SLUMP TESTS

However it must be noted that the slip circles are located well within the coarse slimes zones where adequate consolidation is likely. The Boger slump tests have shown no or negligible

flowable characteristics at dry densities exceeding 1 800 kg/m³ and moisture contents less than 28.3%.
