SAHRA Report for the Vele Colliery Site Visit during 13 October 2021.

SAHRA REF: **9/2/240/0001**

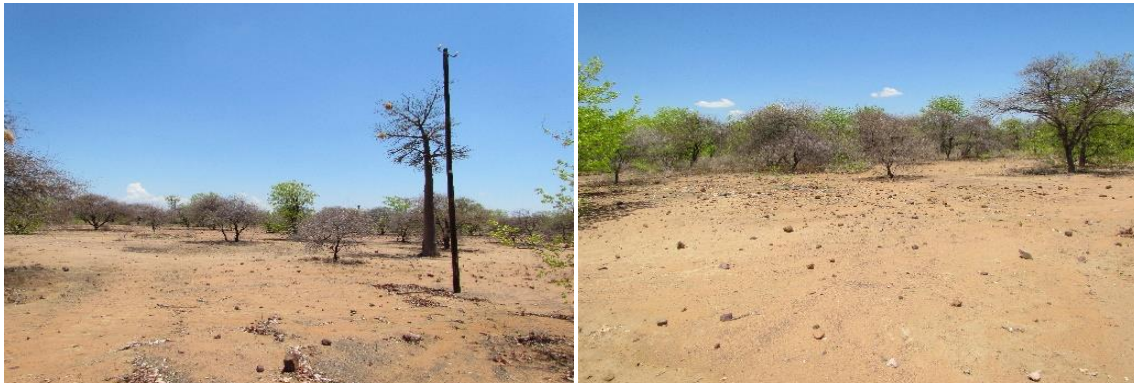
Site 1:

Site no.	Photo no.	Brief description	Significance rating	Planned mitigation as per HIA and HMP	2020 Observations	2021 Observations	SAHRA Recommendations
1	Figure 2	K2 site	Medium	Excavate (Section 35 permit)	No change in conditions from previous year. No erosion observed	There is good grass cover, no visible erosion, but there were animal burrows on site.	Section 35 permit to be applied for the planned mitigation
2	Figure 3	Salt Spring Site	High	Manage and monitor	No further erosion observed. One decorated potsherd still in same position on side of mound as of last year.	The decorated potsherd observed previously has dislodged from the mound and was obscured. It was observed at the bottom of the midden mound. The rehabilitation work on the spring has managed to make it flow and pond again.	Recommended monitoring every 3 months by the consulting archaeologist. Spot checks after heavy rainfall to be done by consulting archaeologist.

Figure 2: Site 1, telephone pole visible.

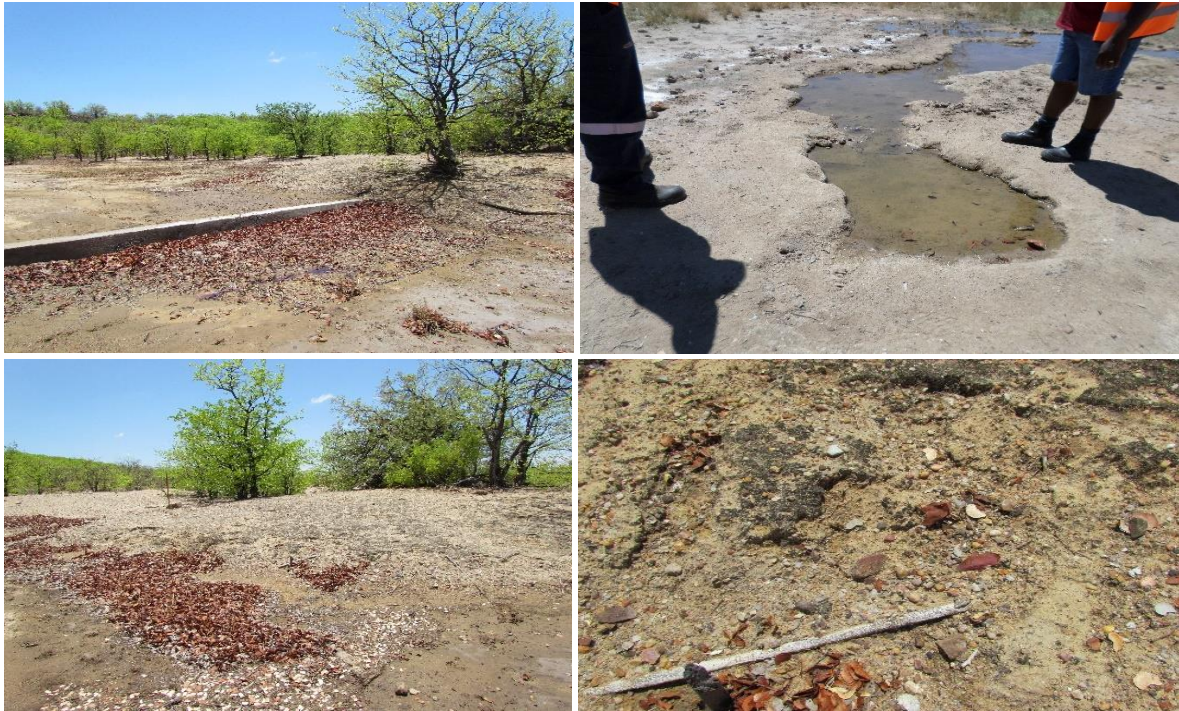
Site 2:

Figure 3: Site 2 midden and small wall visible.

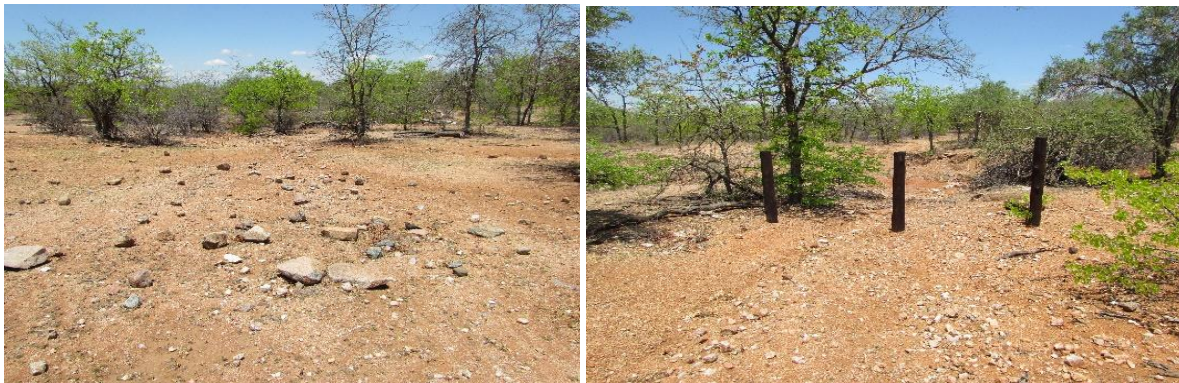
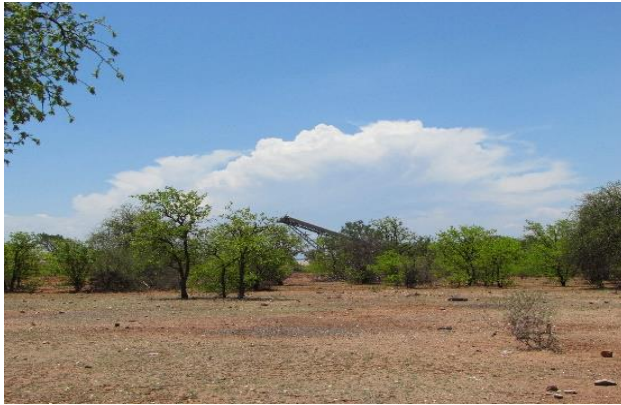
5	Figure 4	K2 site	Medium	Manage and monitor	No change from previous year No erosion observed The plant is not yet operational.	Good grass cover and no erosion observed.	Recommended monitoring every 6 months; Monitor Erosion
8	Figure 5	Historical farmhouse	Low	Manage and monitor	House within property recently sold New owner cleaning and undertaking maintenance on structure MC Mining contacting LIHRA regarding electrification and maintenance	No change from previous year. The house still has old Dutch gables.	Recommended monitoring every 6 months; LIHRA to be contacted regarding any alterations and permits. It is understood that the farmstead will be monitored by the mine as it still remains part of its environmental regulatory requirements.
12	Figure 6	K2 site near road	Medium	Manage and monitor – PVC poles	No issues observed	No change from previous year due to good grass cover.	Recommended monitoring every 6 months

Figure 4: Site 5 view of the plant area from the site, view of the blocked off old farm road and the erosion on site.

- Once the plant is operational site 5 must be monitored on a quarterly basis when the plant becomes operational.
- Once the heritage consultant is able to carry out monitoring then biennial monitoring must resume, and the report must be submitted to SAHRA as and when it is completed.
- SAHRA requests that the wooden post lying on the ground next to site 32 be installed as a preventative measure for any encroachment from road maintenance.

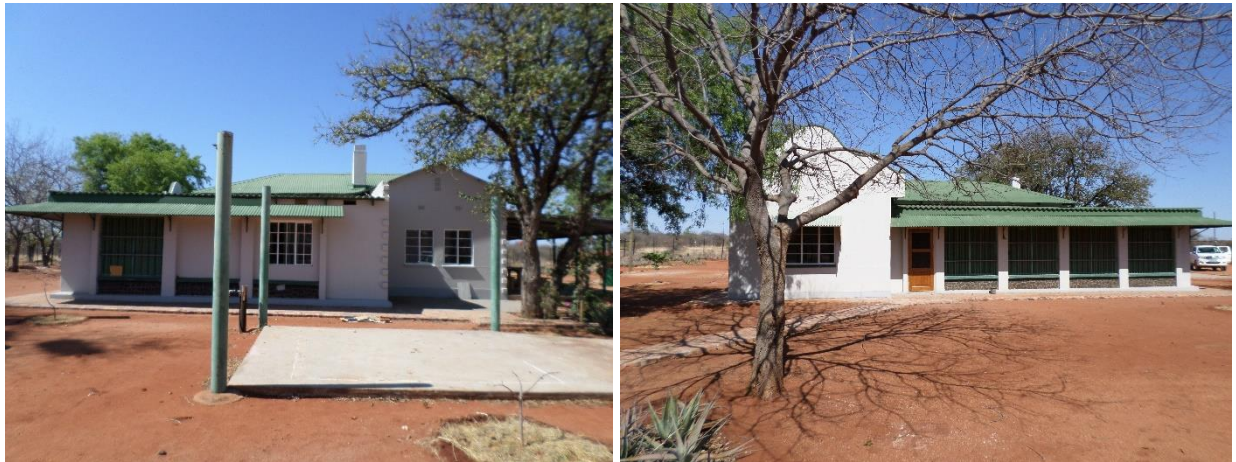
Figure 5: Site 8 view of the front and back of the old farmhouse.

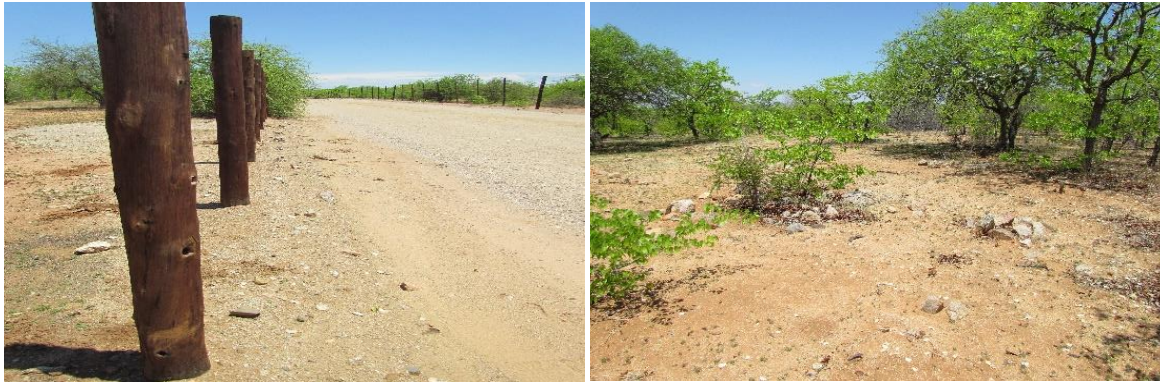
Figure 6: Site 12 view of the installed wooden poles and the grain bin stands.

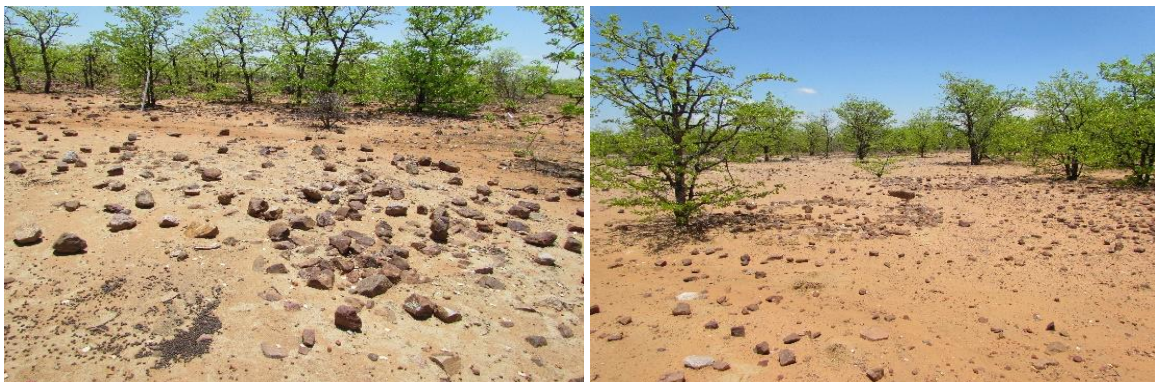
23	Figure 7	Foundations and hut floors- Birwa Site	Medium	Section 35 permitted excavation required	No issues observed	No changes from last year.	Section 35 permit to be applied for the planned mitigation
25a	Figure 8	Grain bins, pottery and slag	High	Toe berm, gabions, surface collection, recording	No issues observed	No change from previous year due to good grass cover.	A section 35 permit will be required for surface collection; Recommended to monitor every 3 months
25b	Figure 9	Grain bins, pottery and slag	High	Toe berm, gabions, surface collection, recording	No issues observed	No change from previous year due to good grass cover.	A section 35 permit will be required for surface collection; Recommended to monitor every 3 months

Figure 7: Site 23 view of the hut foundations and grain bin stands.

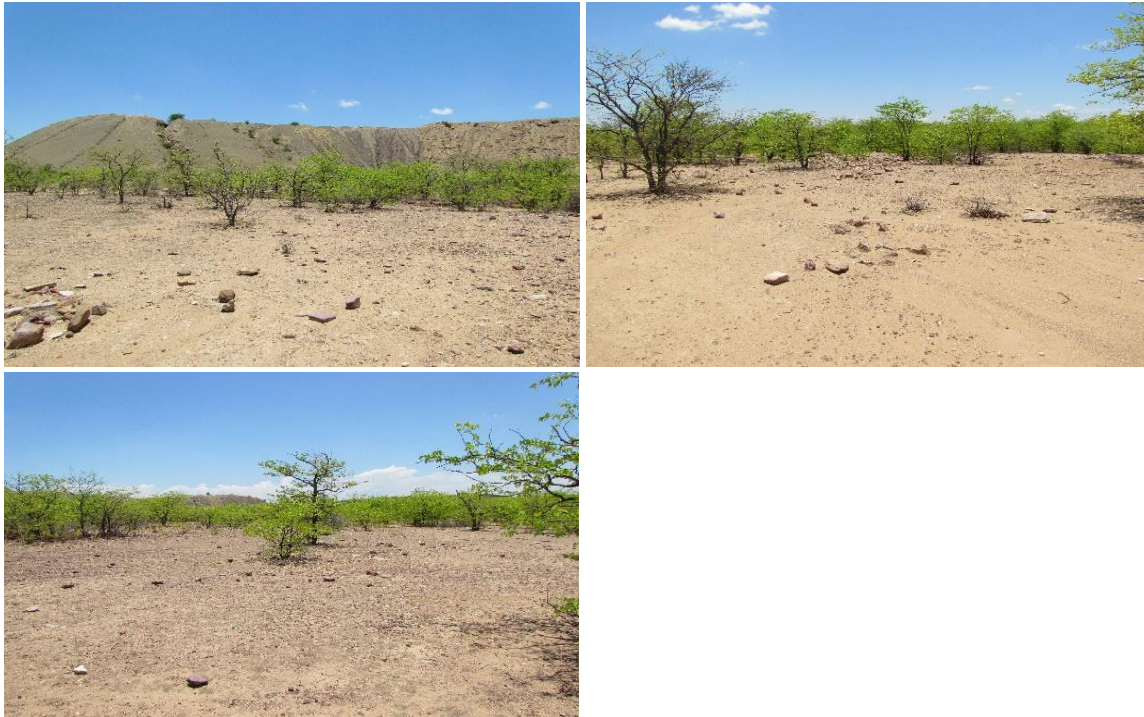
Figure 8: Site 25 a and b with berm in the distance.

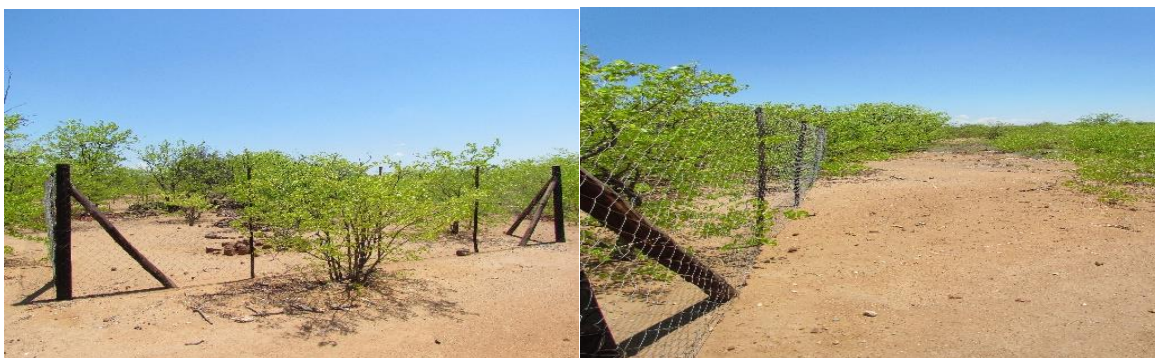
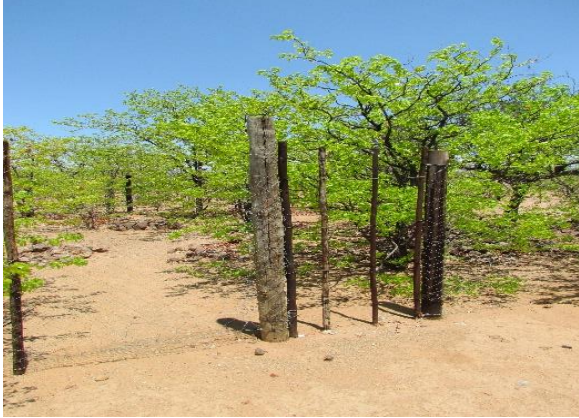
Site 30:

30	Figure 10	11 graves	High	Fence, manage and monitor	No issues observed No visits requested.	No issues observed and no change from last year.	Recommended to monitor every 6 months; Remove rubble next to graves;
32	Figure 11	2 graves	High	Fence, manage and monitor	No issues observed No visits requested	No issues observed, still the same as this year.	Recommended to monitor every 6 months.
34	Figure 12	Kraal next to the road	Medium	Manage and monitor	Runoff being channeled away from site Some archaeological material noted in the section between road and wooden poles.	Road is being re-graded away from the site. There will be less damage to the site by continuous road use. There is no erosion observed on site due to good grass cover.	Recommended to monitor every 3 months; SAHRA notes that the portion of the road is being moved about a metre away from its current position and this will have less impact on the site. This will reduce the amount of erosion that occurs after the rains.

Figure 9: Site 30 fence repaired, and gate installed.

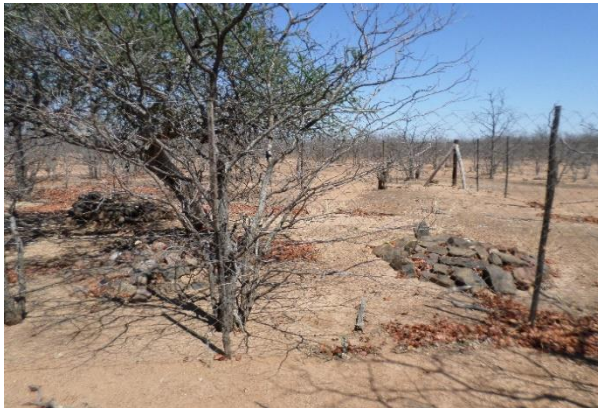
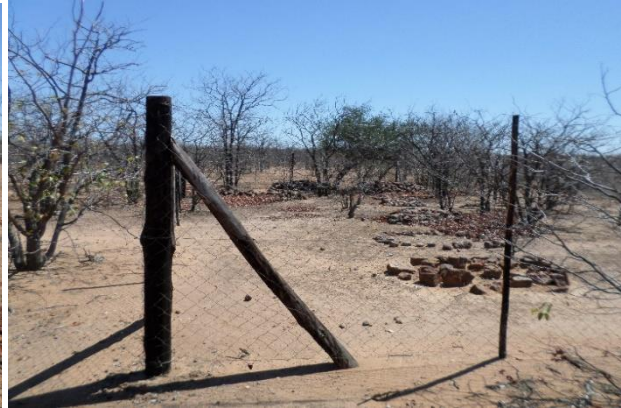
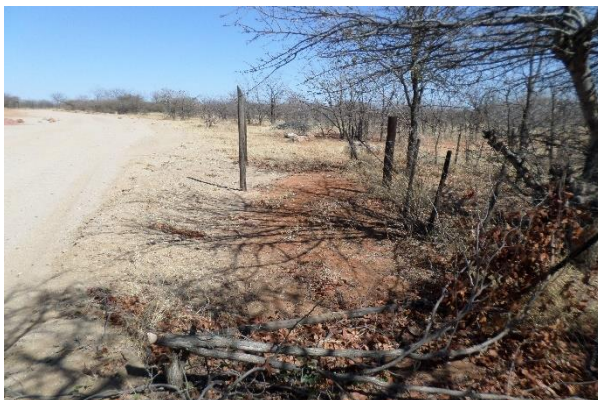
Figure 10: Site 32 images of the graveyard near the farmhouse.
Site 34

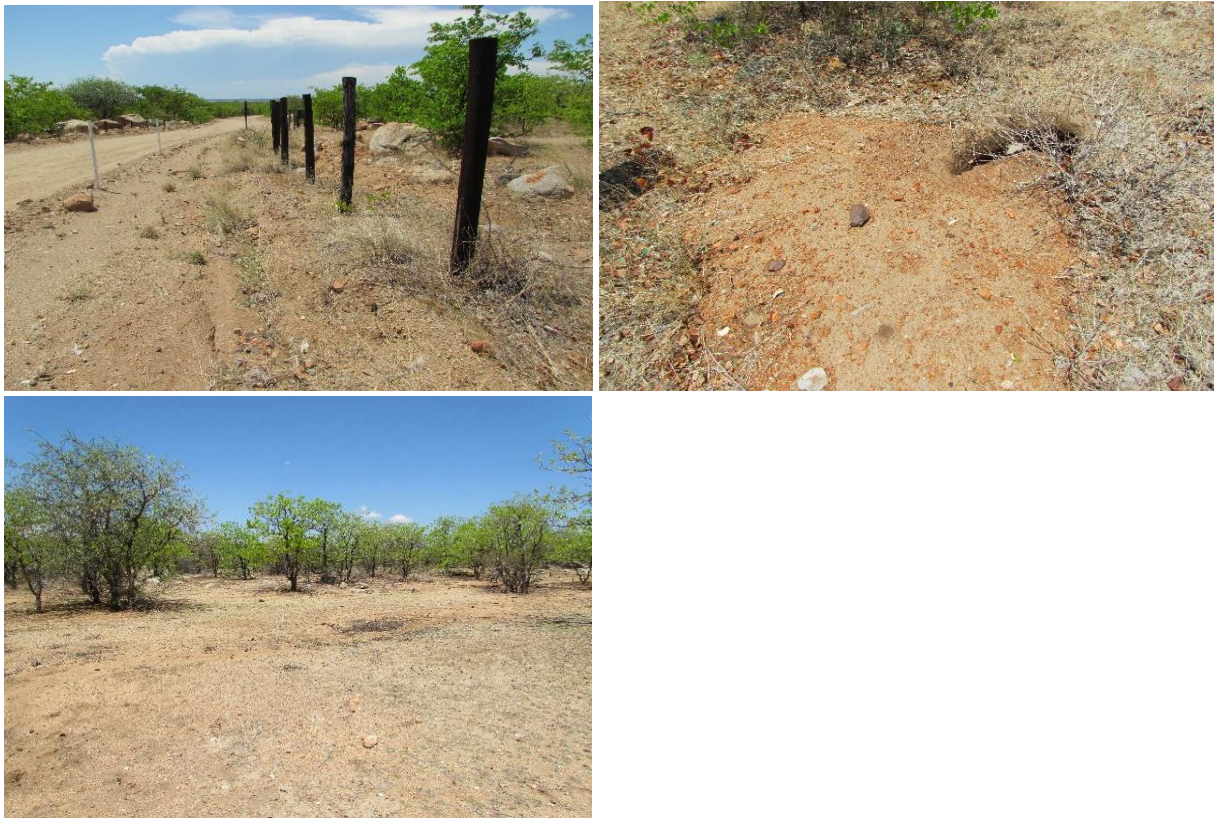
3. SAHRA mentioned that there are no immediate conservation concerns observed during the site visit.	3. Noted by all parties.
4. SAHRA noted that the new grading of the road by site 34 and observed that the small channel created during previous road maintenance work was corrected.	4. The EO mentioned that the road is being relocated to its original position away from site 34.

Figure 11: Site 34 view of the site, with animal burrows and the profile of the road and site edge with signs of erosion between the site edge and new road grading.

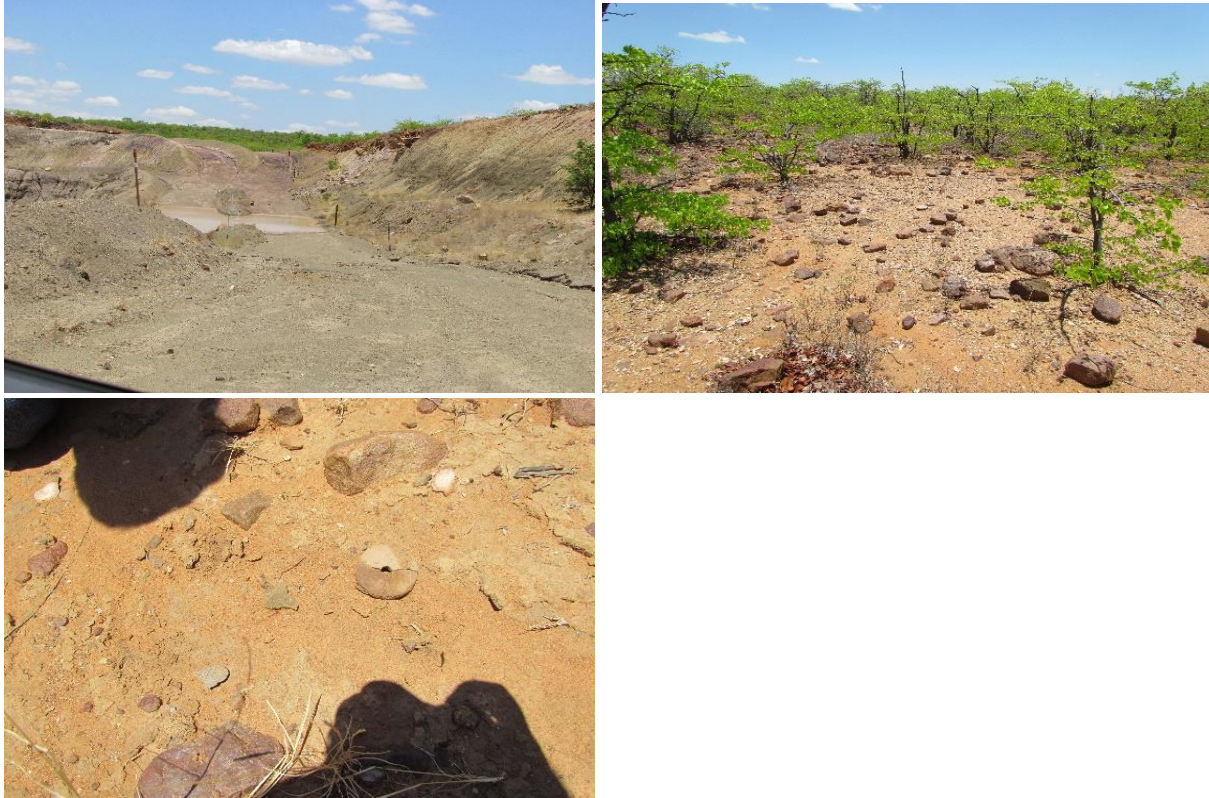
37	Figure 13	Bead and midden site Zhizo?	Medium	Near prospecting trench from Vele operations. Excavation planned.	No issues observed	Observed some surface artefacts like slag and pottery. The site has not changed since the previous year.	Recommended to monitor every 6 months; Section 35 permit to be applied for the planned mitigation.
38	Figure 14	K2 Site	Medium	Monitor and Manage	No issues observed New farm owner to repair dam wall below site and allow dam to fill.	Site lies on the Koppie above the dam that will be repaired. No visible surface changes observed.	Recommended to monitor every 6 months. If metal spear is found it must be sent to a registered repository and accessioned.

Figure 12: Site 37 view of the spindle whorl found on site and the mine pit area near the site.

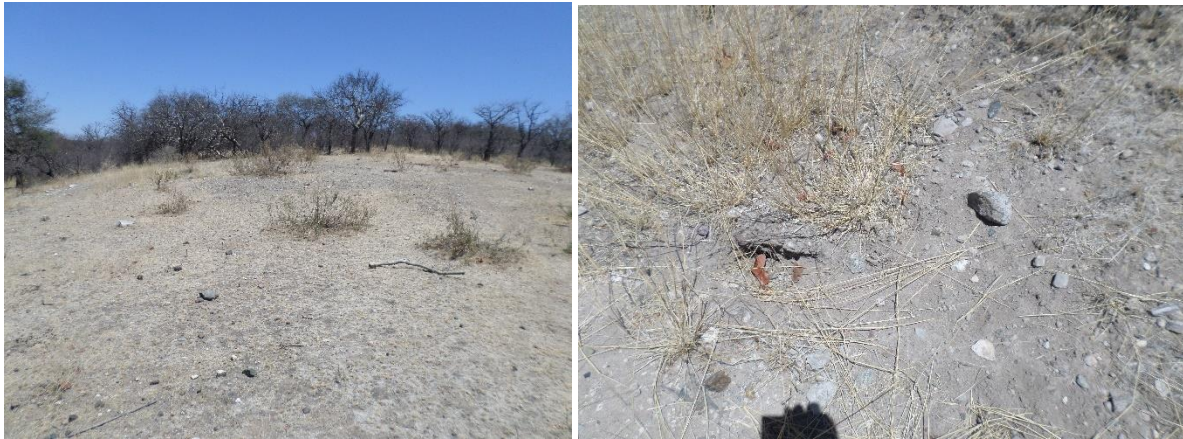
Figure 13: Site 38 view of the kraal and the dam wall below it.

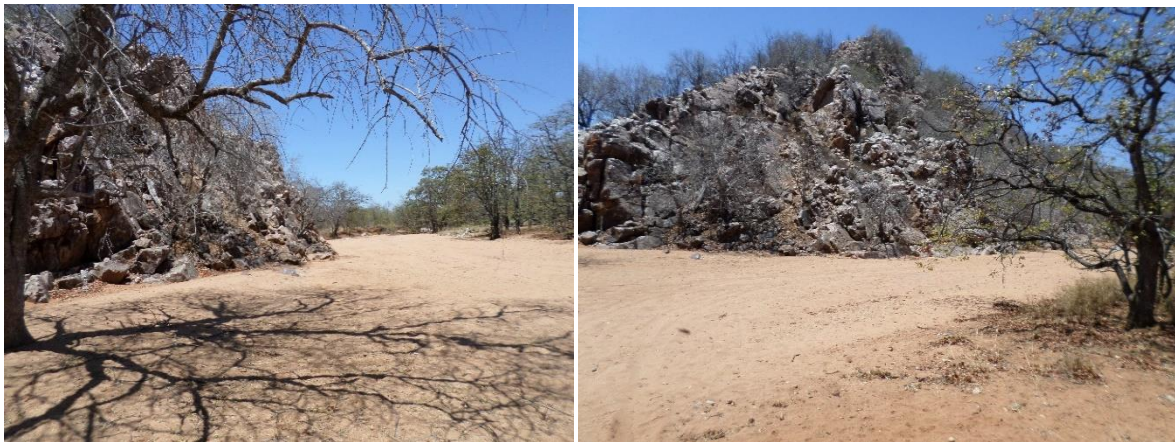
Kabida Dam Wall

2. SAHRA enquired about the name of the farm next to the mine on the access road. SAHRA also mentioned that they received an application for a dam on the farm Bergen Op Zoom and a portion of Overvlakte.	2. The EO mentioned that it is Noordkrans. The area where the dam wall will be constructed was visited during the site visit.

Figure 15: View of the location where the Kabida dam wall will be constructed.
