OUR REF: N-2329/Gen/Out

DATE: 29 November 2012

REHABILITATION OF ROAD P127/2: REPLACEMENT OF CULVERT C7

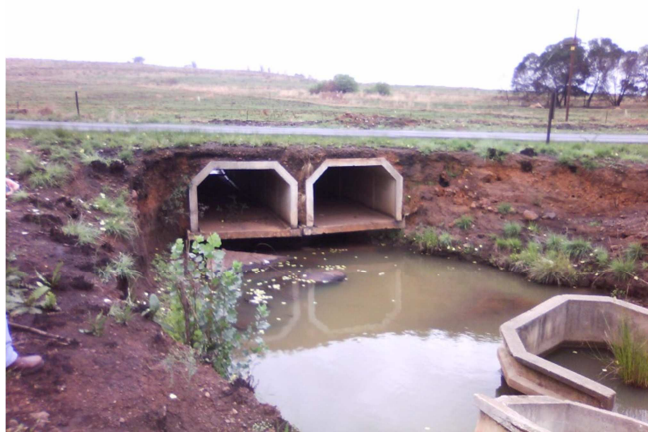
Culvert C7 is structurally damaged, and is failing in such a way that if maintenance is not done as a priority, then the road will fail to such an extent that it will need to be closed. (this can't be allowed, since the road is a main road transporting coal to Duvha powerstation.)

The culvert has already lost some of its spans, together with the outlet structure.

The remaining portion is showing signs of distress, where some of the foundation of the culvert have already been washed out, causing the culvert to split in two with one side already sagging with +50mm.

It is our belief that there was a miscalculation during the initial design of the culvert structure, and that the actual size of the structure should be 2 of 1.8 x 1.8m, instead of the 2 of 1.8 x 1.2. The new culvert footprint will stay exactly the same and only the height of the culvert will differ.

The process of maintenance that will be followed on this culvert, necessitates us to remove the culvert, in order to secure the foundation of the culvert, and then to replace the culvert with like on like. Since the culvert structure cannot be removed without damaging the spans, we need to replace them with new spans.
