## PHOTOGRAPHS

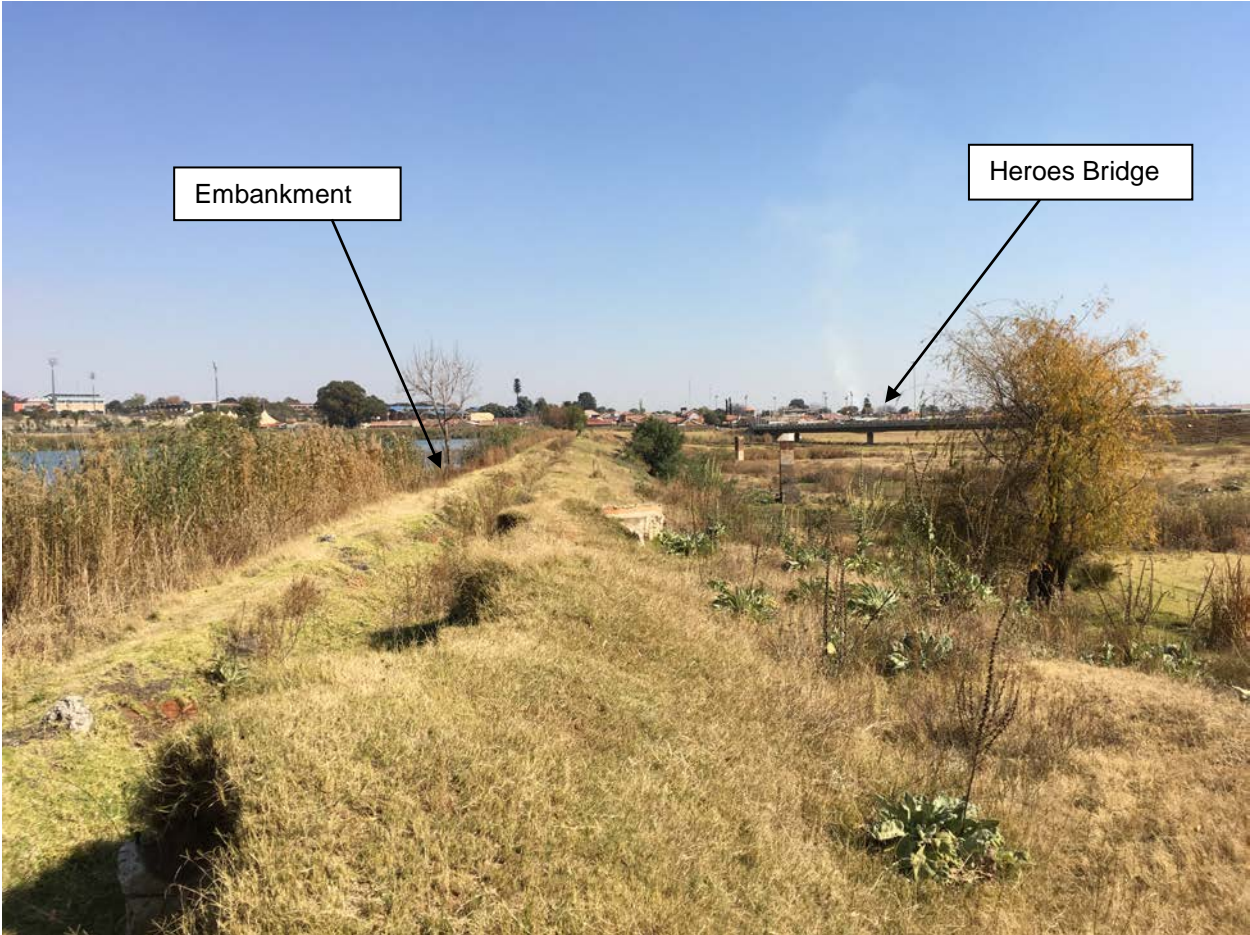
2. View of the embankment illustrating lack of maintenance

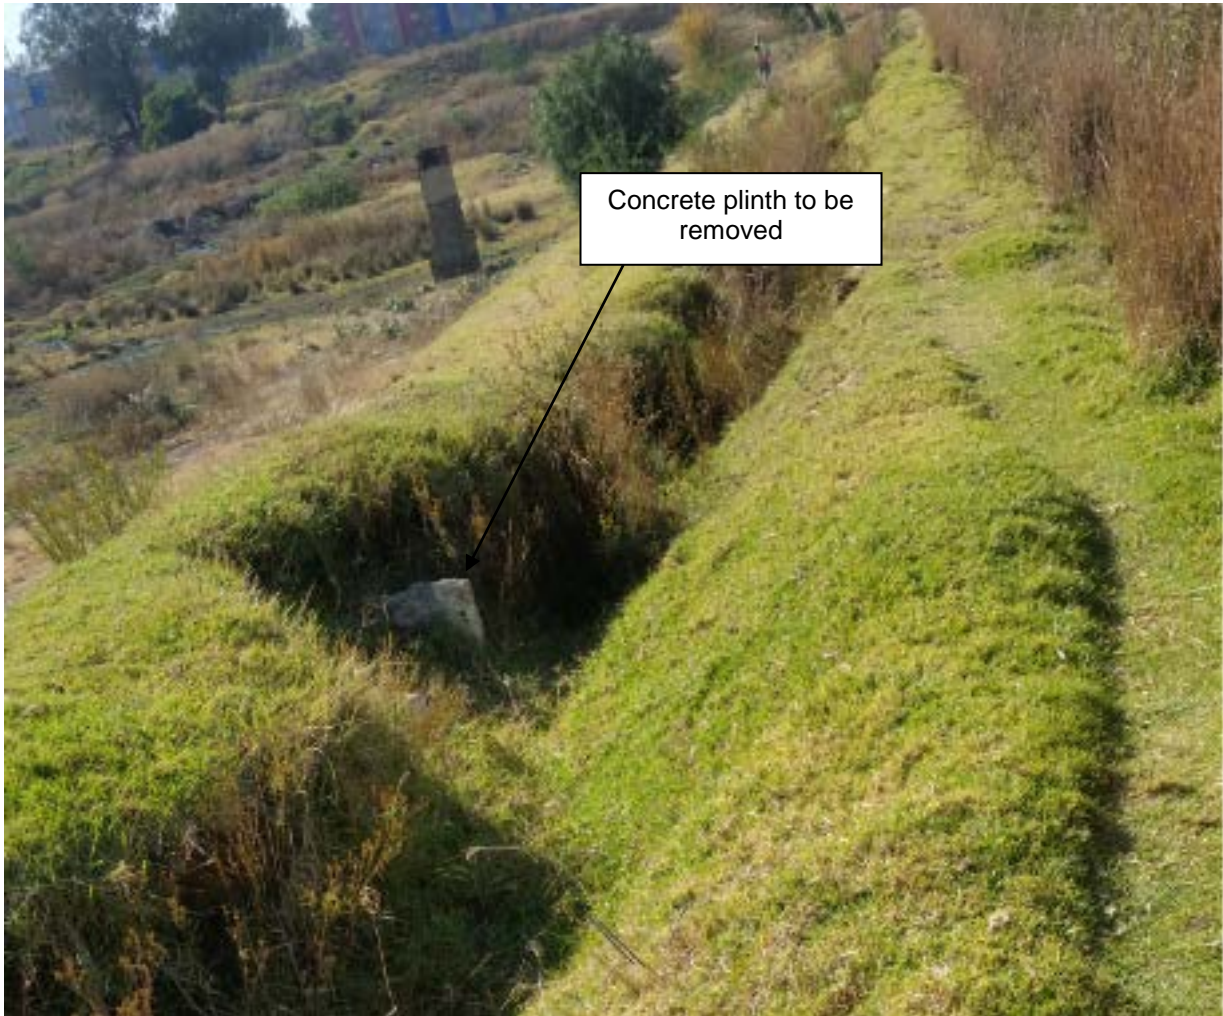
3. Trench on NOC (non-overflow crest) of embankment. Extends for 260 m of 280 m of the crest length, concrete plinth to be removed.

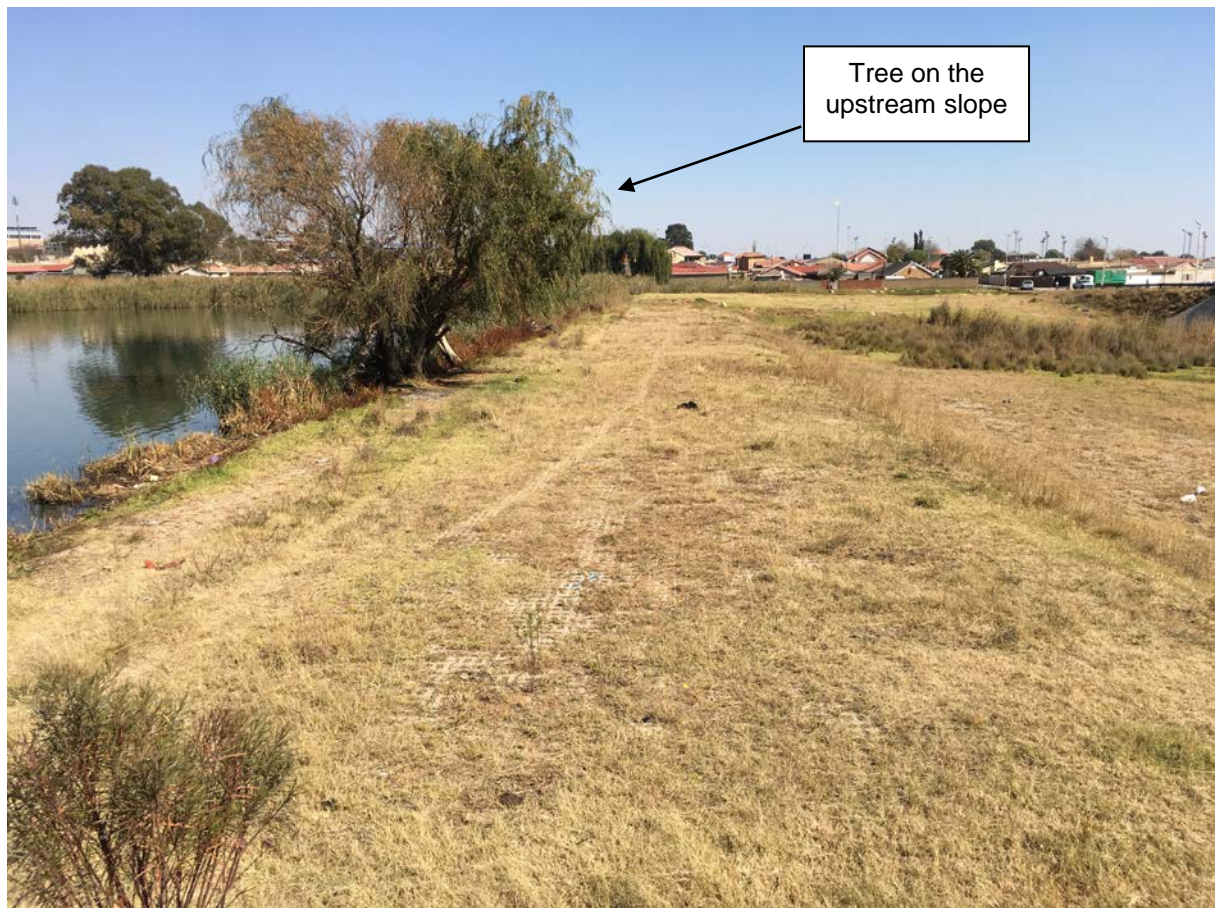
4. View of Auxiliary Spillway showing large tree on the upstream

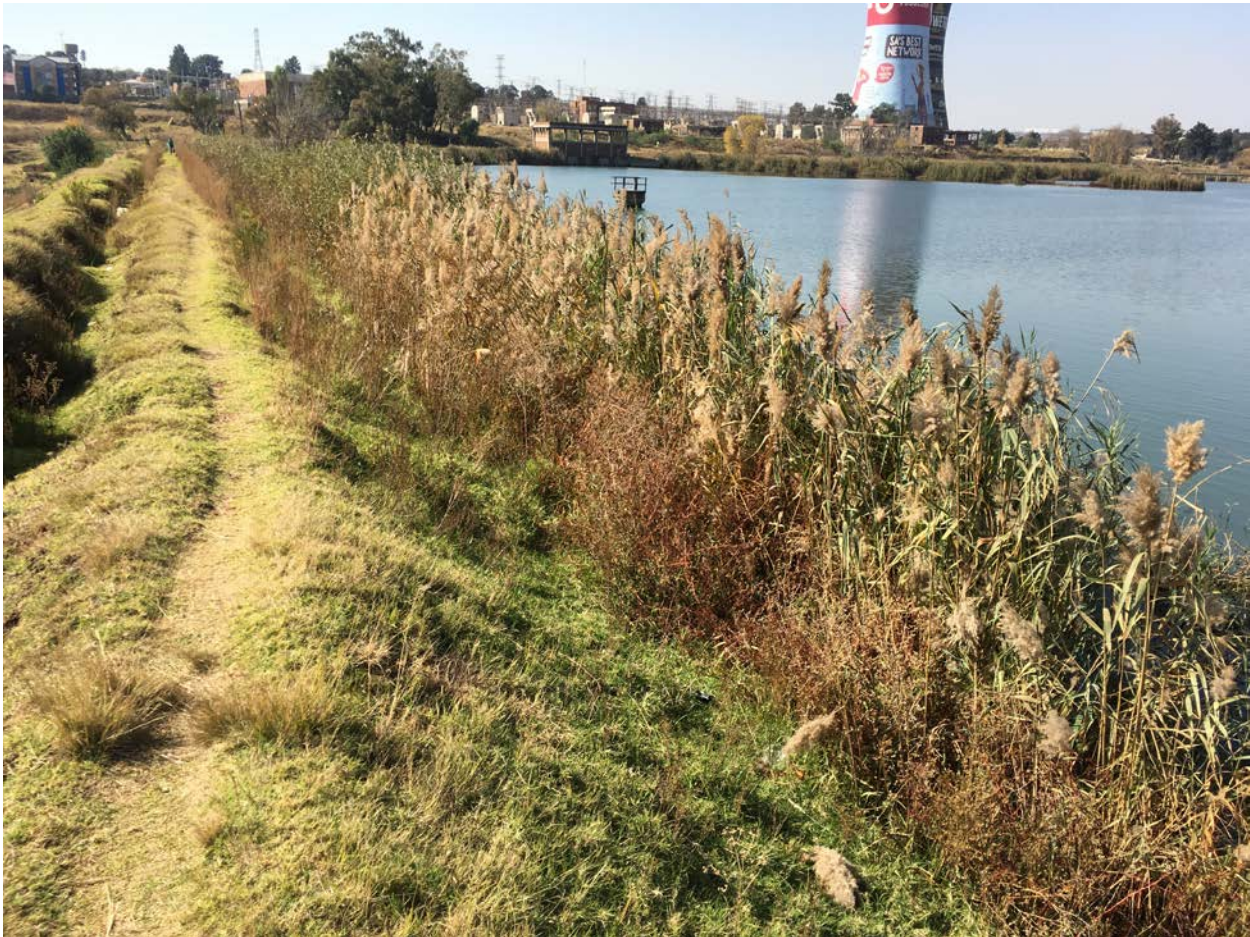
5. Reeds on the upstream slopes (routine maintenance required)

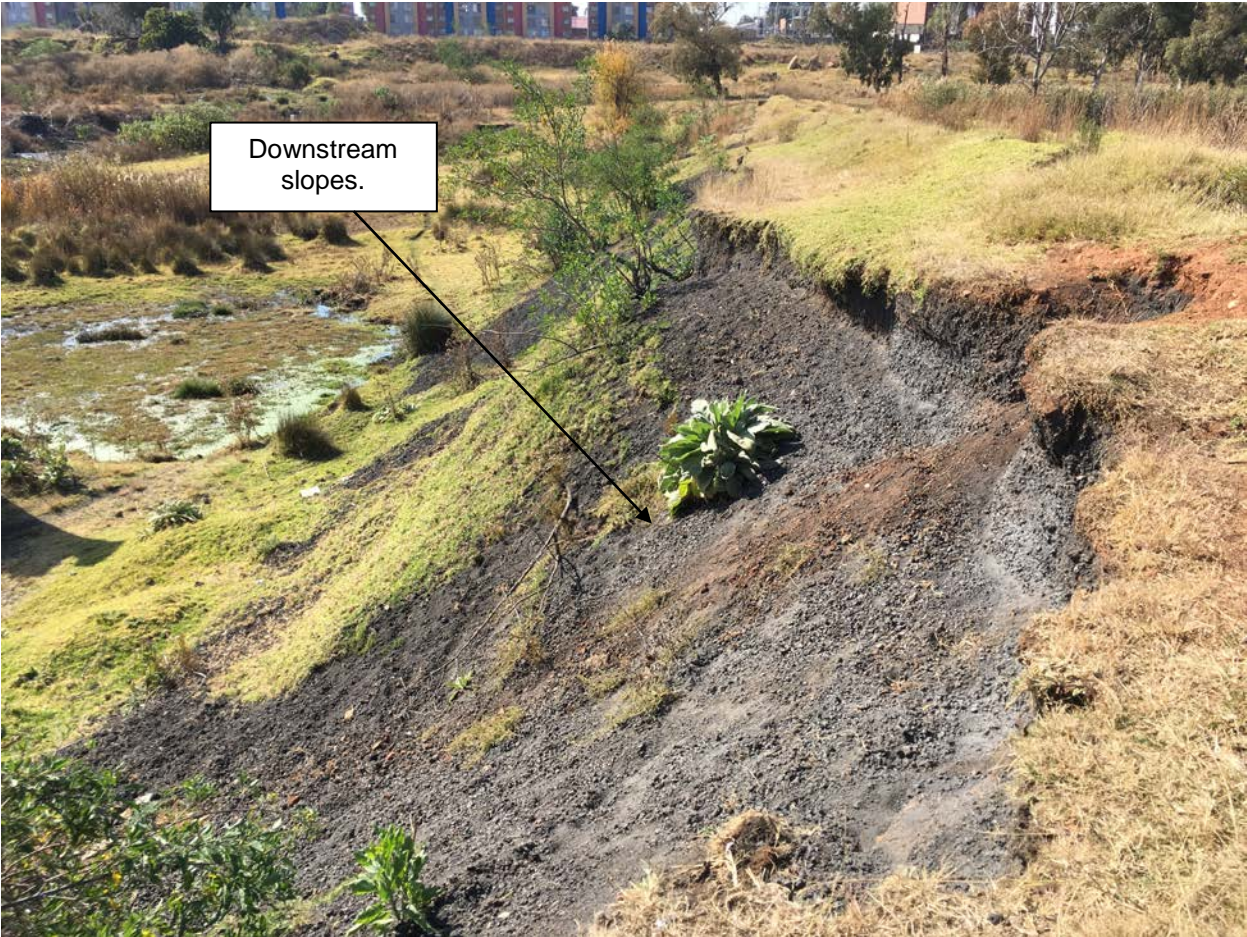
6. General view of downstream slope showing vertical ash dumps (unsafe condition)

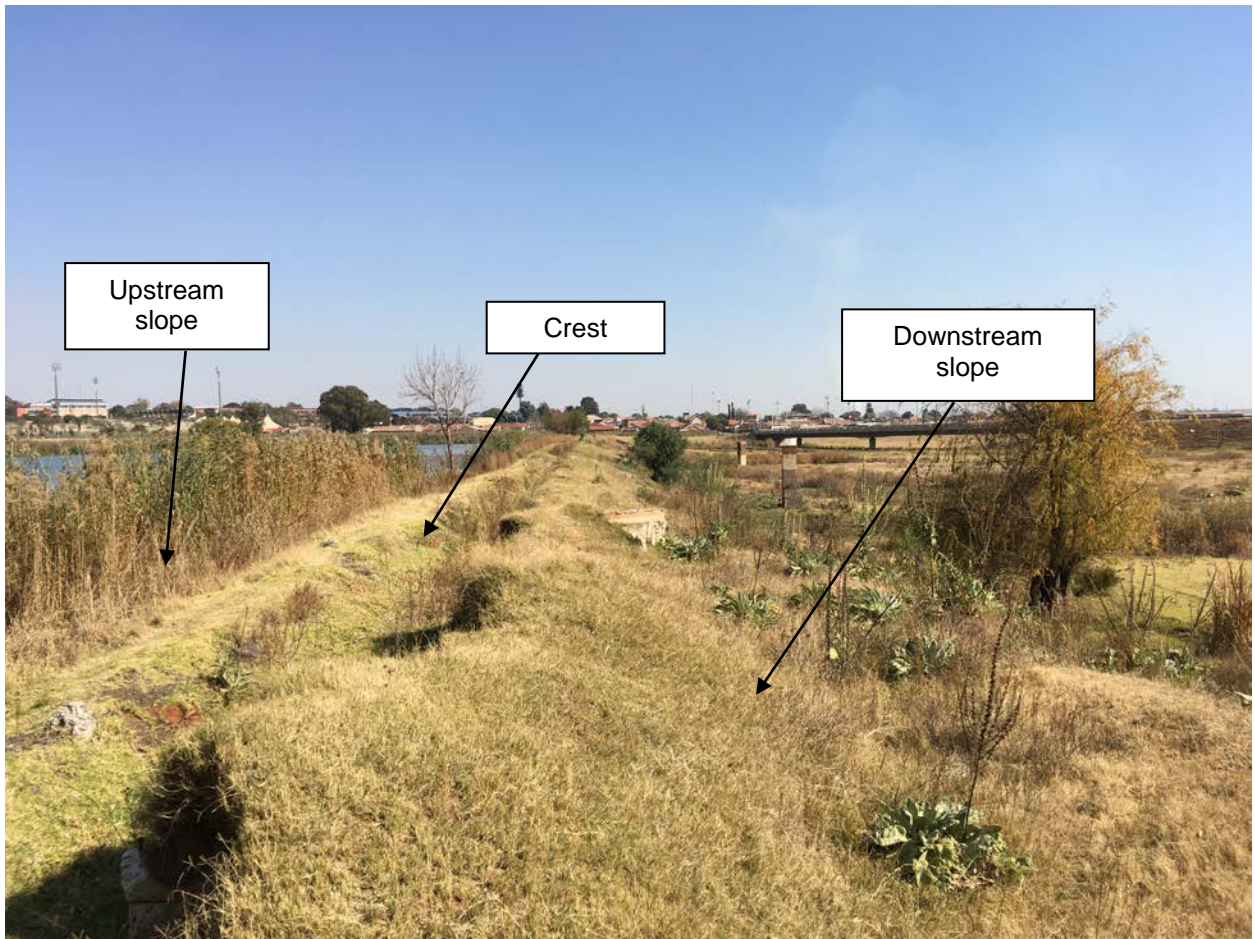
7. Various types of vegetation on the dam (routine maintenance required)

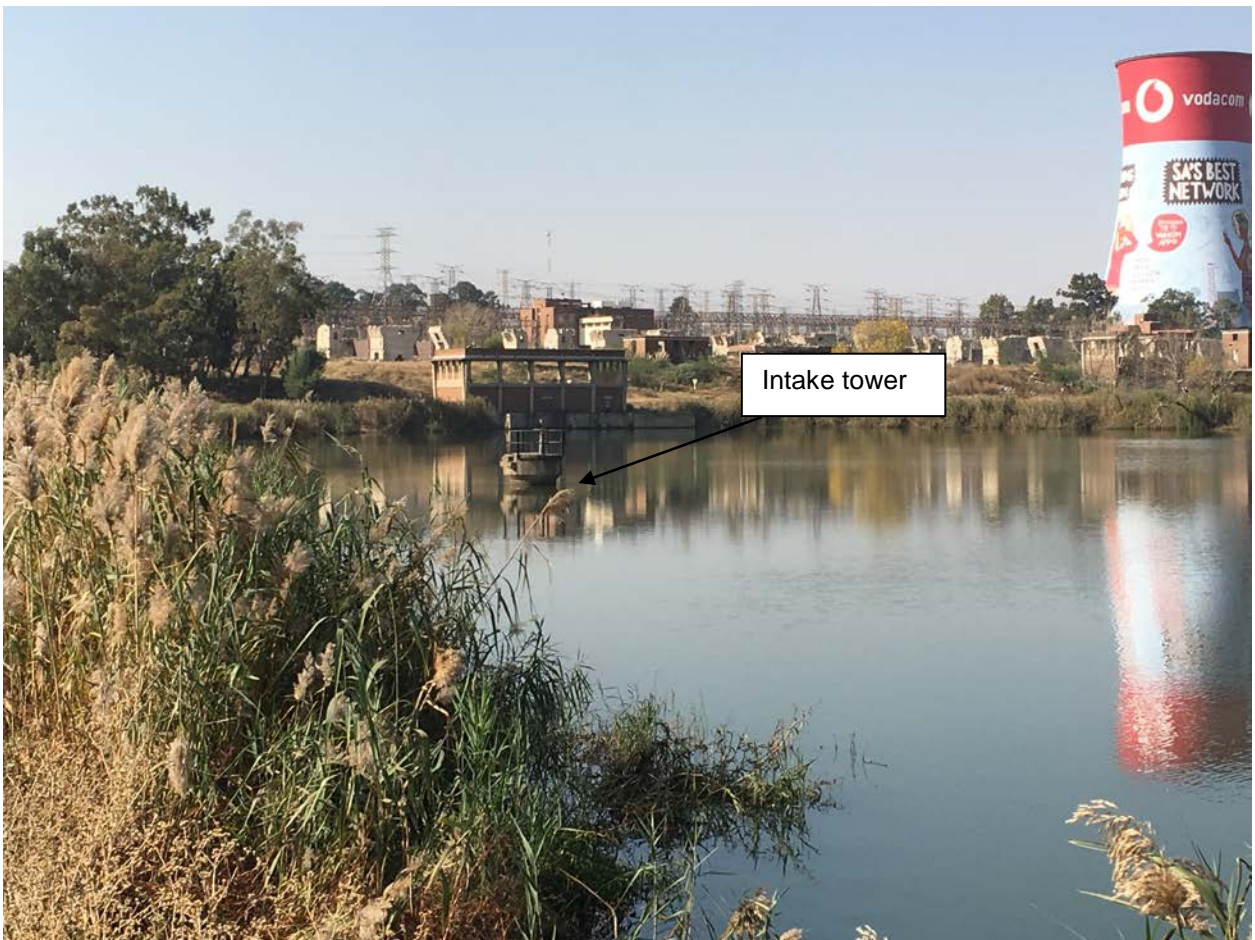
8. View of the intake tower, NOTE the dense reeds surrounding the embankment

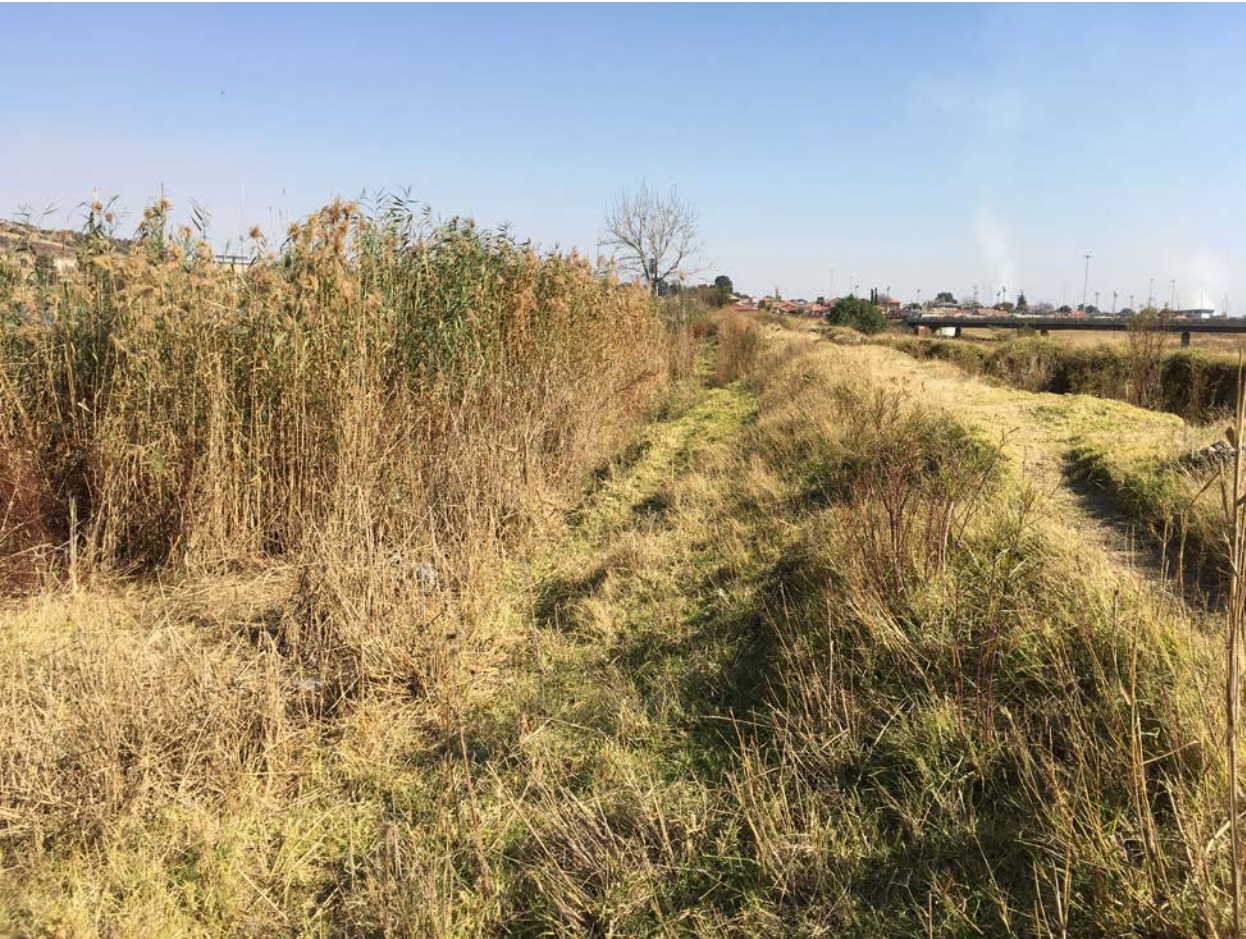
9. Poor condition of the NOC illustrating lack of maintenance.

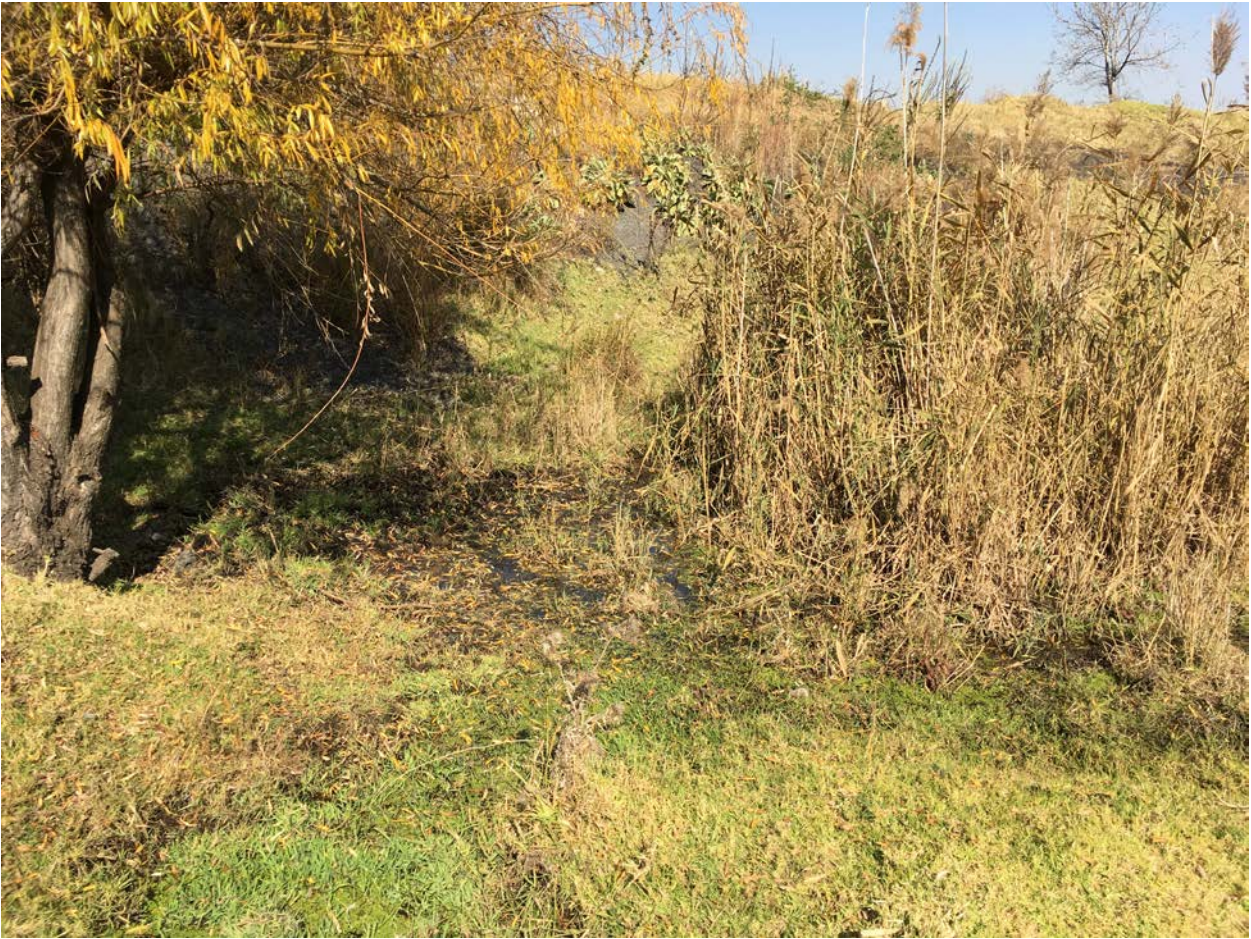
10. Standing water from seepage just downstream of the crest

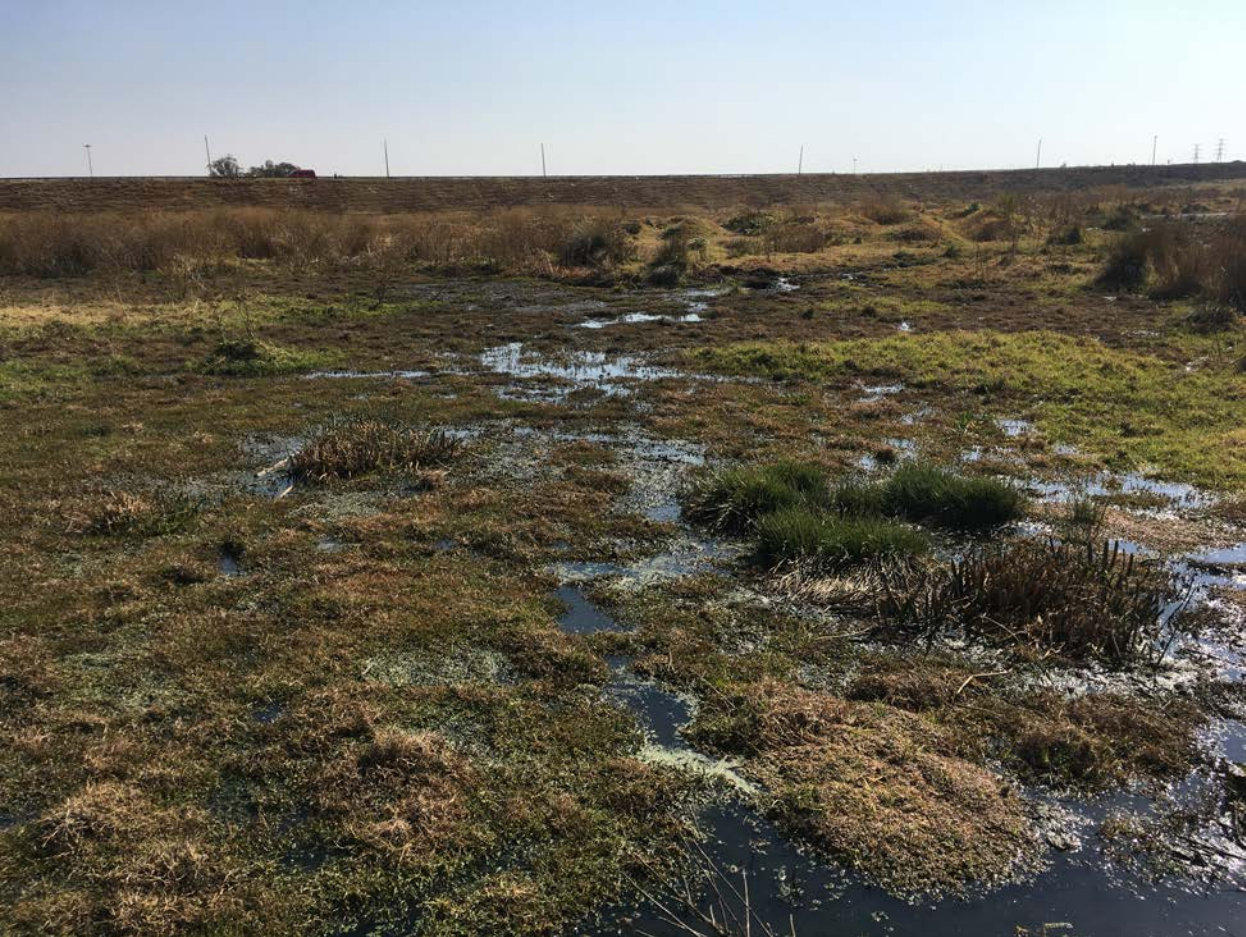
11. Standing water caused by sewer water flowing from the adjacent buildings.

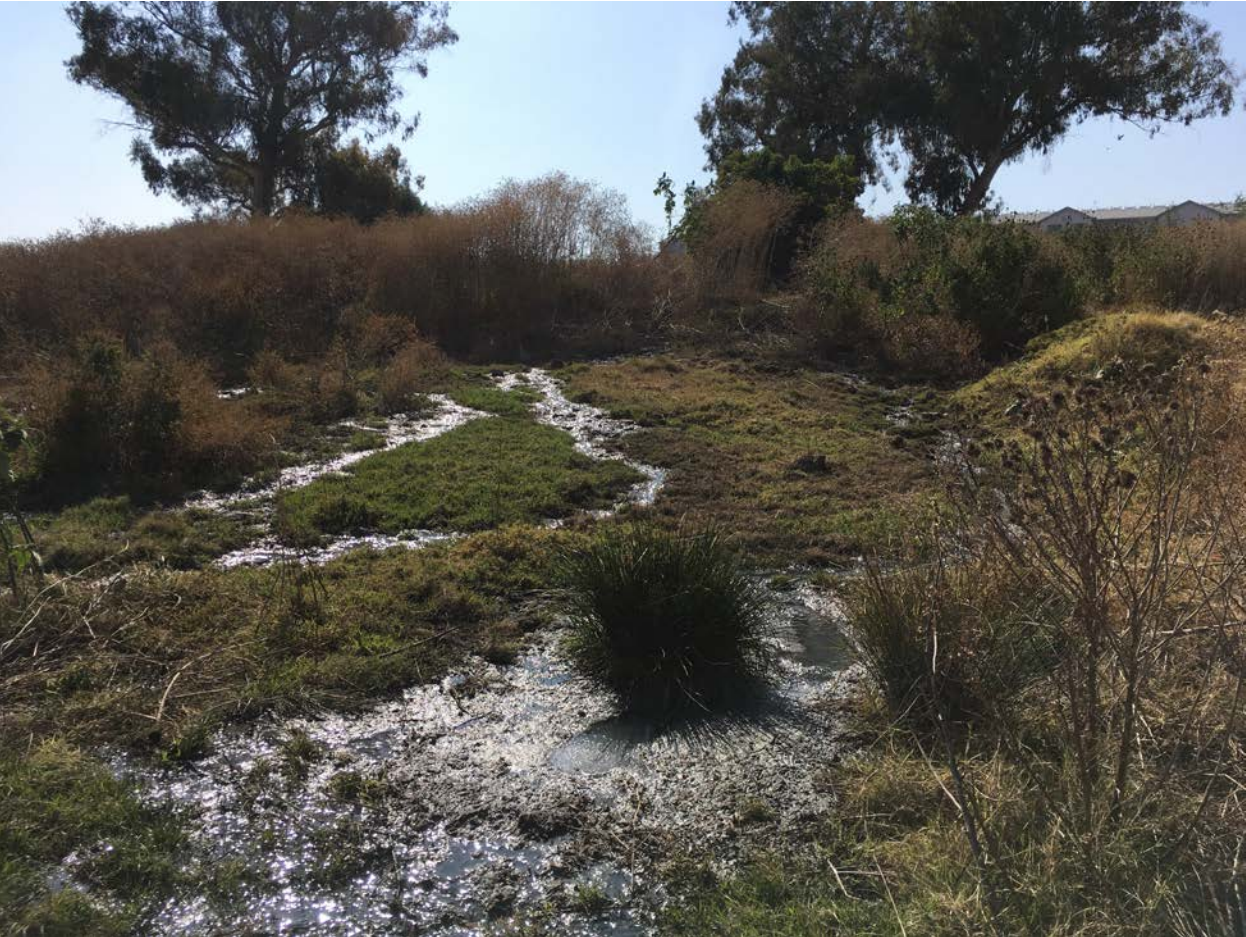
12. Sewer Water flowing into the wetland downstream of the embankment.

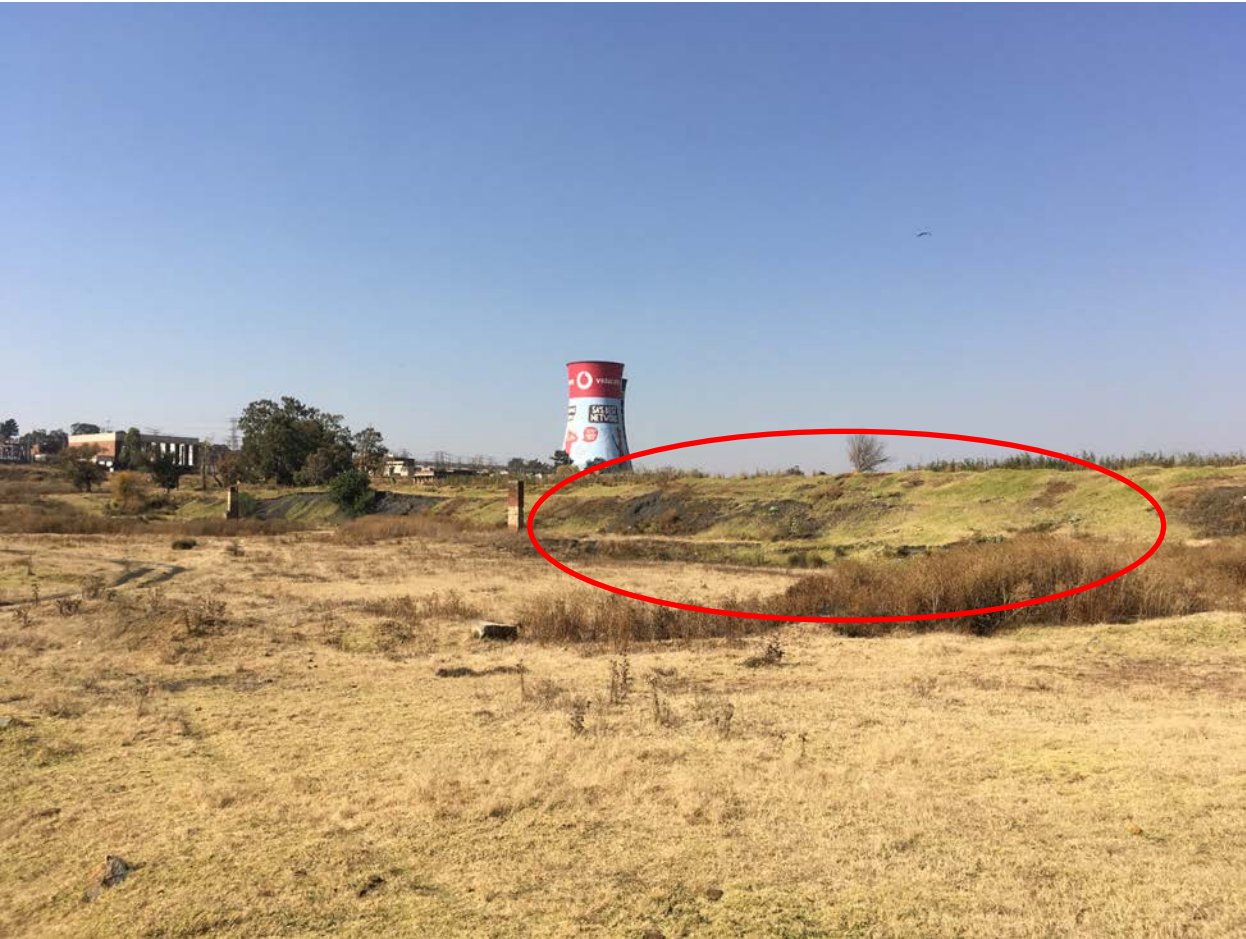
13. Downstream slope. Not maintained, in poor condition and very irregular profiles

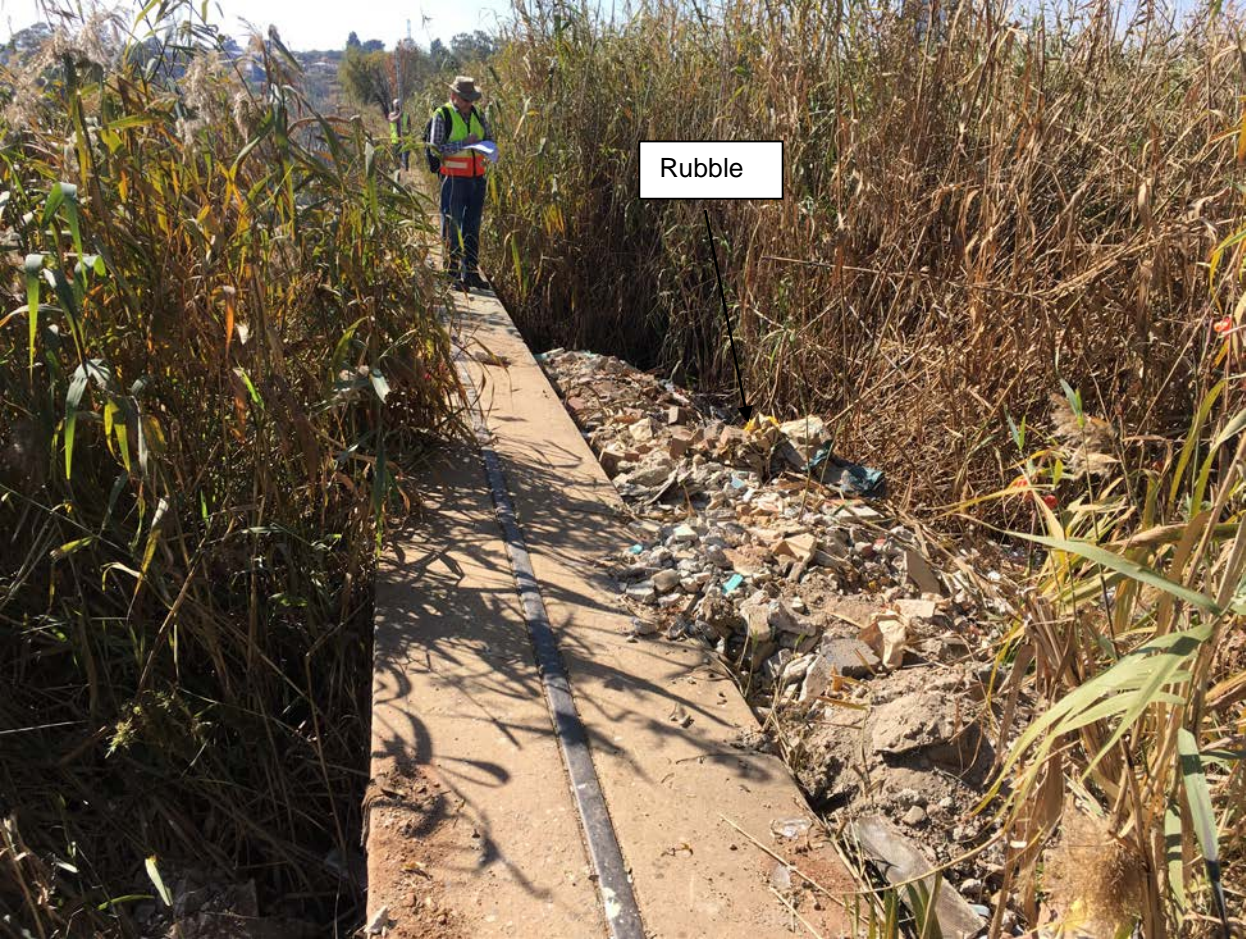
14. Pedestrian bridge across main spillway, Reeds to be removed on both the upstream and downstream side. Rubble to be removed on the upstream side.

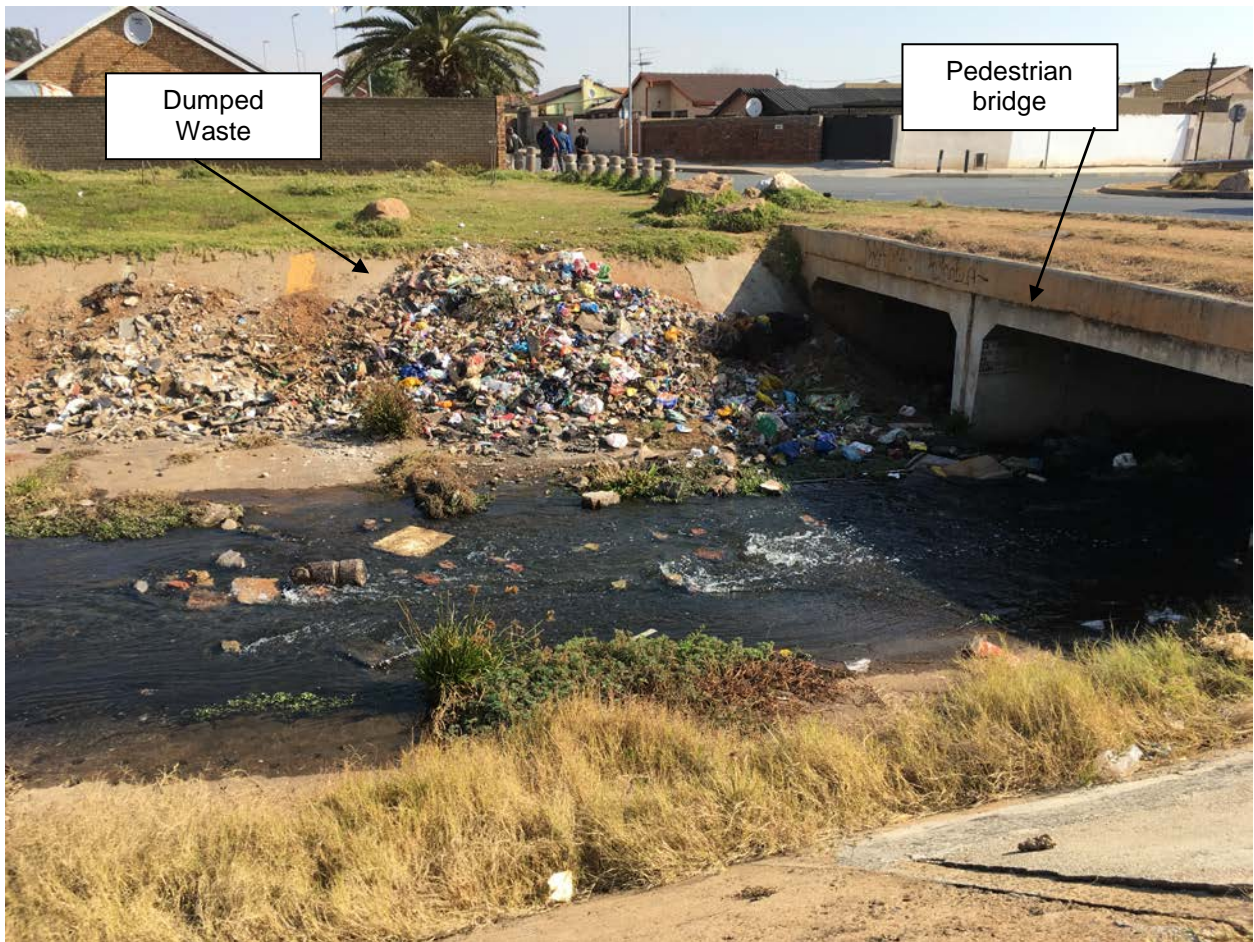
15. Klipspruit Canal and main pedestrian bridge. Used as a dumping spot

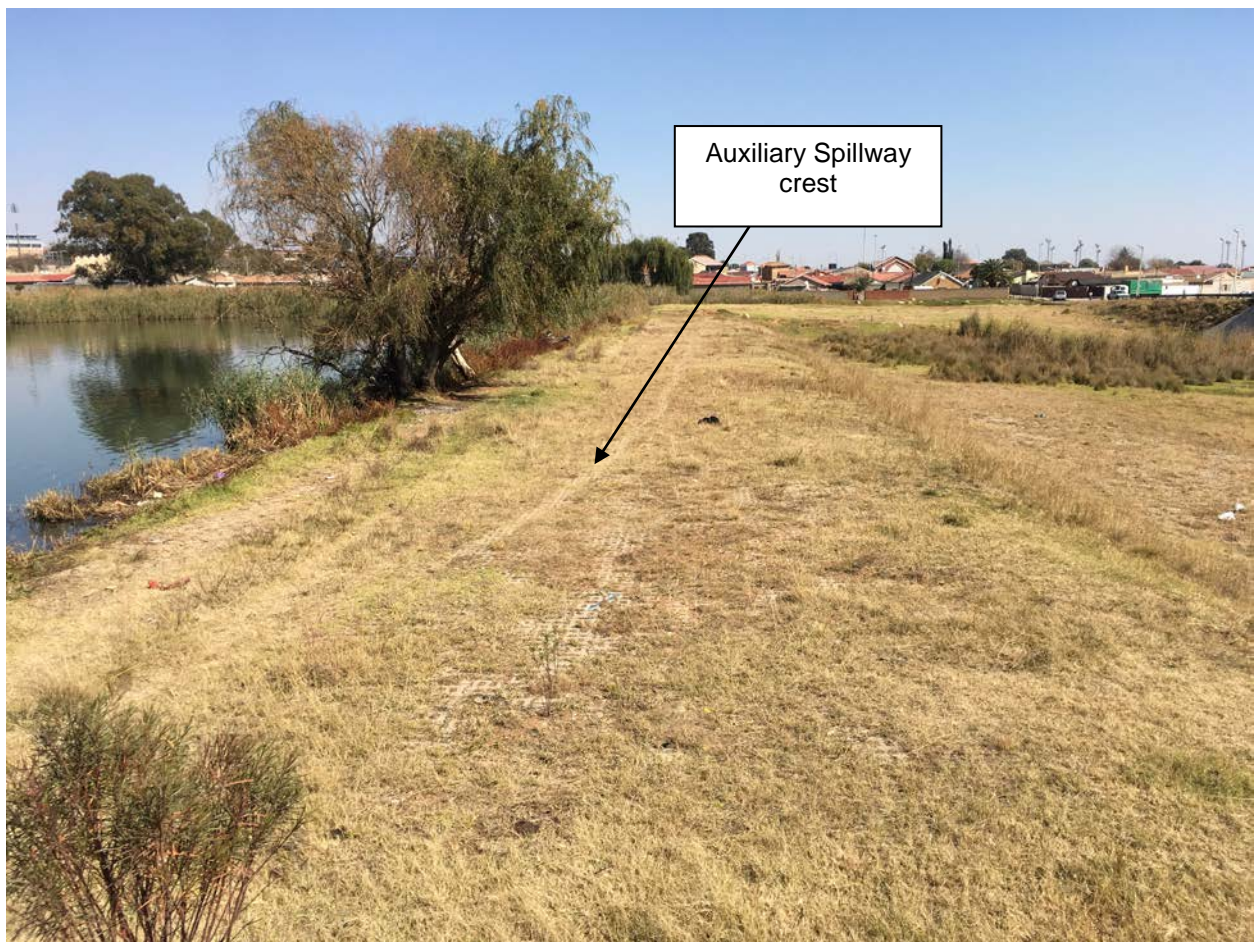
16. Auxiliary Spillway Lack of maintenance, vegetation covering the Armorflex.
