**KWAGGAFONTEIN SITE PHOTOS**

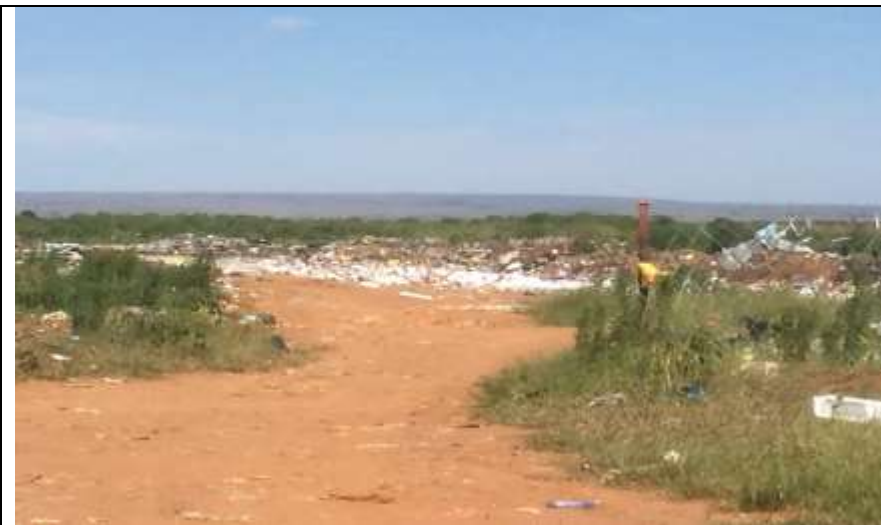
**Figure 1:** View of the Kwaggafontein landfill site from the north west

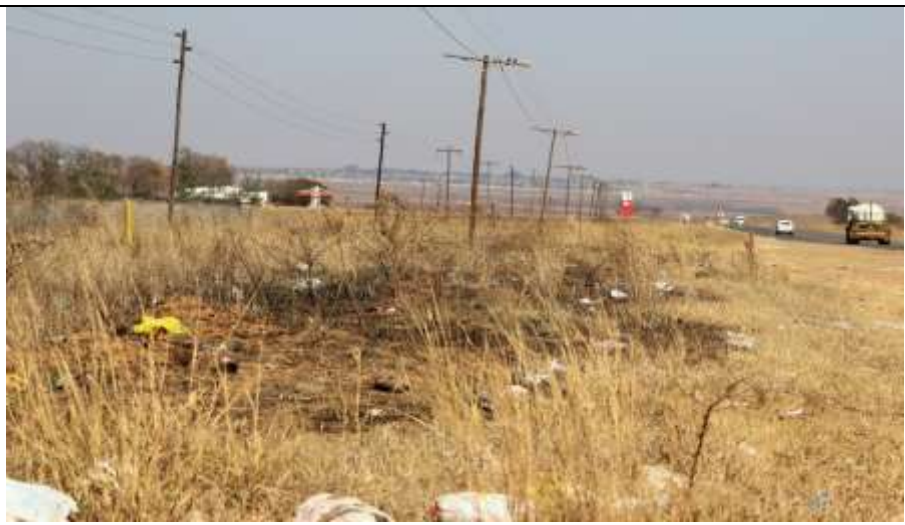
**Figure 2:** Eskom distribution line along the landfill side and the R537

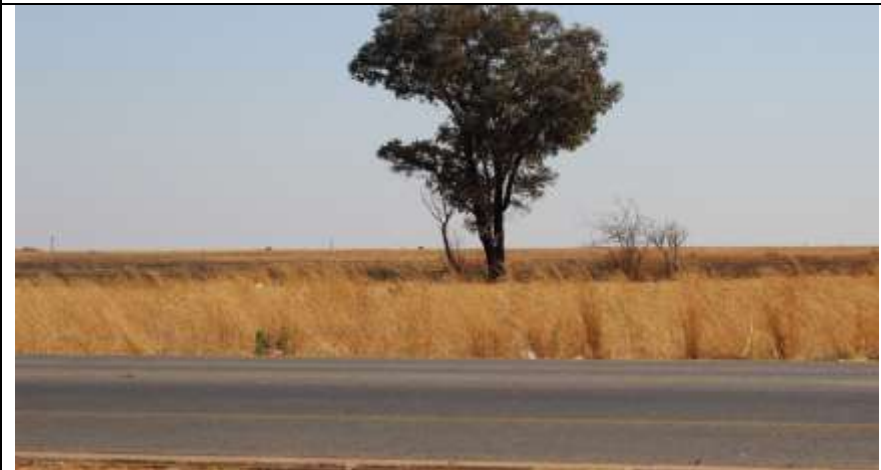
**Figure 3:** The R357 (Moloto Road) running along the north west of the site

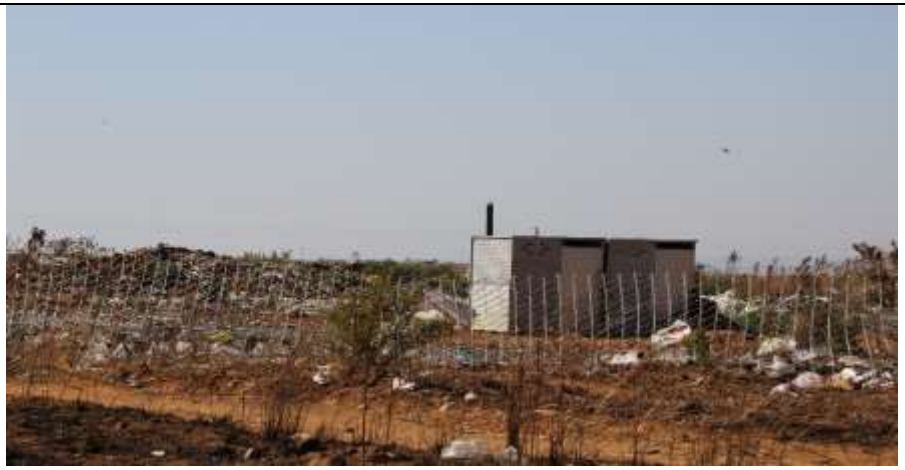
**Figure 4:** Ablution facilities are observed on the eastern boundary of the site

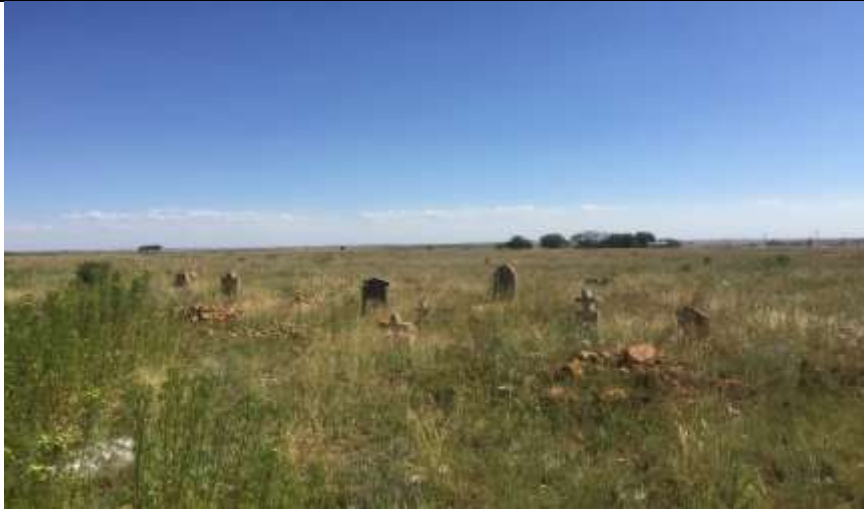
**Figure 5:** A cemetery is observed on the western boundary of the site

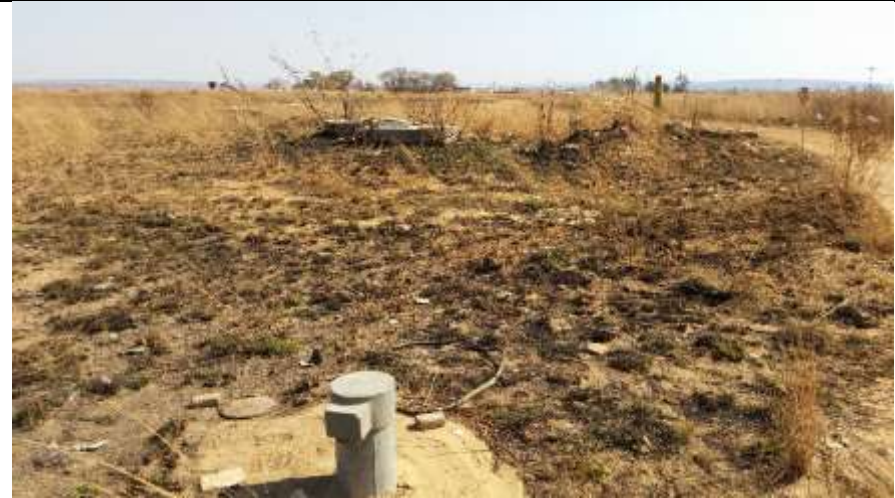
**Figure 6:** Municipal servitudes are observed along the south western boundary of the site

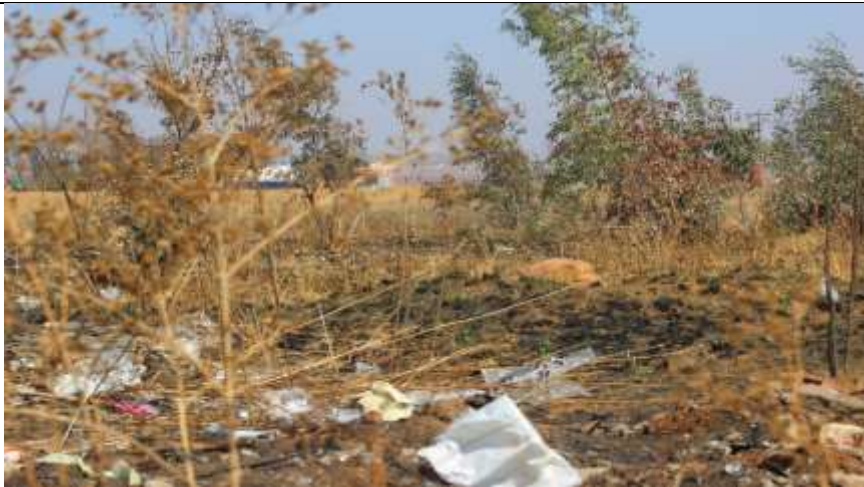
**Figure 7:** Waste/Litter is seen at the south western boundary of the site

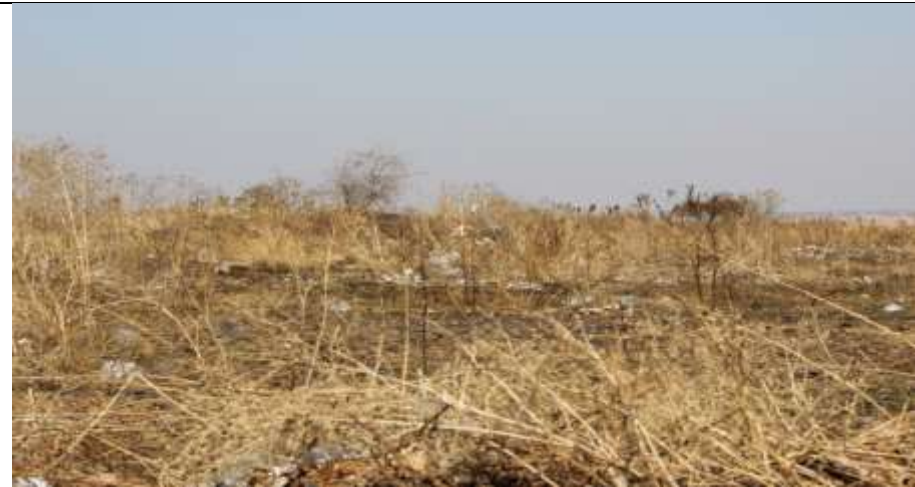
**Figure 8:** Waste/Litter is seen at the south eastern boundary of the site

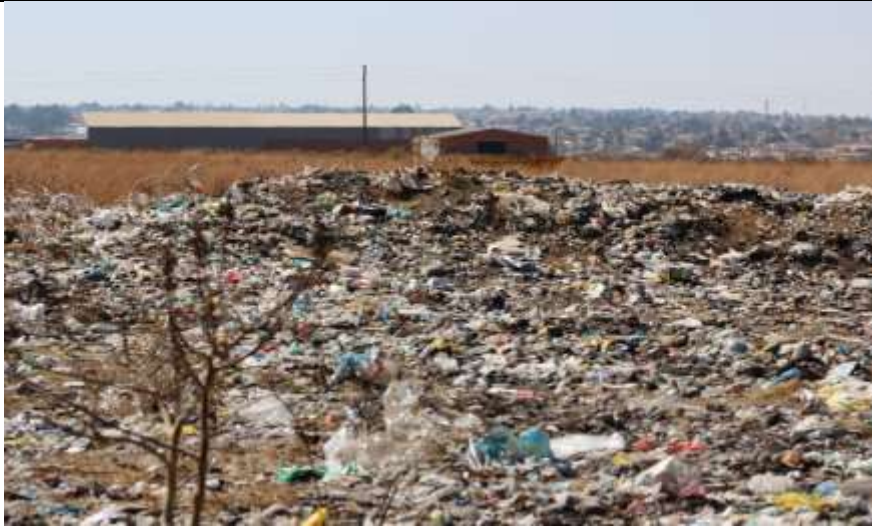
**Figure 9:** View of the landfill site from the eastern boundary of the site

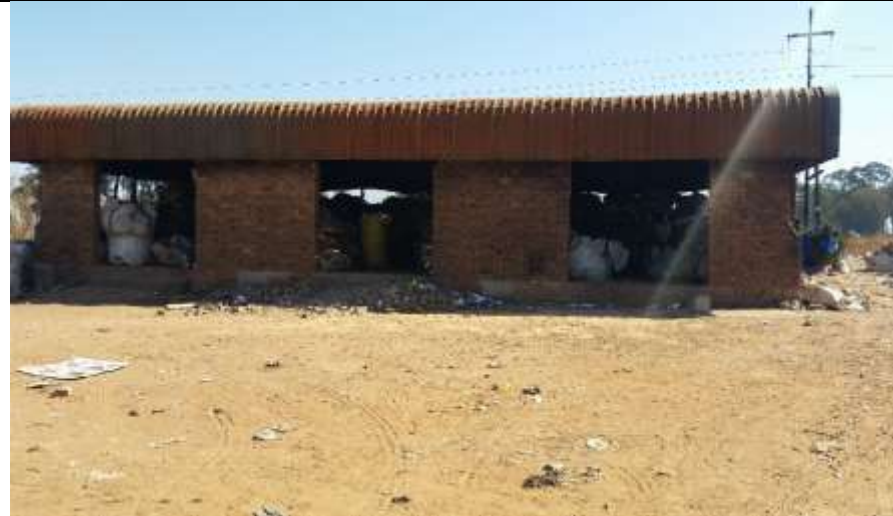
**Figure 10:** A degraded buy back centre is observed on the western boundary of the site

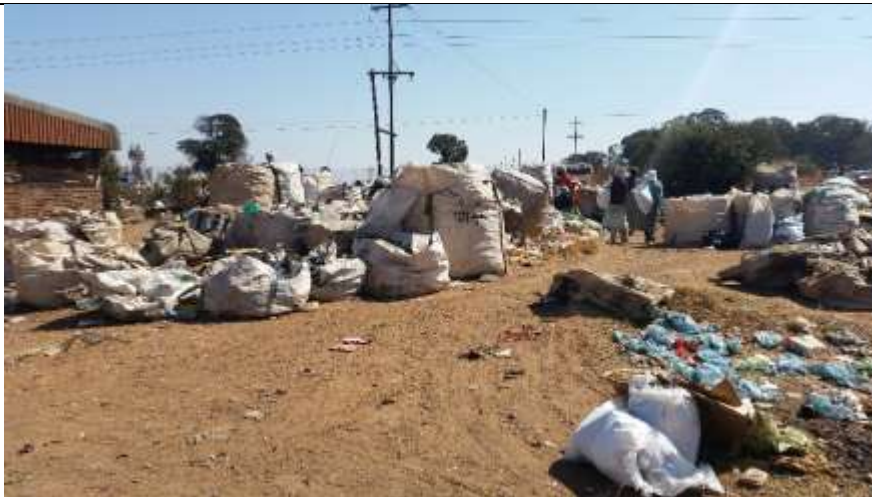
**Figure 11:** Reclaimers are observed collecting and sorting waste material within the landfill site.

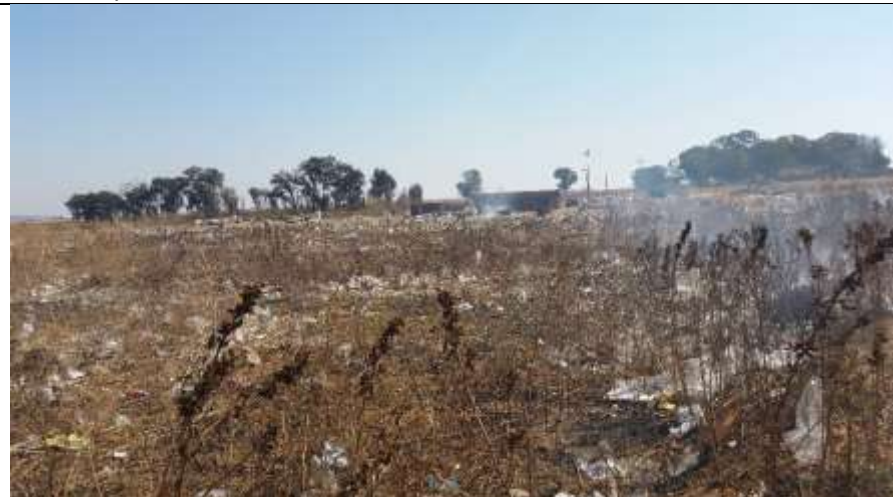
**Figure 12:** View of the Kwaggafontein landfill site from the south of the site
