PIET PLESSIS LANDFILL- SITE PHOTOS

SITE: PIET PLESSIS- KAGISANO MOLOPO LOCAL MUNICIPALITY Site photos taken on the 02nd SEPTEMBER 2015

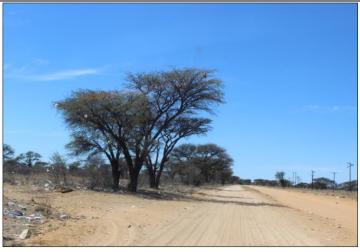
Figure 1: View towards the west along the R377 towards Piet Plessis. The site is located on the left. Note windblown litter across the road

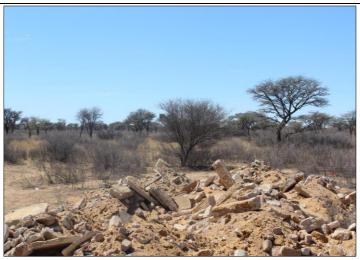
Figure 4: View towards the North showing an excavation (red arrow)in the background and rubble in the foreground

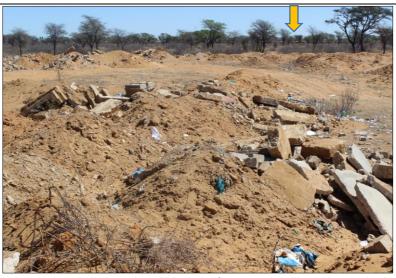
Figure 7: View south west towards the site entrance (red arrow) . Note large volumes of rubble on site

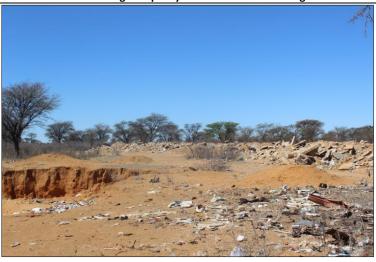
Figure 9: View towards the northwest showing the quarry and houses in the background and rubble in the foreground

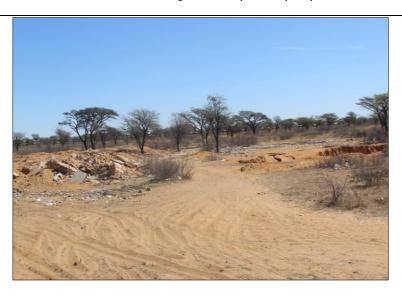
Figure 11: View towards the east showing the close up of the quarry within the landfill site

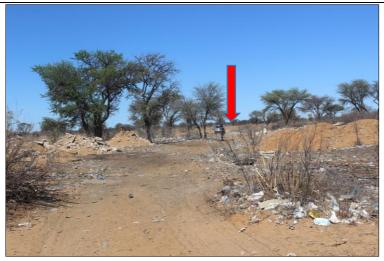
Figure 12: View west towards showing the quarry on the right and the rubble on the left

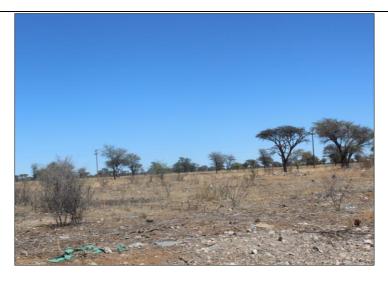
Figure 14: View north toward the new housing area in close proximity to the site. Note the roofs of the housing development indicated by the yellow arrow

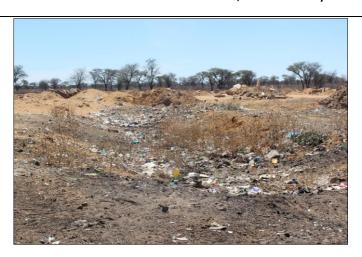
Figure 17: Additional view towards the entrance to the site, note the donkeys feeding on waste

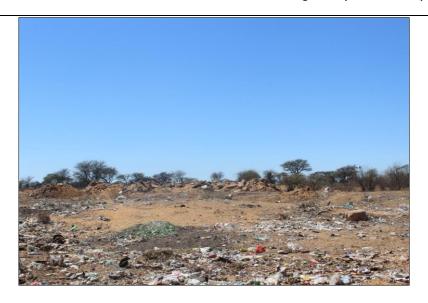
Figure 21: View north towards the access road from the site towards the housing development in close proximity to the site

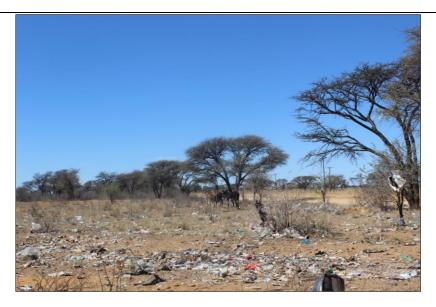
Figure 22: View towards the east showing the waste body on the site
