WINDSORTON LANDFILL SITE

Site Photos taken in August 2015

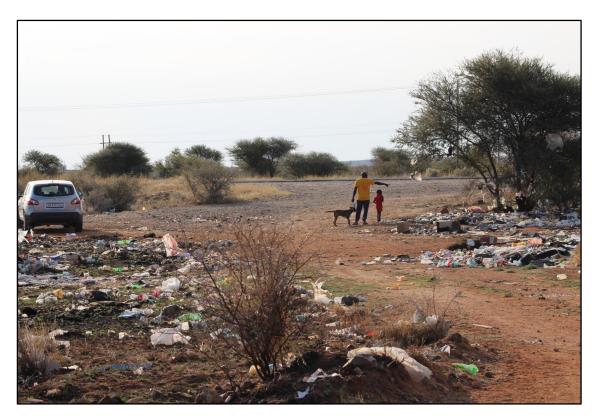
Figure 3: Additional view north towards the entrance of the site showing the waste disposed off close to the entrance

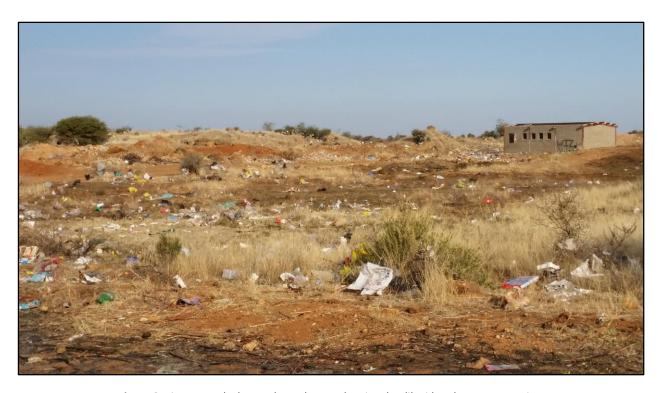
Figure 6: View towards the south south west showing the dilapidated structure on site

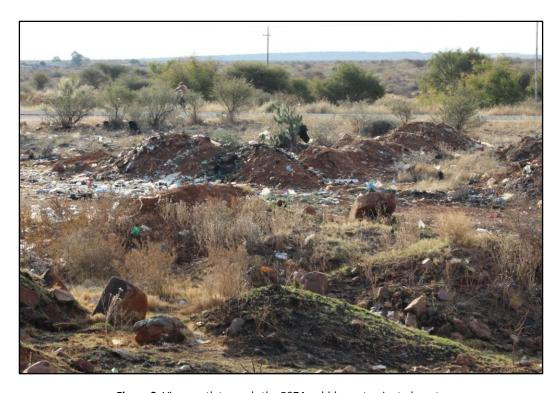
Figure 8: View north towards the R374, rubble contaminated waste

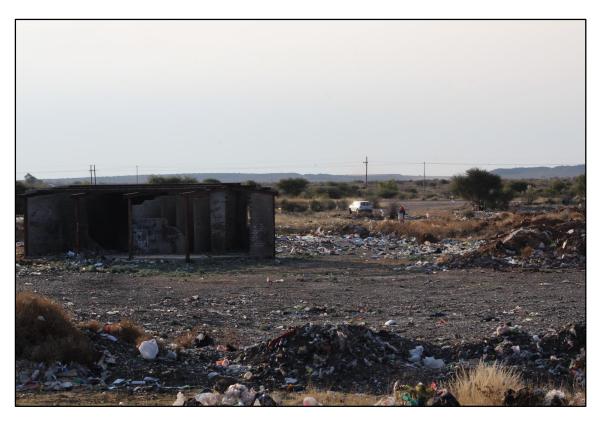
Figure 9: View towards the north showing the dilapidated structure and the entrance to the site in the background

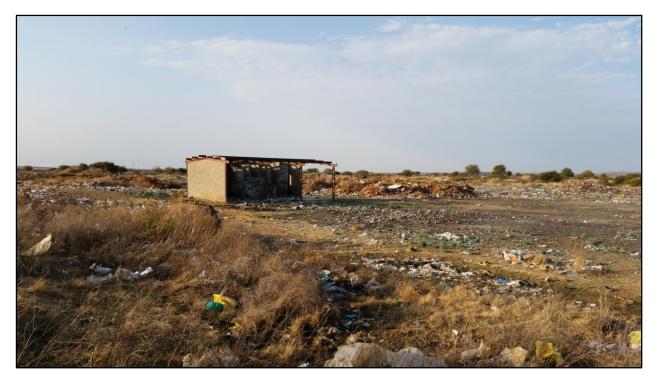
Figure 10: View towards the north east, note extent of dumping to the right of the side

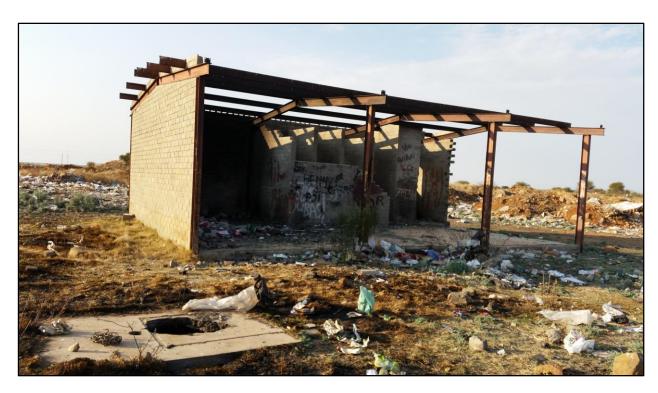
Figure 12: Close up view of the dilapidated structure on site

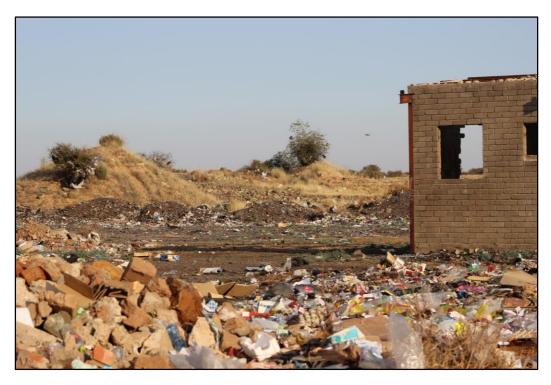
Figure 14: View south east showing waste around the structure

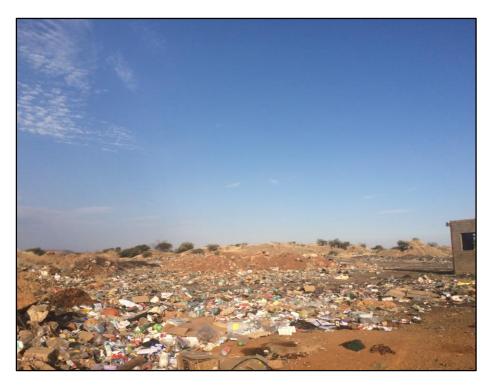
Figure 15: Additional view related to Figure 14 showing extent of dumping

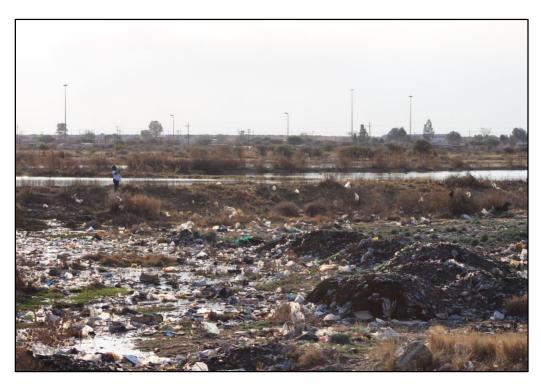
Figure 17: View west towards the oxidation pond. Note the effluent from the pond within the waste

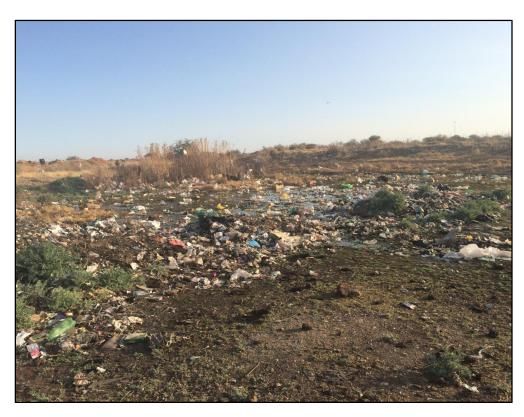
Figure 18: View of the effluent on the south west of the structure on site

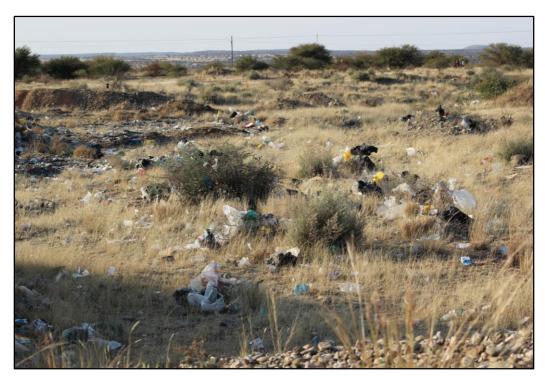
Figure 20: View towards the south east showing windblown litter

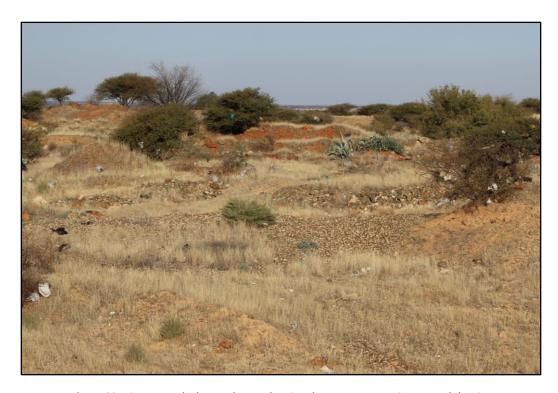
Figure 22: View towards the south east showing the sparse vegetation around the site

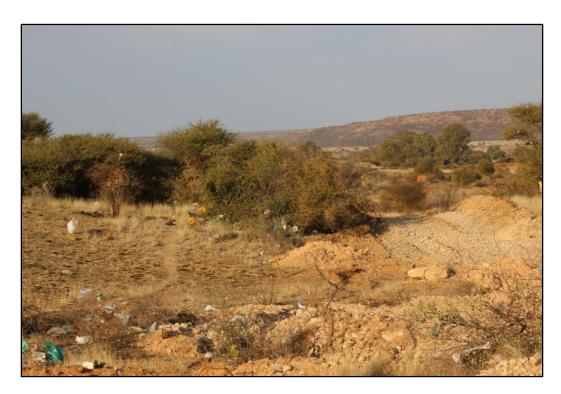
Figure 23: View east showing windblown litter around the site
