DEFECTS AND REPAIR STRATEGY FOR BRIDGE No. 4048						
DEFECT	PHOTO REFERENCE	REPAIR STRATEGY	REFERENCE DRAWINGS	REFERENCE DETAILS	PAYMENT ITEMS	*RECOMMENDED PRODUCTS
CONCRETE DELAMINATION AND REBAR CORROSION TO ALL BALUSTRADES	1-2	REPAIR CONCRETE DELAMINATION AND REBAR CORROSION TO BALUSTRADES	34161.00C-215-04-101	DETAIL 4	B123.03	SIKA TOP-ARMATEC 110EC, SIKA MONO TOP-615HB AND ANTISO-15
LONGITUDINAL DECK CRACKS (0.5-5mm)	3	CRACK REPAIR INCLUDING SEALING AND INJECTING OF CRACKS, TO METHOD 2	34161.00C-215-04-100	DETAIL 3	121.04, 124.05	SKADUR-33 CF NORMAL, SKADUR-52 ZA
MODERATE DAMAGE TO DECK EDGE AND UPSTAND BEAM	4-5	REPAIR SPALLED CONCRETE ON DECK EDGE	34161.00C-215-04-100	DETAIL 1	121.04, B123.03	SIKA TOP-ARMATEC 110EC, SIKA MONO TOP-615HB AND ANTISO-15
GENERAL VERTICAL WALL CRACKS (0.5-5mm)	6	CRACK REPAIR INCLUDING SEALING AND INJECTING OF CRACKS, TO METHOD 2	34161.00C-215-04-100	DETAIL 3	121.04, 124.05	SKADUR-33 CF NORMAL, SKADUR-52 ZA

PROPOSED REPAIR OF BRIDGE No. 4048 ON TRUNK ROAD 3305 AT KM22.78 OVER MODDERDRIFT STREAM
DEFECTS AND REPAIR STRATEGY

P.R.E.'s FILE No. 16/64/1/4-TR03305-C1183	SCALE AS SHOWN
CONTRACT No. C1183	WCG STRUCTURES PLAN No. 4048
CONSULTANT'S PLAN No.

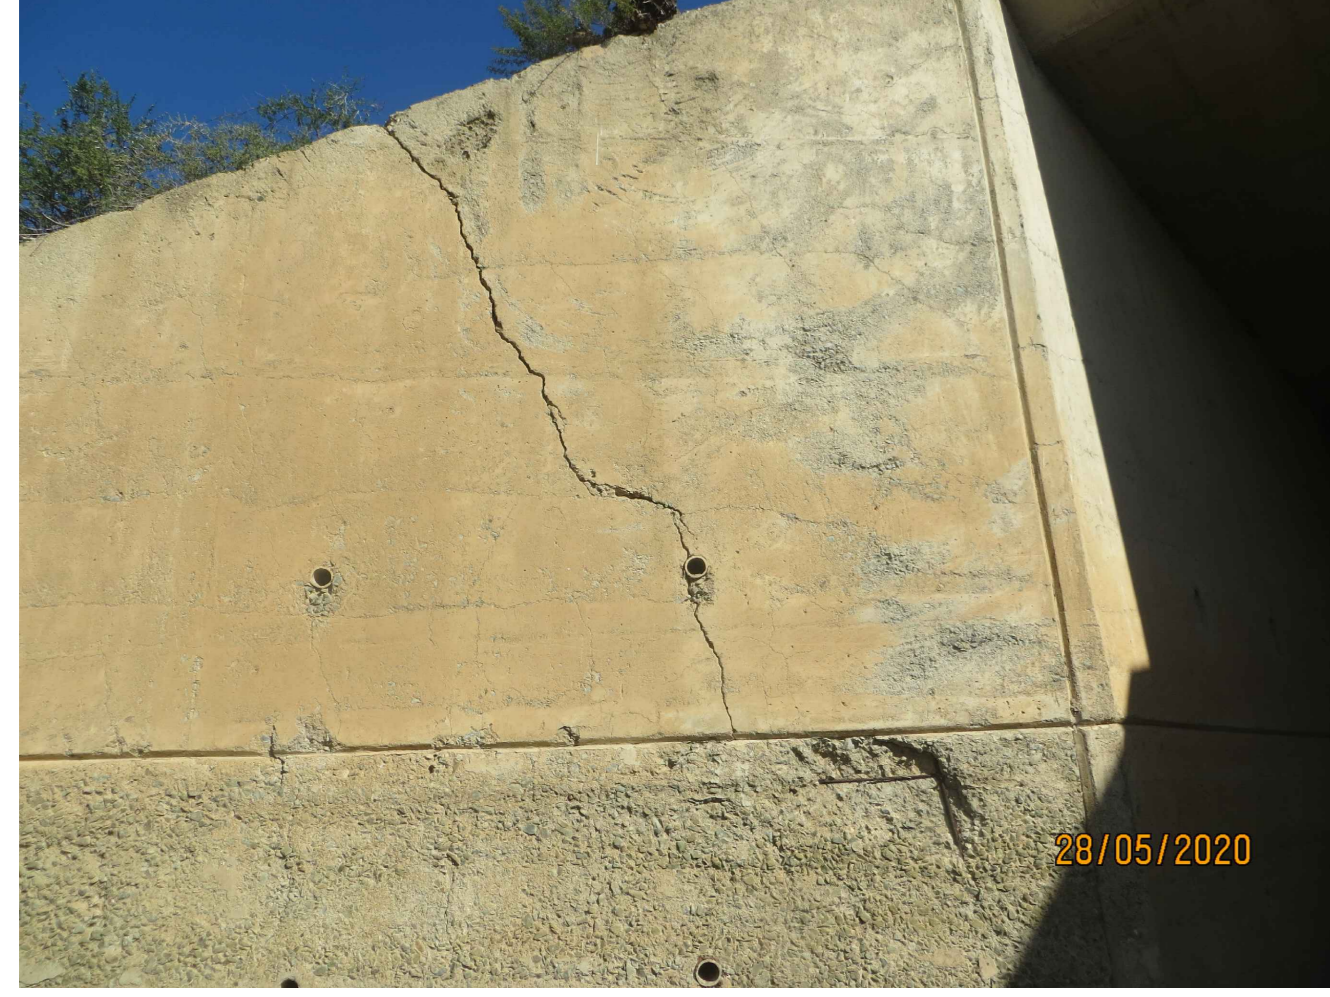
PHOTO 7

MAJOR DIAGONAL CRACK IN SOUTH-EAST WINGWALL (5mm)	7	CRACK FILLING TO METHOD 3	34161.00C-215-04-100	DETAIL 3	124.07	SKADUR-52 ZA, SIKA TOP-ARMATEC 110EC, SIKA MONO TOP-615HB AND ANTISO-15
MODERATE TO SEVERE SPALLING OF WINGWALL AND ABUTMENT CONCRETE	8-9	REPAIR SPALLED CONCRETE ON DECK EDGE	34161.00C-215-04-100	DETAIL 1, DETAIL 2	121.01, B123.03	SIKA TOP-ARMATEC 110EC, SIKA MONO TOP-615HB AND ANTISO-15
SEVERE WINGWALL CORNER CRACKING AND SPALLING DUE TO DECK MOVEMENT	10-12	DEMOLISH AND RECONSTRUCT TOP CORNER OF NORTHERN WING WALLS	34161.00C-215-04-101	DETAIL 7	21.04, 64.06, 63.01, 62.02, 64.01	-
WESTERN WINGWALLS OF POOR CONCRETE QUALITY	11	TEST FOR COMPRESSIVE STRENGTH TO DETERMINE THE CONCRETE QUALITY AND IF THE STRUCTURE HAS ADEQUATE LOAD BEARING CAPACITY	-	-	81.02	-
WATERWAY EROSION AT NORTH-EASTERN WINGWALL	13	CONSTRUCT GABION WALL AND BACKFILL ERODED AREA AT WINGWALL	34161.00C-215-04-105	DETAIL 13	52.01, 52.02, 52.03, 52.04, 66.21, 66.23	-

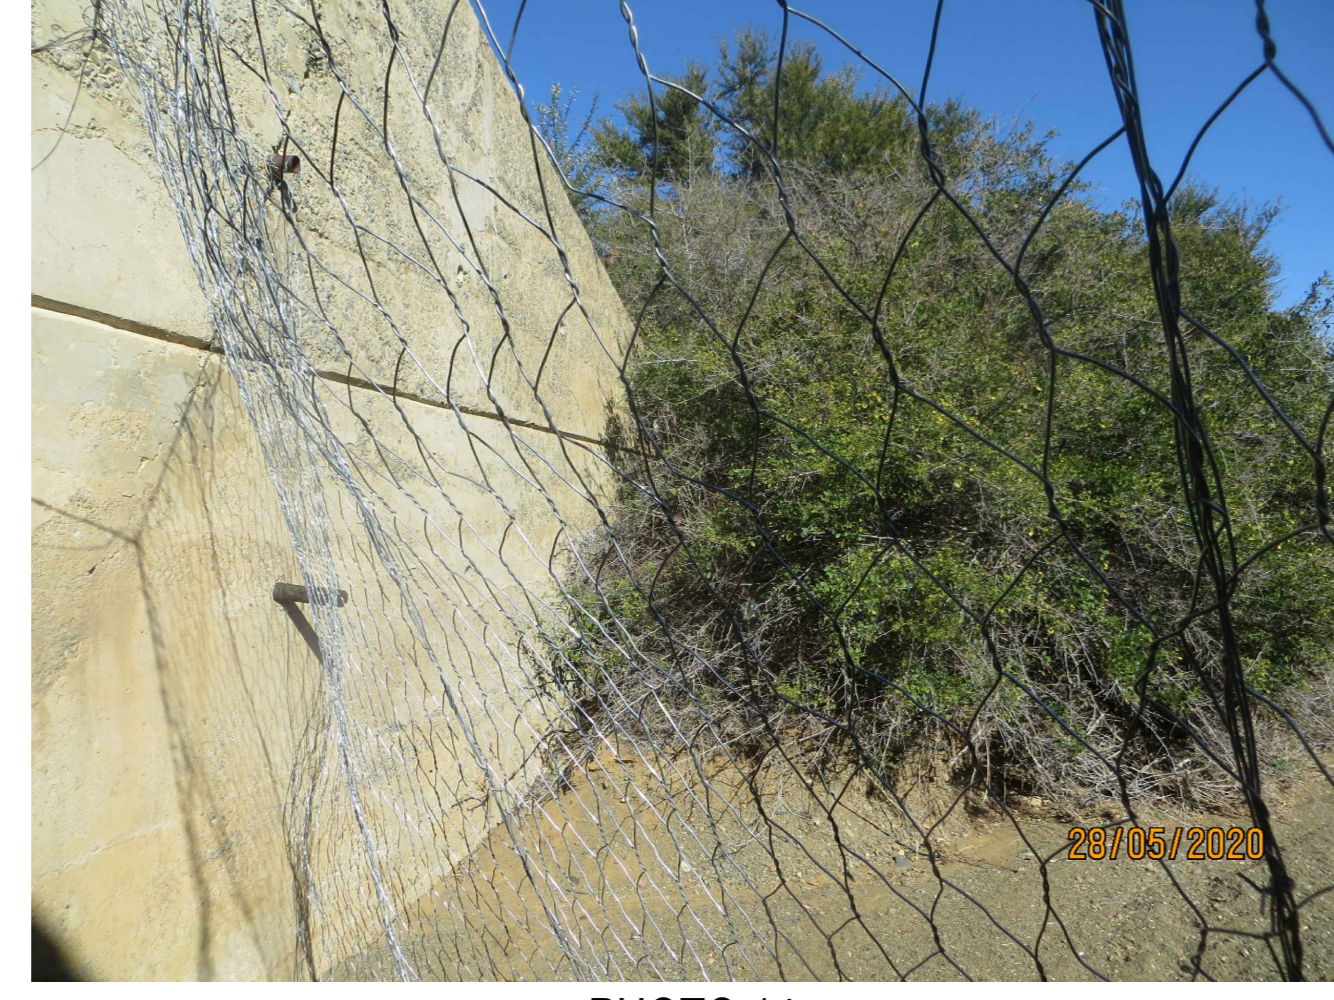
PHOTO 14

VEGETATION IN WATERWAY	14	CLEAR VEGETATION IN WATERWAY	-	-	1212.02	-
