APPENDIX C: PHOTOGRAPHIC EVIDENCE

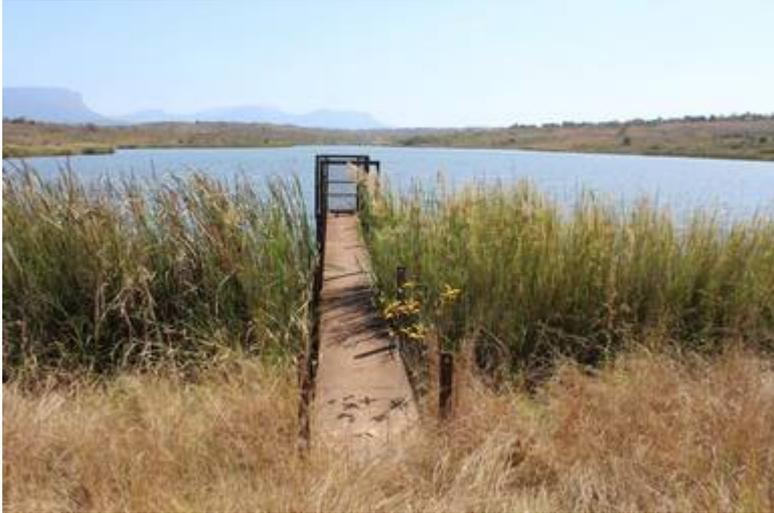
Photo 1: Casteel Dam facing upstream

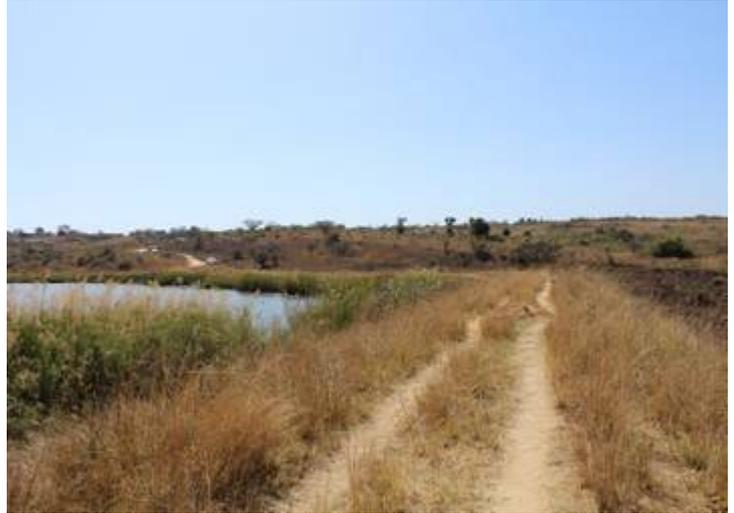
Photo 2: Dam crest (access road on dam wall)

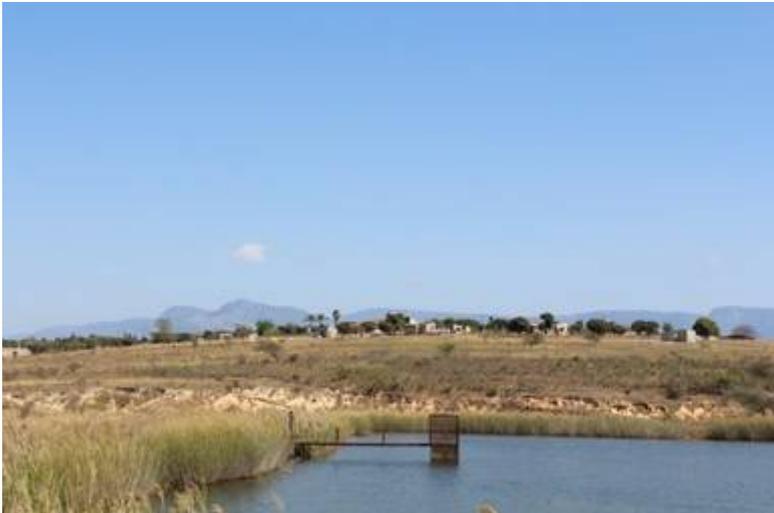
Photo 3: Dam embankment (upslope). The reeds will be removed from the upslope embankment and spillway as part of rehabilitation works.

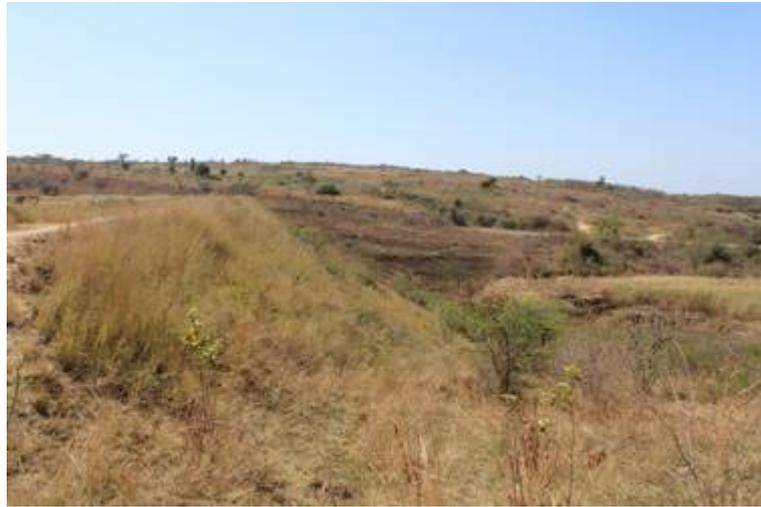
Photo 4: Downstream slope of dam embankment where rehabilitation works are proposed. The embankment is mainly covered in re-established grass.

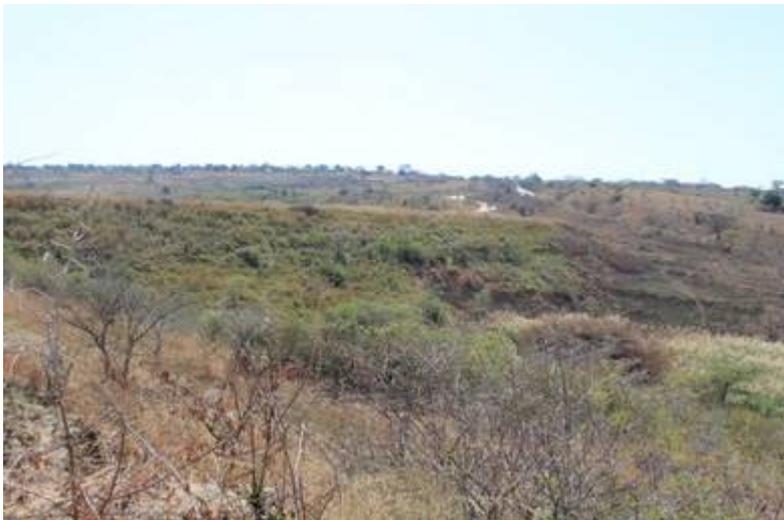
Photo 5: Downstream slope of dam embankment where rehabilitation works are proposed. Photo taken facing north towards the embankment.

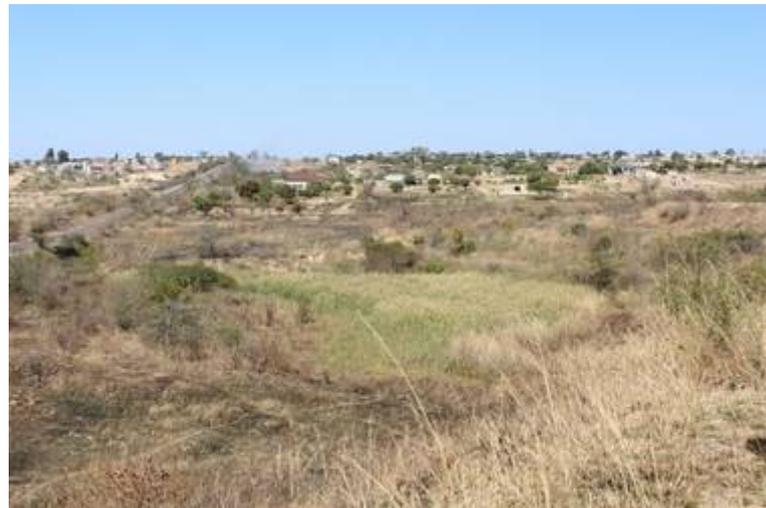
Photo 6: CVB wetland below dam embankment

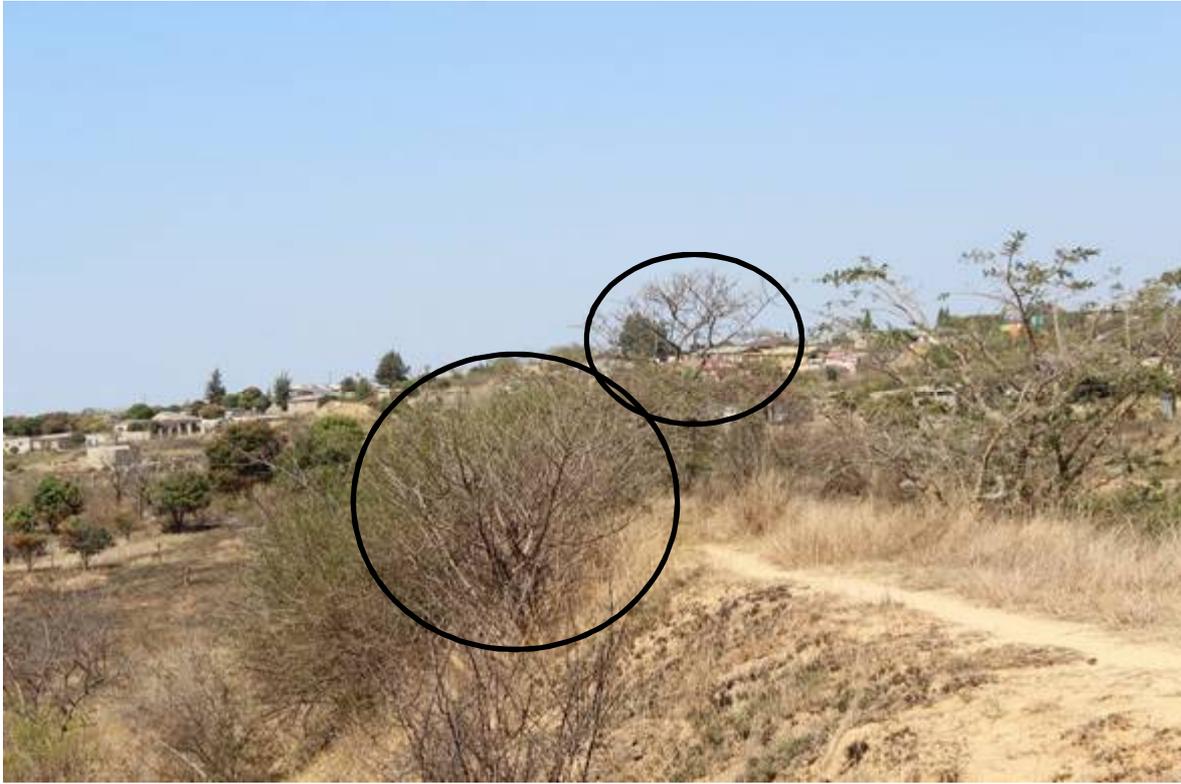
Photo 7: Several Marula trees (encircled), without leaves, located on the groin of the dam embankment.

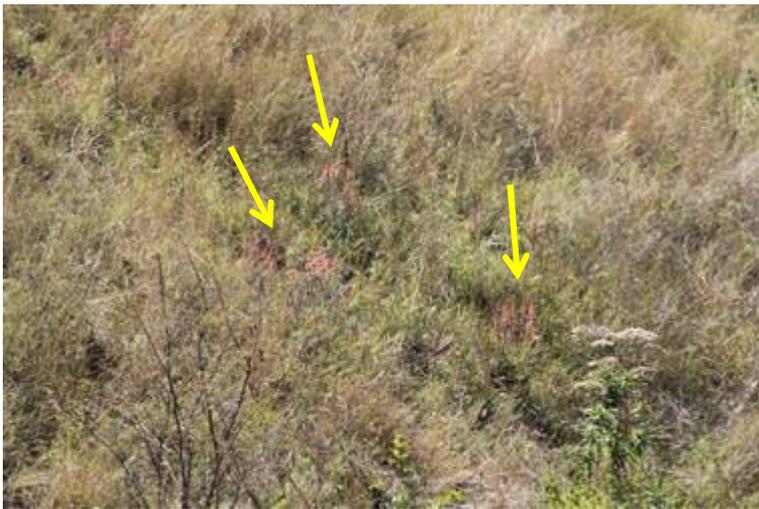
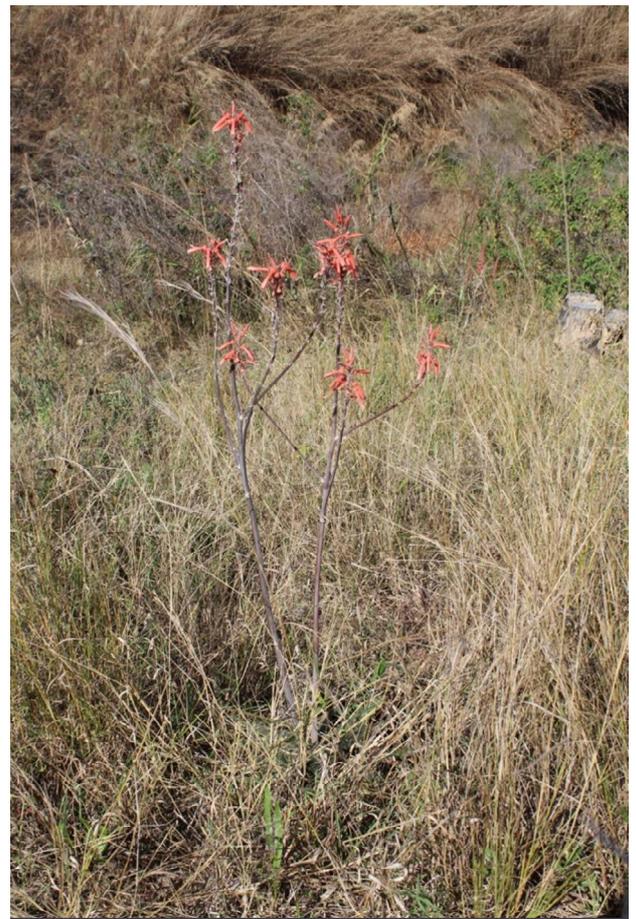
Photo 8 (above) and 9 (right): Several *Aloe Simii* succulents spotted on the downstream slope of the dam embankment. These are provincially protected species.

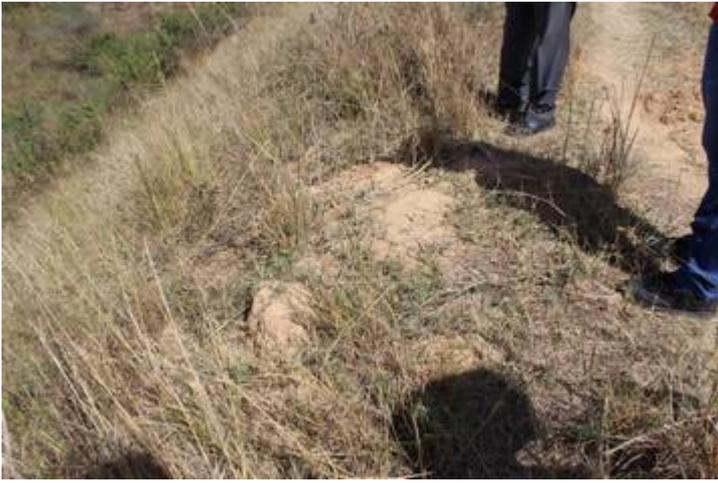
Photo 9: Termite nest on the dam downstream slope

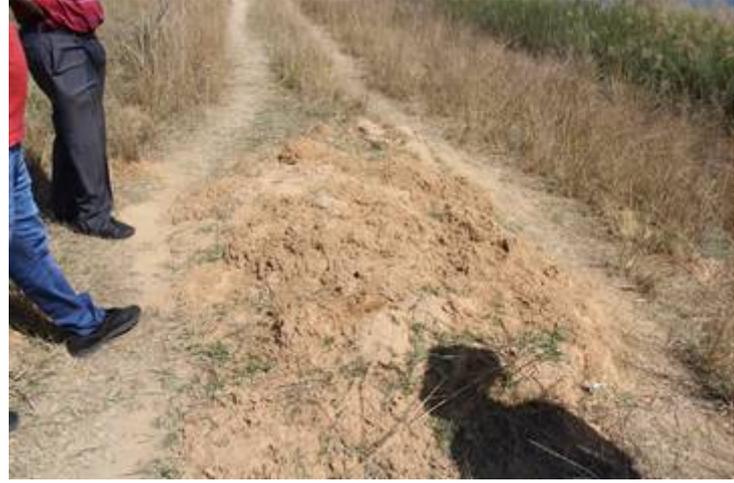
Photo 10: Termite nest on the dam crest

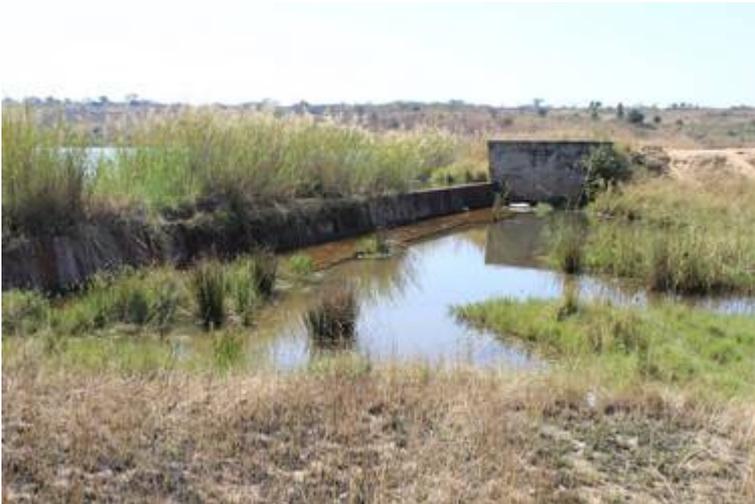
Photo 11: Sharp crested weir spillway

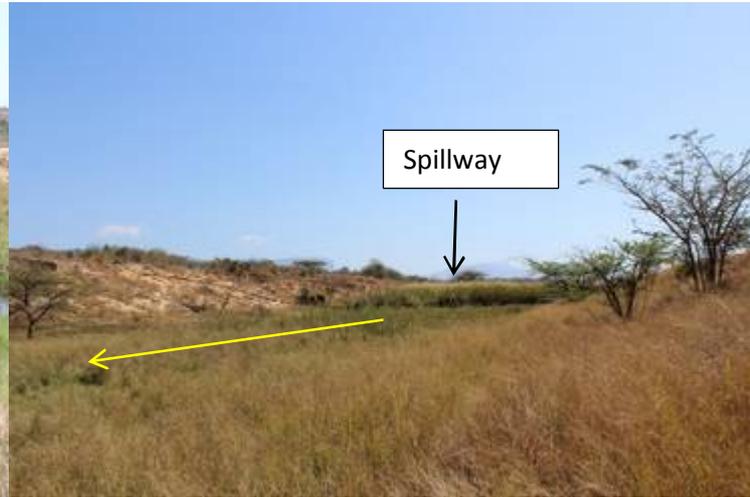
Photo 12: Spillway channel

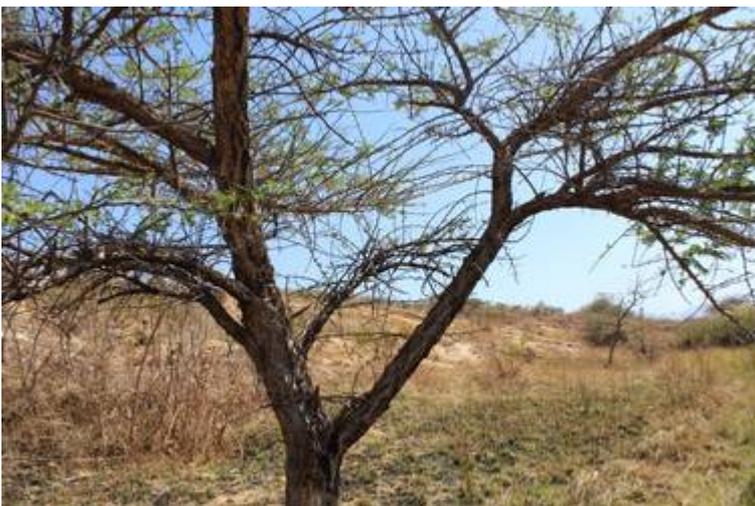
Photo 13: Umbrella Thorn tree next to spillway channel

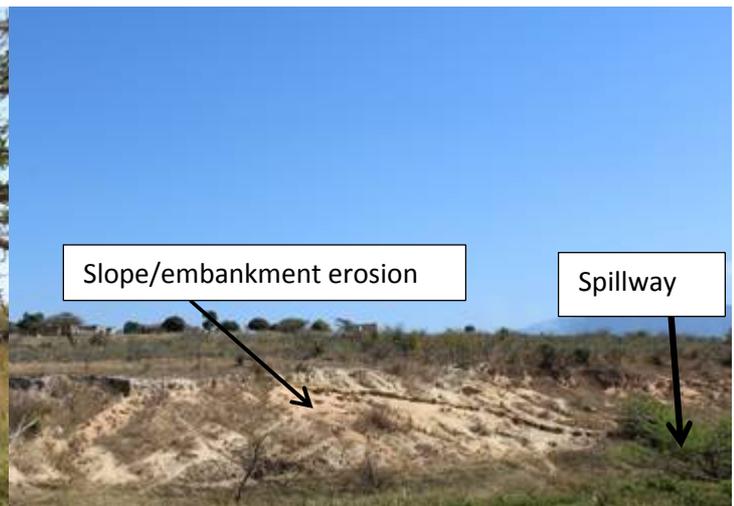
Photo 14: Slope/embankment erosion along spillway channel

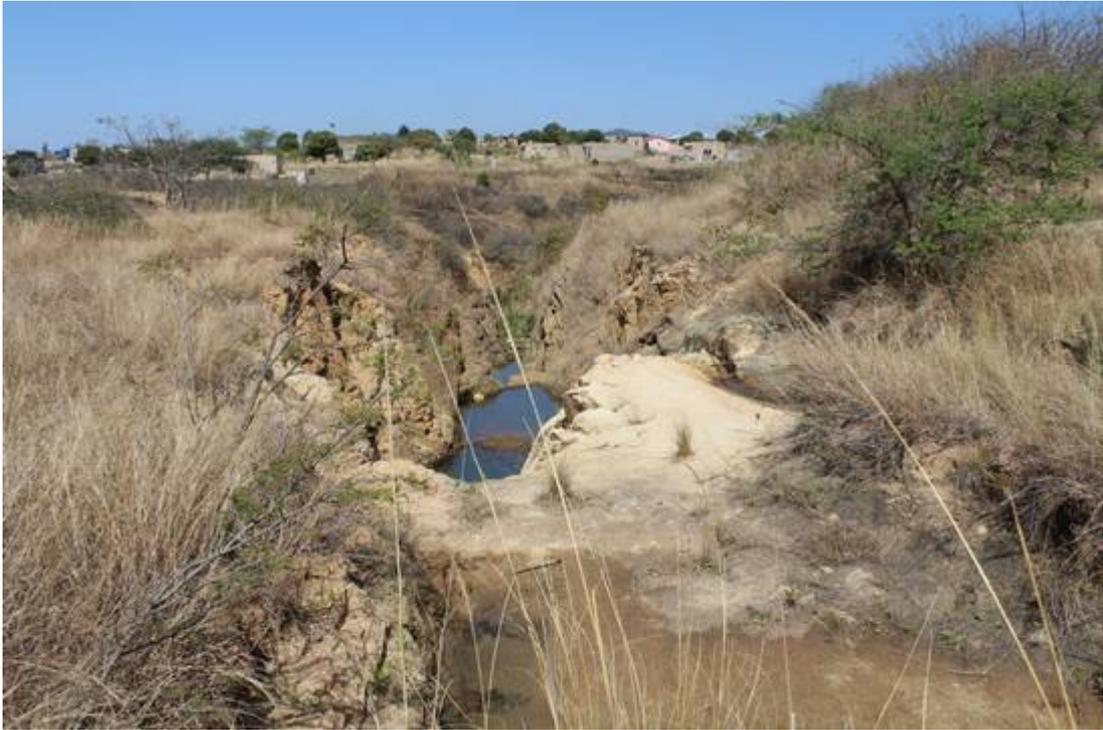
Photo 13: Large donga formed below the spillway channel.

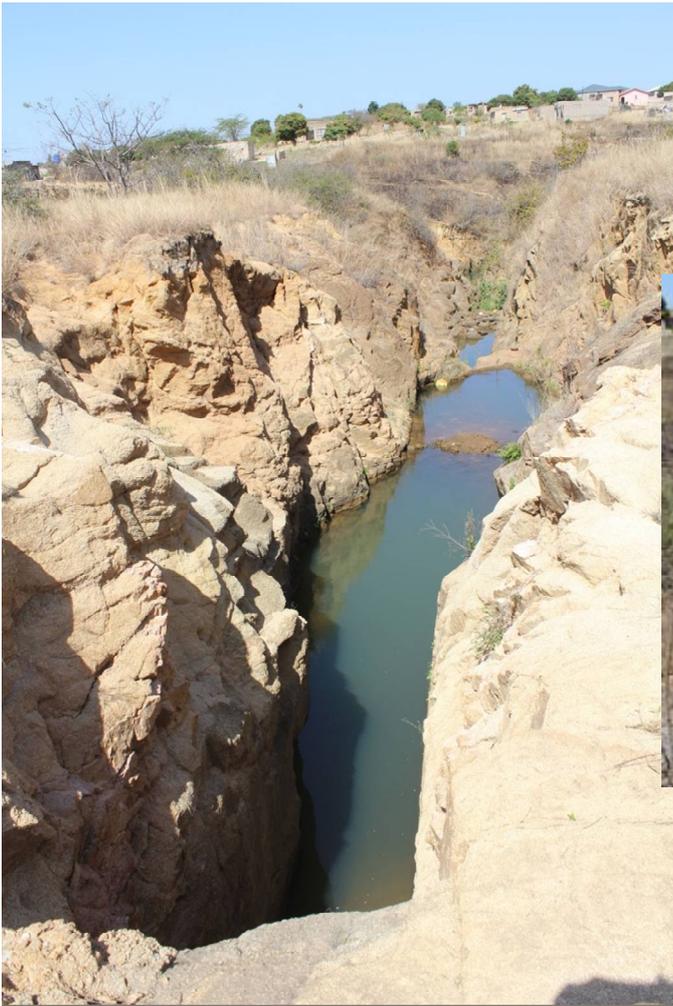
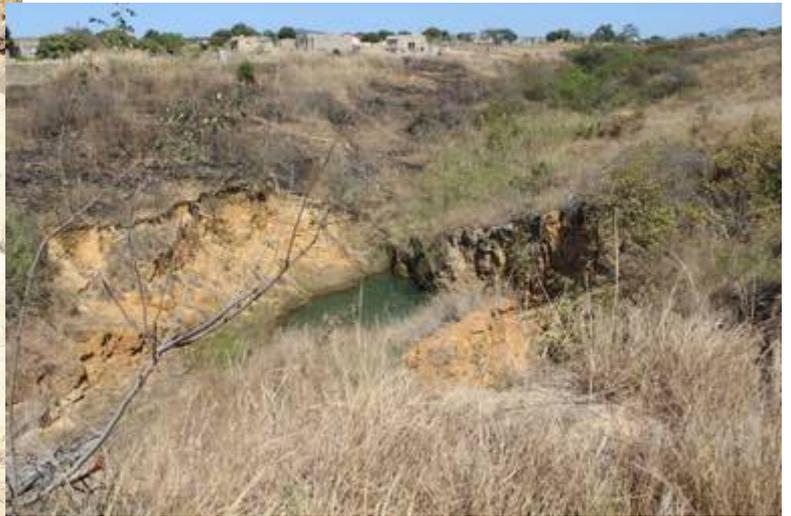
Photo 14 (left) and 15 (above): Large donga below the spillway channel.

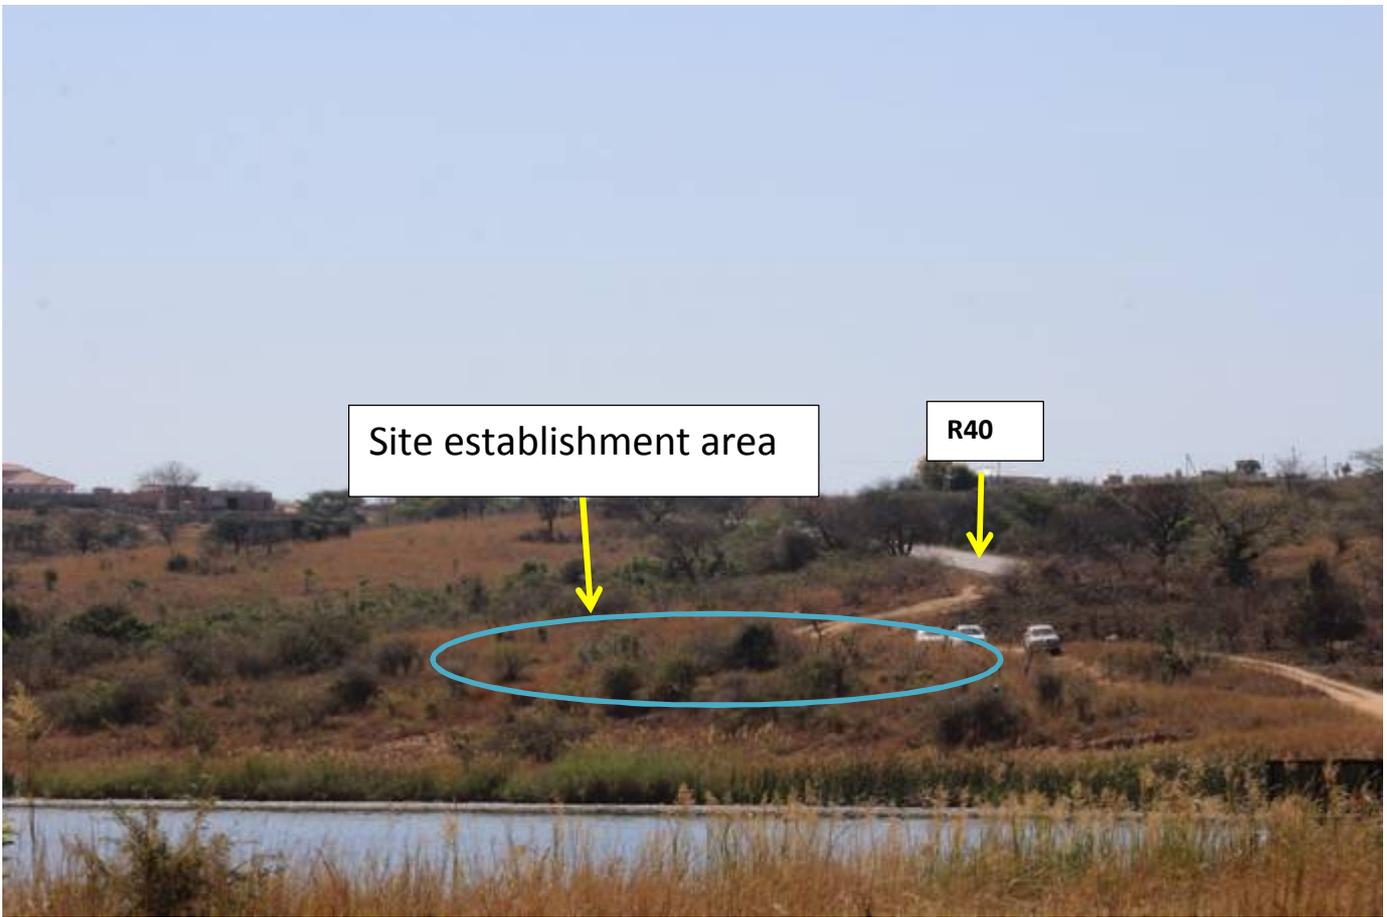
Photo 16: Site establishment area viewed from the dam embankment, located northeast of the dam embankment and west of the gravel access road

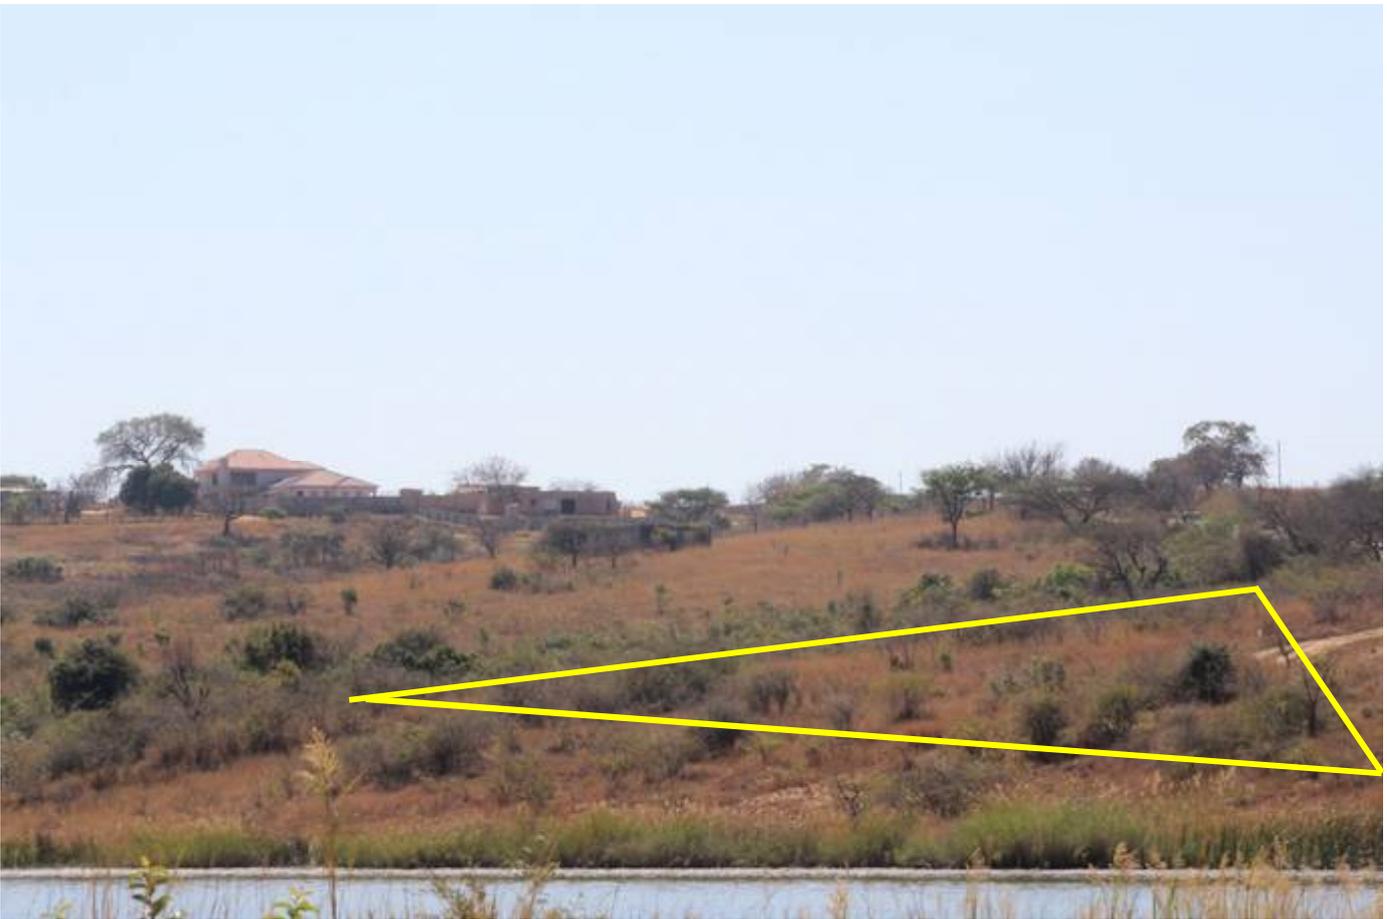
Photo 17: Site establishment area is proposed approximately 40 meters above the bank of the dam. The site is covered in disturbed Granite Lowveld open woodland / veld.

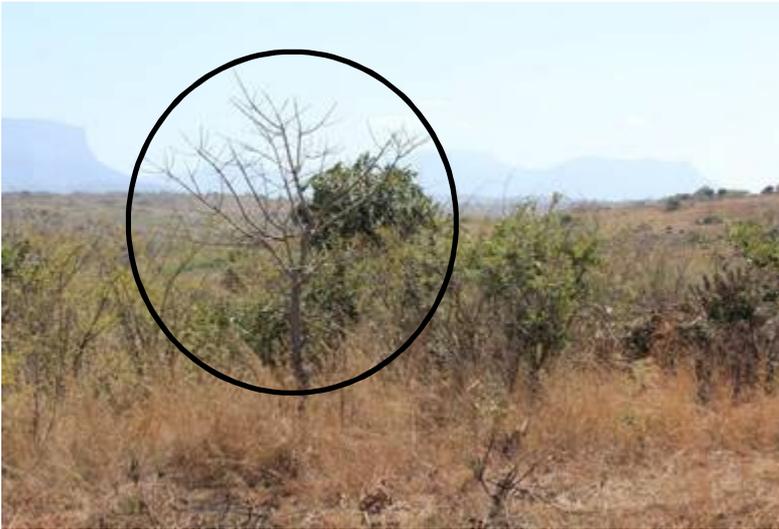
Photo 18: Marula tree (encircled) without leaves on site establishment area.

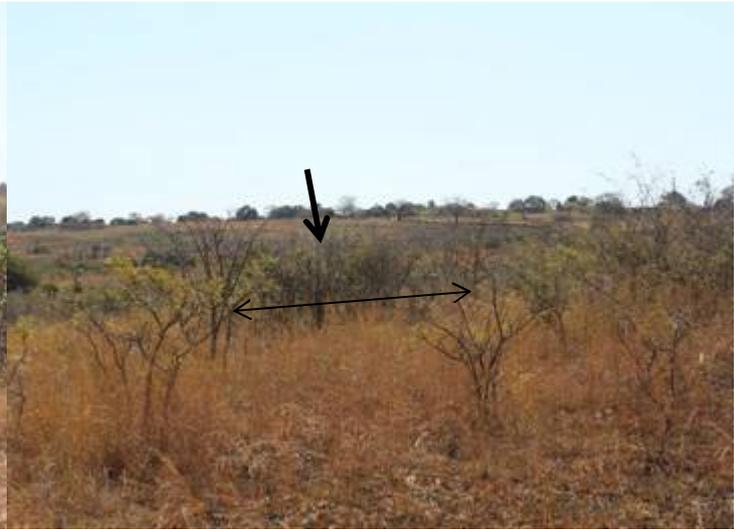
Photo 19: Dense cover of Sicklebush on the site establishment area

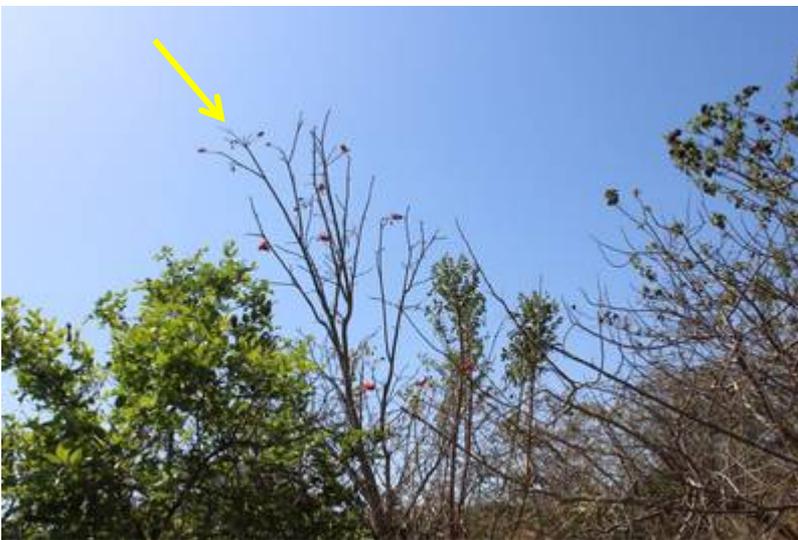
Photo 20: Coral Tree (Koraalboom) located close to the drainage line north of site establishment areas.

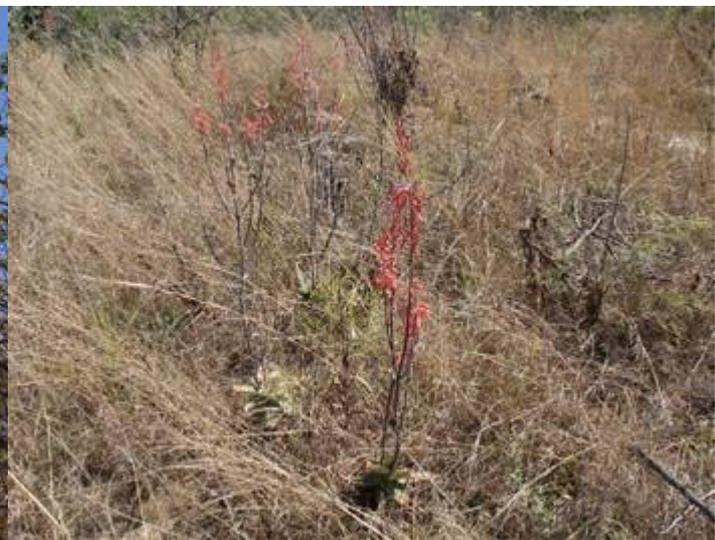
Photo 21: Aloe Simii succulent located within the site establishment area.

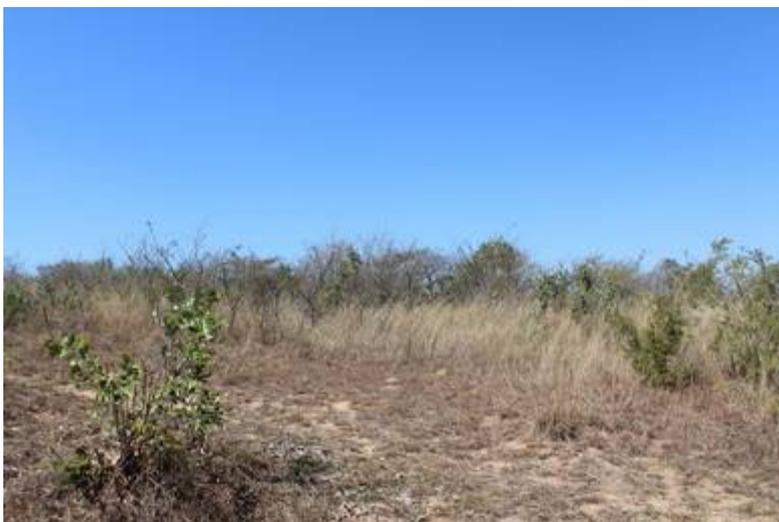
Photo 22: Disturbed areas amid the Granite Lowveld open woodland at the site establishment area

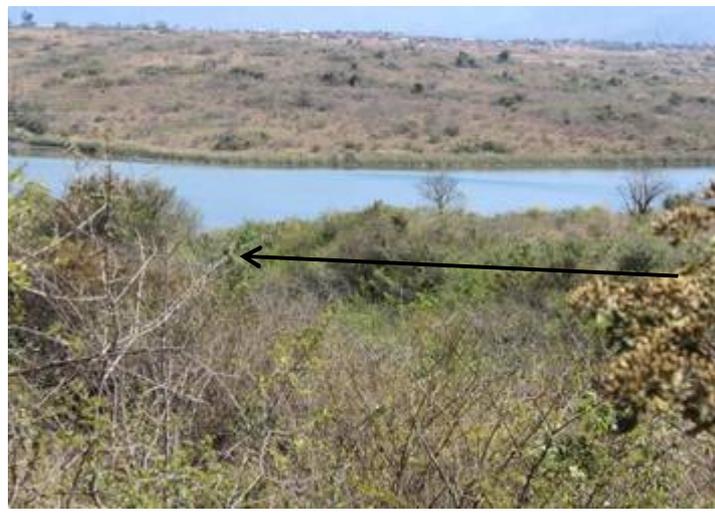
Photo 23: Drainage line north of site establishment area

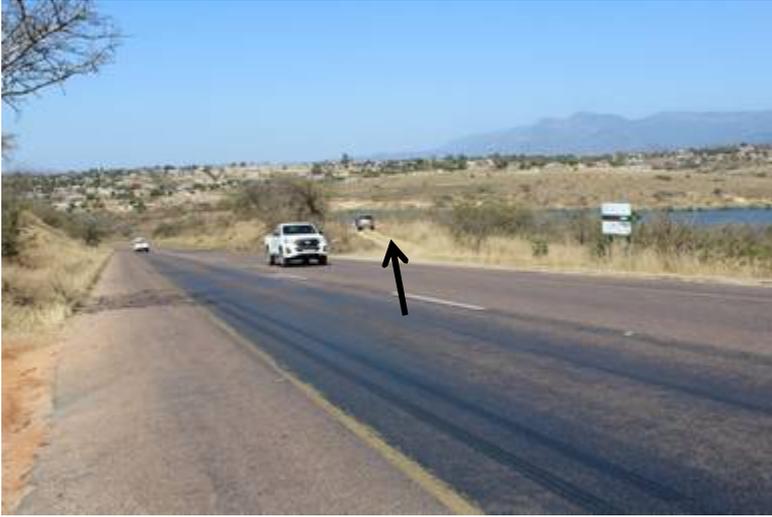
Photo 24: Existing gravel access road from the R 40 to Casteel Dam

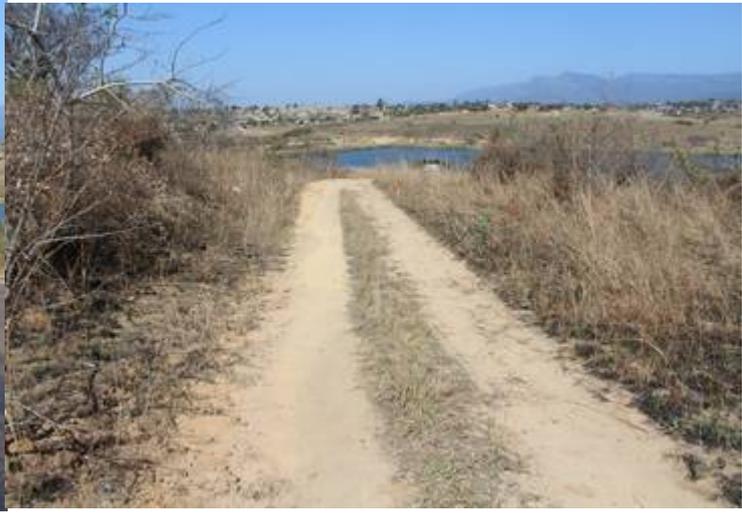
Photo 25: Existing gravel access road to the Casteel Dam embankment which will be upgraded (Section 1).

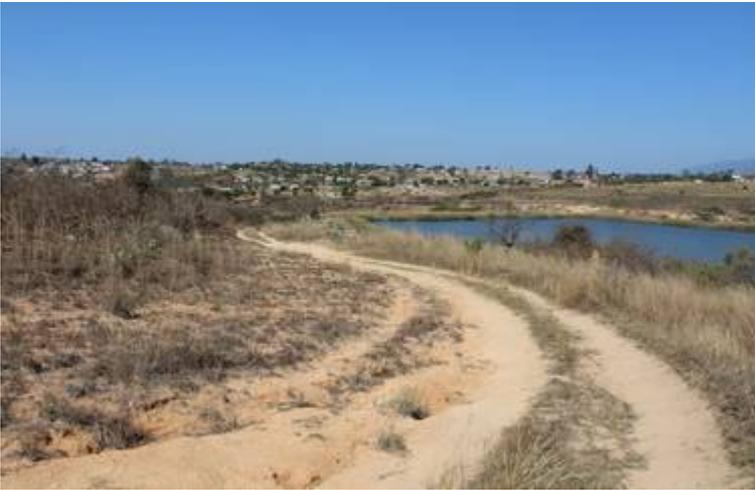
Photo 26: Existing gravel road to the Casteel Dam embankment. (Section 2)

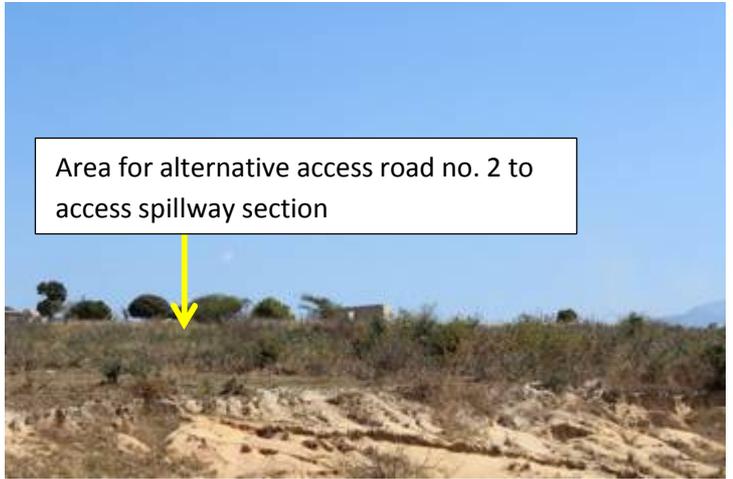
Photo 27: Modified old lands where the alternative access road to the spillway section will be established. Majority of the existing road passes through the Casteel settlement. Only a short distance of additional access road will need to be created to access the spillway (i.e. 350m).
