## Bushbuckridge Local Municipality Site Inspection

### RE: BASIC ASSESSMENT (BA) PROCESS FOR THE PROPOSED CASTEEL DAM SAFETY REHABILITATION PROJECT, FARM KASTEEL 231-KU, BUSHBUCKRIDGE LOCAL MUNICIPALITY, MPUMALANGA PROVINCE

<b>Project name</b>	Casteel Dam Safety Rehabilitation Project
<b>Date &amp; Time Meeting</b>	25 October 2022, 14:30 – 15:30
<b>Venue</b>	At Casteel Dam (onsite)
<b>Chairperson</b>	Marissa Botha, Naledzi Environmental Consultants (Pty) Ltd (Naledzi) and Rodney Siwelane (DWS:SIAM)
<b>Attendees</b>	Please refer to the attached <b>signed attendance register</b> under <b>Annexure A</b> .
<b>Apologies</b>	None received.
<b>Contents of Minutes</b>	<p>No specific discussions took place. The Bushbuckridge Local Municipality, Environmental Section was showed the Casteel Dam site including the location of the proposed rehabilitation works, access intersection to the upgraded and temporary site camp area.</p> <p>Mr Rodney Siwelane explained the scope of works, location of works and proposed project schedule.</p> <p>A short discussion text is included and the photographic proof of the site inspection.</p>

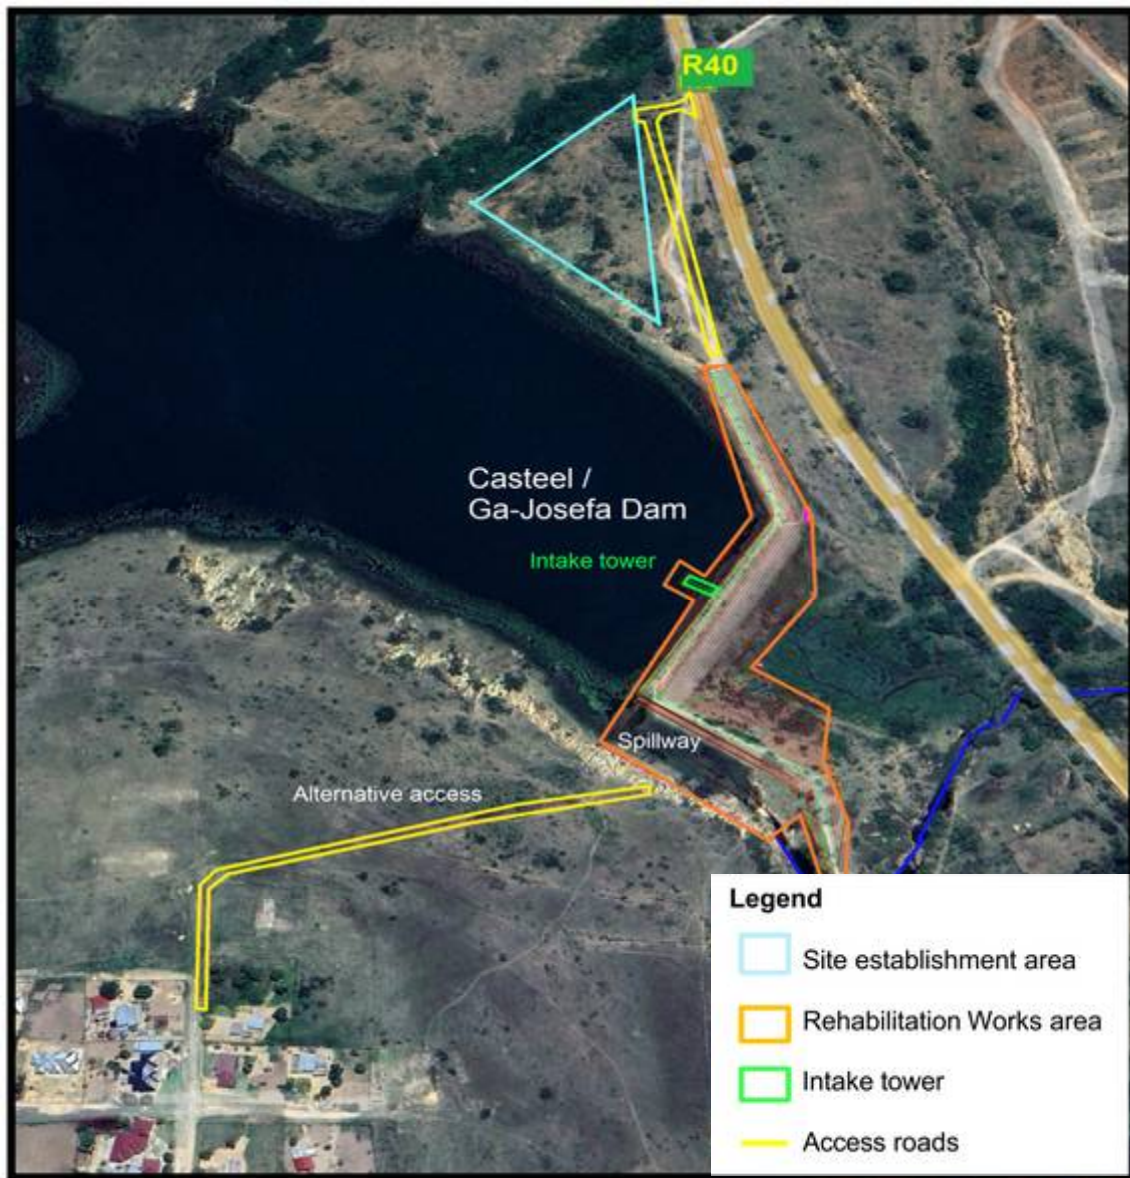
**Figure 1: Proposed Casteel Dam rehabilitation works, site establishment area and access roads superimposed on Google Earth Satellite imagery.**

Mr Rodney Siwelane (DWS: SIA) started the site inspection at the Casteel Dam access road intersection with the R40. It was explained that the access road would be upgraded and realigned to be 6 meters (wide) and extend from the R40 to the toe of the dam (250 meters). It would be realigned to a 90 degree angle with the R40 to make the intersection with the R40 safer.

The temporary site camp of 0.9ha would be established west of the R40 and existing gravel access road. The site establishment area comprises degraded shrubland that would need to be cleared to accommodate the site offices and construction material stockpiles.

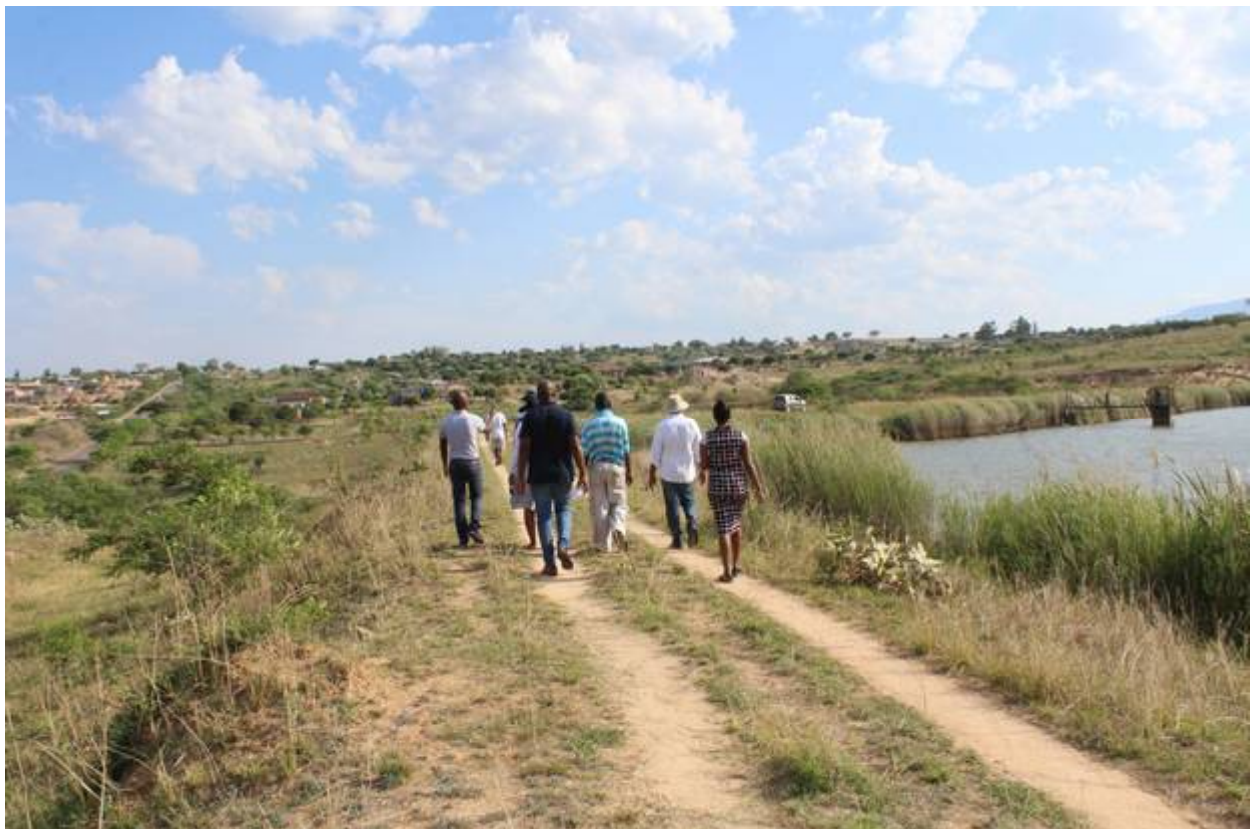
**Figure 3: Delegates inspecting the Casteel Dam embankment heading towards the intake tower.**

The attendees moved south toward the dam embankment where it was outlined that the DWS would remove all reeds and vegetation on the spill approach channel and upstream slope along the dam embankment as part of the rehabilitation works. It will promote the free flow of water, prevent spillway blockages and allow for the placement of slope protection material (rocks).

The dam outlet works would be repaired and the intake tower expanded from 1.5m x 1.5m to 5m x 5m. A concrete intake tower bridge would be provided and a temporary coffer dam will be constructed around the tower to create a safe working space.

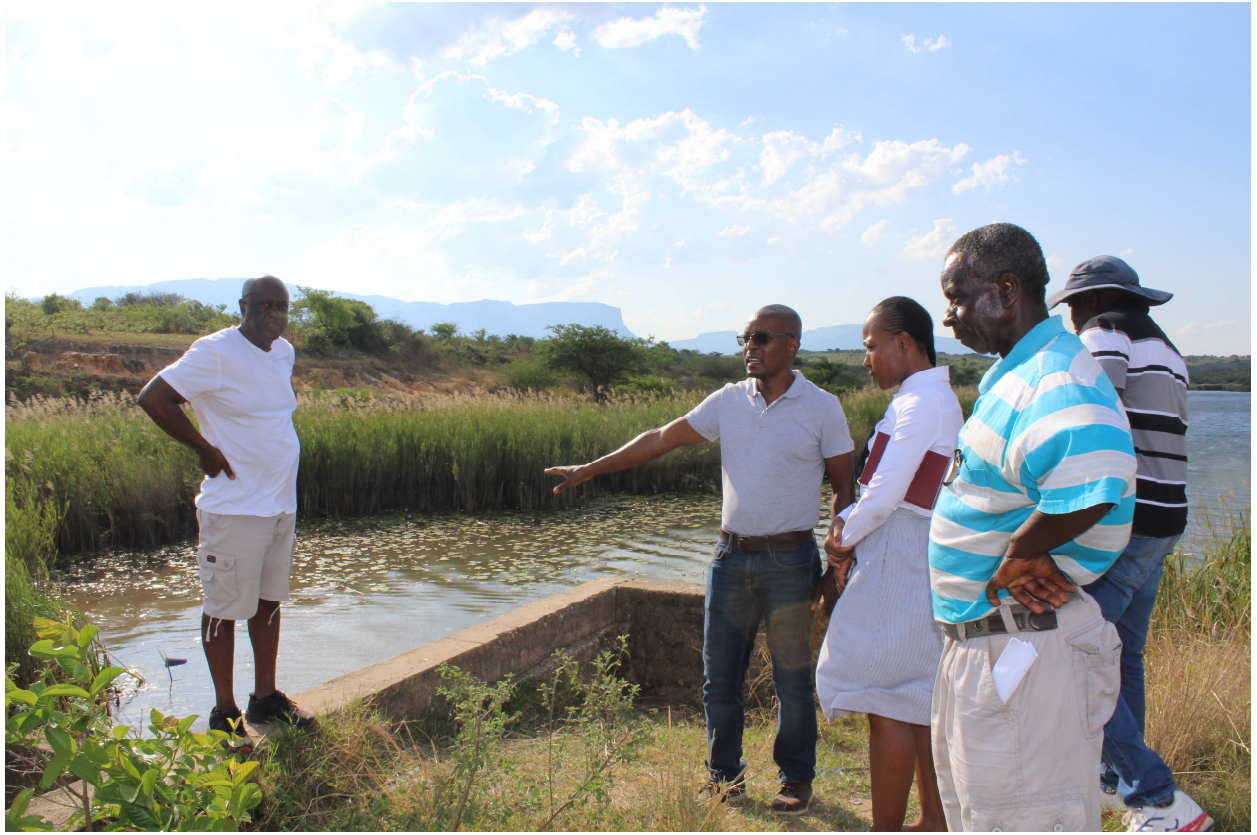
**Figure 4: Delegates inspecting the spillway section of Casteel Dam.**

<b>Spillway channel</b>	<ul style="list-style-type: none"> <li>• Slope channel (right and left flank) to 1:0.75;</li> <li>• Line both sides of spillway using Amoflex / Geocell (i.e. erosion protection) ;</li> <li>• Construct a new training wall raised to 605.5 mabsl (existing wall foundation to be demolished).</li> </ul>
	<b>Embankment drainage and filter system</b>	<ul style="list-style-type: none"> <li>• Construct an inclined chimney drain and a toe drain to control dam wall seepage;</li> <li>• Two 160mm perforated collector pipes (embedded in 19mm stone) will discharge collected seepage;</li> <li>• A V-notch will be used to monitor seepage;</li> <li>• Existing 3 x 250mm pipes will be replaced with up to 1000mm pipes.</li> </ul>
<p><b>Construction of a paved walkway on the dam crest.</b></p>		
<p><b>Construction material:</b> All the materials required for the rehabilitation works will be sourced from a licensed commercial quarry/crusher.</p>

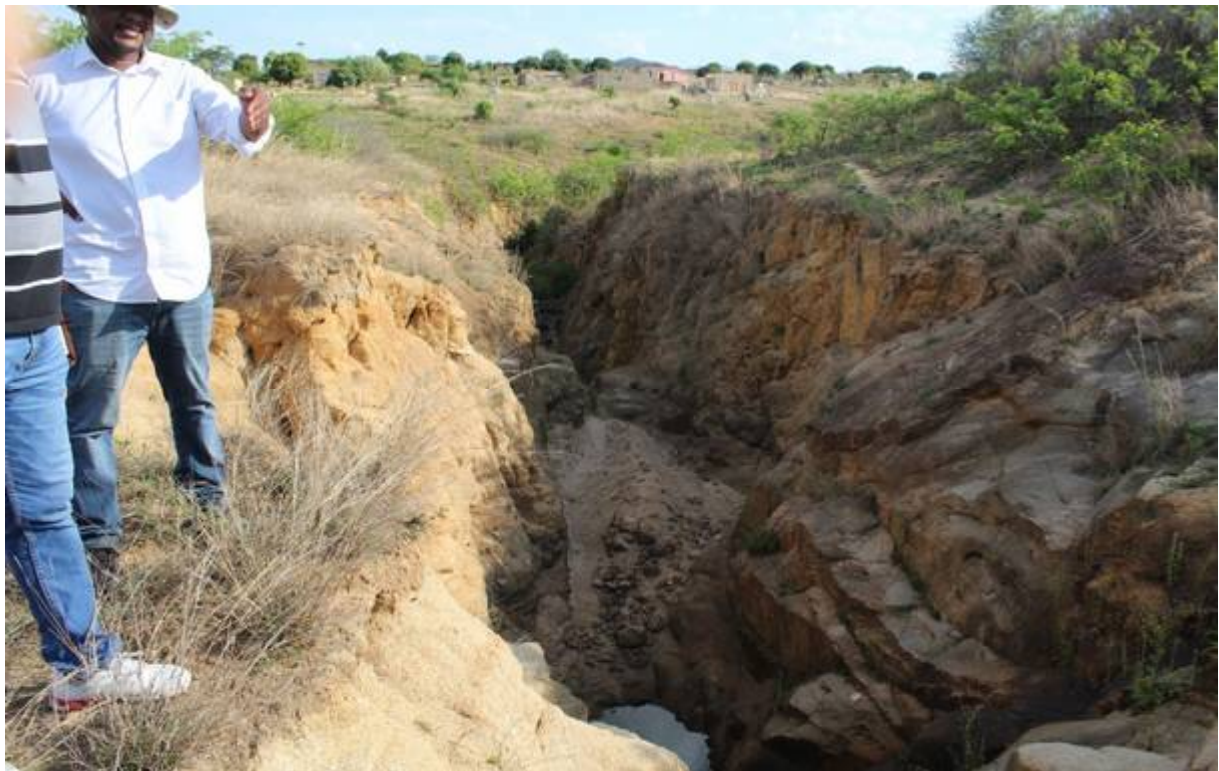
**Figure 5: Delegates inspecting the large donga below the spillway of Casteel Dam.**

There is also a significant donga downstream of the dam spillway section that needs to be rehabilitated. The water fro the spillway would be calmed by putting a concrete wall and stepped spillway to the bottom of the donga. Stone/large boulders would be dumped in the donga. The donga is a public safety issue. An alternative access road through Casteel settlement will be used to access the spillway section of the dam.
