APPENDIX C: PHOTOGRAPHS: ALTON WASTE FACILITY

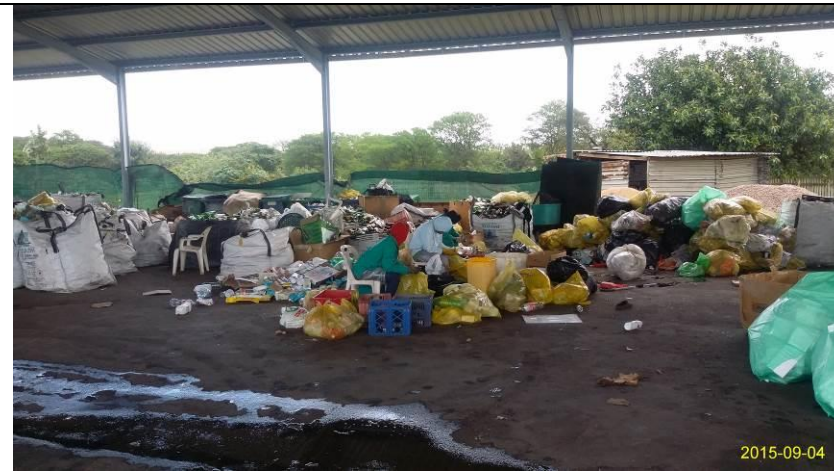
Looking west.
Photograph taken near Position 1.
Area where employees (of the NGO with whom uMhlathuze LM has an SLA) sort the recyclable materials to be sold off.

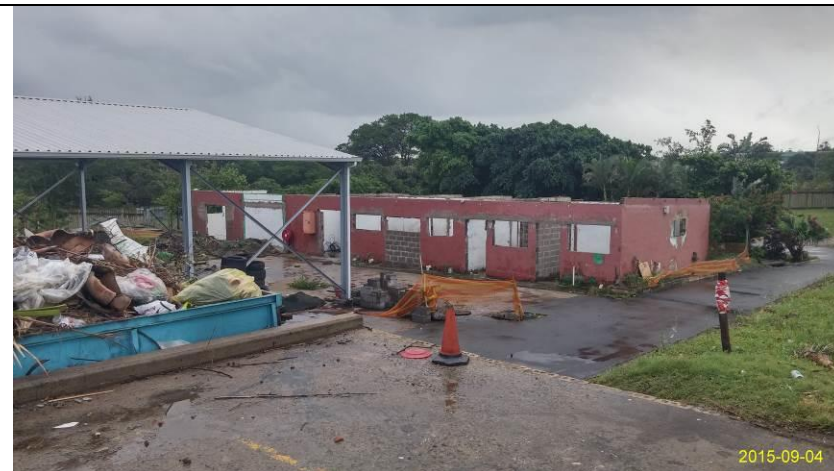
Looking north-west.
Photograph taken near Position 1.
Admin block, plans are underway for its rebuilding.

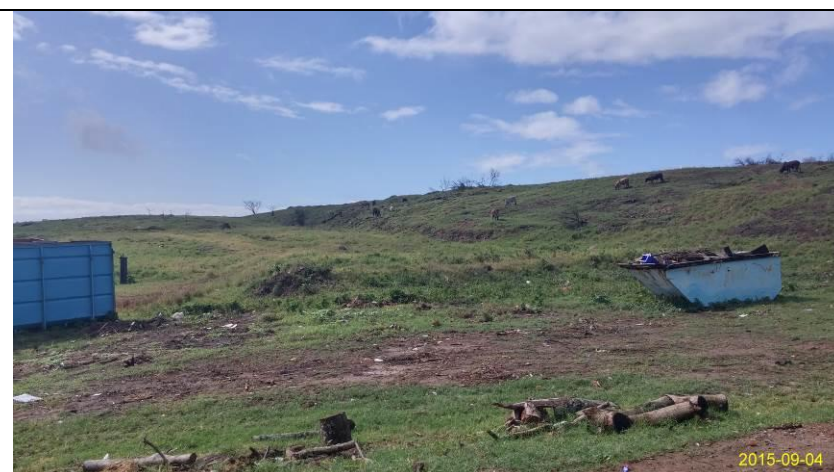
Looking east.
Photograph taken near Position 2.
Decommissioned landfill. Note the stormwater diversion channel. Cows have entered the site for grazing.

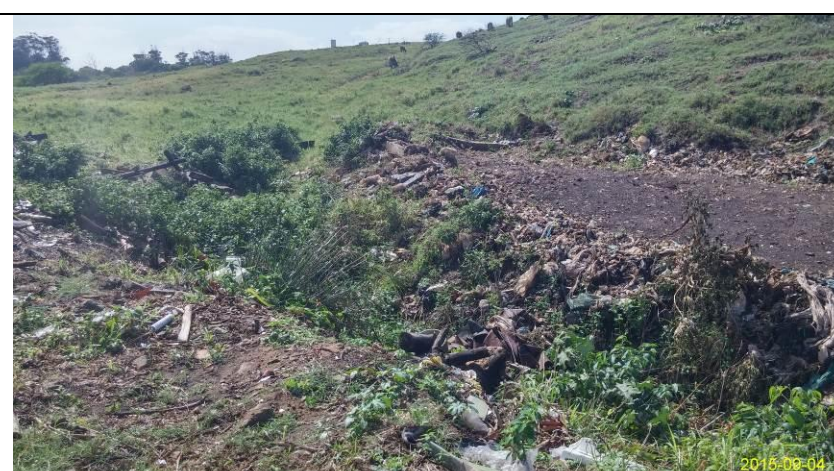
Looking east.
Photograph taken near Position 2.
Decommissioned landfill. Note the stormwater diversion channel at the foot of the landfill. This needs to be cleaned and maintained.

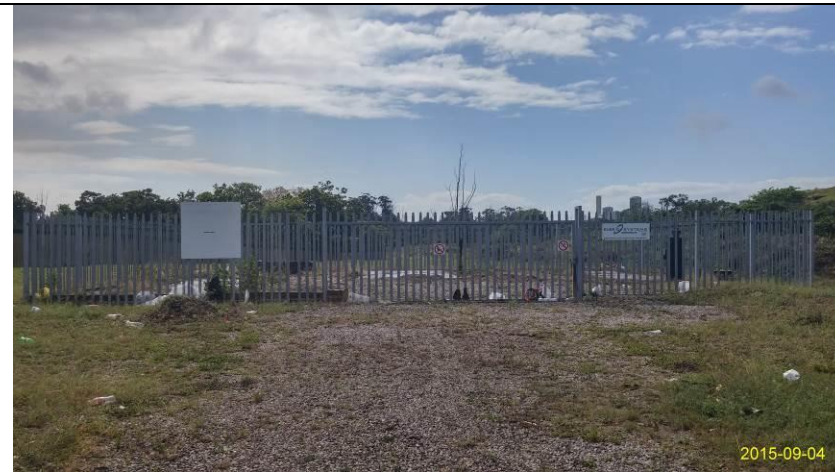
Looking north-east.
Photograph taken near Position 2.
Defunct landfill gas energy production facility (infrastructure has been removed).

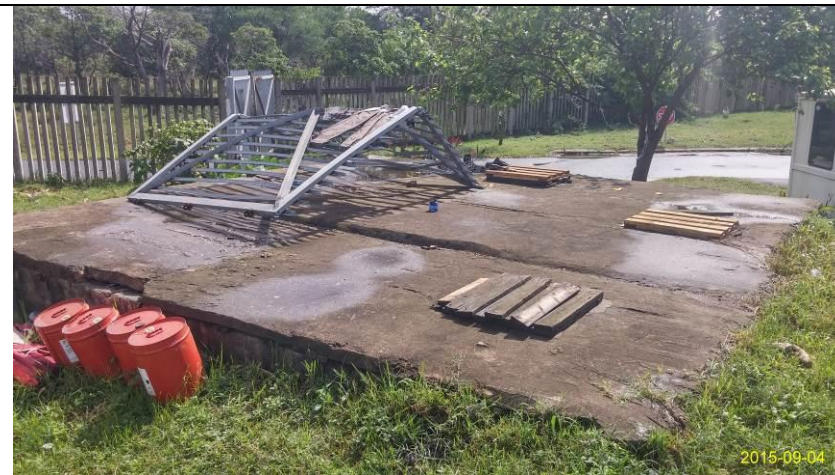
Looking west.
Photograph taken near Position 3.
Defunct leachate collection infrastructure.

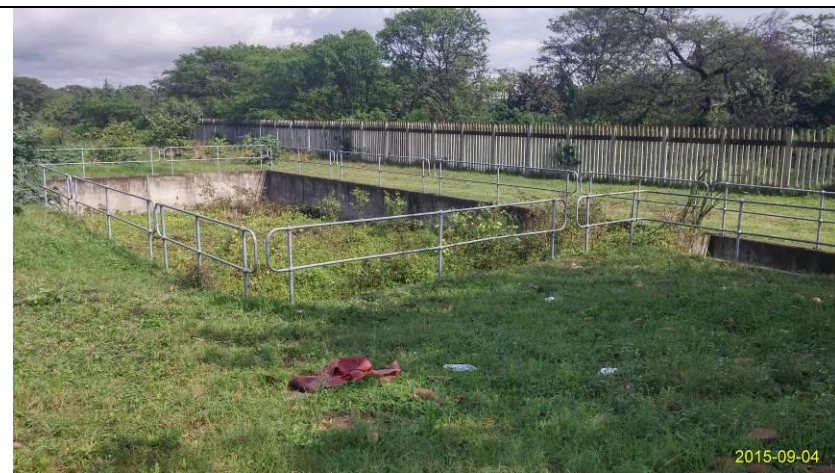
Looking south-west.
Photograph taken near Position 3.
Defunct leachate collection infrastructure.

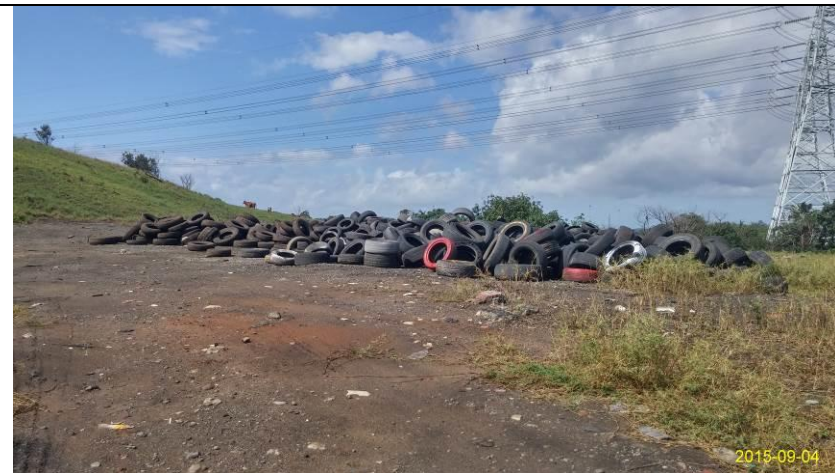
Looking east.
Photograph taken near Position 4.
Waste tyre stockpile.

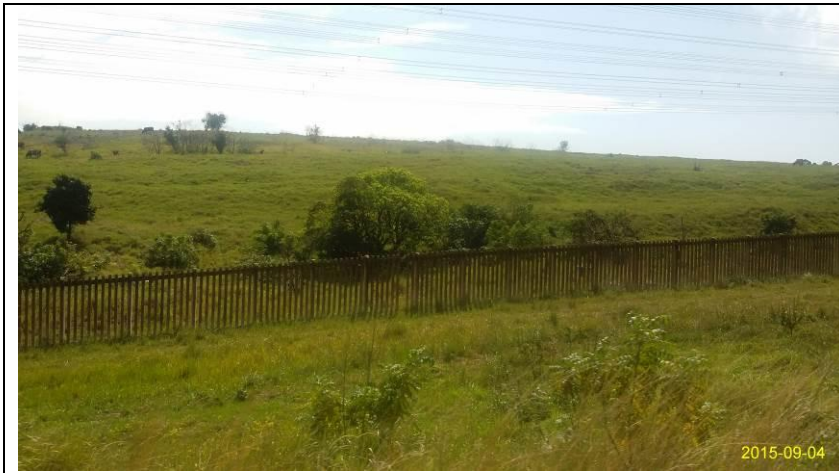
Photograph taken near
Position 4.

Open land beyond site
fence.
