APPENDIX C: PHOTOGRAPHS: DANNHAUSER WASTE FACILITY

Google Earth satellite image of the Dannhauser Waste Facility and its **site elements** and **photo viewpoints**

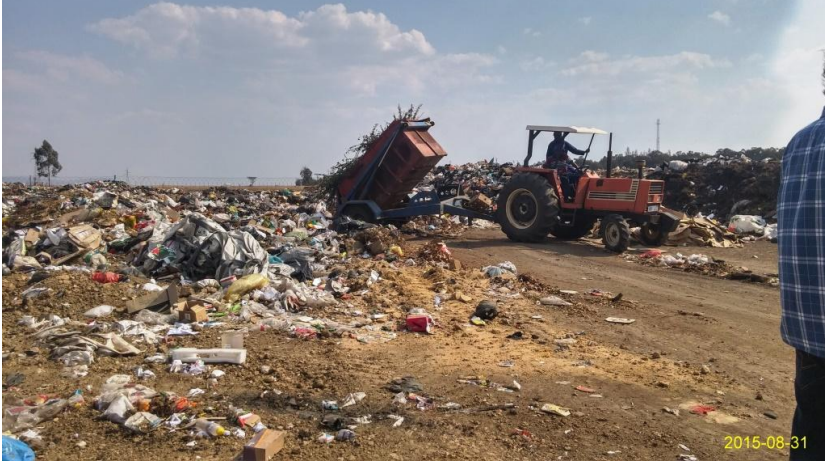
<p>Looking west.</p> <p>Working face of landfill.</p> <p>Photograph taken near Position 2.</p>

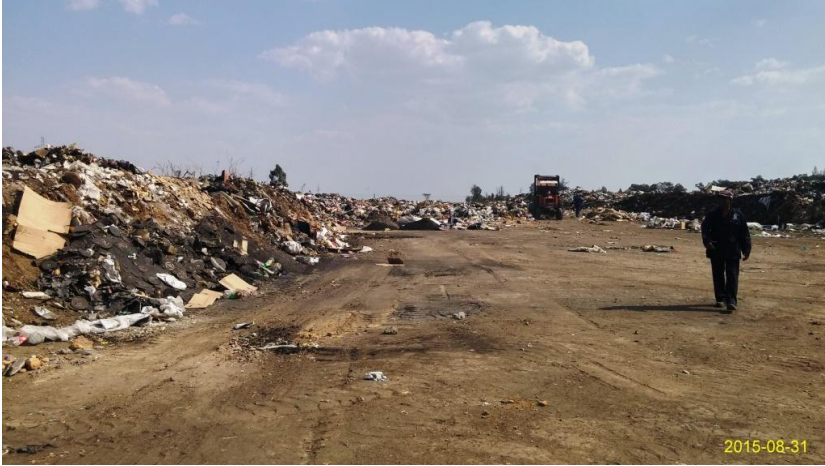
<p>Looking west.</p> <p>Working face of landfill.</p> <p>Photograph taken near Position 2.</p>

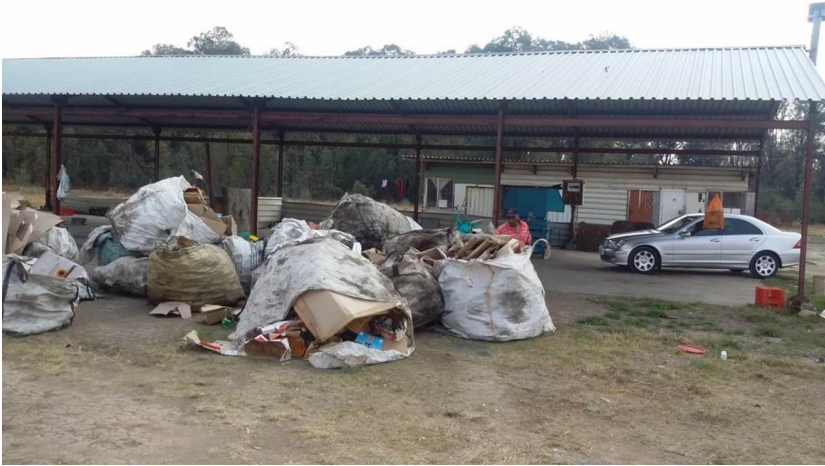
<p>Looking north.</p> <p>Recyclables sorting and baling area.</p> <p>Photograph taken near Position 1.</p>

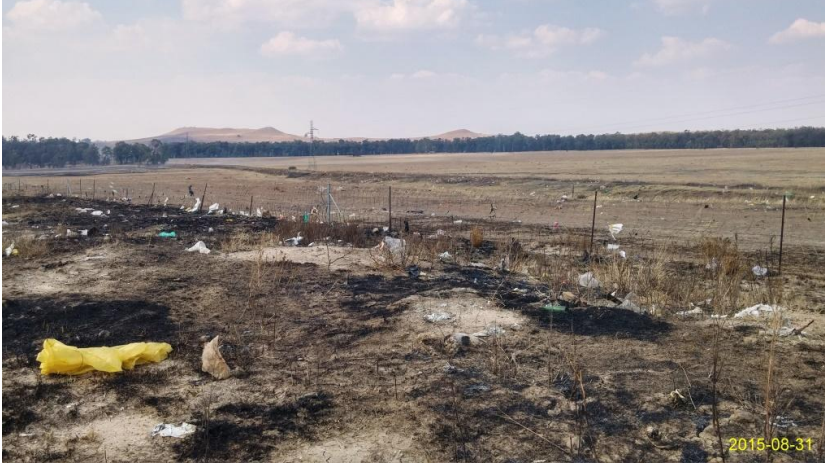
<p>Looking south-east.</p> <p>Firebreak on south-east edge. The line in the background is a defunct Transnet line.</p> <p>Photograph taken near Position 3.</p>

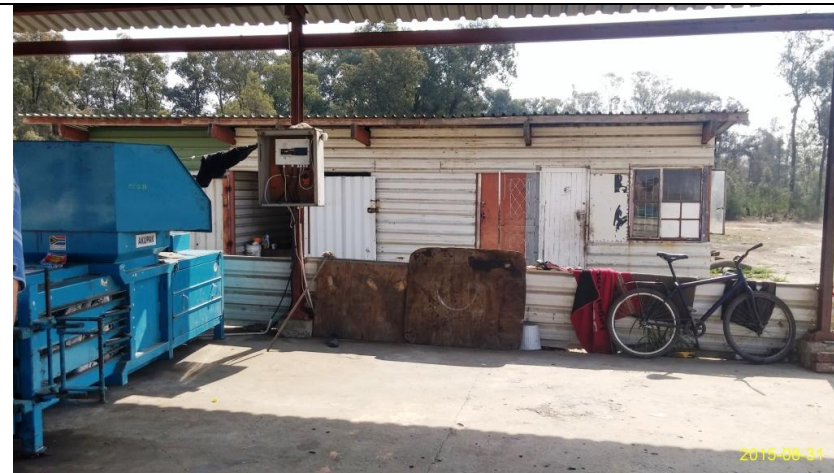
Looking north.
Recyclables sorting area, baler machine on left.
Photograph taken near Position 1.

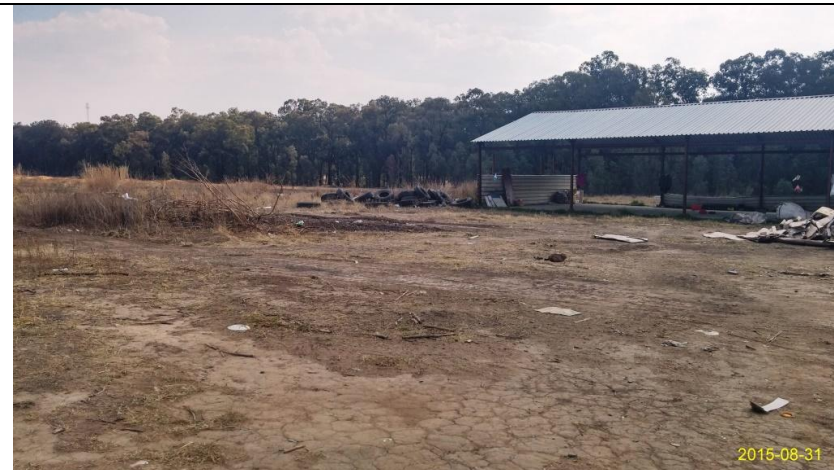
Looking north-west.
Waste tyre stockpile to left of recyclables sorting area.
Photograph taken near Position 1.

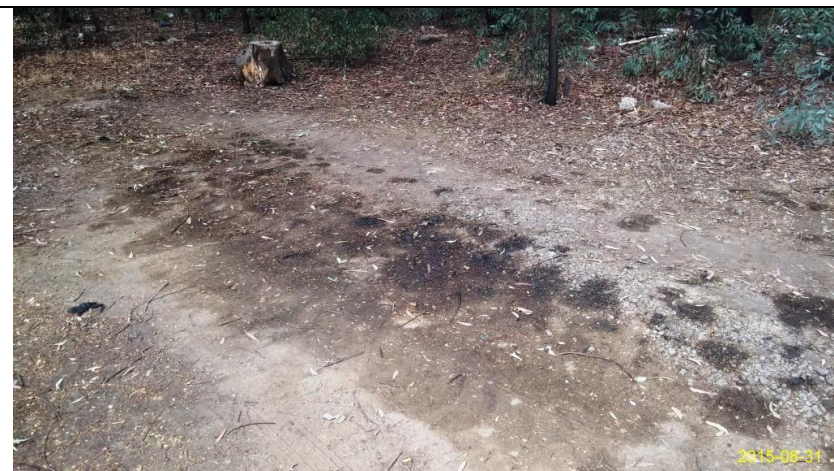
Soil contamination by leaking oil from the TLB. A drip tray should be used.
Photograph taken near Position 4.

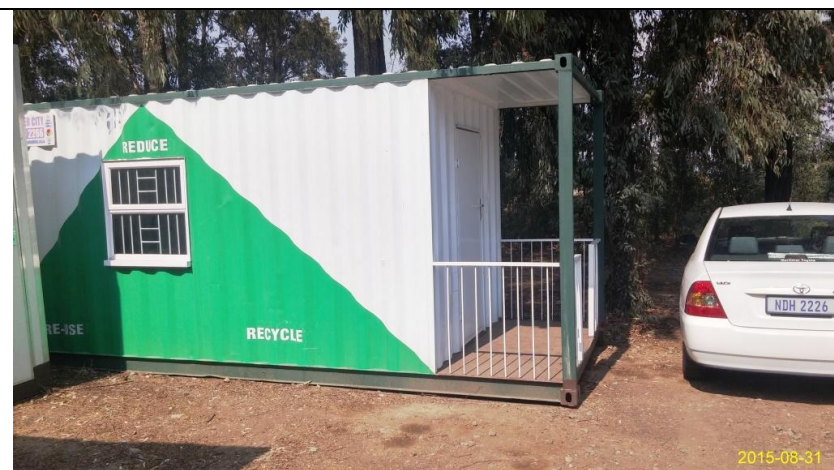
New container office for EPWP workers. Located adjacent to the guardhouse near the site entrance.
Photograph taken near Position 4.
