APPENDIX C: PHOTOGRAPHS: HLABISA WASTE FACILITY

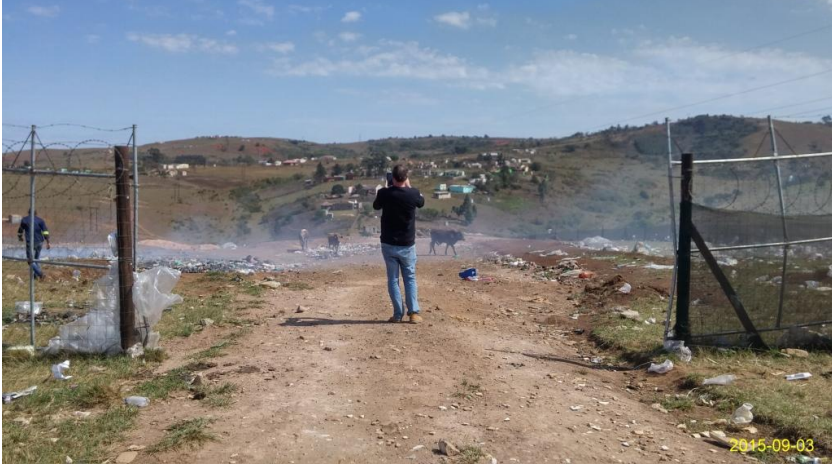
<p>Looking south-south-west.</p> <p>Site entrance. Site is fenced but there is no access control. Cattle are grazing on site.</p> <p>Photograph taken near Position 1.</p>

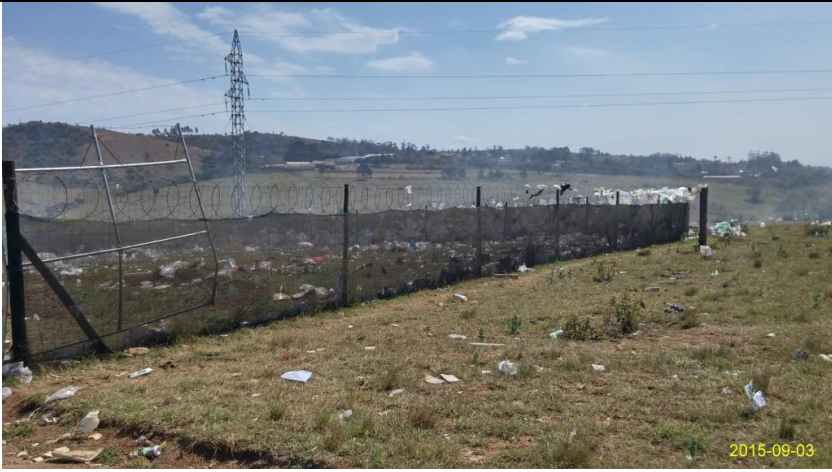
<p>Looking north-west.</p> <p>Windblown litter, electrical infrastructure in the background.</p> <p>Photograph taken near Position 1.</p>

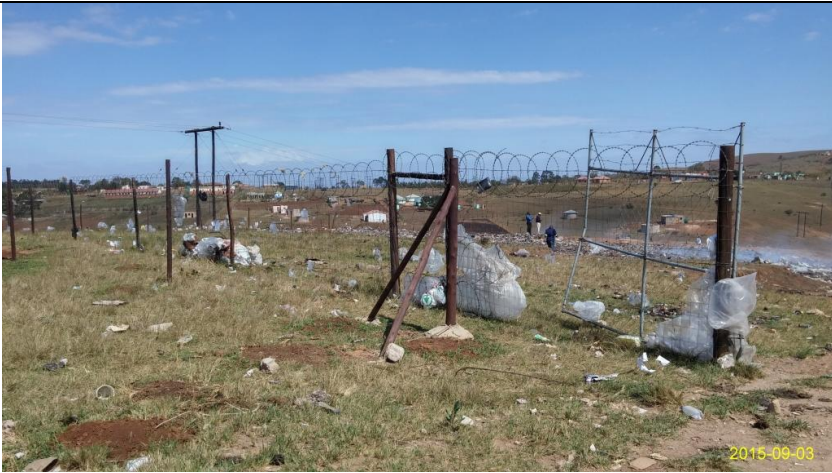
<p>Looking south-west.</p> <p>Telephone infrastructure, site fence, windblown litter.</p> <p>Photograph taken near Position 1.</p>

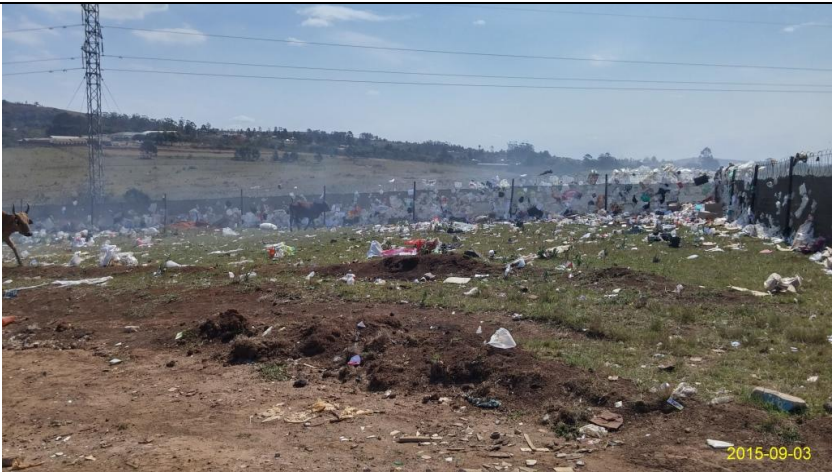
<p>Looking north-north-west.</p> <p>High winds during the site visit meant there was a lot of windblown litter. The shade cloth helps to contain some of the litter.</p> <p>Photograph taken near Position 2.</p>

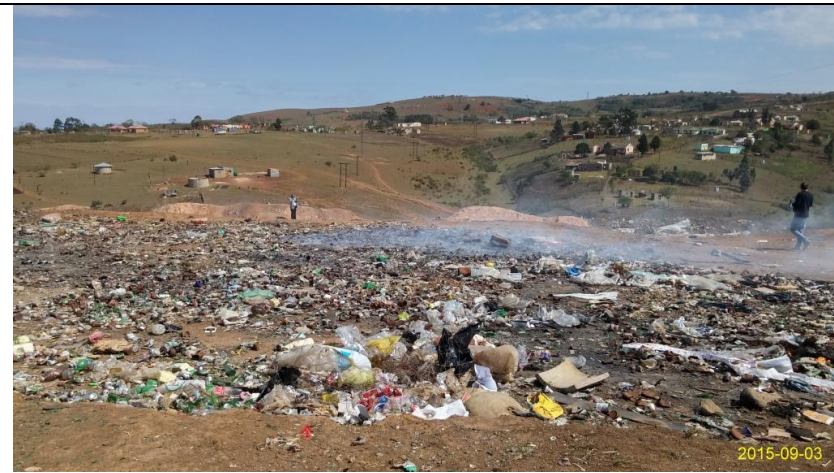
Looking south-west.
Burning waste, human settlement opposite the valley.
Photograph taken near Position 2.

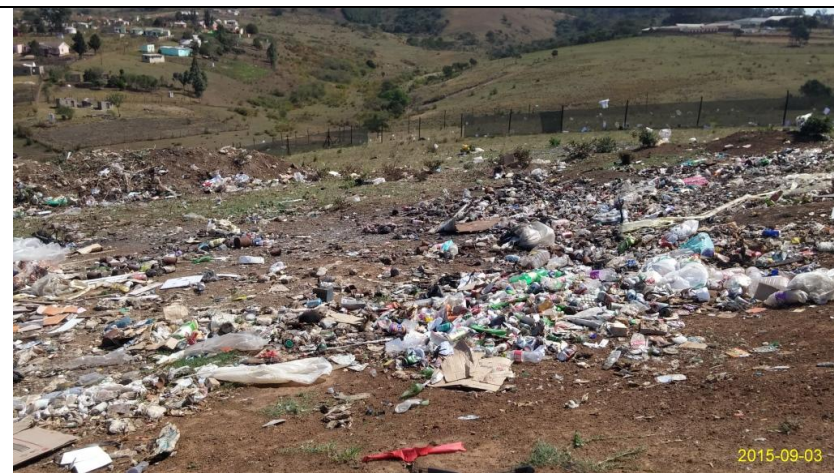
Looking north-west.
Nearby valley (watercourse) and human settlement.
Photograph taken near Position 4.

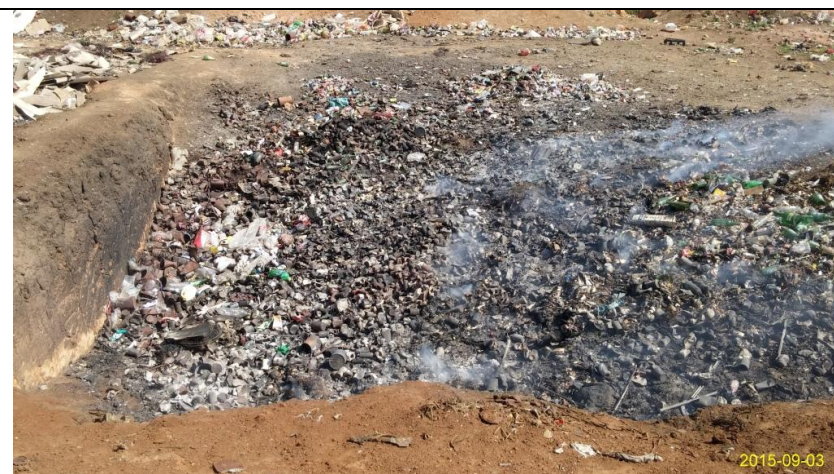
Looking south-west.
Waste disposal trench.
Waste has been burned.
Photograph taken near Position 3.

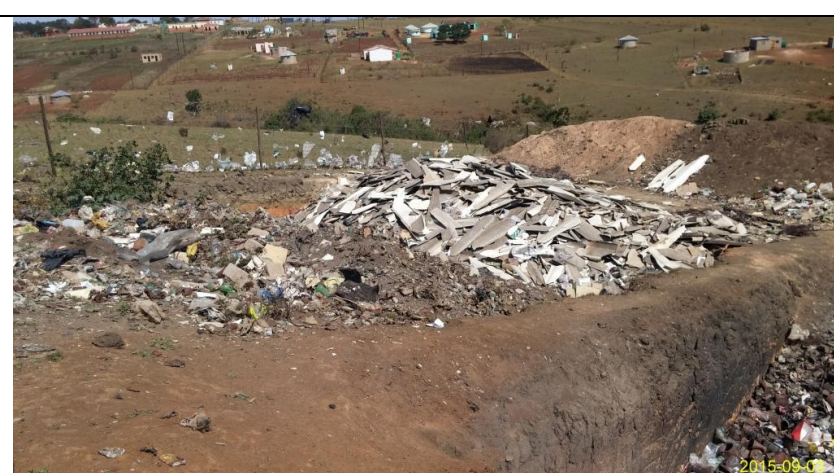
Looking south.
Building waste.
Photograph taken near Position 3.

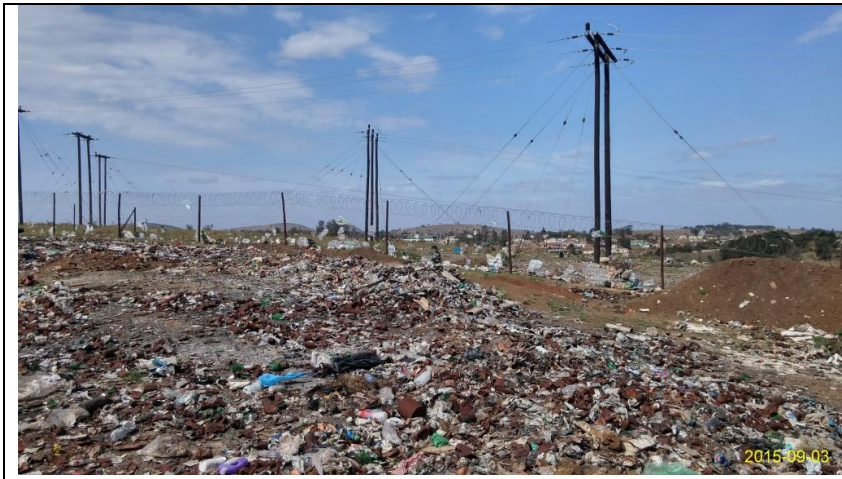
Looking north-east.

Telephone infrastructure.

Photograph taken near
Position 3.
