## APPENDIX C: PHOTOGRAPHS: MBAZWANA WASTE FACILITY

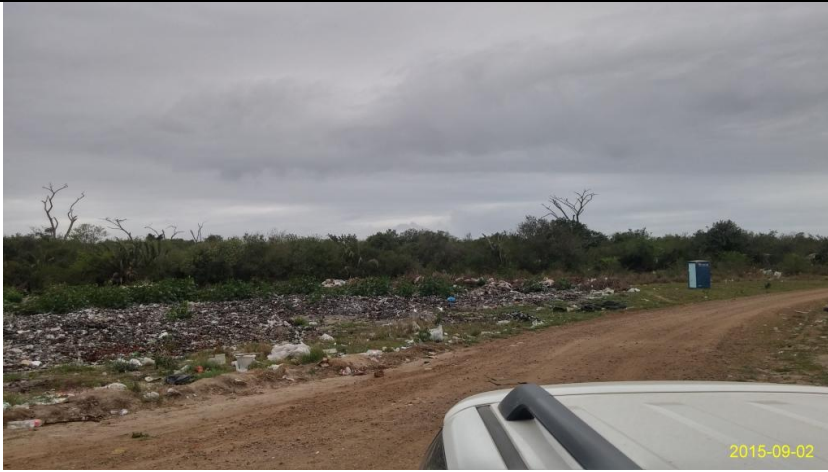
Looking north-west.  
Contested access road  
and dump site.  
Photograph taken near  
Position 4.

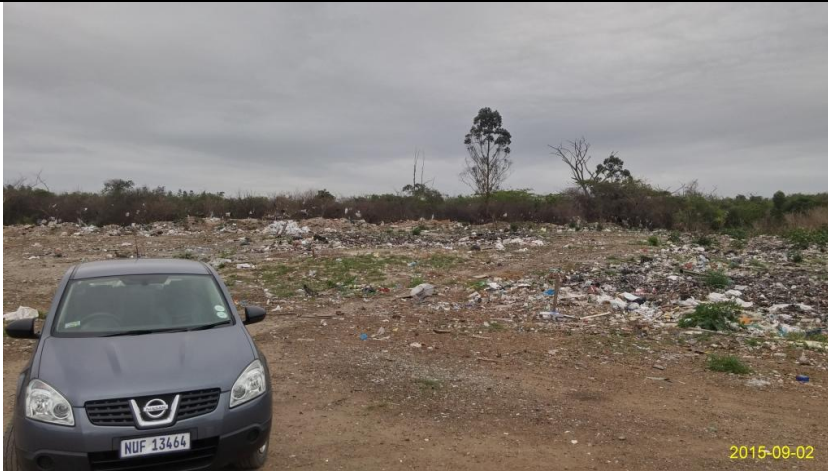
Looking north.  
Litter strewn around site.  
Photograph taken near  
Position 1.

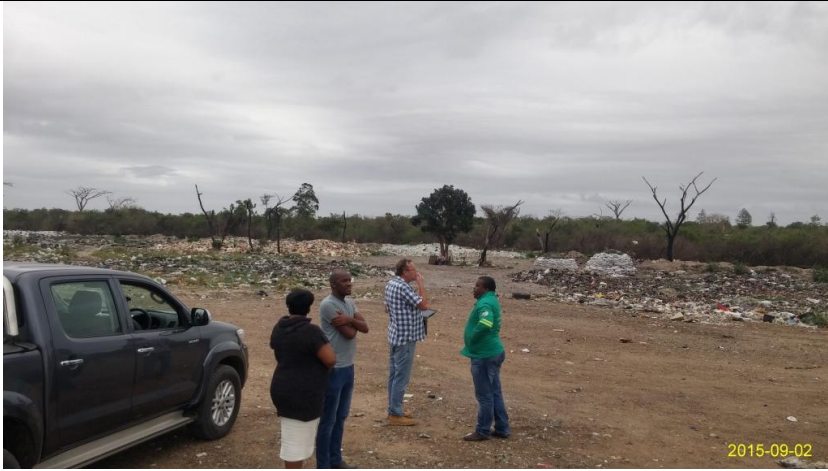
Looking west.  
Litter strewn around the  
original dump area.  
Photograph taken near  
Position 1.

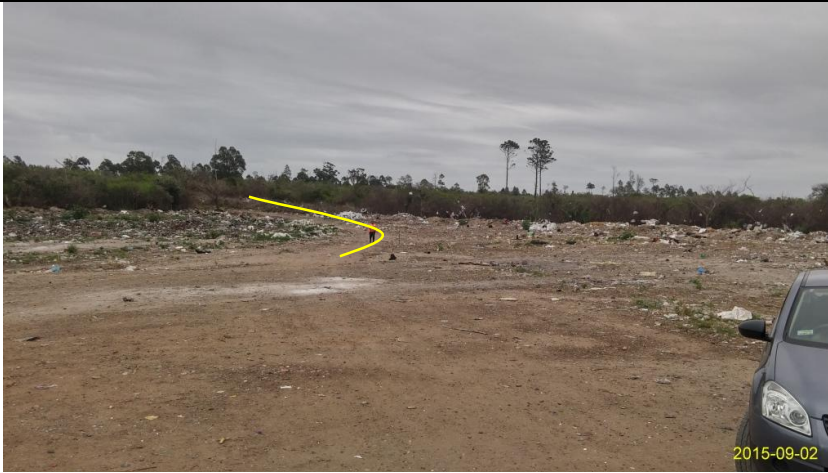
Looking north-west.  
Note the track that leads  
to the new dumping area  
at Position 3.  
Photograph taken near  
Position 1.

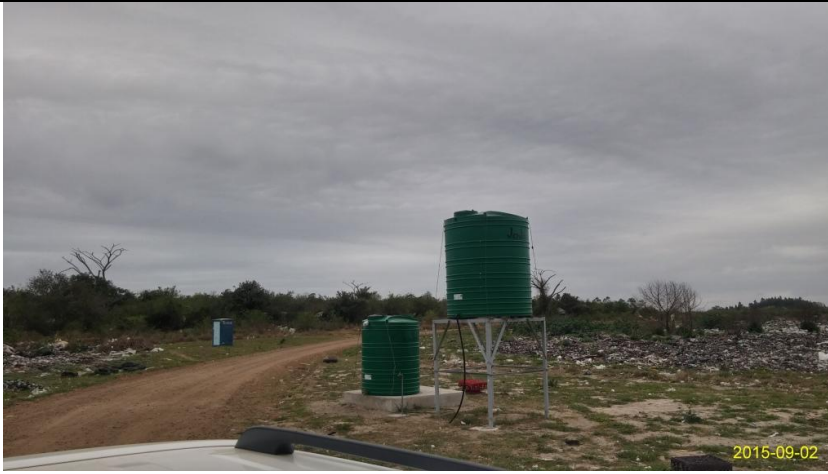
Photograph taken near  
Position 4.

Looking south.

JoJo water storage tanks,  
possibly a borehole.

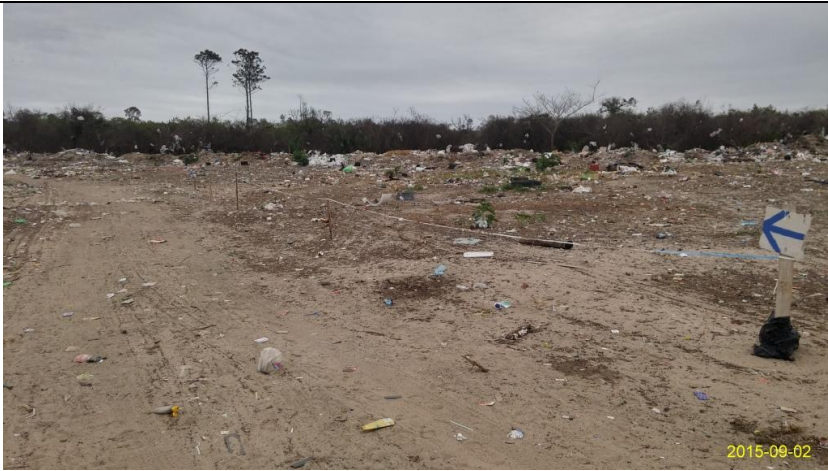
Photograph taken near  
Position 1.

Looking north-west.

Track leading to the new  
dumping area at Position  
3.  
Note the sandy ground  
conditions.

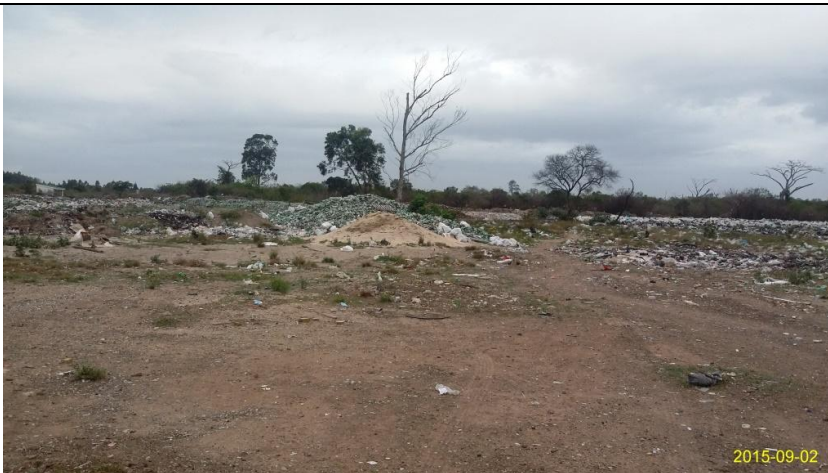
Photograph taken near  
Position 1.

Looking south-west.

Glass stockpile.

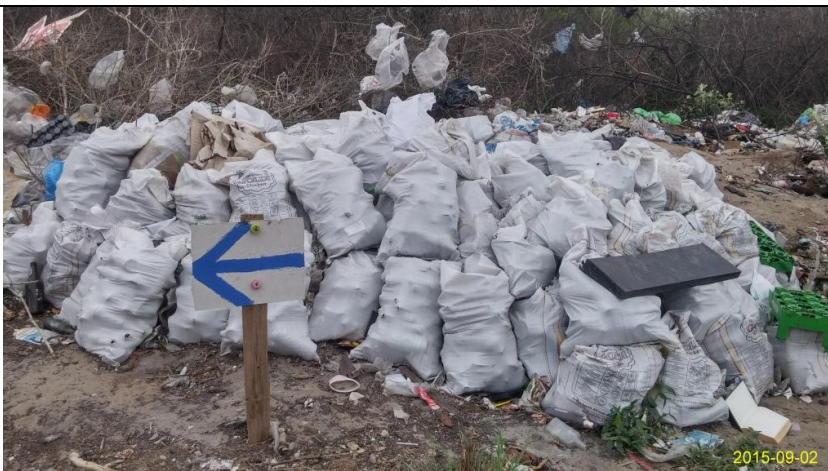
Photograph taken near  
Position 2.

Looking north-north-west.

Stockpiled recyclables  
along the track.

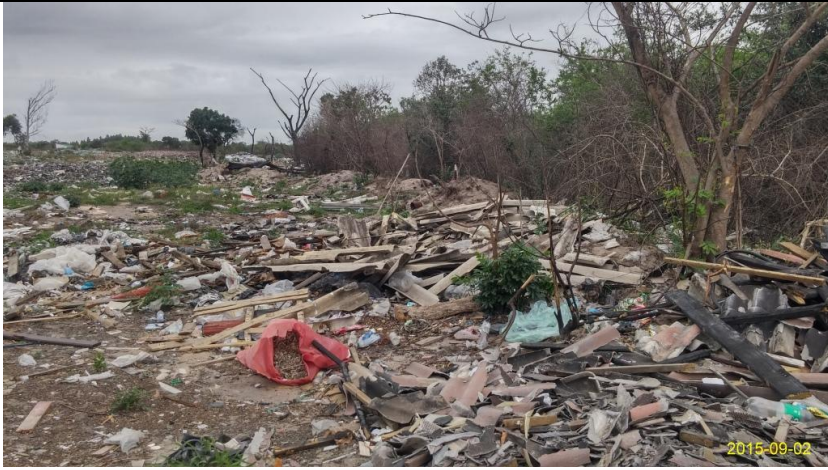
Looking south.  
Building waste alongside the track.  
Photograph taken near Position 2.

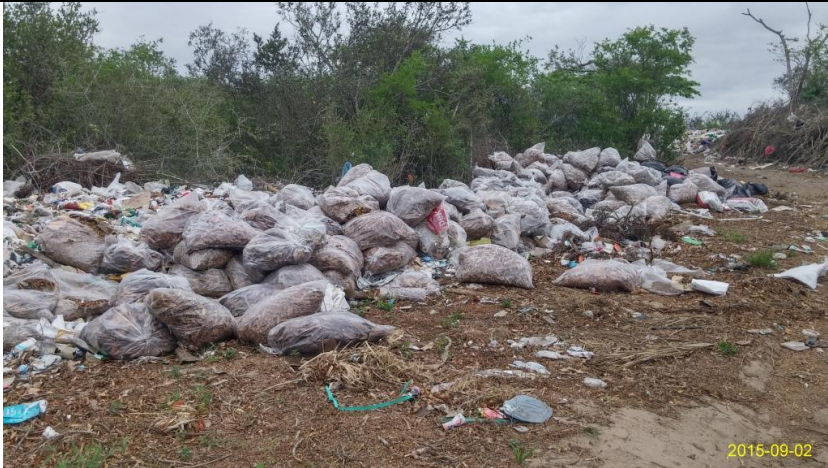
Looking west.  
Bags of garden waste along the track.  
Photograph taken near Position 2.

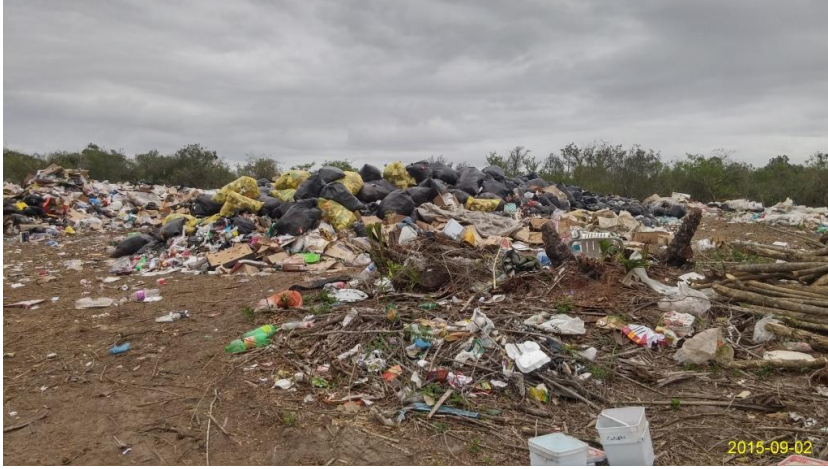
Looking south-west.  
General unsorted waste that has been tipped by a municipal truck.  
Photograph taken near Position 3.

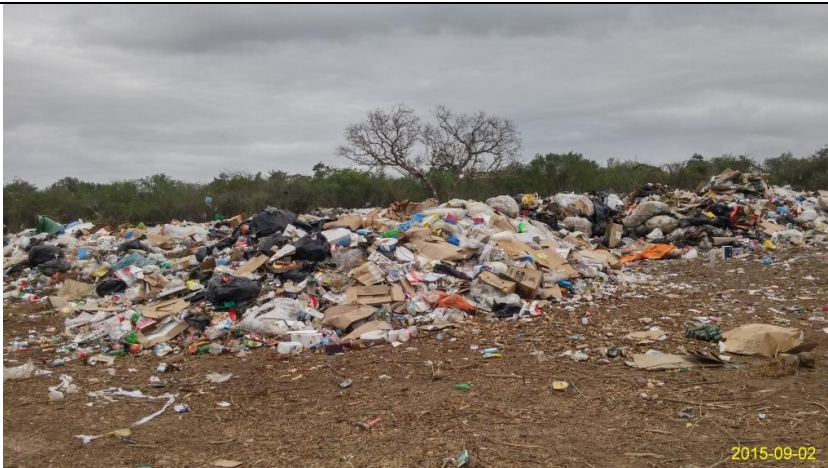
Looking west-south-west.  
General unsorted waste that has been tipped by a municipal truck.  
Photograph taken near Position 3.

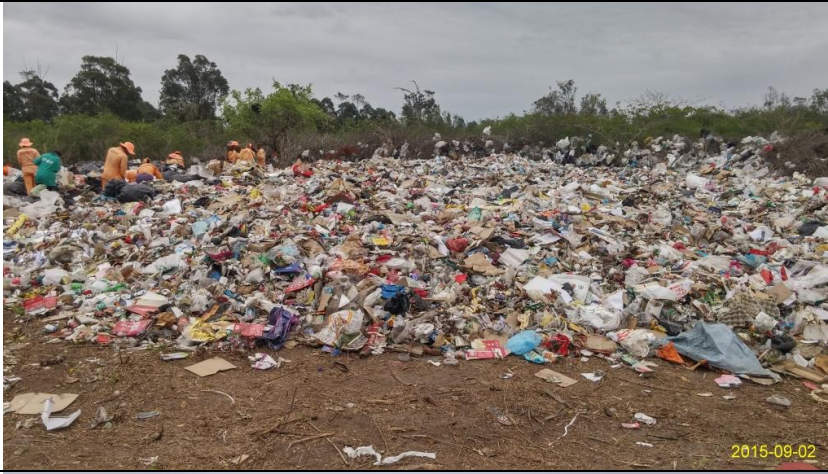
Photograph taken near Position 3.

Looking north-west.

General waste being sorted by EPWP workers.

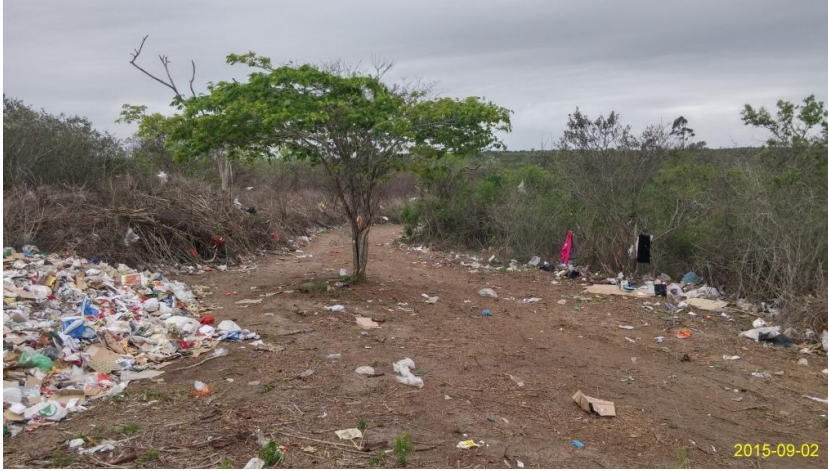
Photograph taken near Position 3.

Looking east.

The track that leads back to the original dumping area.
