RONDAVEL 1

NOTES : ALL SPECIFICATIONS TO BE CHECKED WITH ARCHITECTS. ALL DISCREPENCIES TO BE REPORTED TO THE ARCHITECT.
ng to be re-used. ginal thatch. must_not_be_removed_and_be_surface	
g to later detail the original thatch must not be removed and be surface scraped th a blade to remove the dried and possibly rotten grass. The wigrass should be placed on top of the current grass with mmercial grass from the Drakensberg or other commercially decified sources. The thatch shall have a thickness of at least 10 mm. +913 060 Eaves level +912 100 Door/Window head level (sting external walls shall be repaired with traditional ethodology and hand plastered. The weathered side shall be abilized with a cement based 16 plaster mixture combined with it to mimic the same texture as the old plaster. +910 000 Finished Floor Lavel 1:100	Image: Image
+915 440 Boof Apex +913 060 Eaves level The ventilation apertures shall be left as is and +912 100 Door/Window head level Repaired with traditional methodology, hand plastered and painted with traditional coulours. +910 000 Finished Floor Level 1:100	Implimenting Agent: Project title : OR TAMBO HOMESTEAD Building : FAMILY SHRINE Dwg title : FLOOR PLA

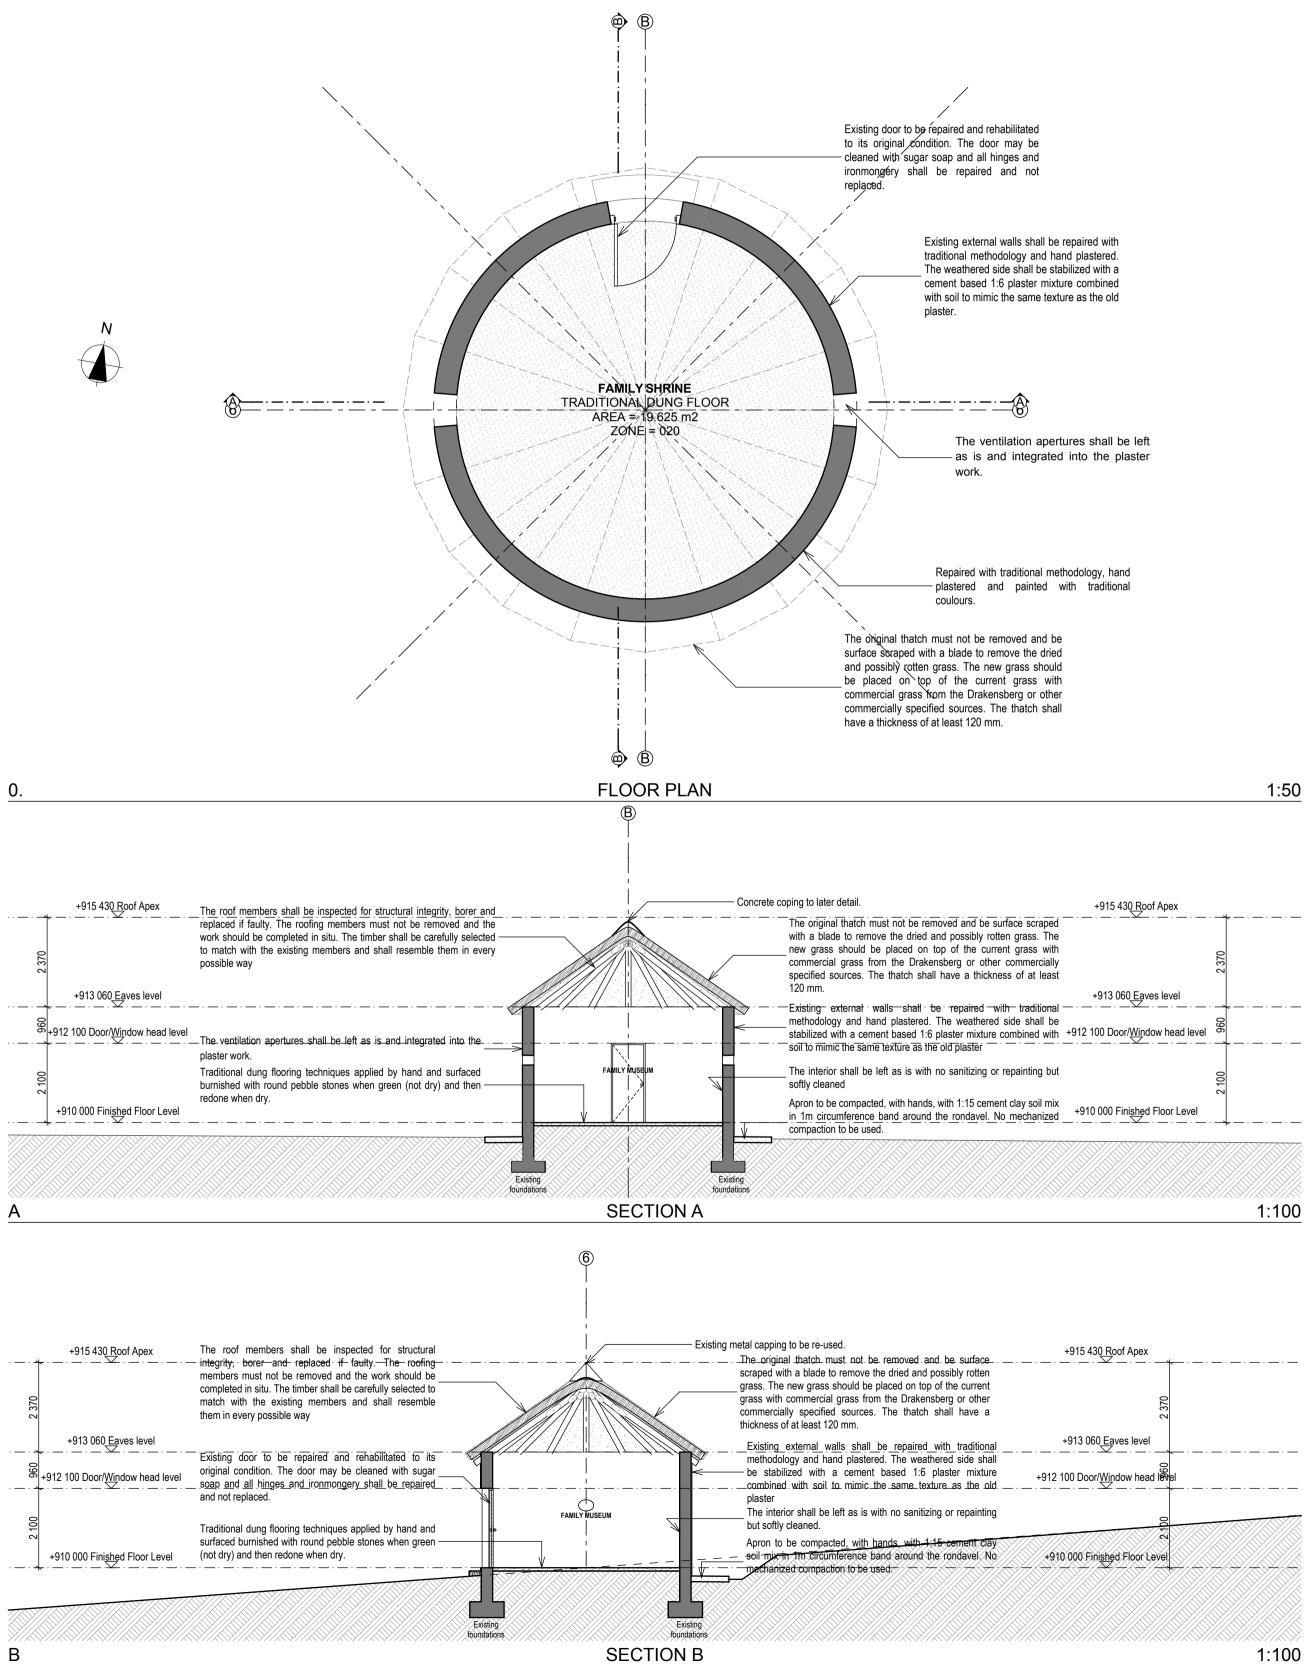
Built in 1942 and has been plastered in mud repeatedly since its construction. Thatched with local grass, Aristidia junciformis. Preferred thatching grass is Hyparhenia hirta but is locally in very short supply due to overgrazing and annual veld burns. Aristidia junciformis is a second choice thatching grass.

- Roof poles are gum (Eucalyptus sp)
- Withies are wattle
- Beam fill is plaited Aristidia grass rope
- Walls are in situ produced sun-dried clay bricks plastered with local clay. Painted with Trading Store stock light turquoise-blue lime and water based paint.

- Plaster has been reapplied to close expansion cracks. Cement used in plaster on larger cracks. Repairs have failed.
- No windows: Two apertures in wall along middle meridian (450x 250 mm)

- Door frame: Trading Store stock in SAP.
- Door: Trading Store stock SAP stable door on mild steel T-hinge. Wire hasp and clasp with padlock.
- Floor: Dung plastered with central hearth. Walls clay plastered. No paint.

- Problem: Roof eaves do not extend far enough away from the wall to deflect rain water. Insufficient slope at base of wall to drain away ponding water. Foundations become saturated and compromised. Flag stones in place have failed to alleviate the problem.
