CONSERVATION MANAGEMENT PLAN FOR “BLACKIE” A SPECIFICALLY DECLARED STEAM RAILWAY LOCOMOTIVE

SAHRA/HO/07/2014

DRAFT

27 March 2015

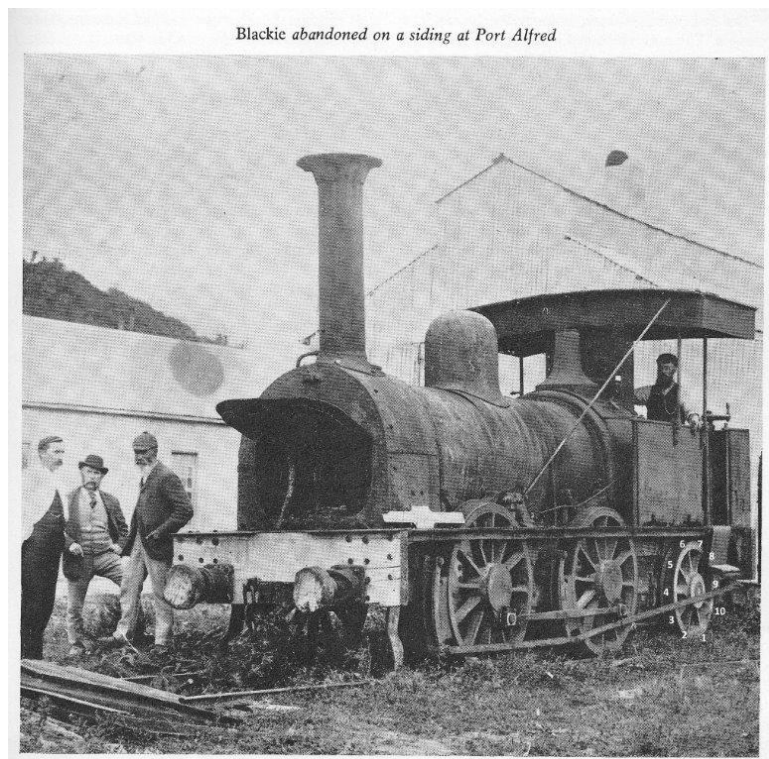
5.8. The rear wheels as seen in the Port Alfred photograph have 10 spokes.

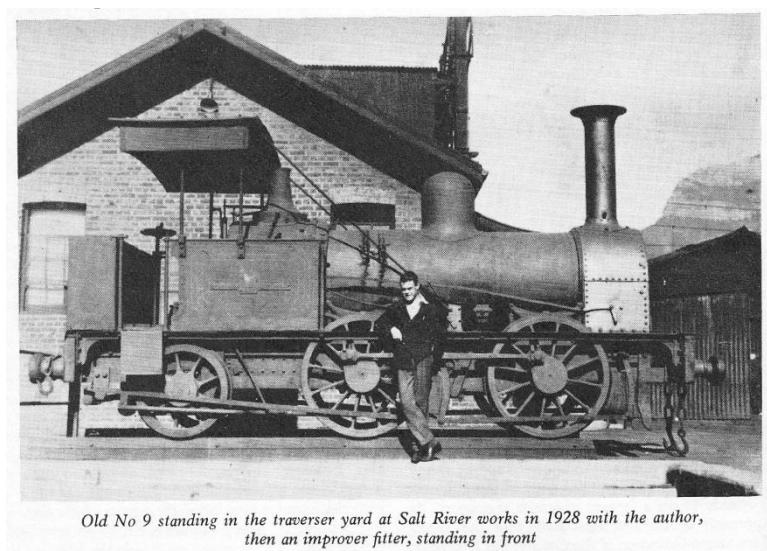
5.9. The rear wheels as seen in the Salt River photograph taken in 1928 have 9 spokes.

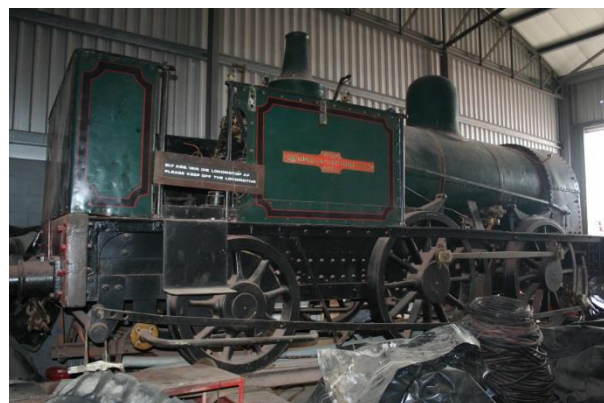
5.10. The rear wheels as seen currently in storage at Firgrove have 9 spokes.

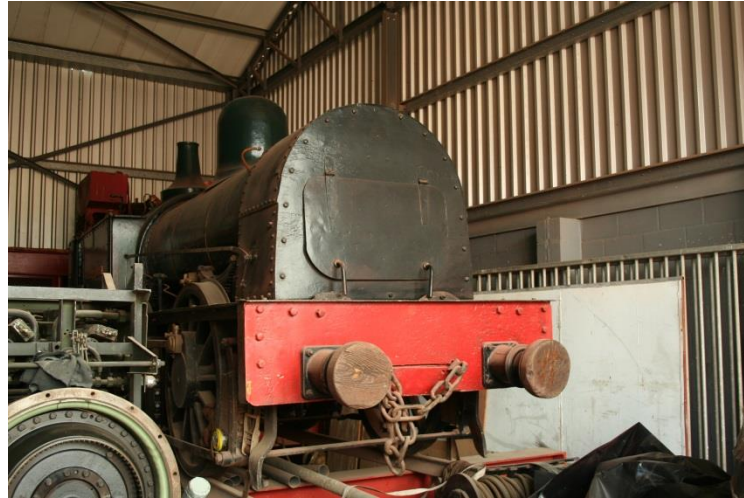
- 6.6. The locomotive is currently extremely dirty and will need to be properly cleaned before a final review of the condition of the paintwork can be finally determined – it does not seem to be too bad.

- 6.7. The underside of the locomotive and the motion are covered in dust and will need to be thoroughly cleaned.
- 6.8. From the information given to us the locomotive has been moved whilst in storage at ALE.

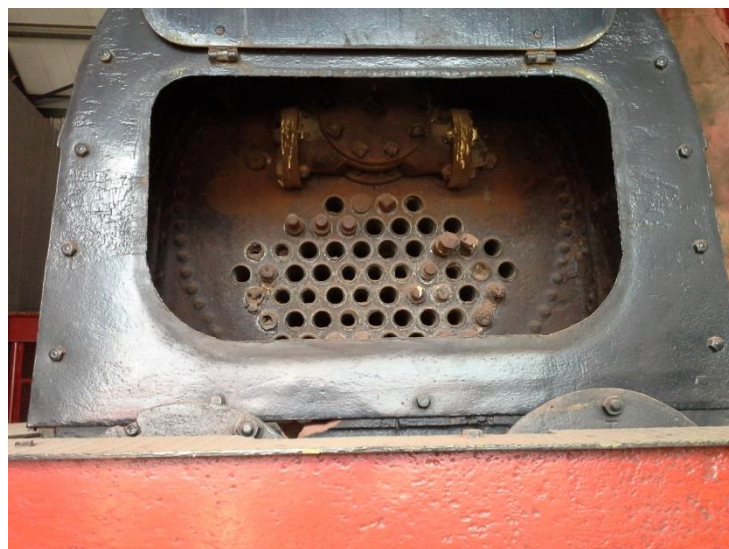
- 6.12. The boiler tubes are still in place although some of them have been plugged and sealed off.
- 6.13. The main steam pipes and exhaust blast pipe are missing from the smokebox.

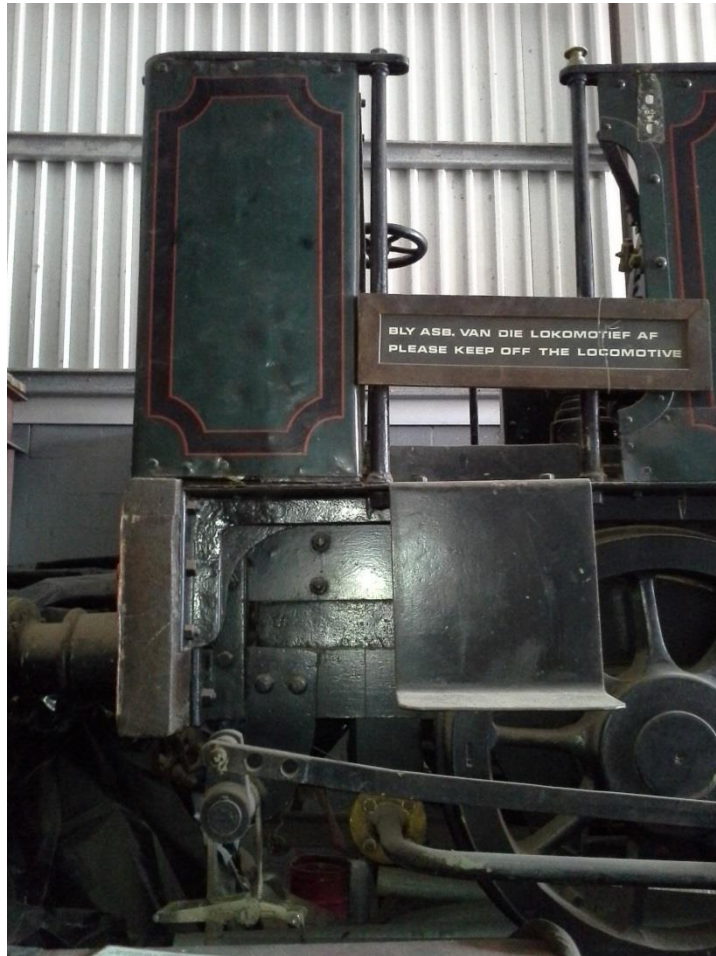
6.15.1. We surmise that a water tank was contained in the bunker space at the rear of the cab.

6.15.2. This aspect requires further investigation.

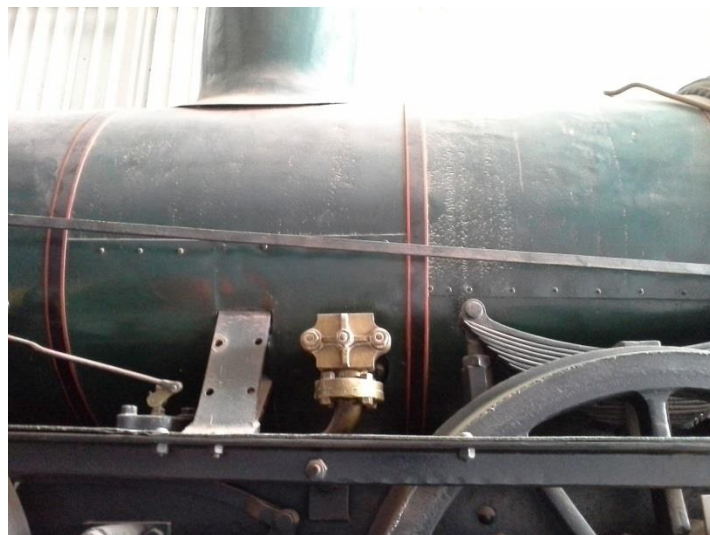
6.16. There are brackets on either side of the boiler which have bolt holes that are not currently used except for the cab stays.

6.16.1. There is also evidence that there was something fixed to the brackets on either side of the smokebox which corresponds to the early picture of "Blackie" which shows the locomotive as an 0-4-0 tank locomotive with pannier tanks.

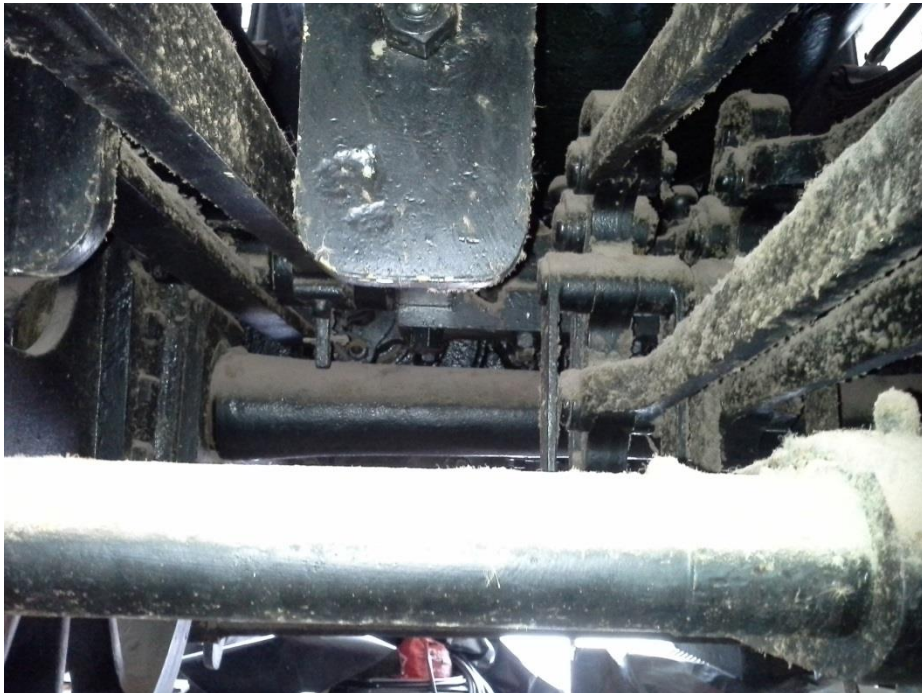
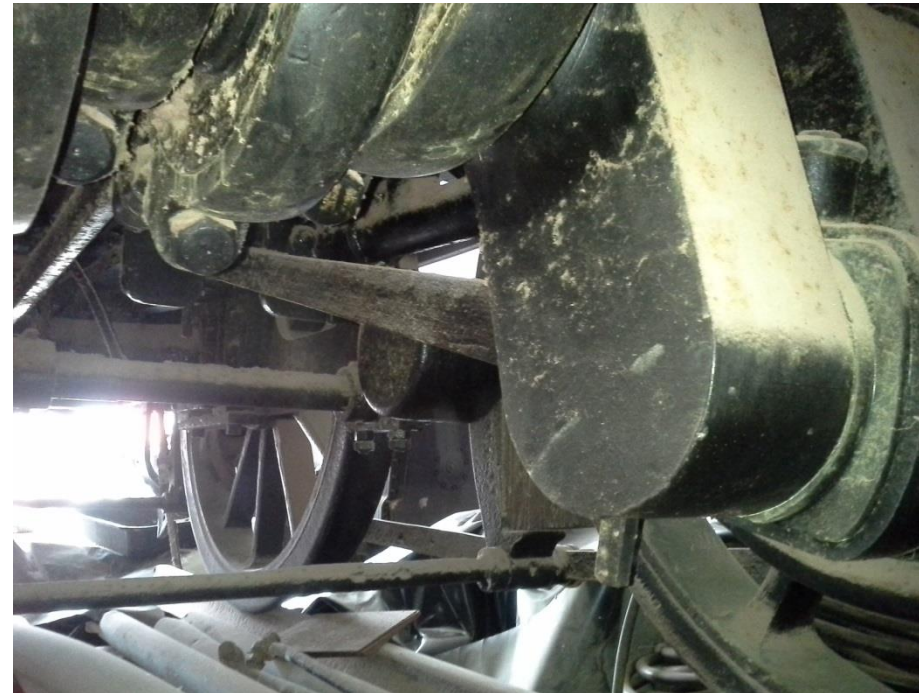
- 8.3. From the information given to us the locomotive has been moved whilst in storage at ALE.
- 8.4. The locomotive is currently covered in black plastic sheeting with no protective material between the paintwork and the sheeting.
- 8.5. At present neither the cab roof or the smokestack (chimney) are fitted to the locomotive nor were these not available for viewing.
- 8.6. The locomotive is currently extremely dirty and will need to be properly cleaned before a final review of the condition of the paintwork can be finally determined – it looks to be in a reasonable condition and should not need any repainting.
- 8.7. The underside of the locomotive and the motion are covered in dust and fluff and will need to be thoroughly cleaned.

- 8.7.1. An initial cleaning must be done before the locomotive is removed from its temporary support cradle.
- 8.7.2. A final cleaning will need to be done when the locomotive is placed on display.

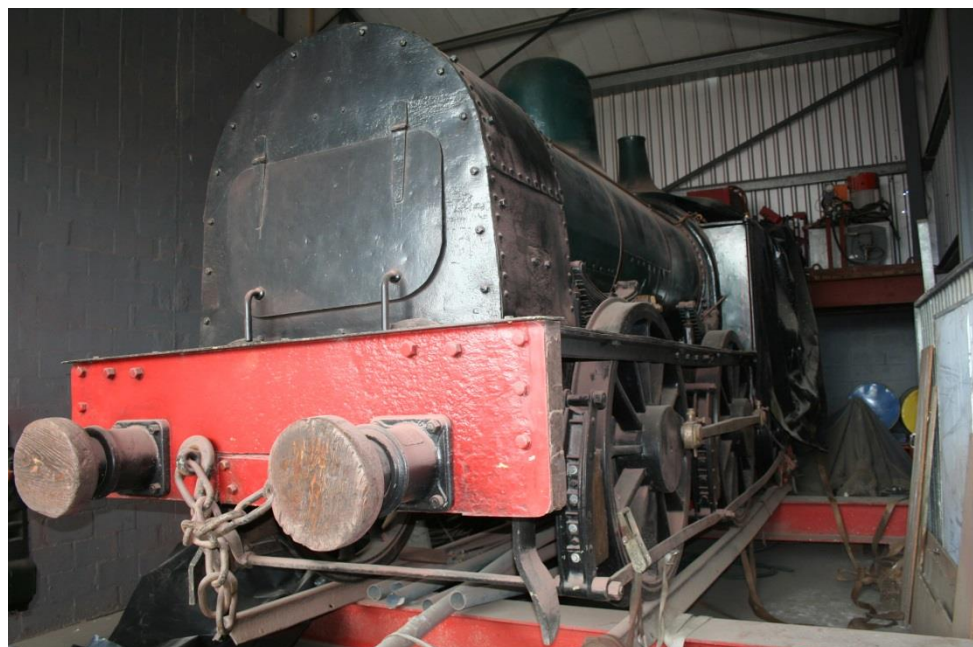
8.8. We are concerned that the current storage arrangements are causing undue strain on the locomotive structure as the rails on which it is resting are not adequately supported and have deflected.

- 8.8.1. We recommend that additional supports be inserted under the rails below the rear driving wheels (centre wheels) to avoid any further possible damage.

- 8.8.2. Provided that the rails on which "Blackie" is standing are propped up to ensure that they are level the locomotive should not need any structural repair work.
