**OLD BETHLEHEM FARM 153
DWARS RIVER VALLEY, DRAKENSTEIN**

HOMESTEAD (T-PLAN)

**STRUCTURAL & ARCHAEOLOGICAL INVESTIGATIONS
& ASSESSMENT OF THE WALLS AND FLOORS,
PREPARATORY TOWARDS REHABILITATION**

APRIL 2013

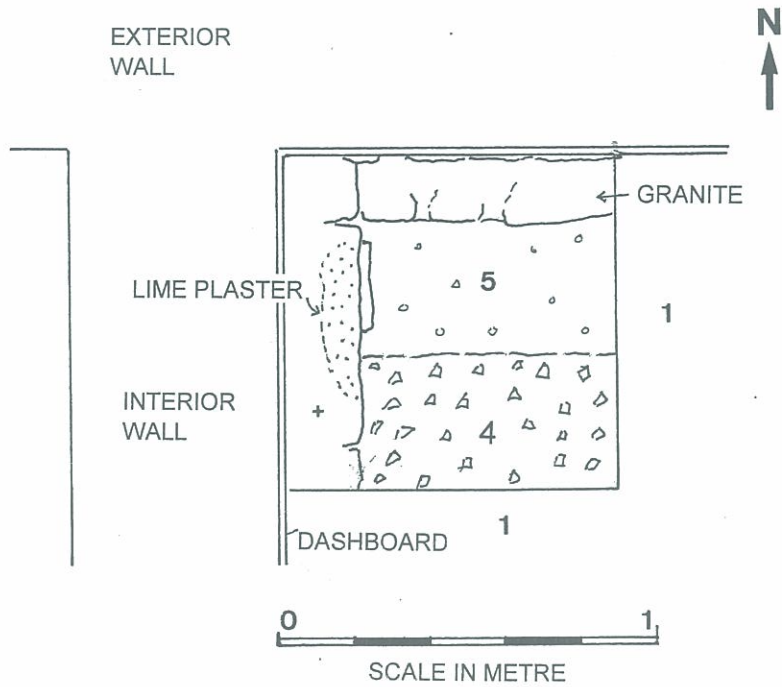
ROOM B
CORNER SECTION B 4/1
GROUND PLAN

FIG.4.1 Ground plan of corner-excitation B1/4 in Room B. Note the wide stone plinths for earlier boarded floors (Vos 2013).

What is obvious are the unusual wide granite plinths of about 200 mm, with the B4 plinth partially covered in a thin, hard lime plaster. These plinths are surely to support regular joists for boarded floors. The layer 5 appears to be a trampled surface when the house was built in 1770s (FIG.4.2).

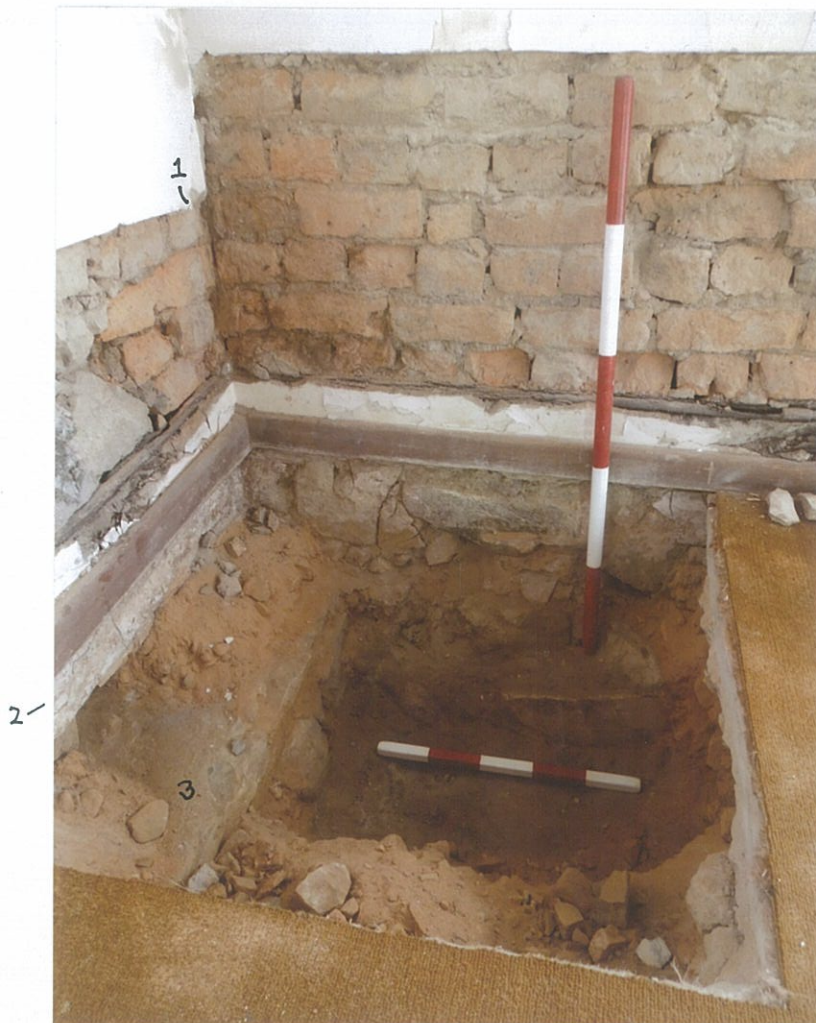
4. In this close-up of B1/4, the corner 18th c bricks bond perfectly (1). At wall B4 the earlier plaster band and floor level is visible (2). Note the wide stone plinth (3) (scales 1m, 50 cm) (look N).

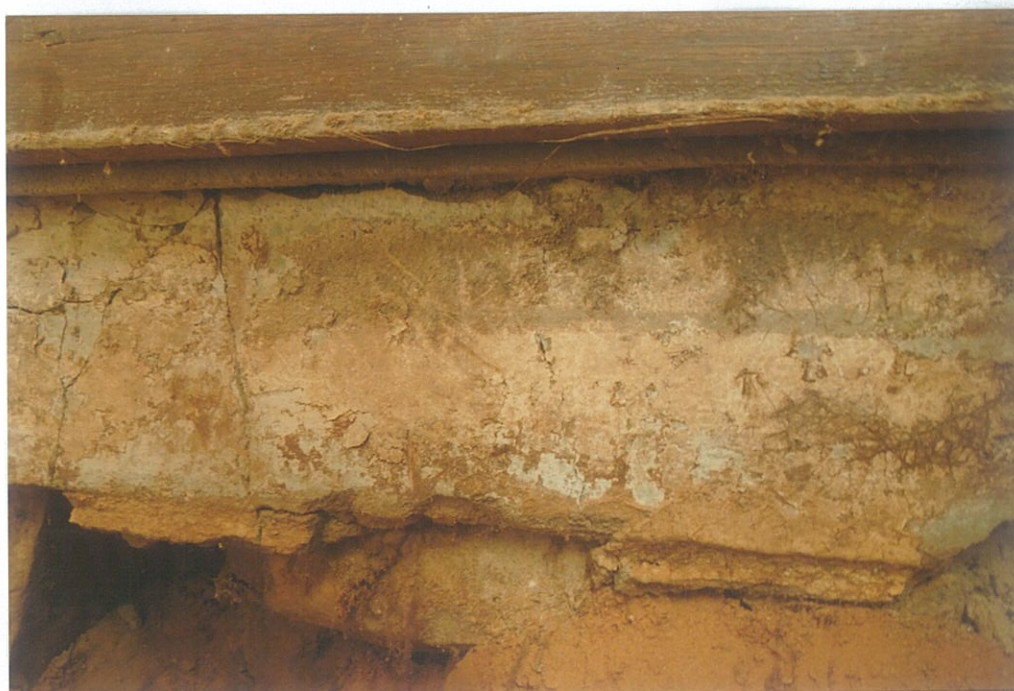
Within the excavation, a 100 mm strip of c.1900 plaster, very hard like cement/lime, showed some early colours. Immediately at its base, are impressions of endboards. This would indicate the Rooms A/B were once at the same level as the Front Rooms C and DE (all 10cm lower). A portion of plaster was stripped above the floor level (carpet), where the cement plaster was already loose. It showed the mid-late 18th century orange brickwork (70 mm high) above the granite footing, the latter for damp proofing.

5, 6. At wall B4 even the interior wall was built-up in stone. Note the earlier floor level (c.1900) with the skirting plaster and the two yellow *in situ* plaster strips below, showing floor board impressions (look W) (scale 50 cm).

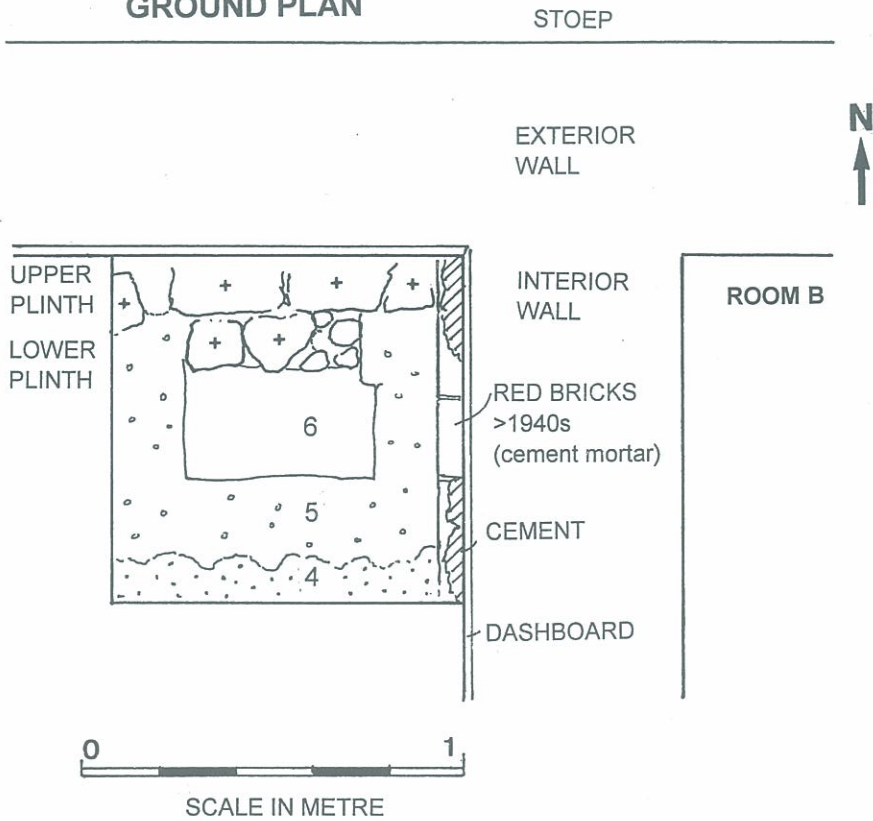
**ROOM C
CORNER SECTION C 1/2
GROUND PLAN**

FIG.5.1 Ground plan of corner excavation C1/2 in Room C. The upper plinth would have carried the joists for a boarded floor.

This section was also filled during post-1940s with a concrete bed (for the *blokkiesvloer*) and filled for a depth of 30 cm of fine white sand (**FIG.5.1**). Below wall C2, next to the stone foundation, a layer of modern, hard-fired red brick in cement mortar, prevented any water seepage to the side. Any gravitational water drainage would have gone straight north below the stoep and unto the yard.

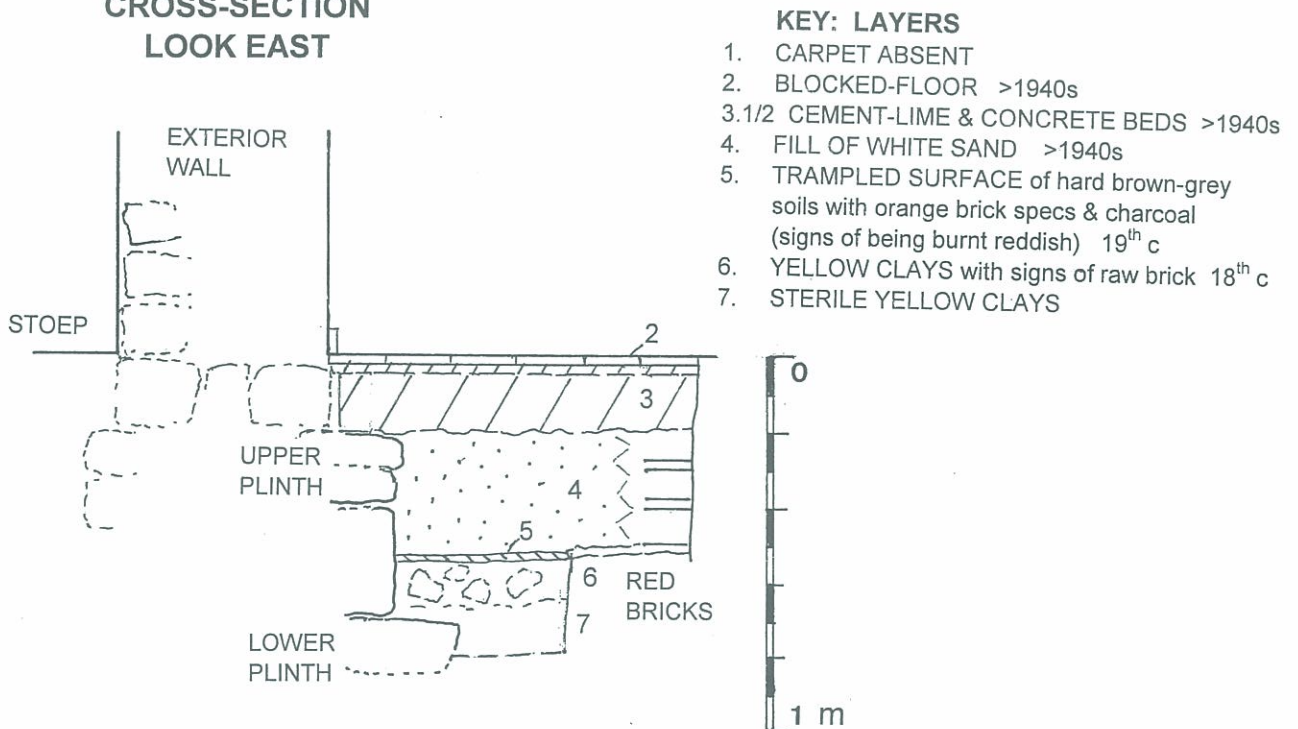
**ROOM C
CORNER SECTION C 1/2
CROSS-SECTION
LOOK EAST**

FIG.5.2 Elevation of the excavation C1/2, till the sterile clays at the base.

At the façade wall C1, there is again a wide plinth of granite stone, indicating a platform for joists and a boarded floor. Surface 5 shows signs of having been burnt reddish and hard, with charcoal specs and other building rubble present. It may represent the trampled surface when the dwelling was built. Below it (layer 6) still contained some fill of raw brick and then sterile clays followed (**FIG.5.2**).

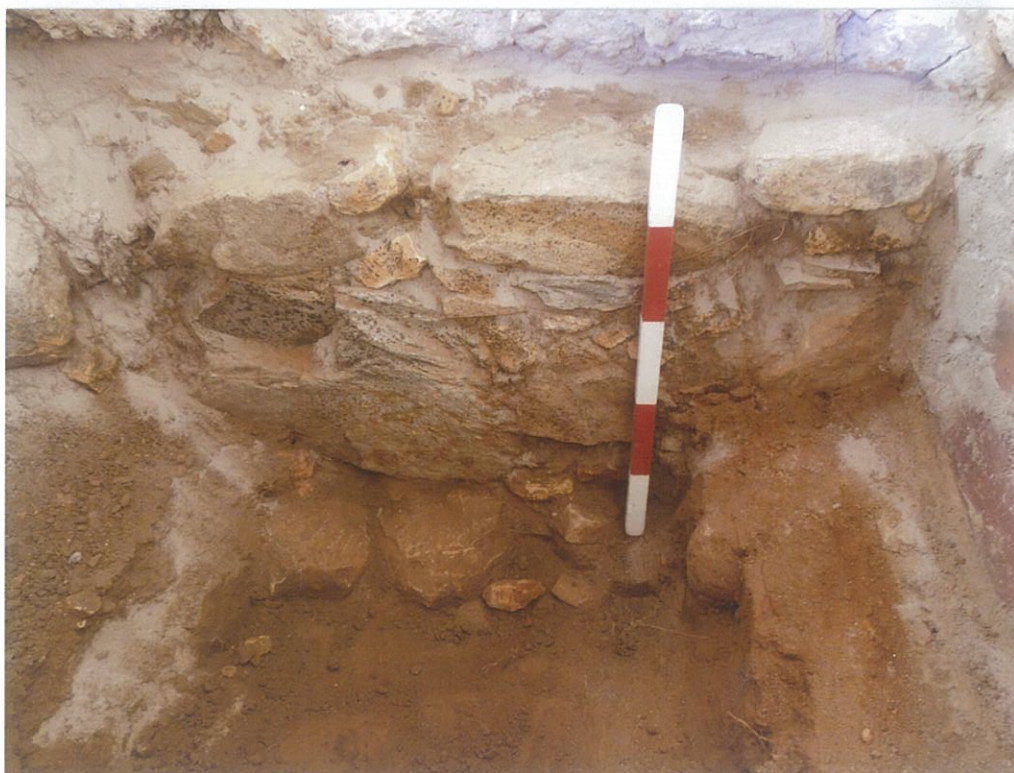
8. View towards Wall C1, with the volume of white sand removed unto layer 5. Note the upper stone plinth for floor boards (look N) (scales 1m, 50 cm).

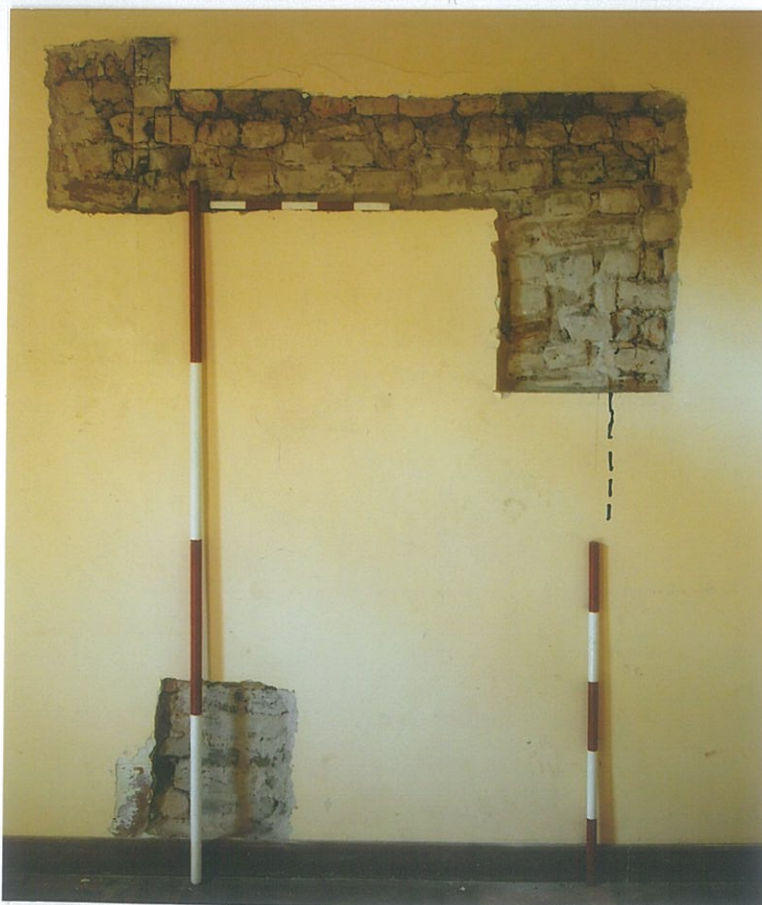
Note that the *Voorhuis* side doors C2 and C4 are situated central unto the demolished wall/screen in *Agterhuis* F (see FIG.2). Minimum plaster was stripped to show the distinction between the *in situ* orange brick, and the filled-in-door, already done during the 19th century. It is recommended that the old door C4 be reproduced and fitted at door C2 to complete the old *Voorhuis* interior.

16. View in Room C2/3, where the earlier, blocked-up door is on the left (scales 2m, 1m, 50 cm) (look E).

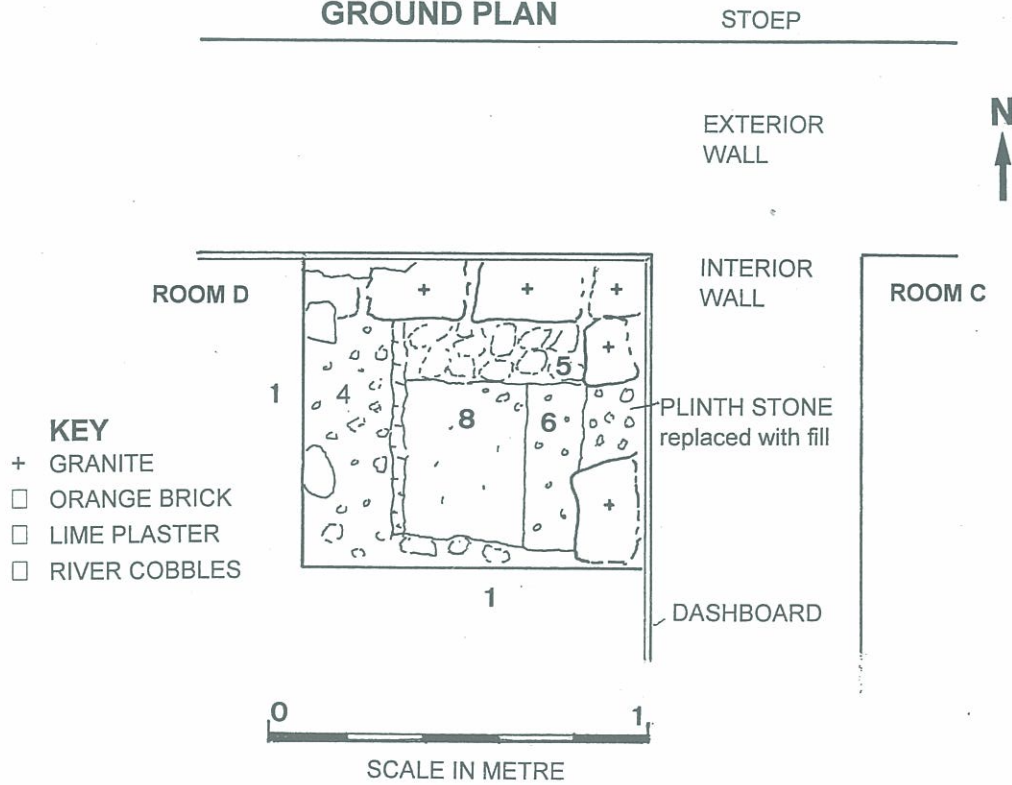
**ROOM D
CORNER SECTION D 1/2
GROUND PLAN**

17. Close-up of the original brick versus fill-in. Its lines are traced along the filled-in brickwork (look E).

FIG.6.1 Ground plan of corner section D1/2 in Room D. Note the similar wide stone plinths as in Room B, for boarded floors. There was no gravel or sand fill of the post-1940s.

In Rooms DE only one floor corner section D 1/2 was dug, which appeared to contain more fill than the other two front rooms (**FIG.6.1**). Note layer 4 with brick rubble (19th c), layer 5 with yellow raw bricks, lens 6 with charcoal and layer 7 with initial fine rubble, both layers of the 18th century (**FIG.6.2**). Note that Section D1/2 and Section B1/4 have similar wide plinth platforms for joists supporting boarded floors. The exterior façade wall is depicted in elevation till window-sill height. The depth of all the foundations was not determined due to a lack of space for digging, which would have destroyed all layers.

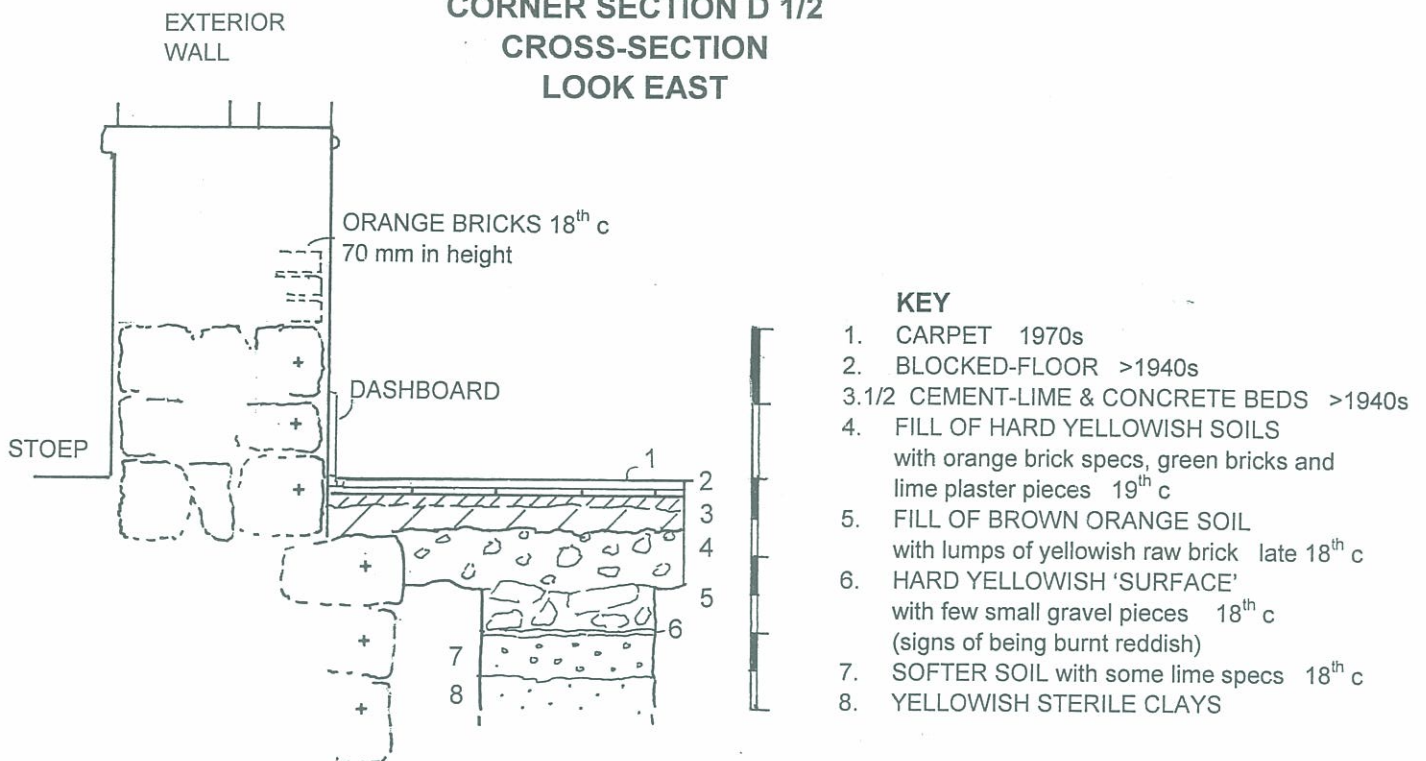
**ROOM D
CORNER SECTION D 1/2
CROSS-SECTION
LOOK EAST**

FIG.6.2 Elevation of the excavation D1/2, containing more earlier fill of raw brick and lime plaster than the other sections.

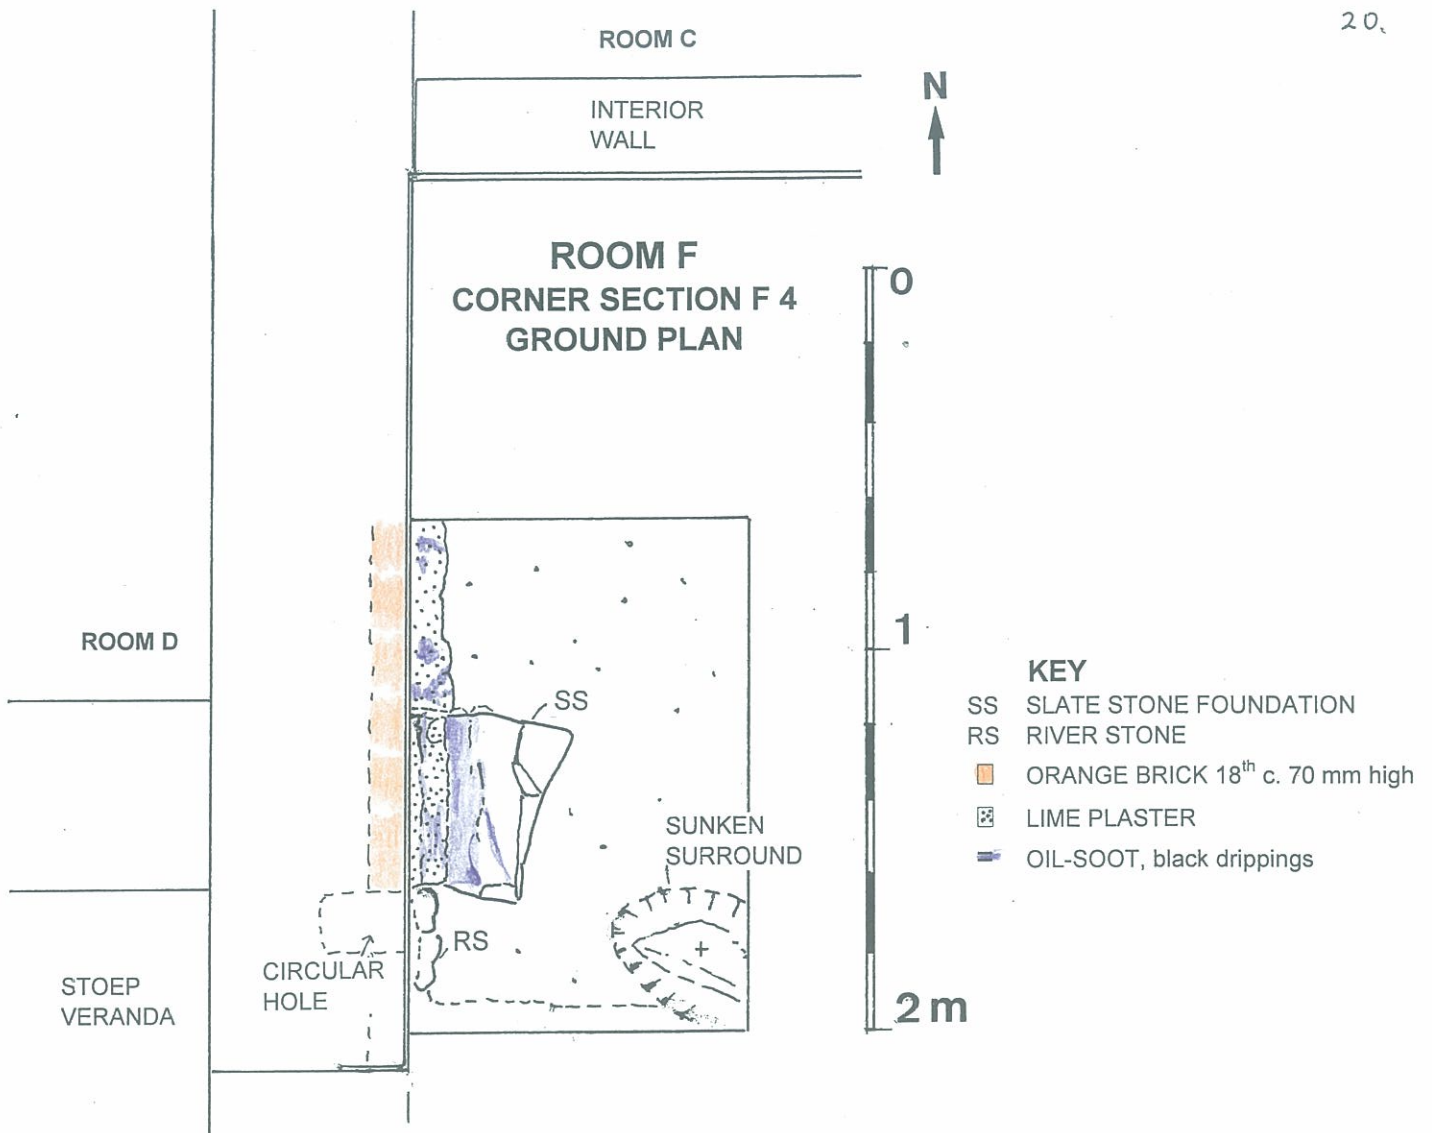
FIG.7.1 Ground plan of section F4 in Room F (*Agterhuis*). The slate slab (no further foundations) as a base for a full width screen. Note the oil-soot drippings.

An isolated piece of granite protruded from the surface, but enlarging its area showed no other stones (see FIG.7.1). A thin iron peg was hammered into the soil along the foundation "line", but no sub-surface stones were encountered. The height of layer 5 being a mere 30 mm lower than the slate stone, indicates either the placement of tiles in Room F, or a very shallow boarded floor.

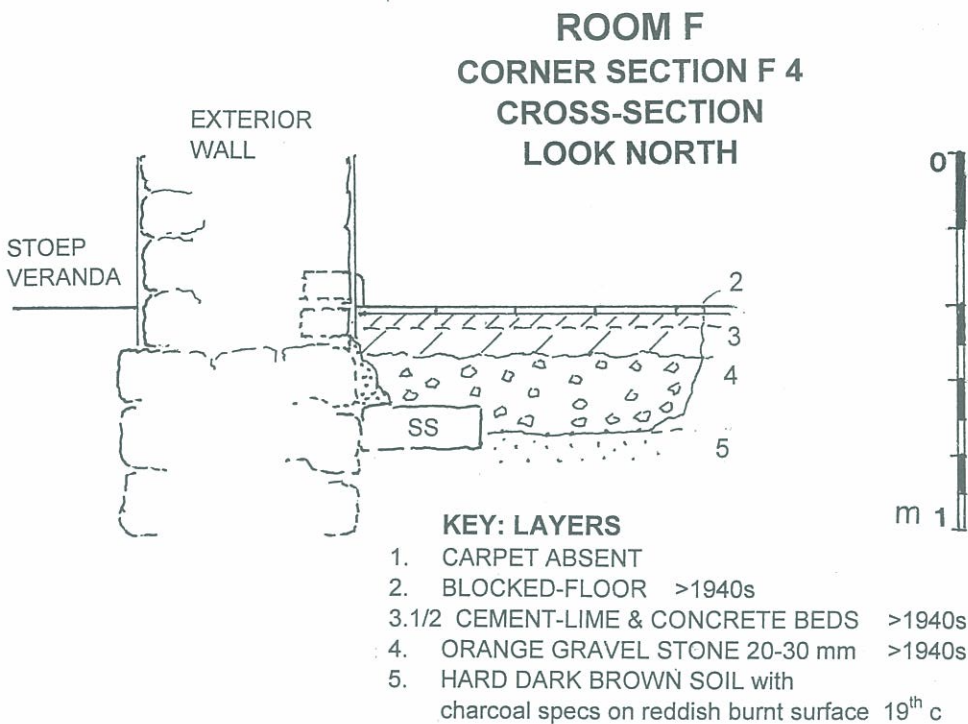
FIG.7.2 Elevation of the excavation F4, filled with gravel (>1940s) till 30cm below floor level.

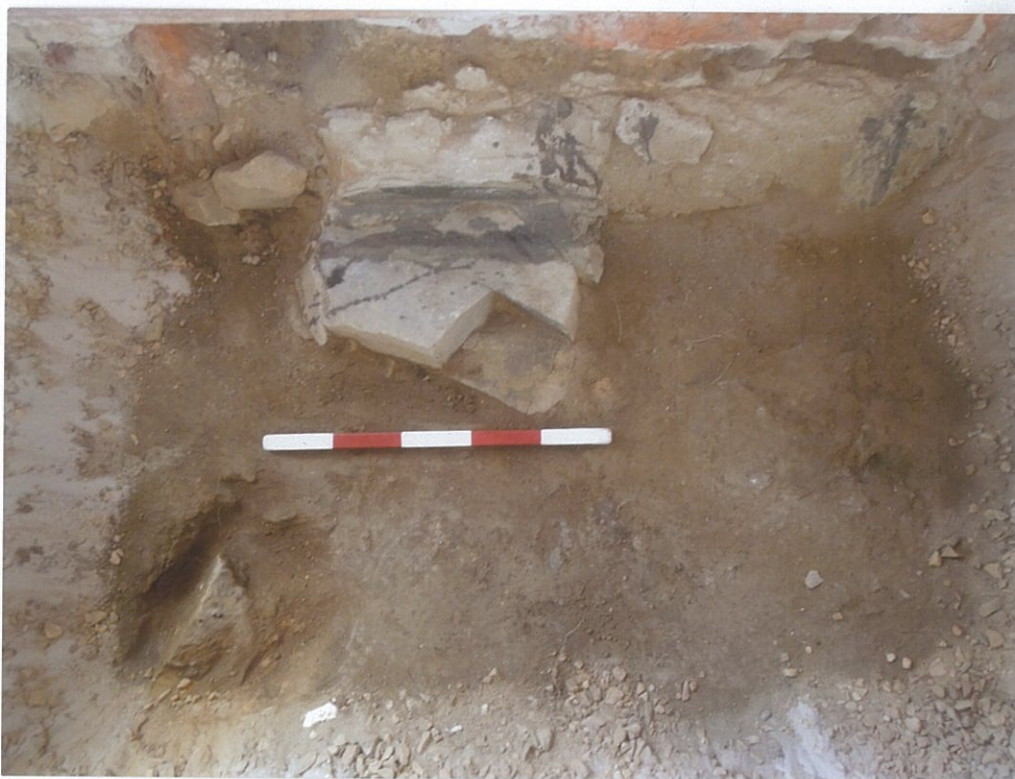
20. In Room F, wall 4, a 50cm wide stone footing was exposed. Volumes of gravel cascade from the sides. Note the granite stone (out of context) on the left (scale 50 cm) (look W).

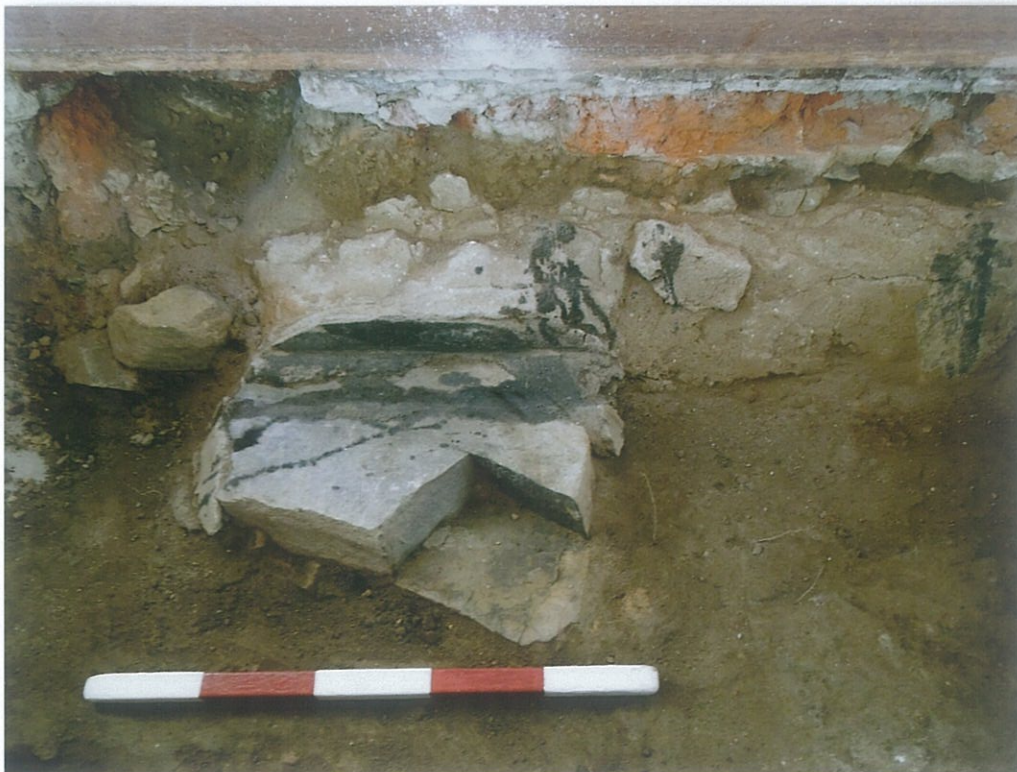
Black creosote oil drippings were present over the slate and the lime plaster (see drawing & photos). The slate bedstone, with no foundations, the black oil drippings and pilaster columns are indicative of a timber screen, with folding doors, probably stretching to the ceiling timbers. The present yellowwood beams have a beading of early 1800, which probably replaced the earlier $\frac{1}{4}$ mould beams. A fire of early 1800 probably razed the floorboards, screen and beams and roof structure. On the surface of layer 5 charcoal specs were also encountered on the burnt surface.

22. A close-up of the slate slab with the trickled creosote at the position of the timber screen. Note the rectangular portion of whitish lime plaster of the "pilaster". On the upper left is a circular hole (scale 50 cm) (look W).

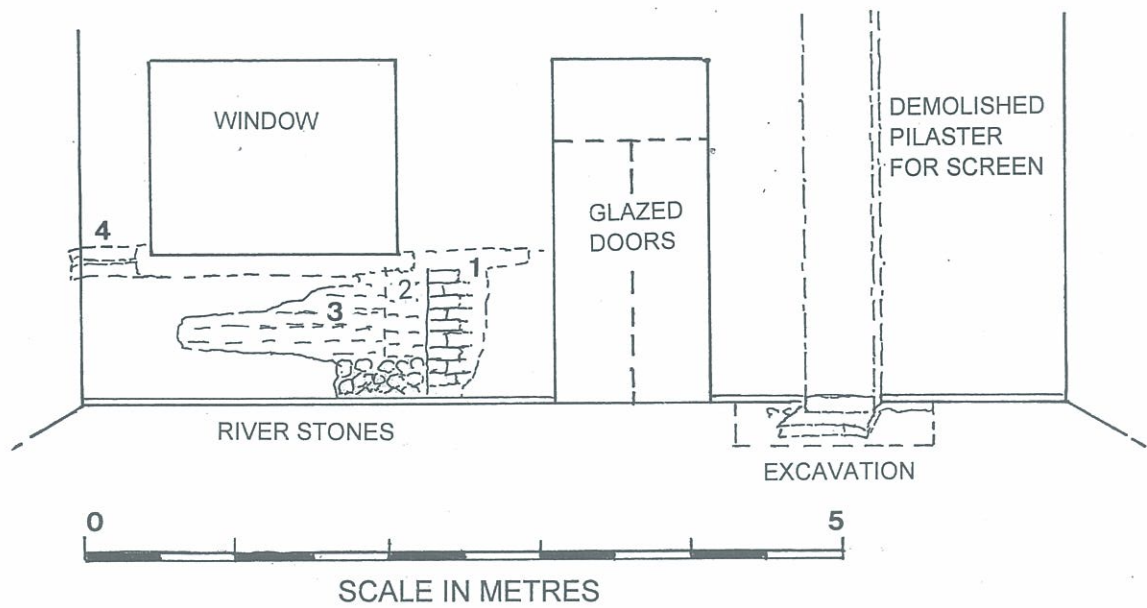
WALL F4
LOOK WEST

FIG.8 Elevation drawing of Wall F4 of Room F (*Agterhuis*). Excavation on right with reconstruction of pilaster for screen. Traces of earlier openings visible on the left on the exposed brickwork.

As much of the plaster was loose below modern window F4, a large portion broke away, facilitating searching for earlier openings (FIG.8).

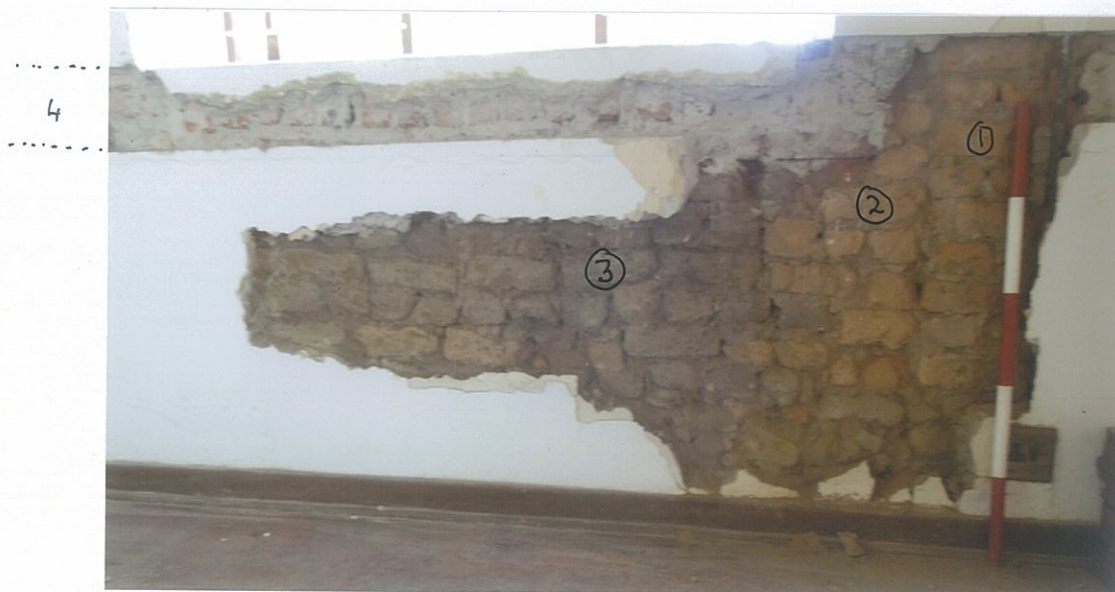
24. Close-up of wall F4 below the window-sill, of the different portions of brickwork (1 to 4) (scale 1m).

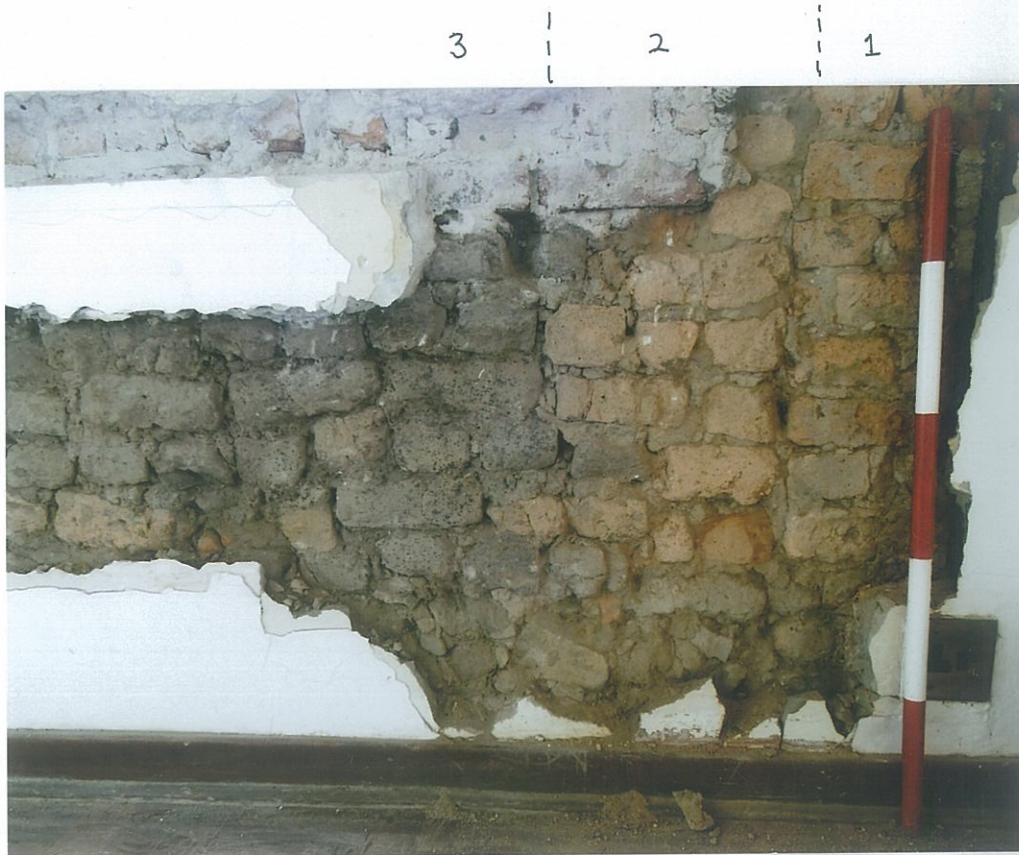
25. Another detailed view of the contrasting bricks and vertical lines (F4), indicating previous openings (look W) (scale 1m).

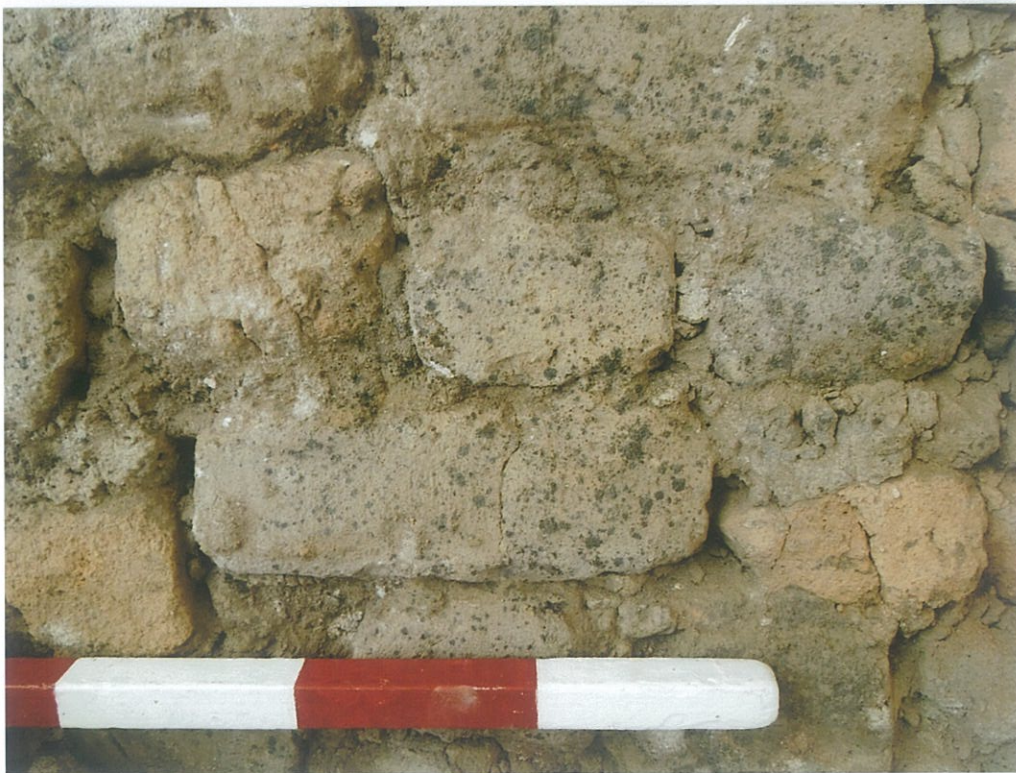
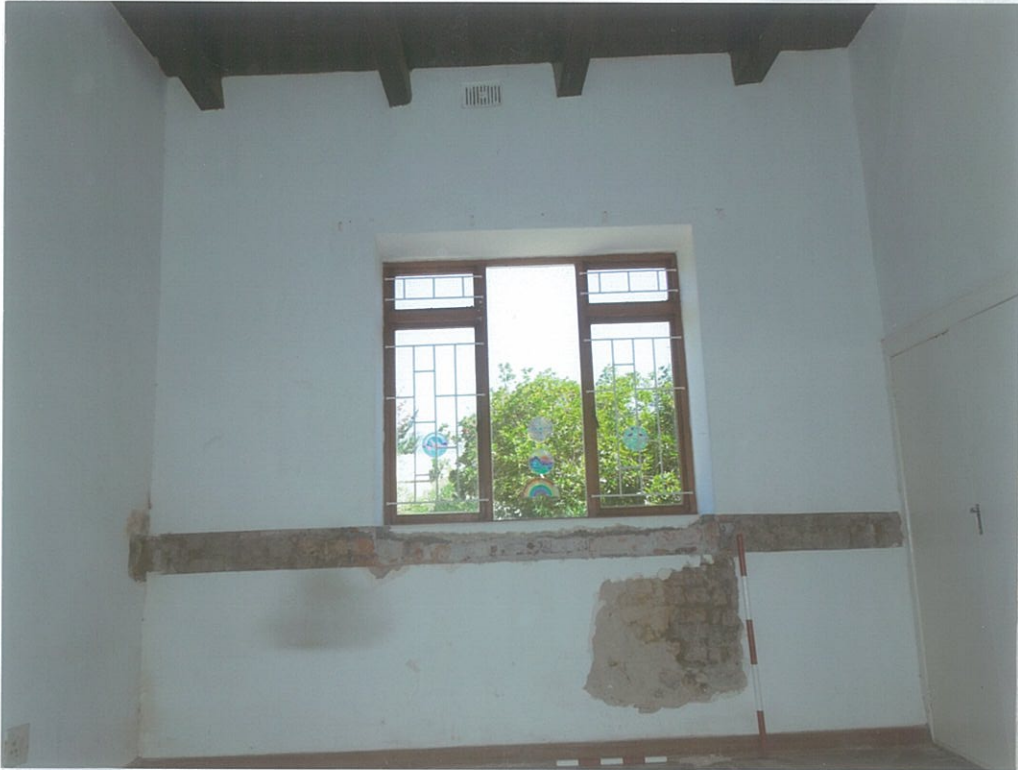
27, 28. View in Room G (*Agterkamer*) of wall G4 and the plaster stripped. Note in the close-up the older 18th c brick (1) and the filled-in brick and yellowish mortar on the left (2) (look W) (scales 1m, 50 cm).

In order to determine if there were also any early openings in exterior wall G4, some plaster was stripped, where large cement portions pulled loose from the wall exposing a variety of bricks and brick lines.

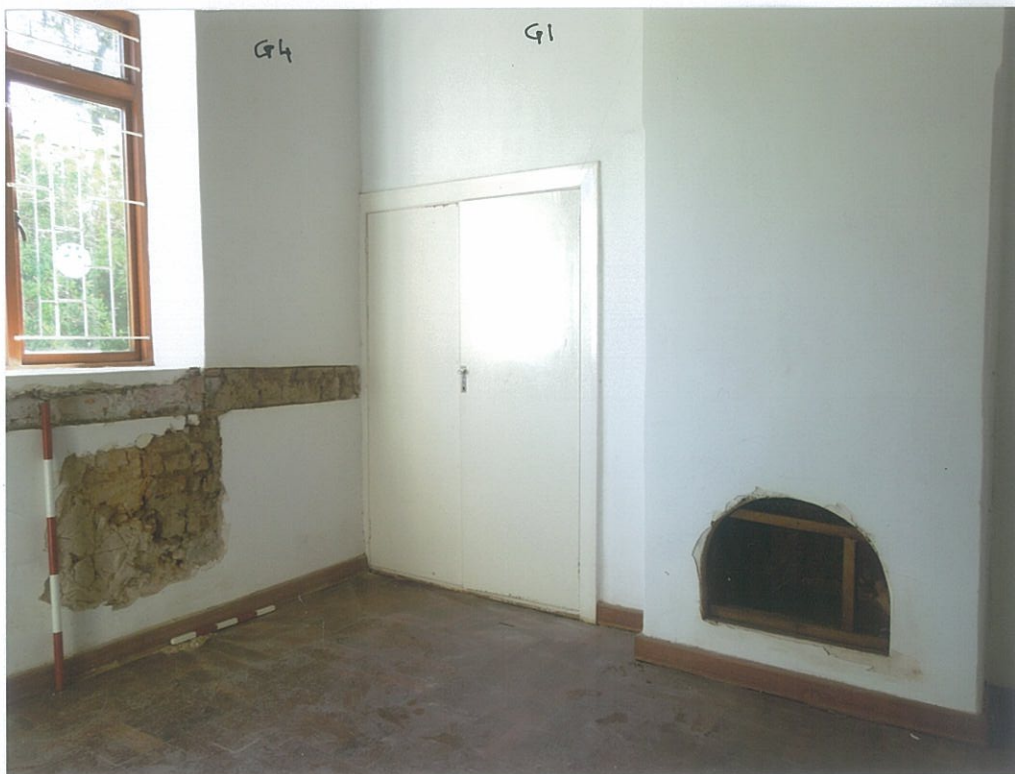
29. View of Room G4/1 of the plaster stripped, the blocked-up cupboard door and the opened-up grate of the late Victorian/Edwardian period (look NW) (scales 1m, 50 cm).

Note the grate G1 was opened up to reveal a domed, niche opening, typical of the late Victorian period. I recommend a cast-iron grate to be installed again.

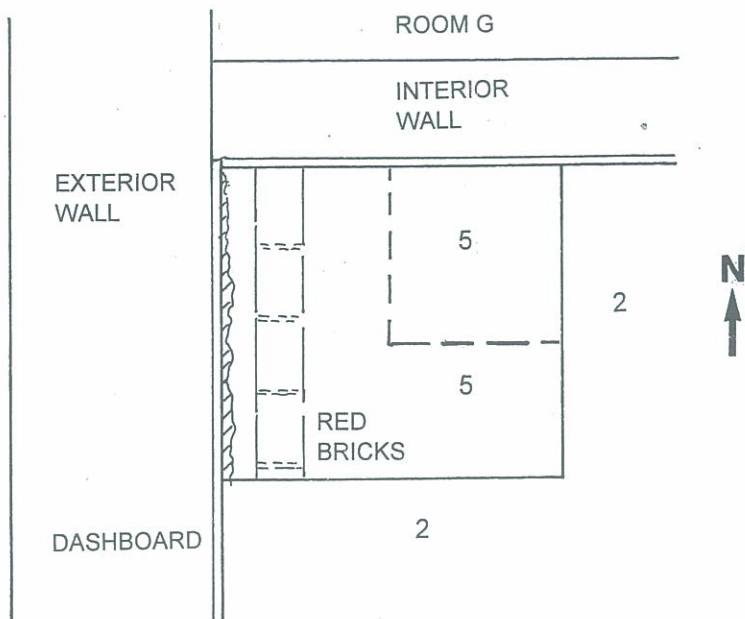
FIG.9.1 Ground plan of the excavation I1/4 in old Kitchen I. Ribbed red brick of >1940s to waterproof the left exterior wall.

I interpret this black loam layer, impervious to water penetration, as an 18th century technique to waterproof a floor layer of Cape tiles (28 cm²). Tiles are the general floor covering for this period. It appears that during 1940s the loam floor was also lowered for the gravel and concrete insertion. Water penetration from the exterior stoep courtyard probably played a major role with water infiltration. Note the red-ribbed, brick line in cement parallel to wall I4 to obstruct damp. No wonder many of the walls were replastered in cement.

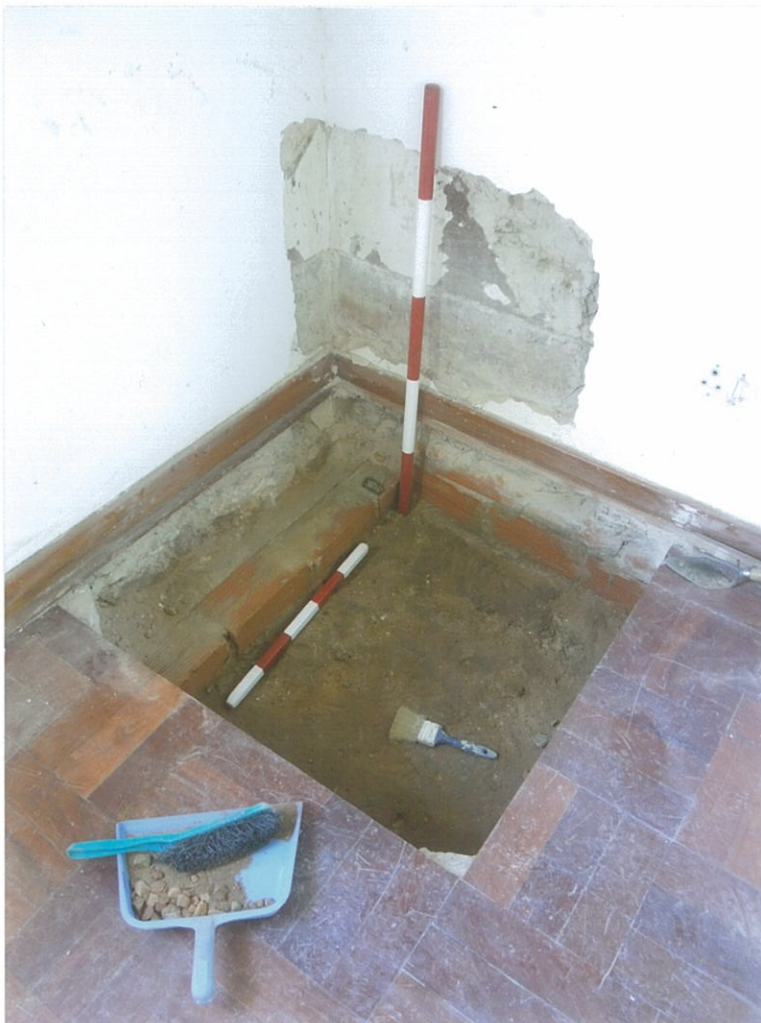
30. Within the Old Kitchen I, a corner section I4/1 only exposed a black matrix of hard clay-loam, its upper portion removed and filled-in with gravel (scales 1m, 50 cm) (look N).

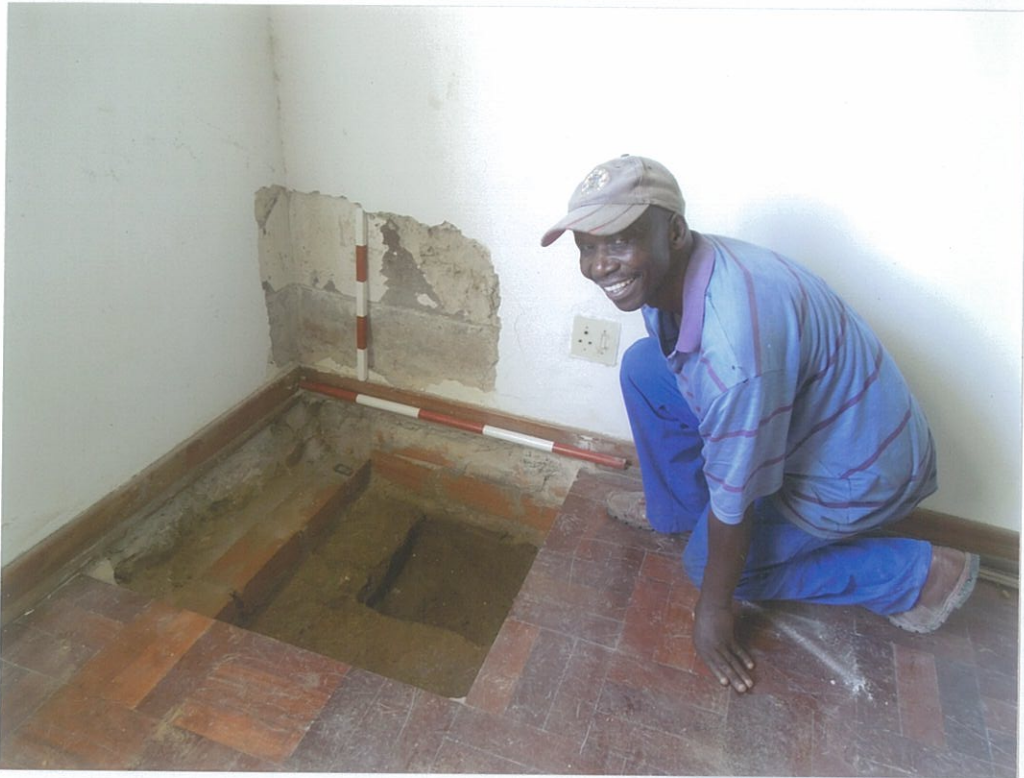
31. Corner section I 4/1 with its deep section as excavated by Jackson. Note the 1940 red bricks on sides I4 and I1 (scales 1m, 50cm) (look N).

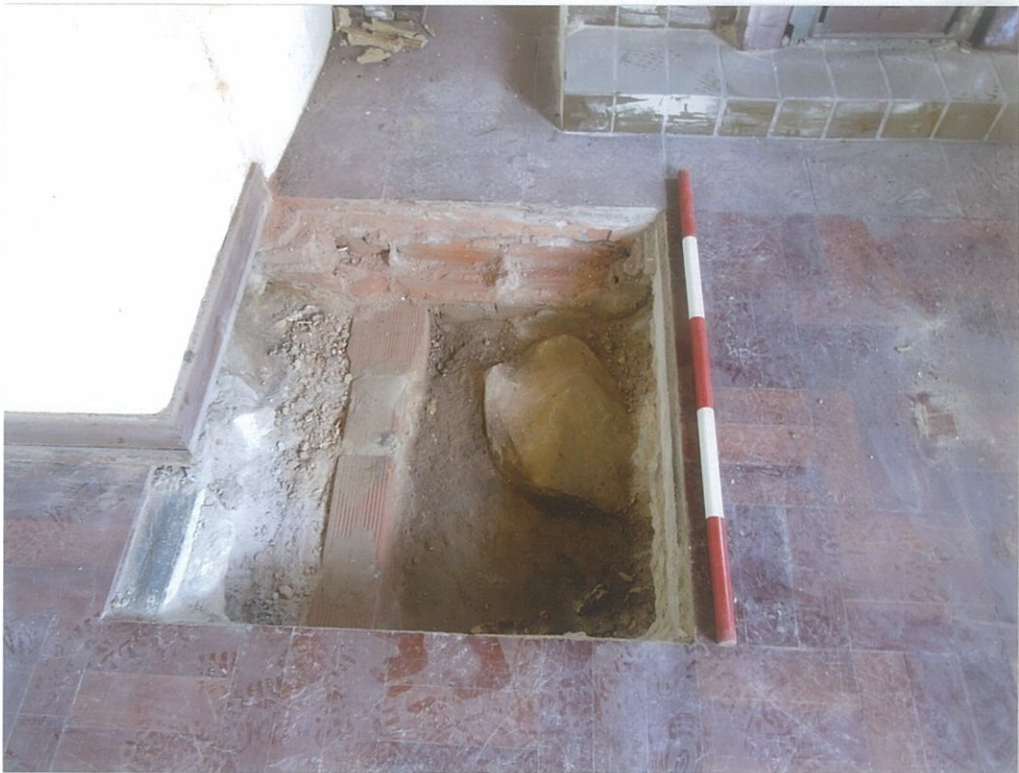
32. Next to the hearth (I3), another section also exposed the 1940 bricks (1) and a large stone (2), probably part of an earlier foundation (scale 1m) (look S).

The Contractor neatly opened up a small section in the hearth floor, which we cleaned out. Once again it contained gravels but also >1940 brickwork which prevented any further digging, a large granite stone, probably part of a demolished foundation line (see Photo).

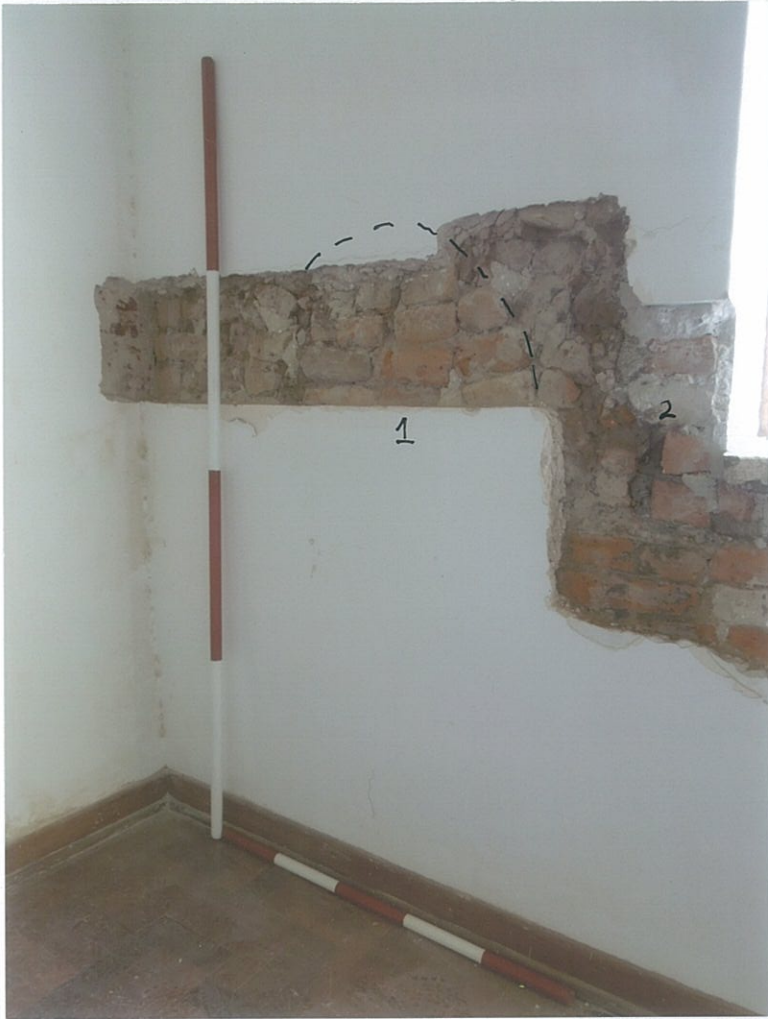
37. This southern section of Wall I4, show where the arched over opening has been filled in (1), as well as the black soot over bricks and mortar (2) (photo 38) (scales 2m, 1m) (look SW).

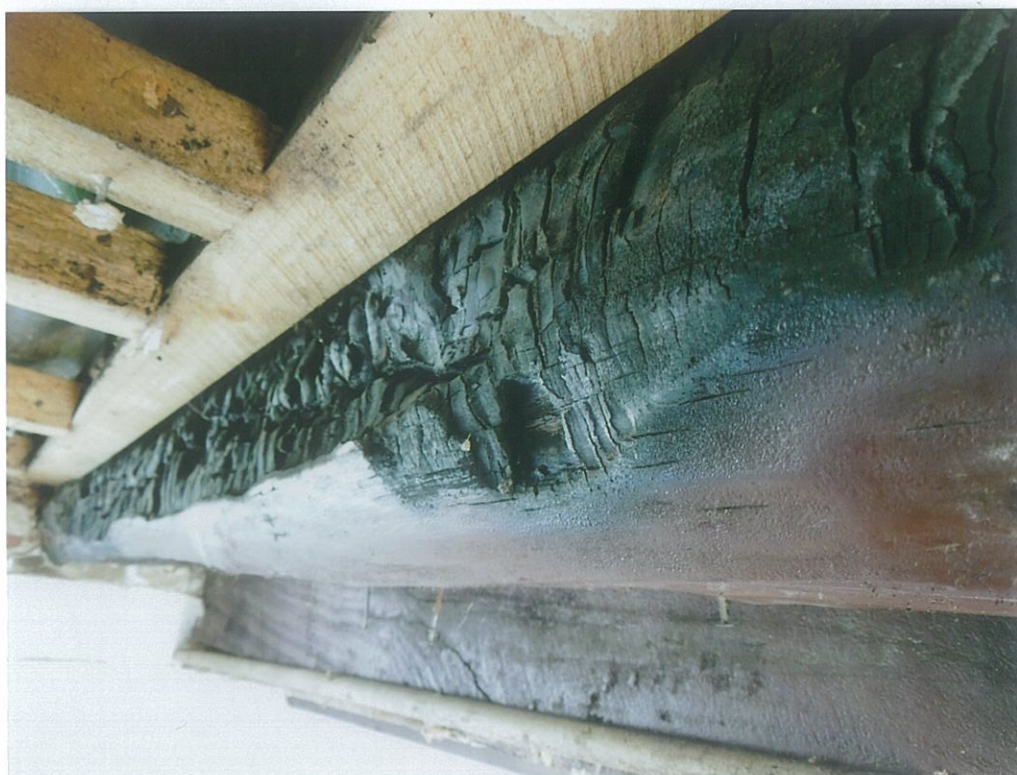
42. A view of the poplar beam heavily charred during a house-fire of the 19th c (look W).
