**OLD BETHLEHEM FARM 153
DWARS RIVER VALLEY, DRAKENSTEIN**

HOMESTEAD (T-PLAN)

**STRUCTURAL & ARCHAEOLOGICAL INVESTIGATIONS
& ASSESSMENT OF THE WALLS AND FLOORS,
PREPARATORY TOWARDS REHABILITATION**

APRIL 2013

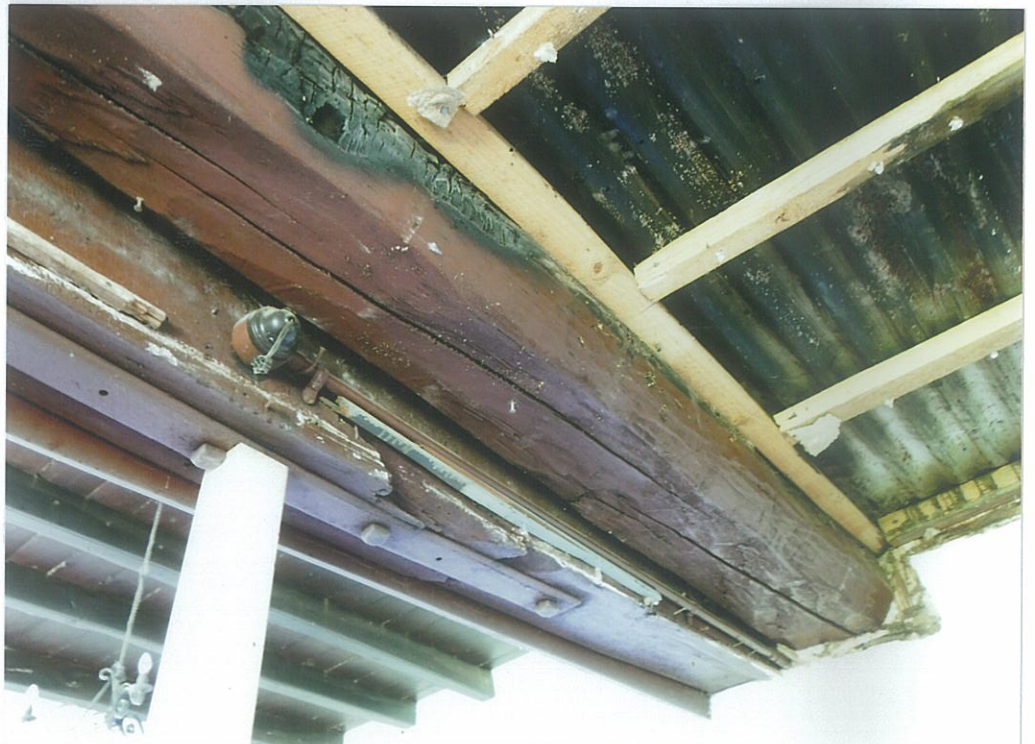
43. The other side of the carbonized poplar, circular beam where it resides next to the square hearth beam, mended with an iron strap to stabilize a crack in the wood (look E).

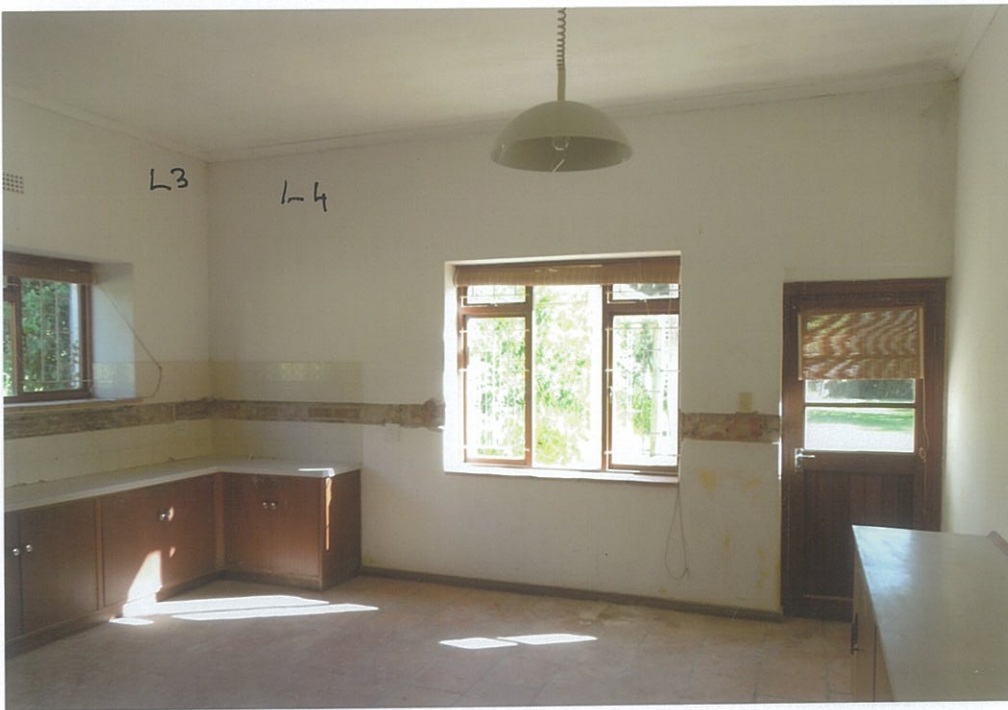
According to my structural report (Vos 2011:62) Room L represents a flat-roofed addition of post-1860, built in clay brick and mortars. None of its doors or windows survived, all replaced with post-1960 doors and windows. A thin bond of plaster was removed all along the walls by cutting through the tiles. Not much new was revealed.

45.1/2 The walls of the modernized Kitchen L were fully tiled. Though a narrow band was cut along the walls, little new information was gained (look W & S).

Due to its many alterations, it is recommended that the (mid to) late Victorian period furniture (glazed doors and sash-windows), in the style of the *Voorhuis* façade be incorporated to harmonizing with the rest of the dwelling. The c.1940 tiled floor is still adequate and suitable. Something very similar would have been in the old Kitchen I.

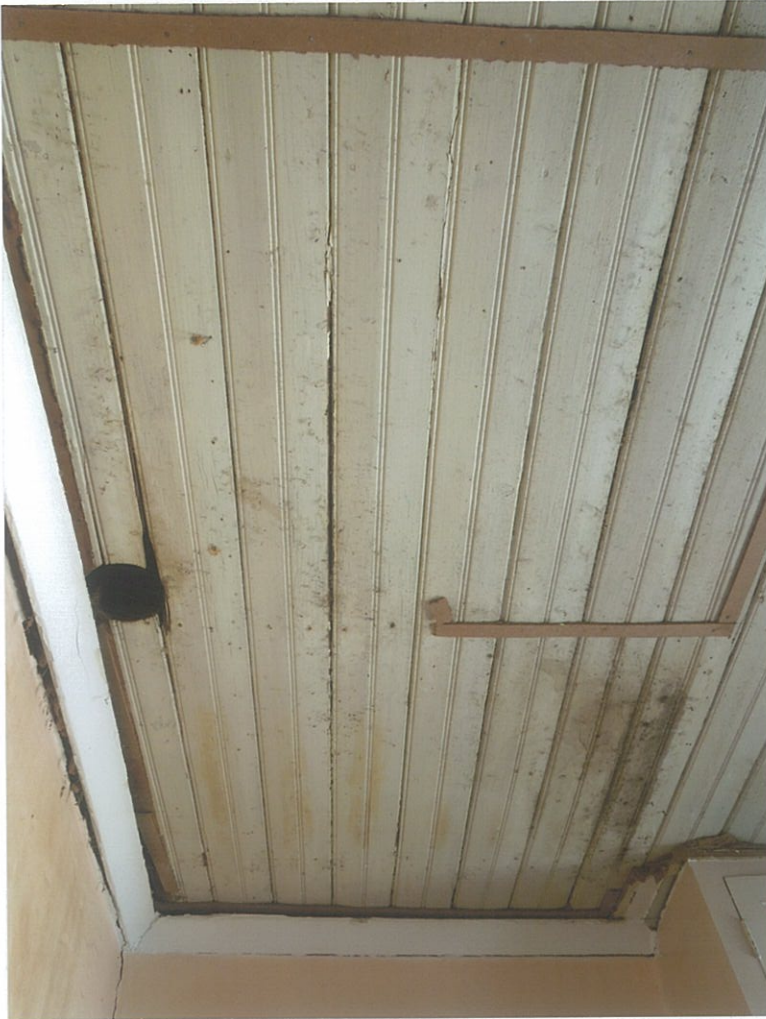
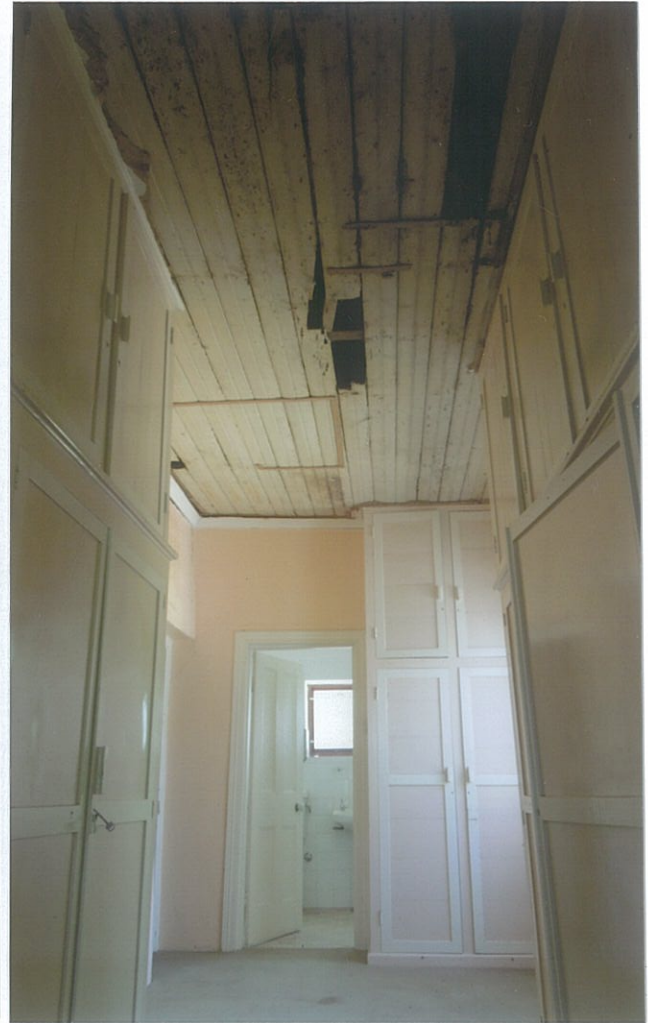
46, 47. In Room M, the modern ceiling was fully removed, exposing the c.1890-1910 tongue-and-groove boards of the flat-roofed additions (look E).

Room M is part of a flat-roofed addition of 1880s to 1900. A modern ceiling hid the old tongue-and-groove boards ceiling of the earlier period. It could be repaired or replaced with something similar.

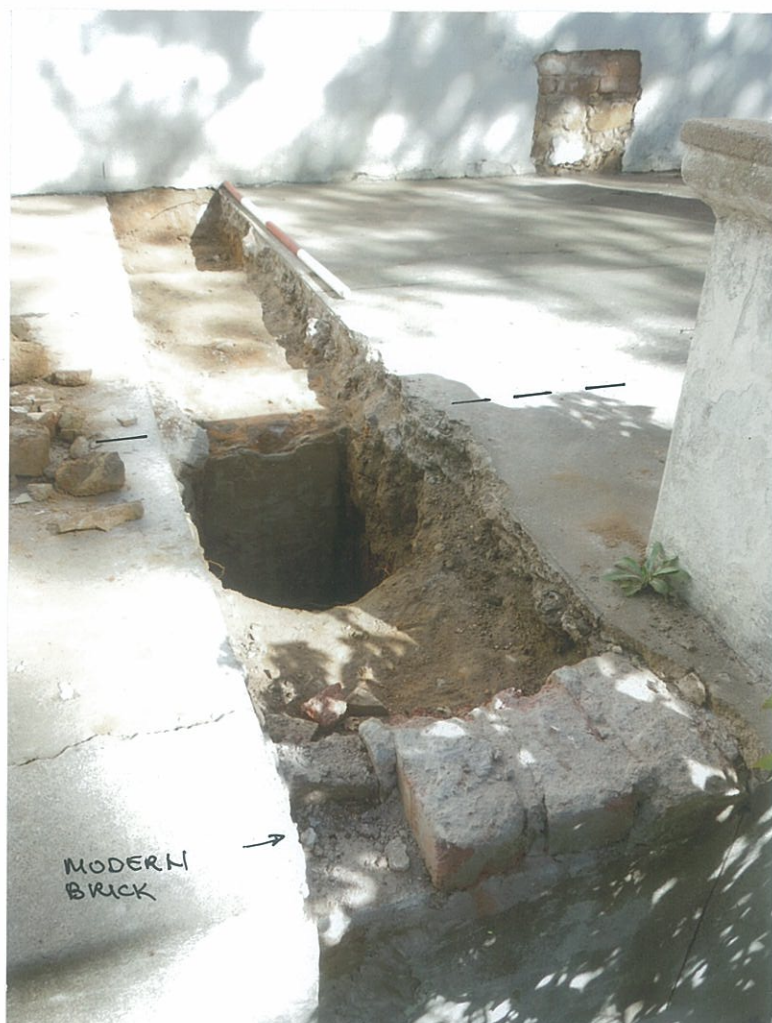
49. The contractor neatly cut a furrow along the broad stoep (see FIG.3), just to the right (west) of the front gable. The earlier 2.5m wide stoep with its plaster still adhering was revealed. Note the modern nose bricks (>1920s) of the broad stoep (look S).

My recommendation is that the c.1920 stoep be retained, but tiled up to the 1920 nose brick, which should be reinstated. The correct stoep incline would also drain water away from the house façade, which is presently not the case.

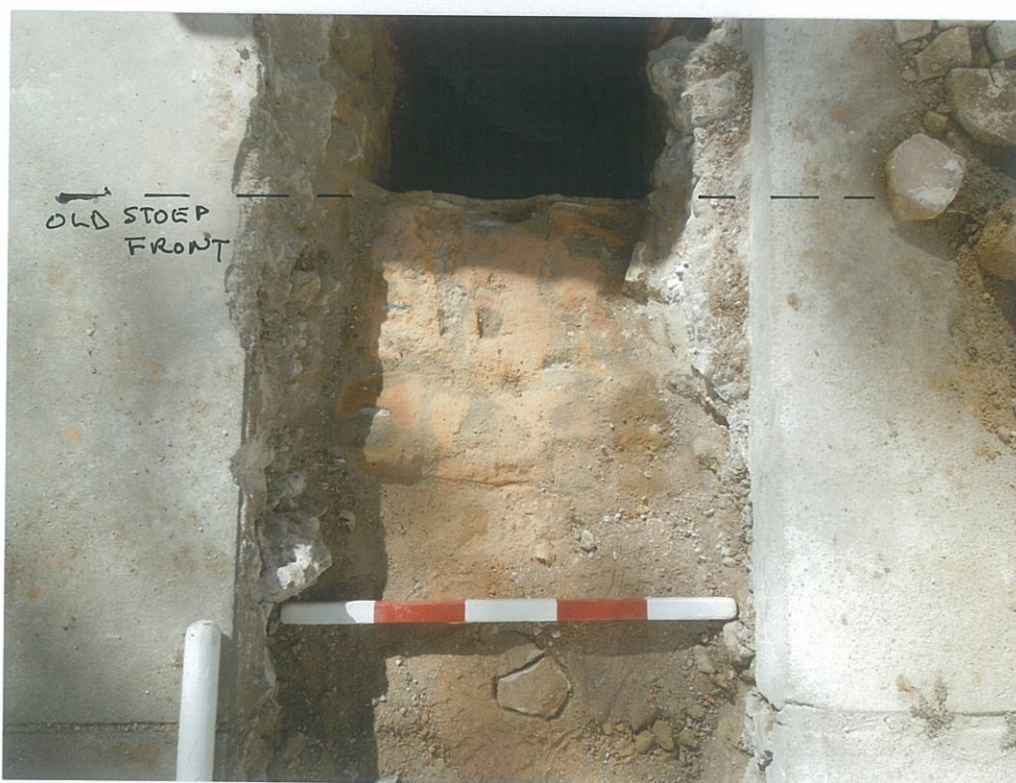
50. Close-up of the well-fired orange bricks (50 cm wide) to stabilize the front section. Tiles probably covered the 1770s stoep (scale 50cm) (look N).

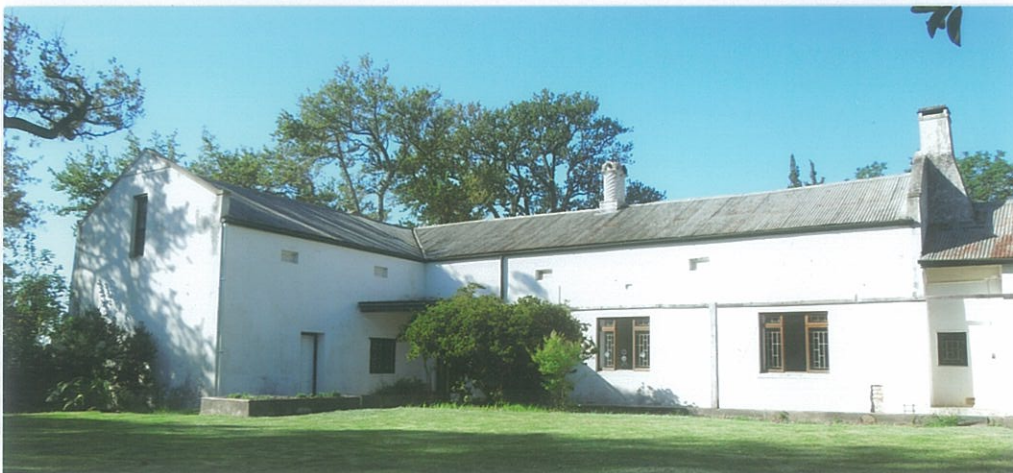
52. View of the western facades of the rear of the building, all facing the garden. All the visible windows and doors are late. Glazed doors and sashes would be more functional & harmonize with the earlier structure (look E).

As a major stylistic element, I recommend glazed double (or single) doors (see glazed Door B3), to be installed in Rooms G and L, but have reservations about the old Kitchen. Here a single sash-window (post-1800) may allow enough fresh air and light. Note the evidence for the earliest hearth and oven against wall I4 should not be compromised with destruction. In Room DE, both the Window and Door (DE3) are later intrusions. Glazed doors and sashes would be more functional and stylistically correct. All the western facing walls (FGL & DE) show earlier alterations in the wall fabrics, as has been shown during the investigations.
