## CARE AND MAINTENANCE PLAN

**NAME OF APPLICANT:** Kophia Diamonds (Pty) Ltd  
**TEL NO:** (084) 466 1021  
**EMAIL:** samuel.kophia@gmail.com  
**POSTAL ADDRESS:** 3 Vergelegen Street  
Royaldene  
Kimberley  
8301  
**PHYSICAL ADDRESS:** 3 Vergelegen Street  
Royldene  
Kimberley  
8301

**FILE REFERENCE NUMBER SAMRAD:** (FS) 30/5/1/2/3/2/0236 MR

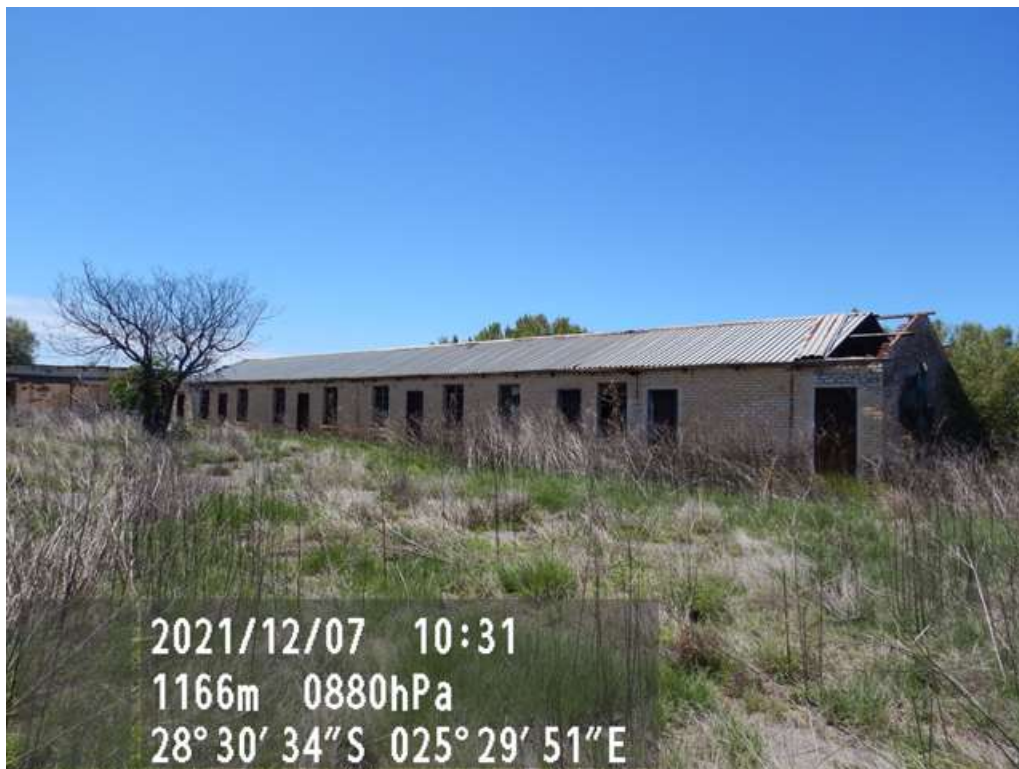
During the site visit the only infrastructure that was observed was the fenced off power station (which is in a good condition) near the entrance of the mine, managers building to the western side of the mining area, an office building and old dam that was located to the north and a hostel area. The overall condition of the buildings was in relatively poor condition as can be seen in the photos provided below.

Figure 11: Old Hostel

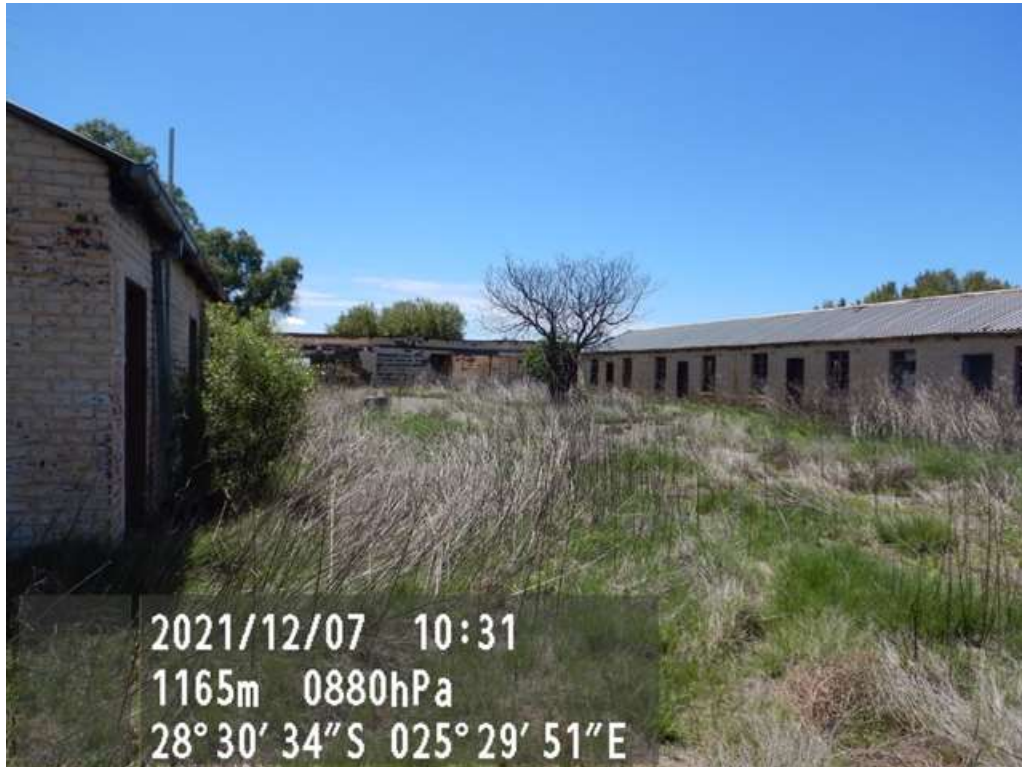
*Figure 12: Old Hostel*

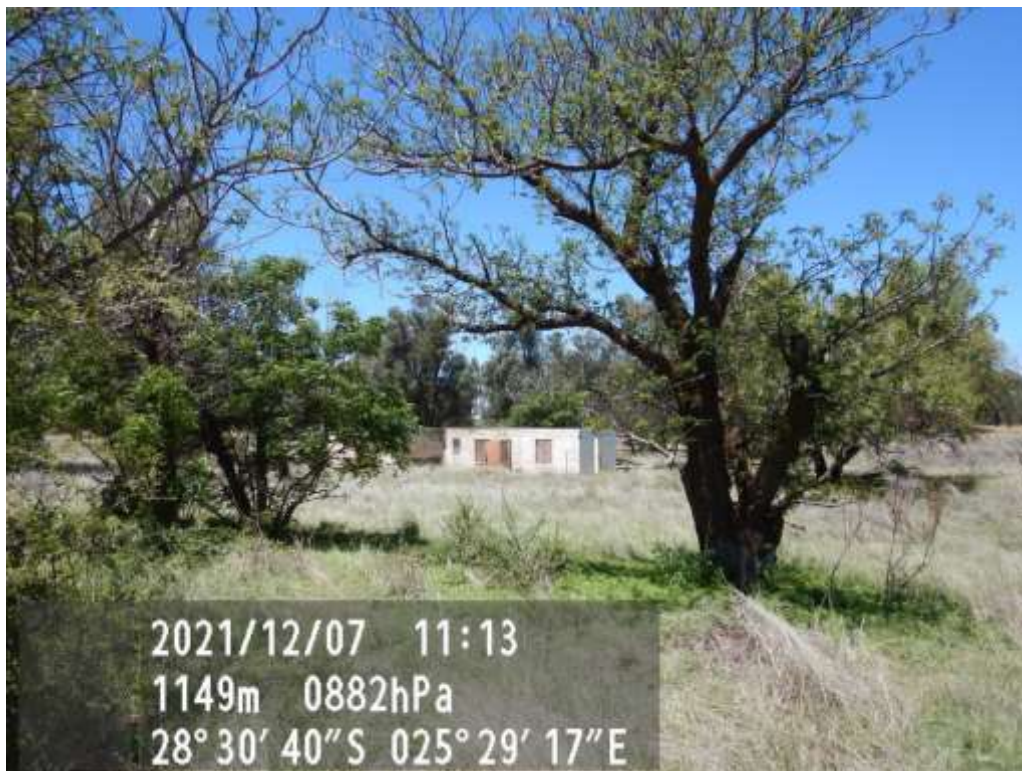
*Figure 13: Old manager's house*

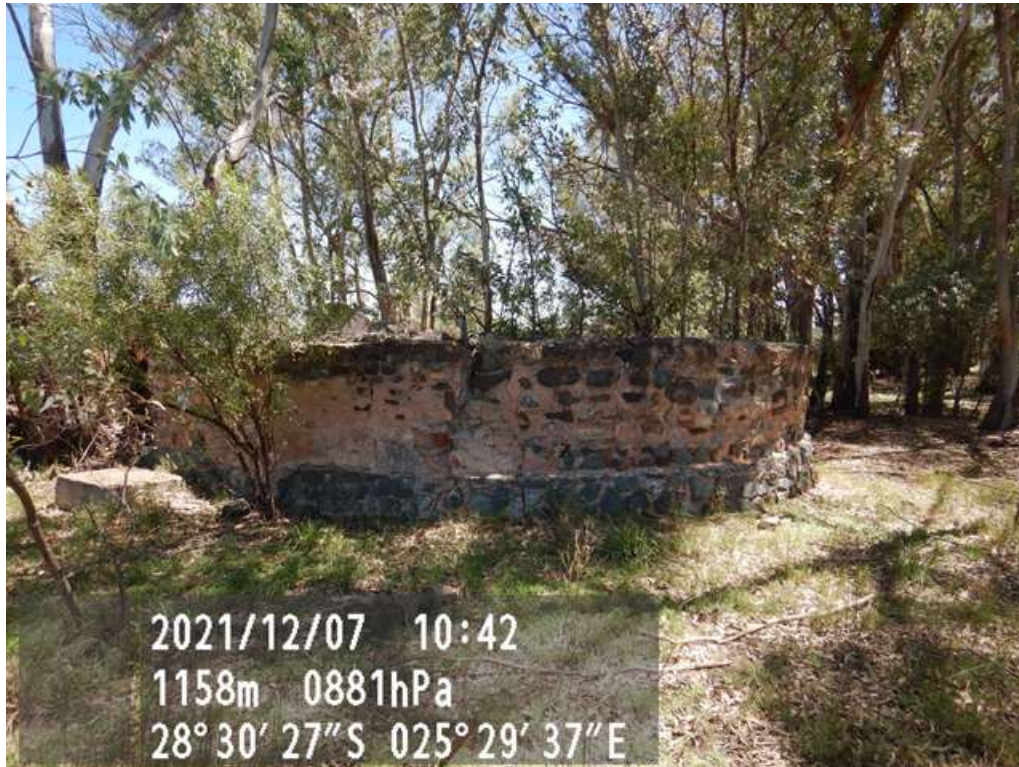
86	Maintain water storage dams.	Non-Compliant	The water storage dam located close to the office area are being used to store building rubble. It is recommended that the building rubble is removed from site and the dam be restored for future purposes.	0

*Figure 14: Old dam that is filled with building rubble*

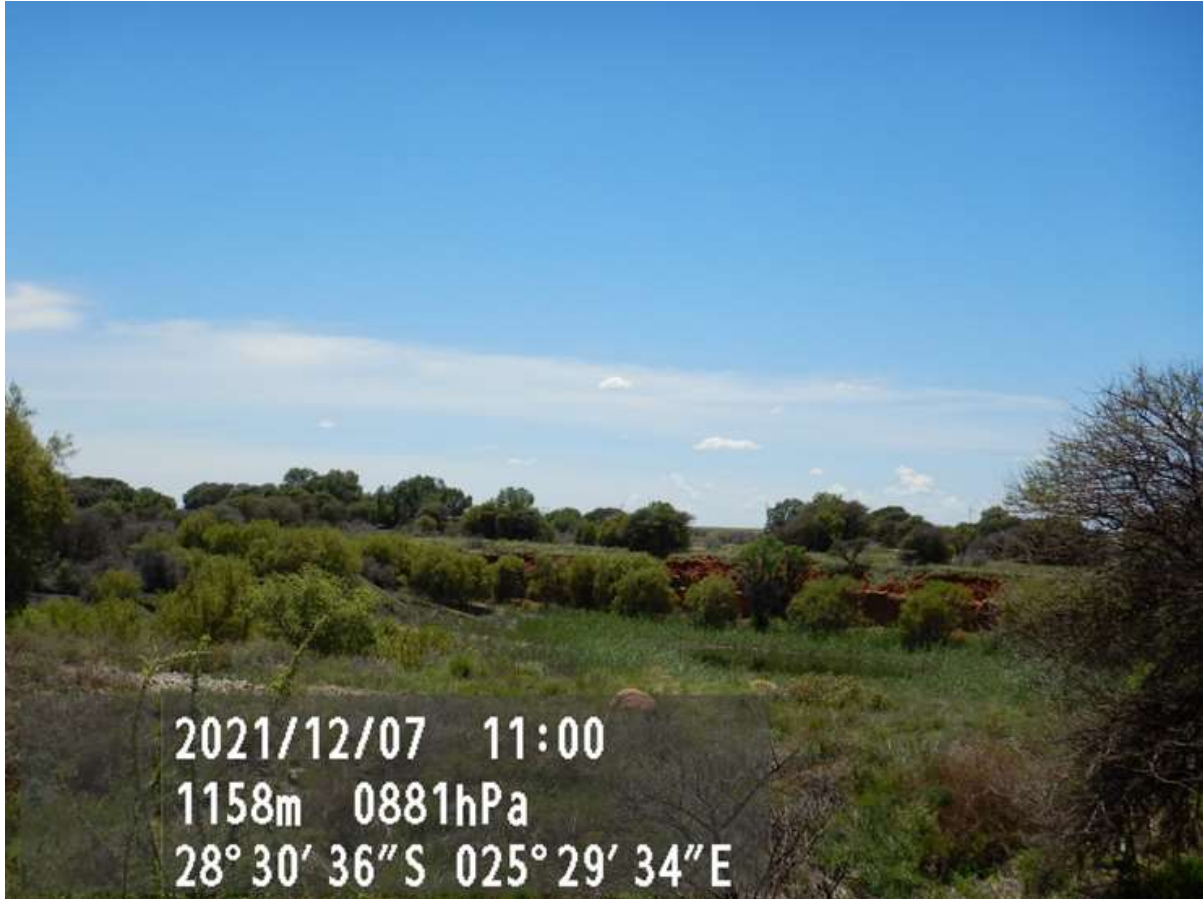
If appropriate bunding or other surface drainage infrastructure is not accommodated during the planning phase, a significant amount of water can find its way into the pit. Depending on the nature of areas around the pit and even inside the pit itself, water quality can deteriorate due to excessive

saline or the lowering of pH. These factors could pose a water quality and quantity risk in terms of disposal when the mine reopens. The open pit could also pose a problem for downstream communities as the pit would accumulate water that would normally have entered surface streams and rivers.

Figure 15: Open Pit

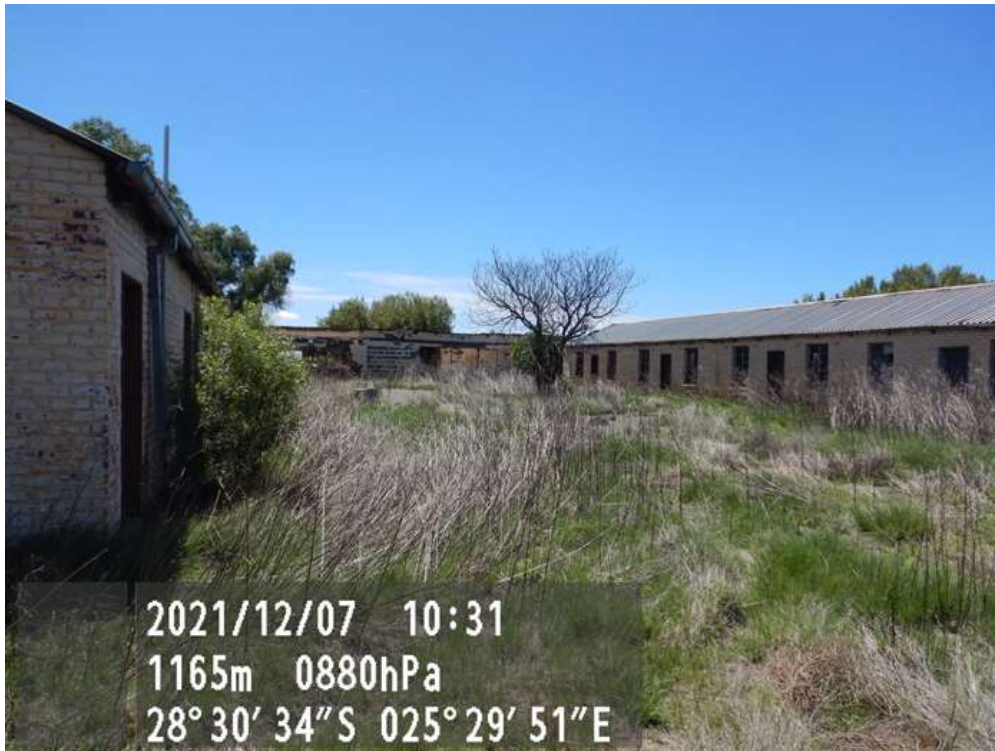
Gutters is equipped at the old hostel building which require some maintenance and must be monitored as this is clean water.

*Figure 16: Gutters that needs to be maintained.*

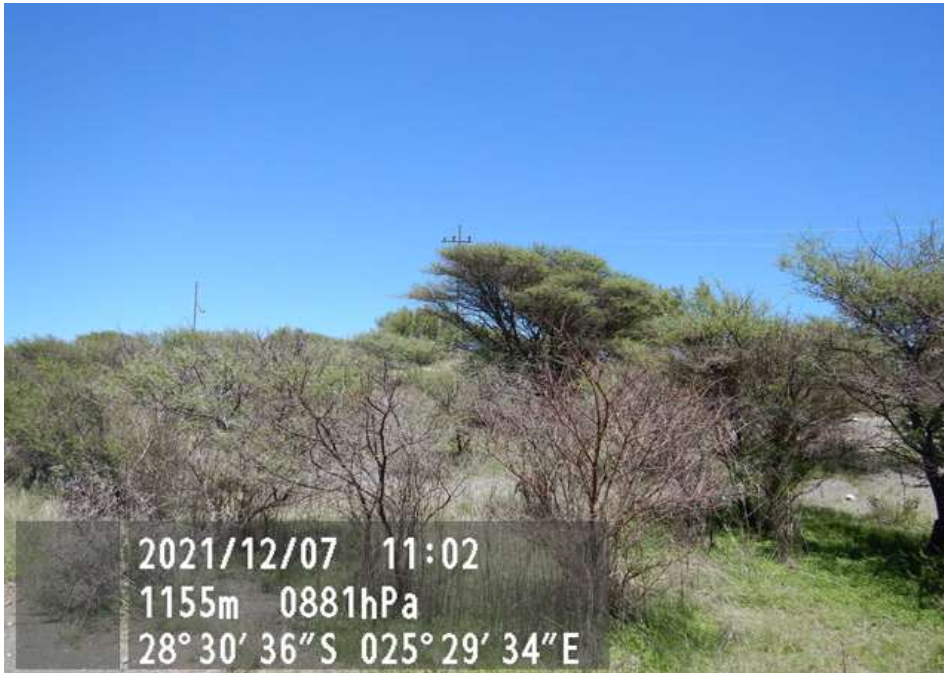
*Figure 17: Powerline on top of tailings*

Un-rehabilitated or partly rehabilitated waste rock dumps would increase the possibility of material movement to the surrounding environment as a result of erosion. Depending on the type of dump, it could also cause pollution of the surrounding environment as a result of chemicals or other materials emanating from the dump.

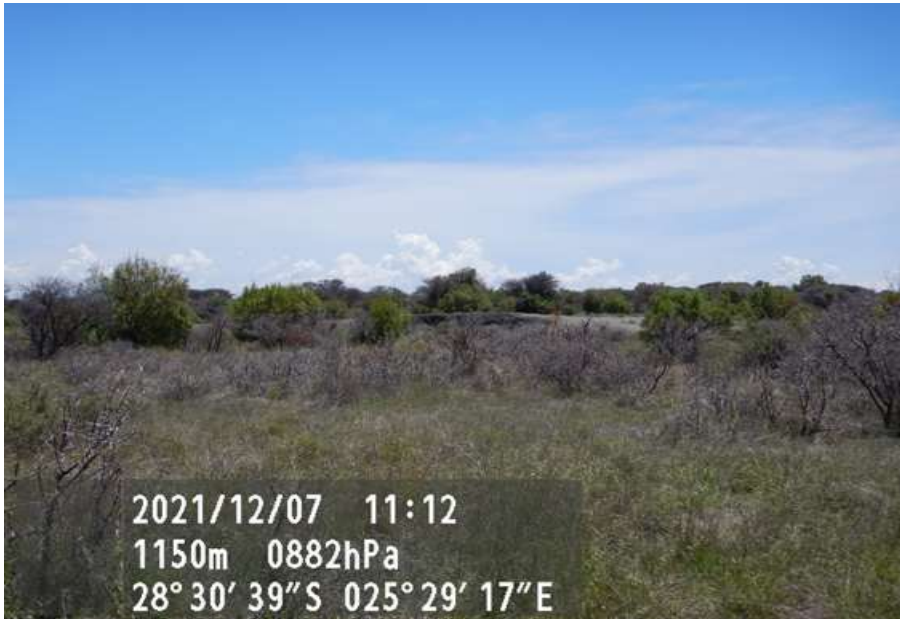
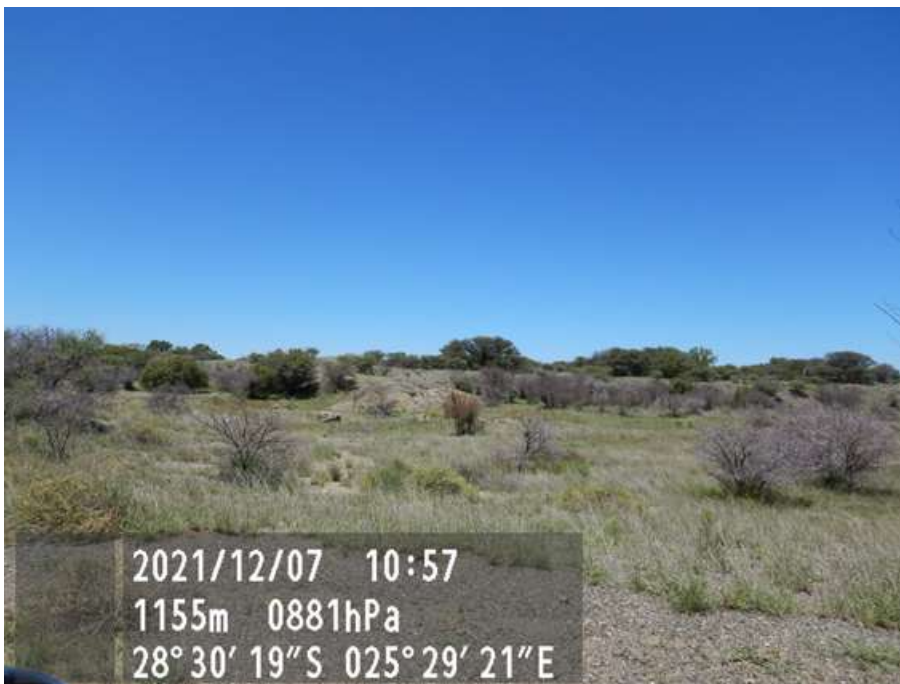
Tailings in general are made up out of sand, silt and also clay which are suspended in water-based slurry which can lead to slope failures. It is therefore important that the mine monitor the slopes of tailings and waste dumps to ensure that slides and slope failures are prevented/minimized as far as possible. The risks involve in tailings that are being stored ranges from fatalities due to mud slides- to drainage contamination, flooding and water contamination

Figure 18 : Tailings

Figure 19: Tailings

Tailing's storage facilities have the same potential risks as waste dumps, with the added risks of release of polluted water from the facility or, in the worst case, catastrophic failure of the facility. Polluted water could find its way through the containment walls, the base of the facility, over the walls of the facility, or through the decant pond. Catastrophic failures of the containment walls could be a result of structural weakness through a design and construction fault or erosion.
