Conditional Assessment for Buildings on Robben Island

CDC-453-17

Date: October 2018

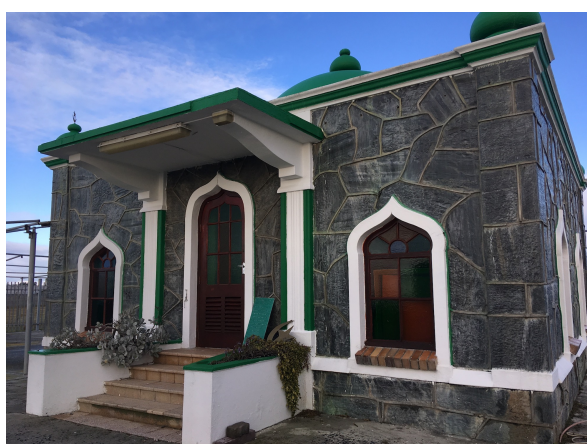
The entrance door is half-glazed and the windows are wooden four-paned casements with fanlights. The inside walls are plastered with minor damage from water leakage. Ongoing maintenance is required to prevent further deterioration.

Fig 3. Entrance to the Kramat

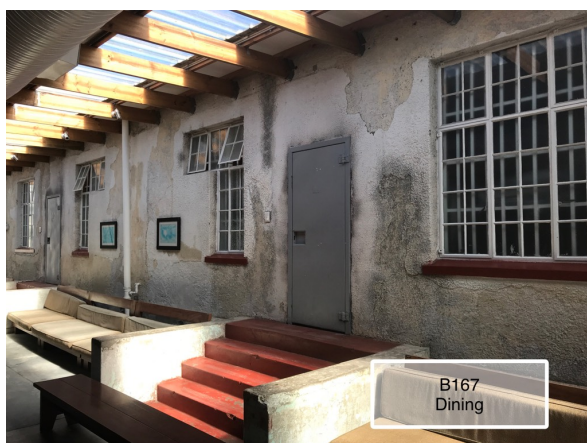
The cause of the black mould, which is quite prevalent in the dining area, needs to be investigated. It is likely that there is inadequate natural ventilation in this space. Surrounding remedial work will be required to prevent this from re-occurring.

Fig 5. Black mould on walls in dining area. Causes need to be established

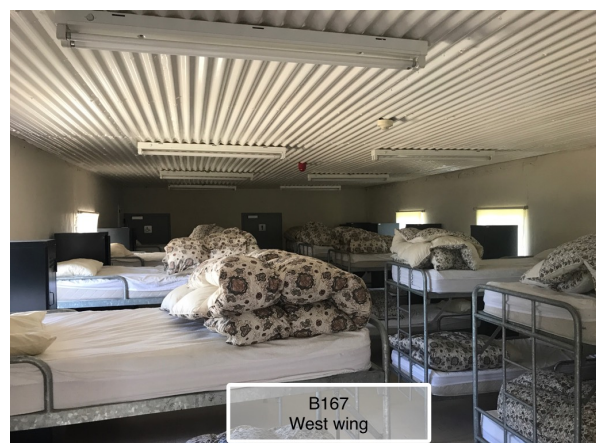
Fig 6. Note the flaking paint on the walls close to the concrete ceiling. Most likely caused by excessive moisture generated by children with walls not being able to 'breathe'.

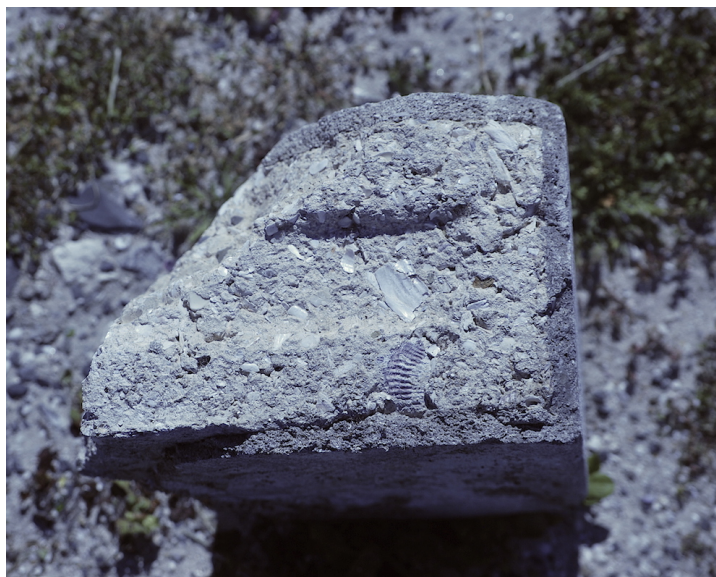
Fig 8. A sample of limestone brick found on Robben Island. A typical example of the quality of brick produced. It appears if the mortar contains cement, which should be analysed to determine the mortar mix for the restoration work.

Following brickwork repair, re-point to match original using a pointing tool and application technique similar to that used originally with a mortar specification to suit the age of the building and the strength of the brick.

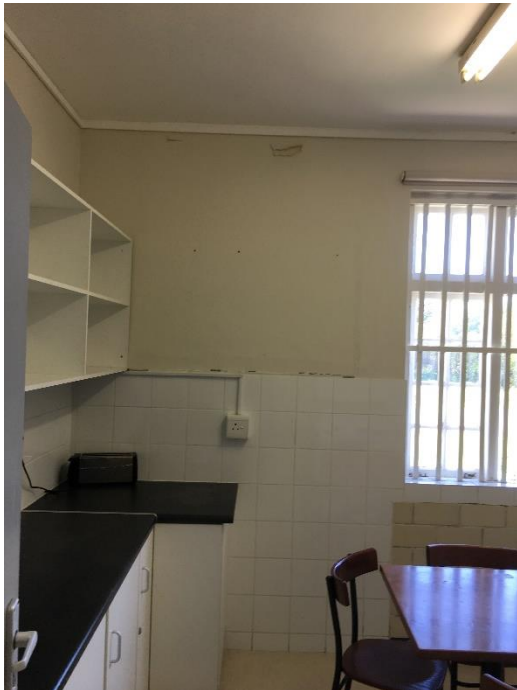
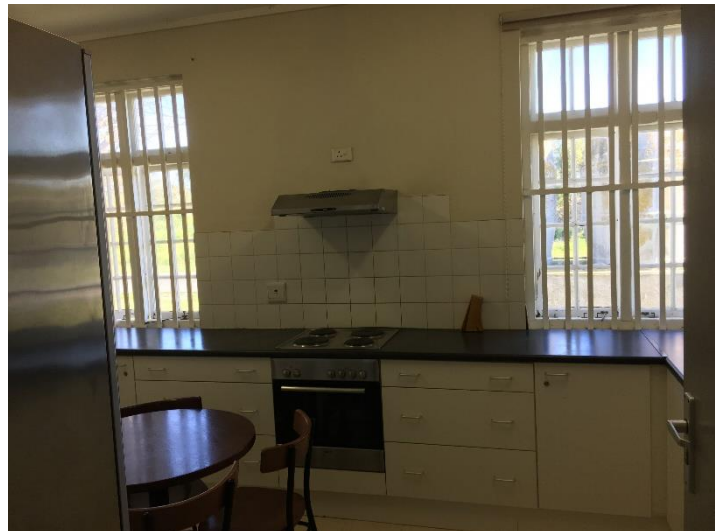
Additional socket outlets in kitchens to be provided – existing outlets are inadequate. Decision by Heritage Architect whether to retain surface mounting or to recess sockets in walls.
