ROOM NO. NORTH WING CORRIDOR P.O.BOX 37188 OVERPORT DURBAN 4067 TELE : 2097245/6 FAX : 2097247 E-MAIL : seedat@ion.co.za AHMED.SEEDAT-ARCHITECT REG no :3140(S.A.C.A.P)	ROOM NAME - PROJECT: NATAL COMMAND -DILAPIDATION REPORT	SCALE: 1/50	DRWG.No: 21126
	DRAWING TITLE: ROOM AND OFFICE DATA SHEETS	DATE: DEC 2022	PAGE.No: 1

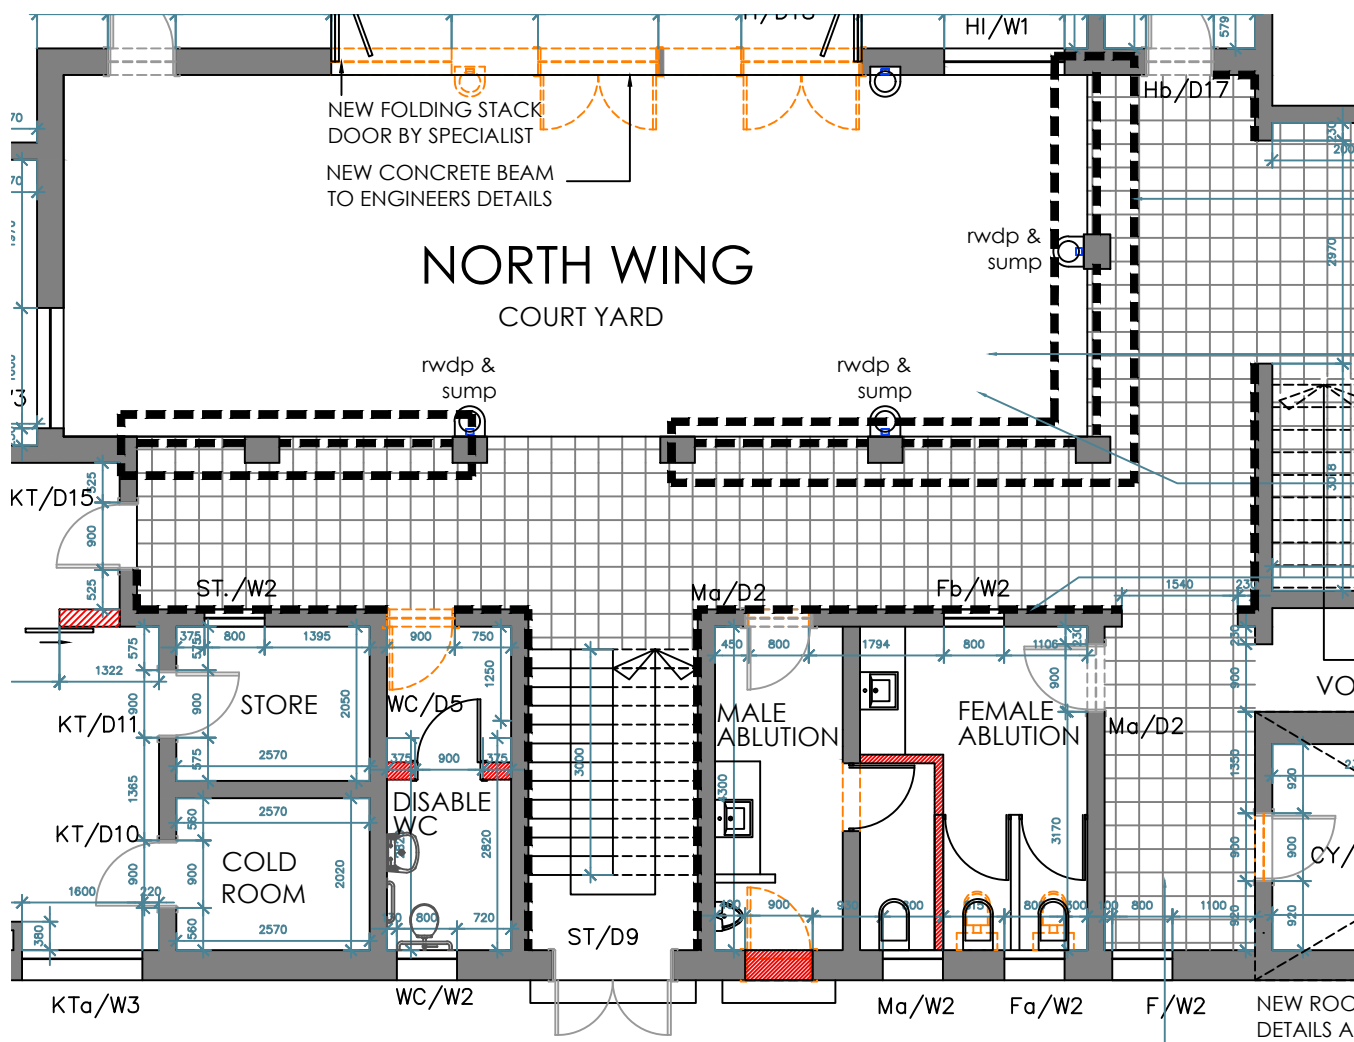
- ex. windows to be removed in its entire, salvaged and stored on site to be reused
- ex. terrazzo floor finish to be pressure cleaned and sealed as per spec.
- existing court yard to be cleared of all landscaping
- ex water damaged 1.4m high timber wall paneling to be removed and replaced with new to match ex.

FLOOR FINISH	• ex. terrazzo floor finish to be pressure cleaned and sealed as per spec. - 129.63m ²
WALL FINISH	• Existing red satin face brick 1.4m above f.f.l to be pressure washed, mortar joints to be filled were required and sealed as per specifications
	Existing plaster & paint above red satin face brick
	- Walls to be scraped, treated, fill all imperfections.
	- Walls to receive new finish as per specifications
CEILING	• - scrape off existing flaking paint, treat and fill all imperfections to receive new finish as per spec.
