CLOSING REPORT: REFURBISHMENT WORK AT THE VISITOR CENTRE, INFORMATION CENTRE AND COMMUNITY HALL

1. BACKGROUND

On 8 January 2019, Robben Island Museum (RIM) received a permit from the South African Heritage Resource Agency (SAHRA) to do refurbishment work on the following buildings:

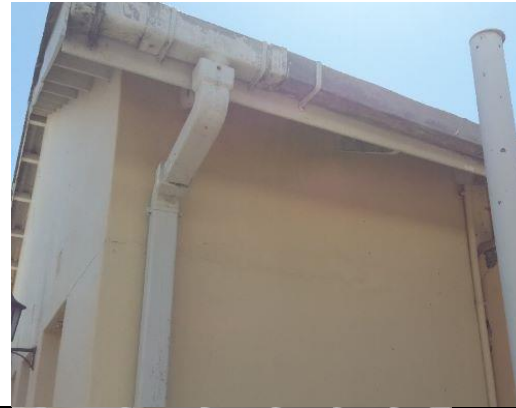
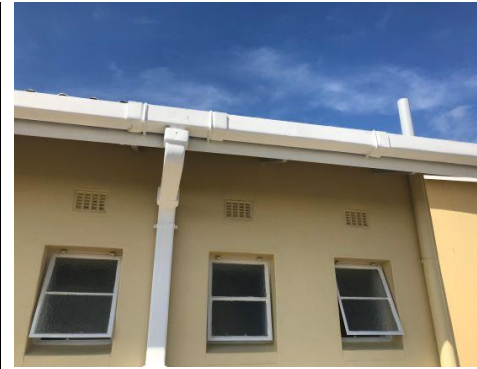
3.5

Sand and paint all gutters and downpipes (all asbestos)

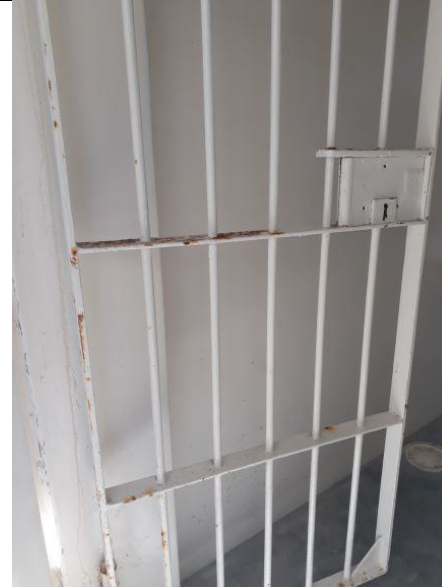
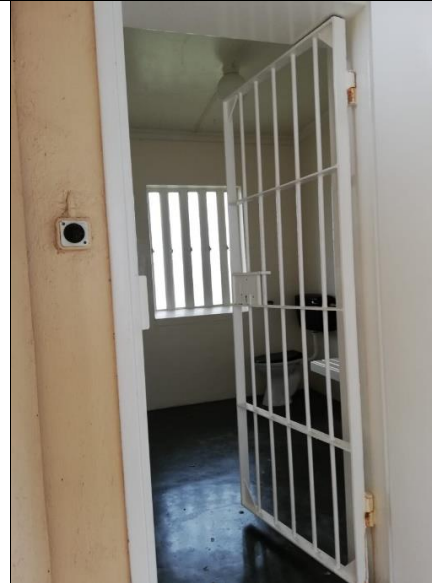
3.6

Prison metal doors to be fixed and painted as per existing

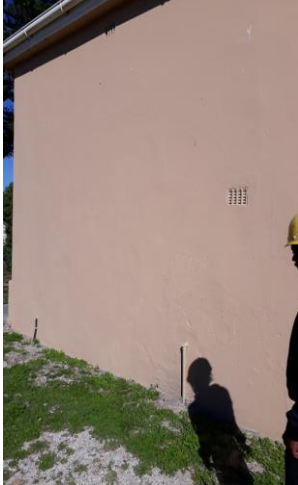
ITEM	DESCRIPTION	IMAGE: BEFORE WORK WAS DONE	IMAGE: AFTER WORK WAS DONE
EXTERIOR			
4.1	Walls Apply one coat primer and two coats finish PVA paint (as per existing)

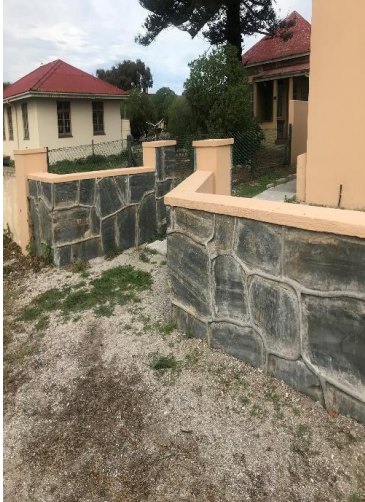
4.2	Boundary wall including pillars Apply one coat primer and two coats finish PVA paint (as per existing)

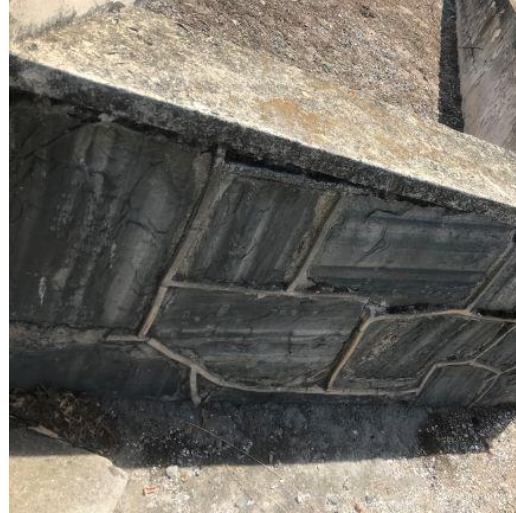
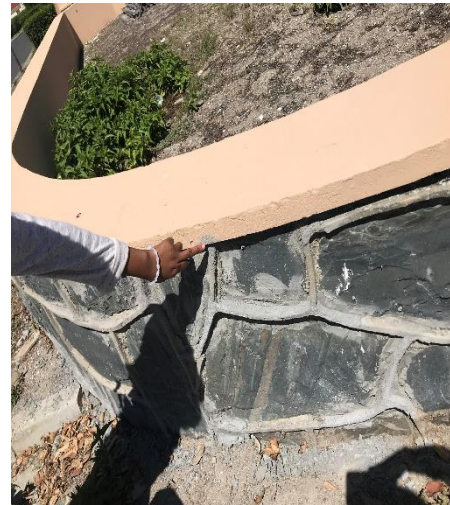
4.11

Refurbish the front facing boundary wall - raised pointing to be restored

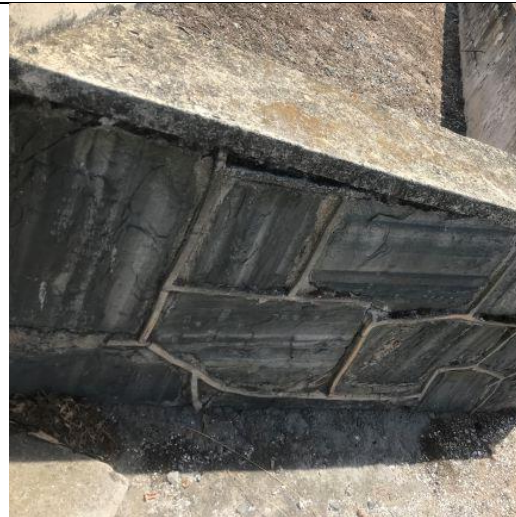
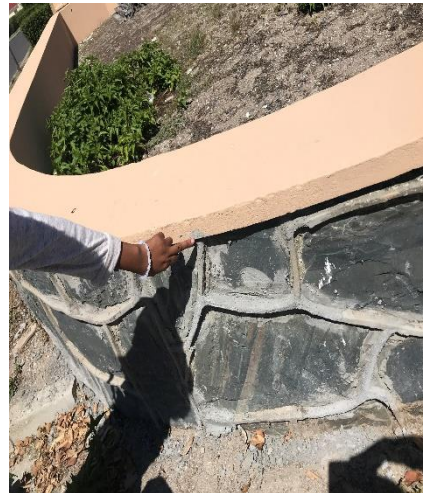
4.12

Repair top wall coping

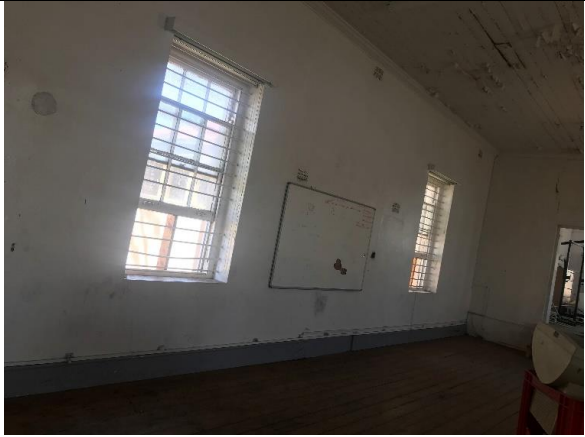
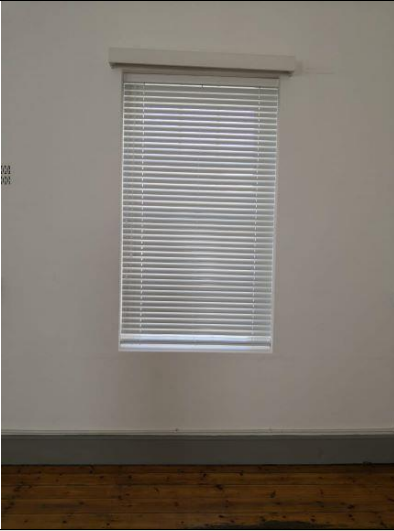
ITEM	DESCRIPTION	IMAGE: BEFORE WORK WAS DONE	IMAGE: AFTER WORK WAS DONE
4.13	<p data-bbox="300 240 427 272">INTERIOR</p> <p data-bbox="300 667 674 805">Walls Apply one coat primer and two coats finish PVA paint (as per existing)</p>

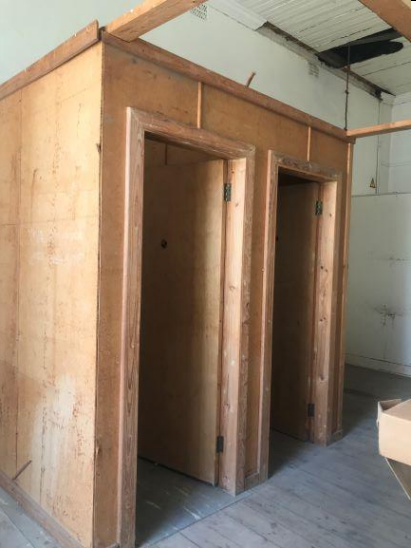
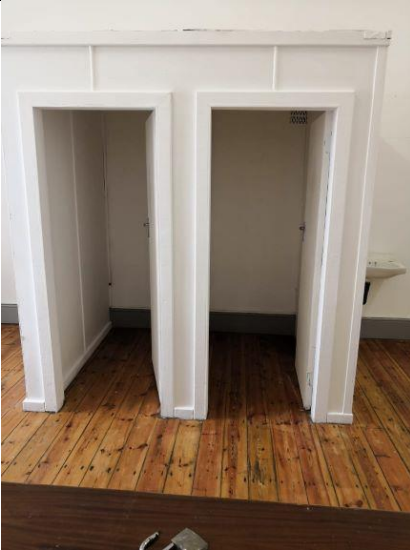
4.14	<p data-bbox="300 1220 674 1359">Partitioning (wooden cubicles) Apply one coat primer and two coats finish PVA paint (as per existing)</p>

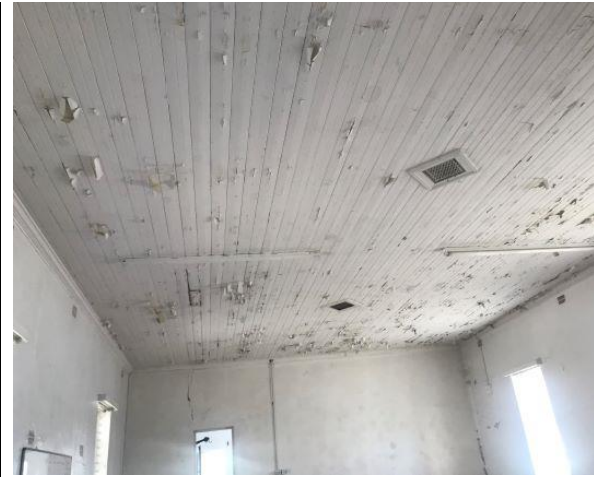
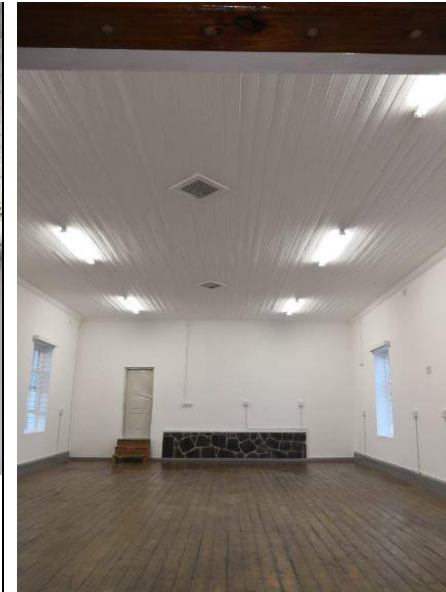
4.15
Ceilings
Apply one coat primer and two coats finish PVA paint (as per existing)

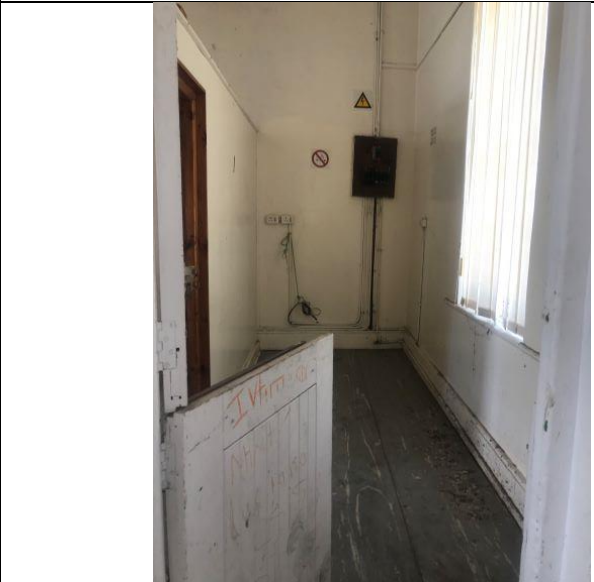
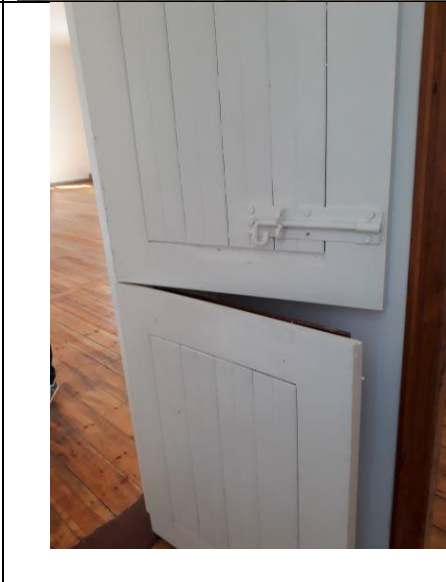
4.16
Stable door
Apply one coat primer and two coats finish PVA paint (as per existing)

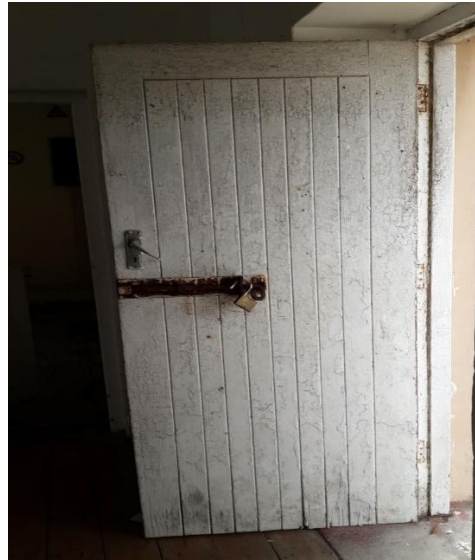
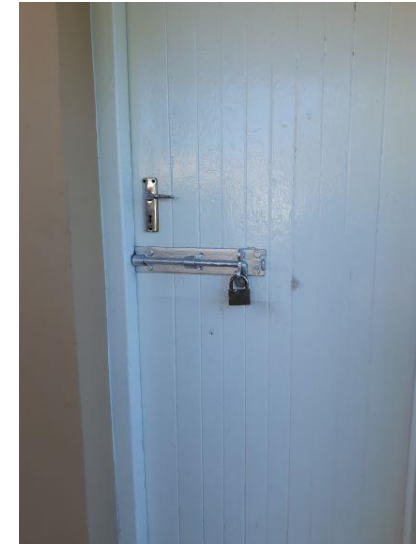
4.17 Front door
Apply one coat primer and two coats finish PVA paint (as per existing)

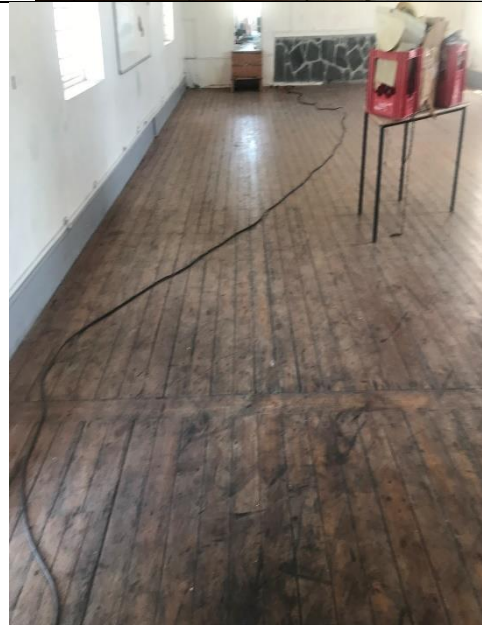
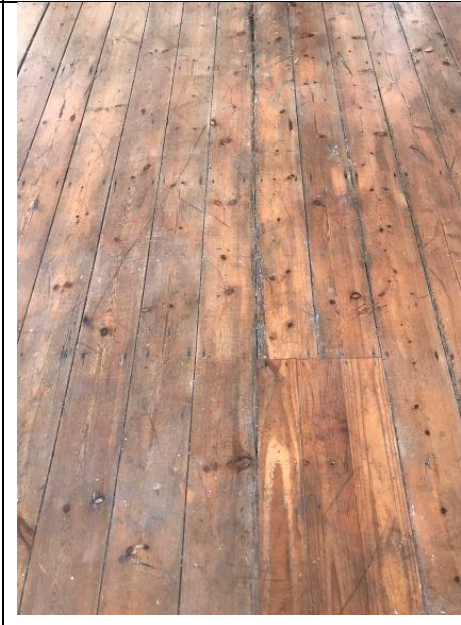
4.18 Floors
Sand and apply two coats of Bournegleem

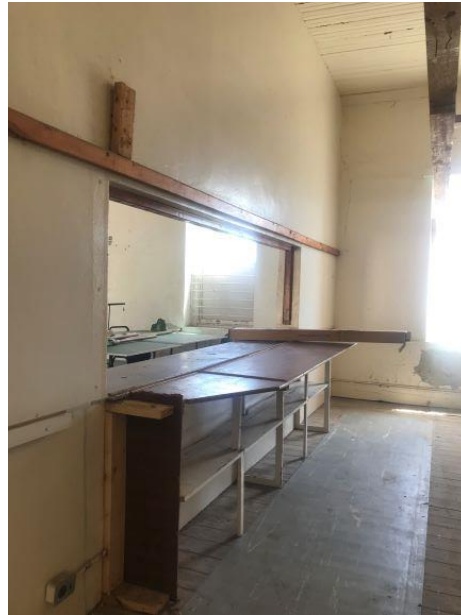
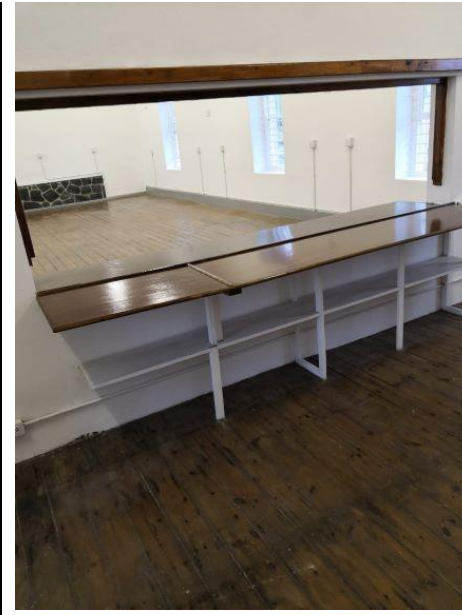
4.19 Sand, prepare and varnish counter top

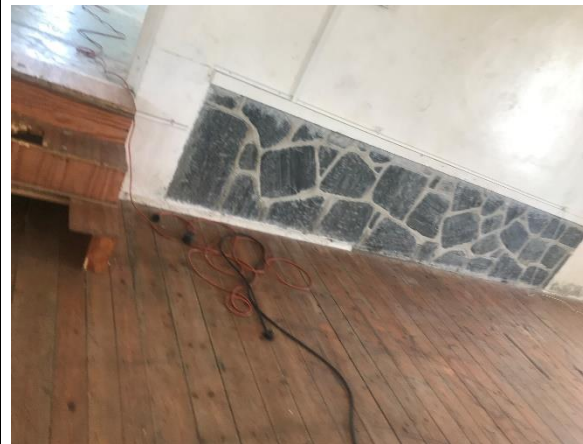
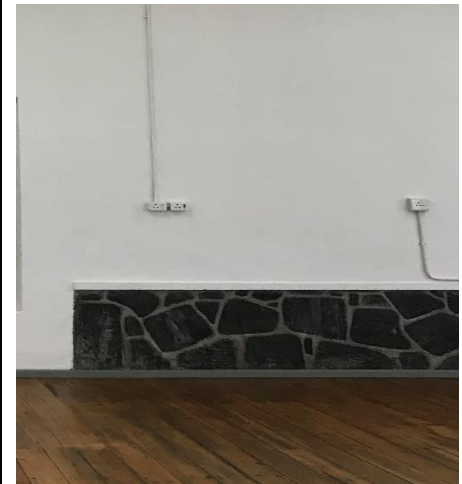
4.20 Seal granite blue stone wall section

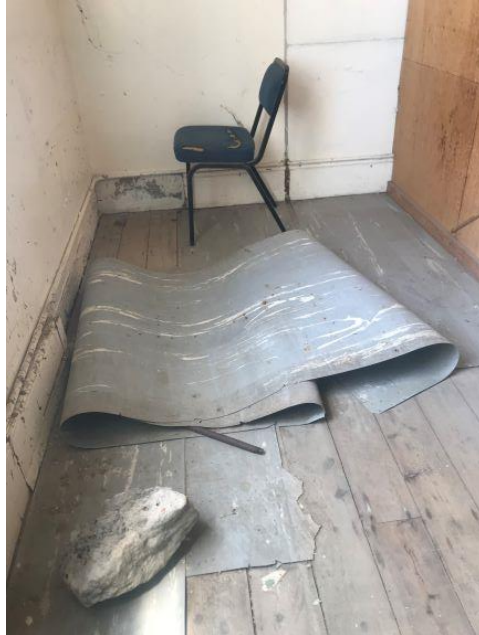
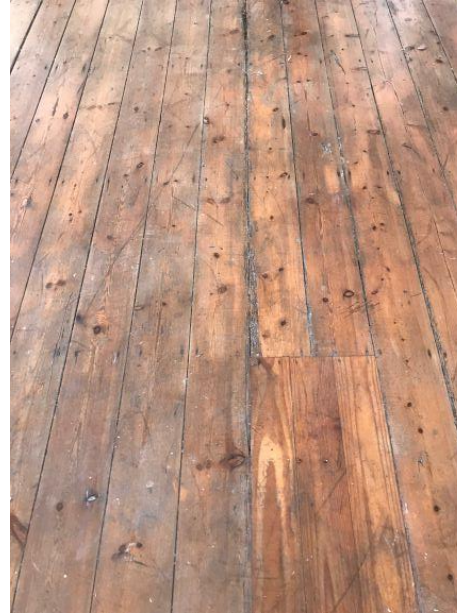
4.21 Remove existing vinyl floor, fix any possible damage underneath, sand and apply two coats bournegleem on the wooden floor beneath

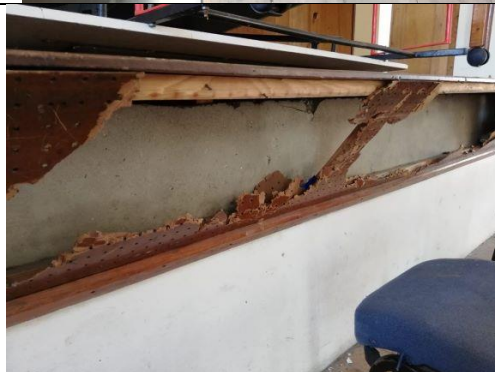
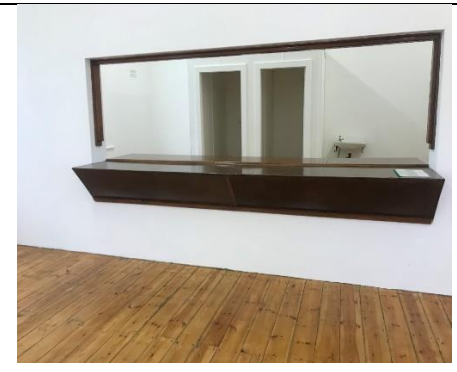
4.22 Replace under counter cover board and varnish

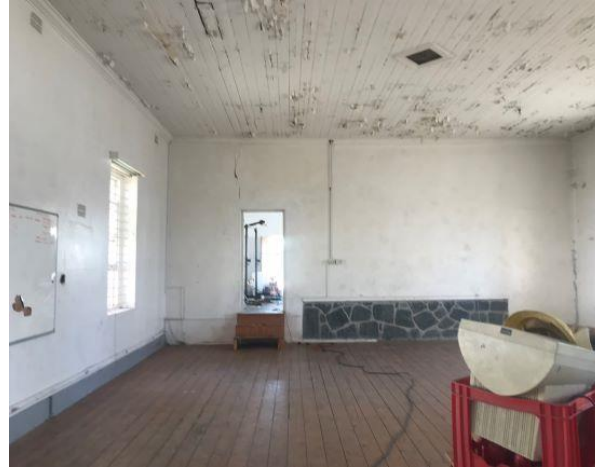
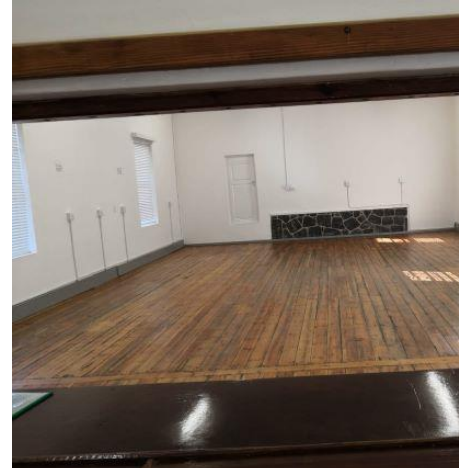
4.23 Fit new solid interleading door including lockset, primer and two coats PVA finish

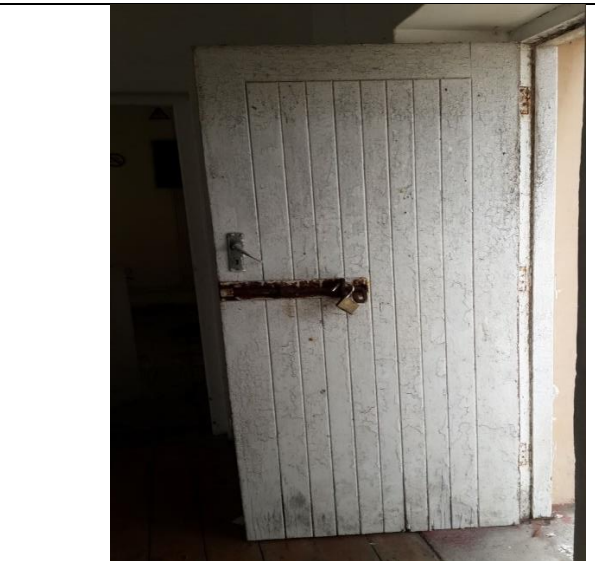
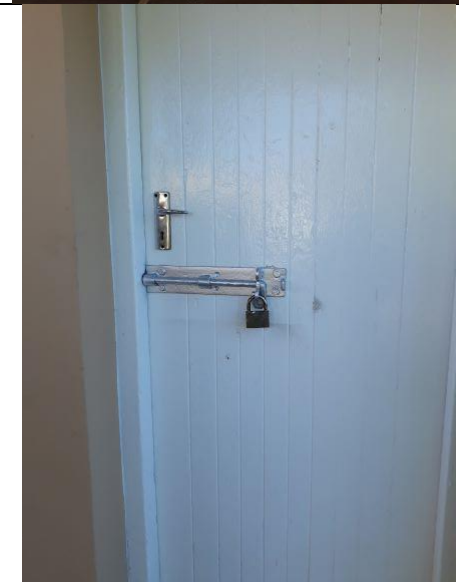
4.24 Refurbish entrance door barrel bolt and make it functional

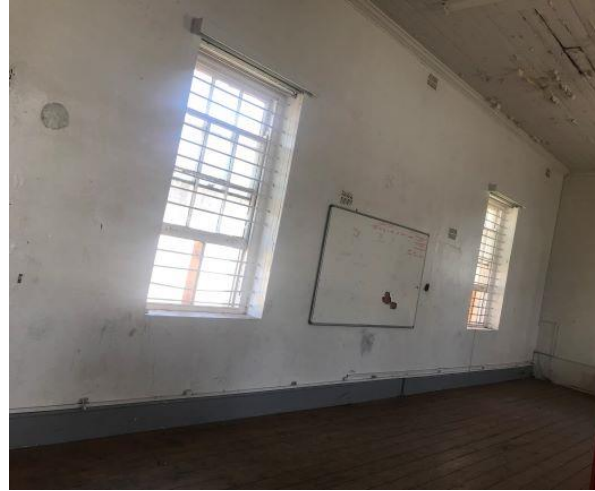
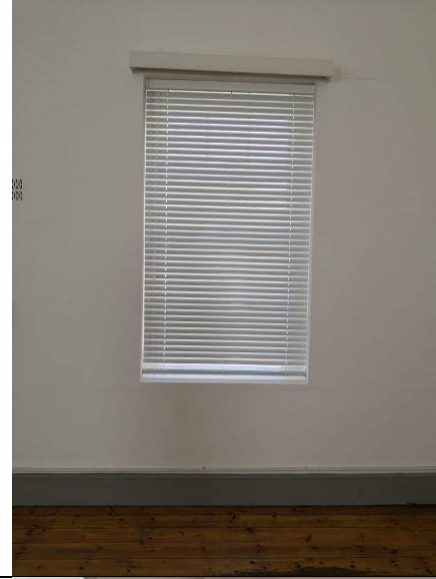
4.25 Supply and fit Venetian 50mm aluminium vane width (white)

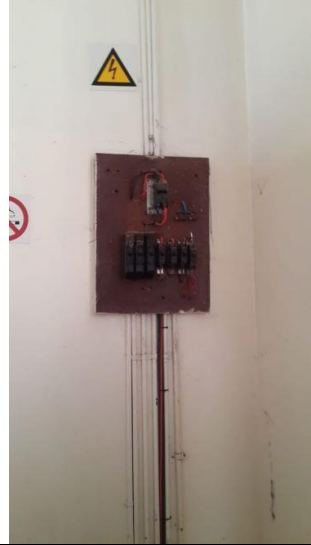
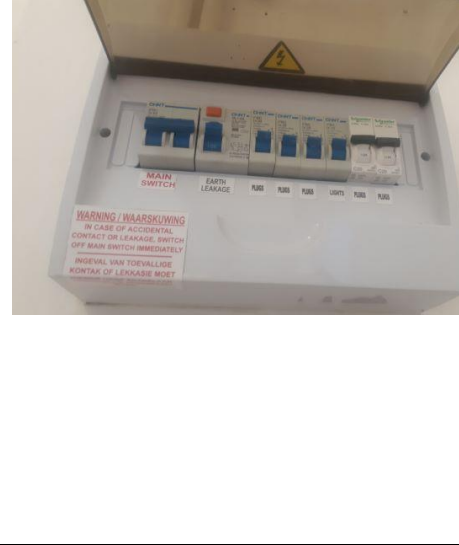
4.26 Revive/restore existing DB board
