*Ref. No. GEOM13-2019-003*

## **ELANDSFONTEIN COLLIERY EXISTING UNDERGROUND WORKINGS SUBSIDENCE INVESTIGATION REPORT**

**DECEMBER 2020**

Report Compiled by:  
**Mr. D. Lees**  
**Senior Rock Engineer**

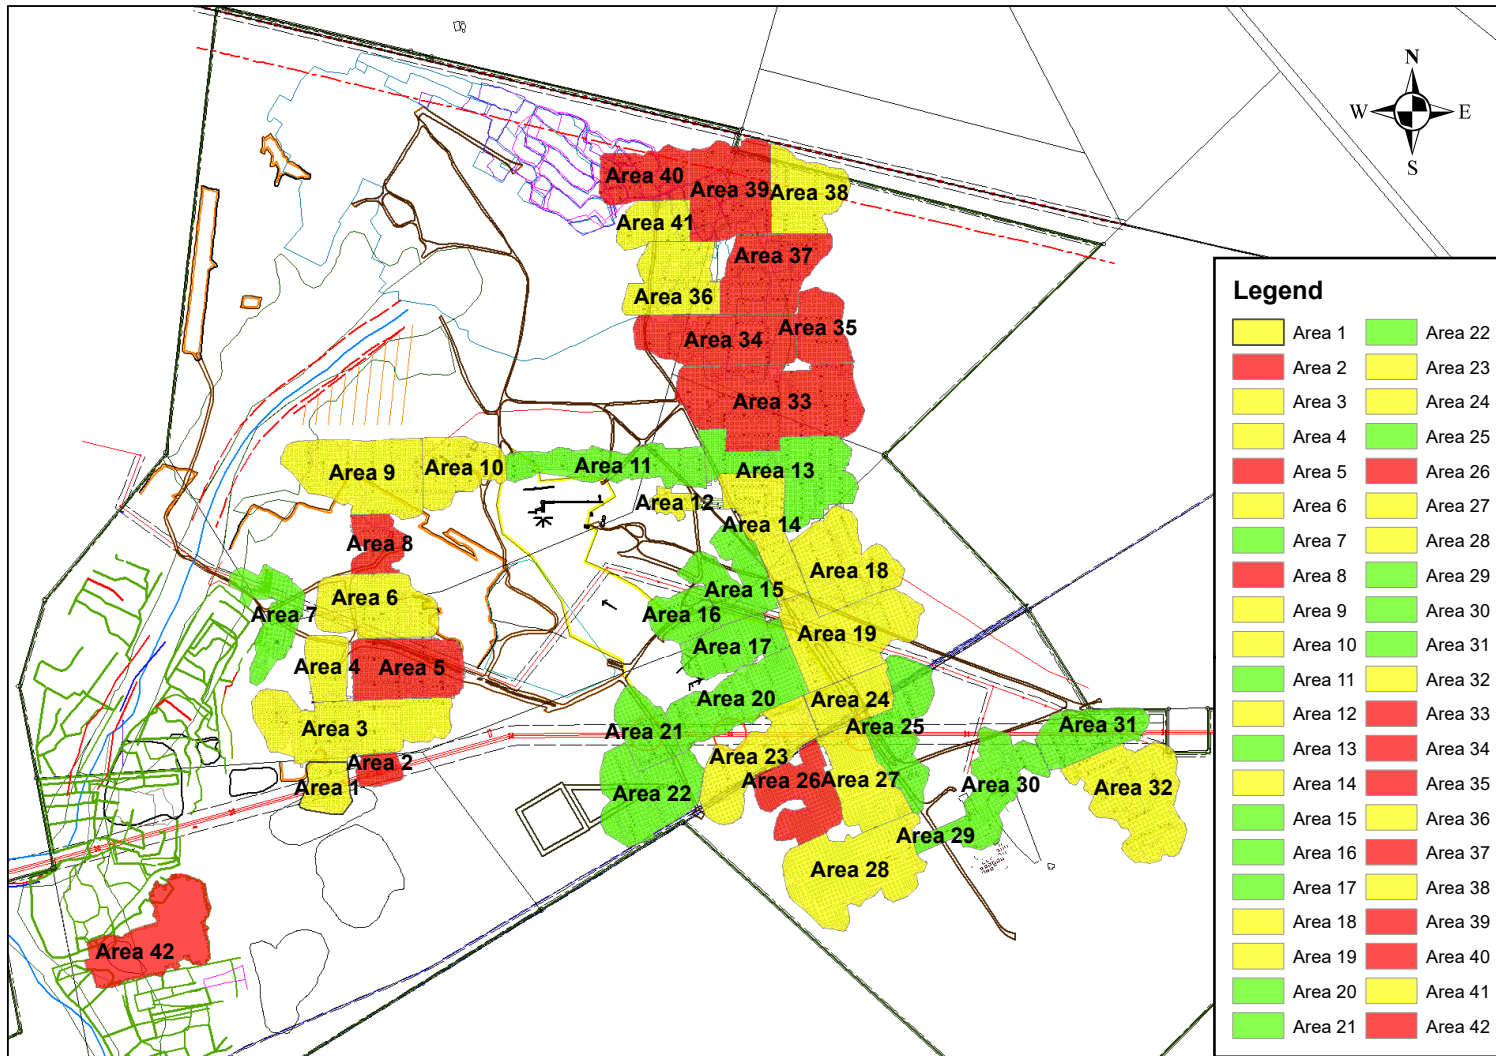
Figure 6 - Illustration of the Calculated Risk Per Investigation Area.

2	Area 2			X	X	X	X	X	5	3	15	Sinkhole formation possible. Eskom pylon on surface
	3	Area 3			X	X	X	X	X	4	3	12	Sinkhole formation possible
	4	Area 4			X	X	X	X	X	4	2	8	Pillar failure possible over time
	5	Area 5			X	X	X	X	X	5	3	15	Sinkhole formation possible. Road on surface
	6	Area 6			X	X	X	X	X	4	2	8	Pillar failure possible over time
	7	Area 7			X	X	X	X	X	5	1	5	
	8	Area 8			X	X	X	X	X	4	4	16	Pillar failure likely over time
	9	Area 9			X	X	X	X	X	4	3	12	Sinkhole formation possible
	10	Area 10			X	X	X	X	X	4	3	12	Sinkhole formation possible
	11	Area 11			X	X	X	X	X	4	1	4	
	12	Area 12			X	X	X	X	X	4	3	12	Sinkhole formation possible
	13	Area 13			X	X	X	X	X	4	1	4	
	14	Area 14			X	X	X	X	X	4	2	8	Pillar failure possible over time
	15	Area 15			X	X	X	X	X	4	1	4	
	16	Area 16			X	X	X	X	X	4	1	4

27	Area 27			X	X	X	X	X	4	2	8	Pillar failure possible over time
	28	Area 28			X	X	X	X	X	4	2	8	Pillar failure possible over time
	29	Area 29			X	X	X	X	X	4	1	4	
	30	Area 30			X	X	X	X	X	4	1	4	
	31	Area 31			X	X	X	X	X	5	1	5	Eskom pylon on surface
	32	Area 32			X	X	X	X	X	4	2	8	Pillar failure possible over time
	33	Area 33	X		X	X	X	X	4	4	16	Pillar failure likely over time	
	34	Area 34	X		X	X	X	X	4	4	16	Pillar failure likely over time	
	35	Area 35	X		X	X	X	X	4	4	16	Pillar failure likely over time	
	36	Area 36	X		X	X	X	X	4	2	8	Pillar failure possible over time	
	37	Area 37	X		X	X	X	X	4	4	16	Pillar failure and sinkhole formation possible over time	
38	Area 38	X	X	X	X	X	5	2	10	Pillar failure possible over time. Railway line next to area on surface			
39	Area 39	X	X	X	X	X	5	4	20	Pillar failure likely over time. Railway line next to area on surface			
40	Area 40	X	X	X	X	X	4	4	16	Pillar failure likely over time

- Taking into consideration the findings of the above investigations, a risk assessment has been conducted to identify the areas which are most at risk when it comes to pillar failure, surface subsidence and sinkhole formation in the short to medium term. These areas have been illustrated on plan and correlate directly with areas in which the pillars have been found to have low safety factors / width-to-height ratios; the No. 1 Seam was significantly thick; there is not expected to be a massive Sandstone layer in the No. 1 Seam’s overburden and / or the No. 1 Seam was mined at very shallow depths. A higher risk rating (consequence) has also been applied to areas in which significant infrastructure occurs on surface (i.e. Eskom pylons and / or the railway line) which would be at risk of surface subsidence were to occur / sinkholes were to form.
