ALTERATIONS TO PIETERMARITZBURG STATION FOR THE BUSINESS EXPRESS LOUNGES
SAHRIS Case ID : 1623

DEVIATION :

1. Replacement of ventilation turret over staff toilet block.
Refer to drawing: s282.3-104
2. Retention of existing roof over staff quarters entry.

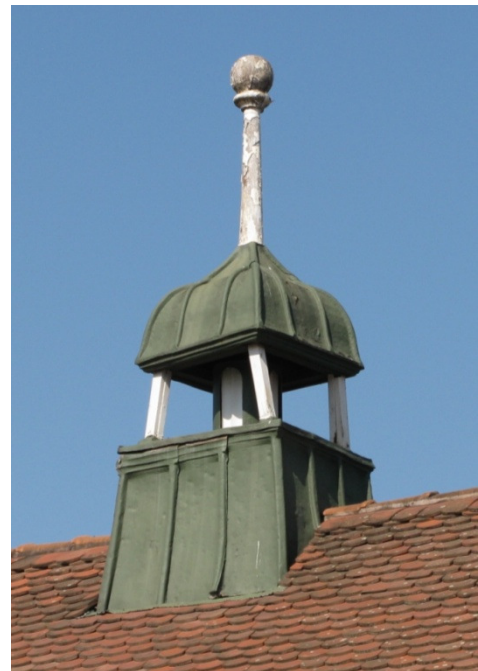
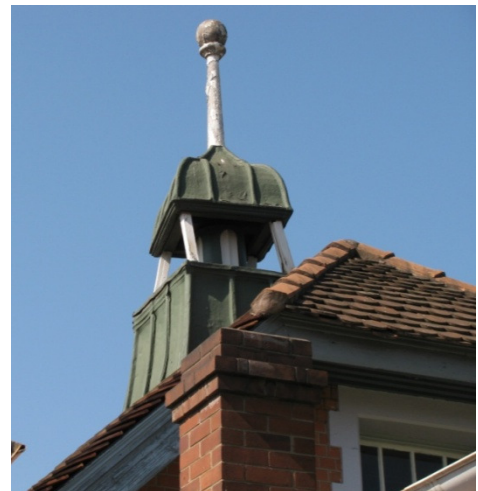
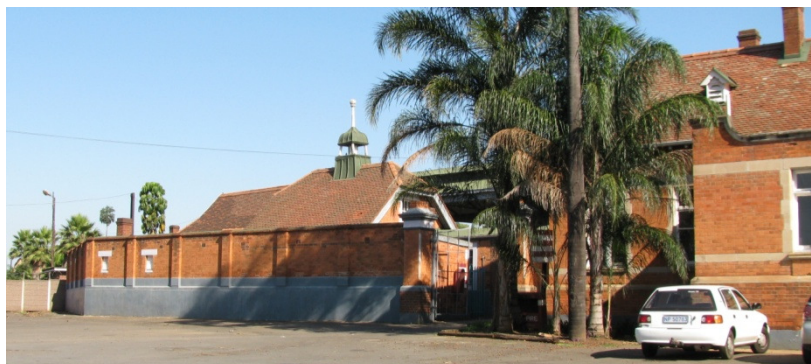
(1.) **The ventilation turret** was inspected both internally and externally and observed that the exposed timbers had disintegrated and were completely rotten at the base. The weight of the lead and steel domed roof had caused it to twist and collapse onto the central ventilator.

Furthermore the lead capping and base of the 4-posts had disintegrated and was no longer water proof. See photos overleaf.

As the instability of the turret now posed a safety hazard, it was decided that the turret should be removed in two parts, which was done by crane. The damage was further assessed and was more extensive than first envisaged.

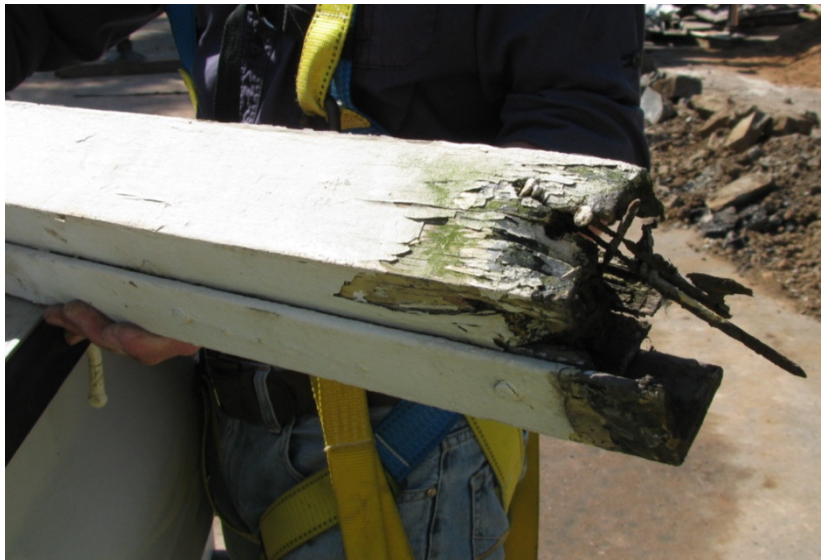
Base of corner post

The most suitable alternative is a fibreglass product. It will be made from a mould from the original and will be a fraction of the weight of the original, therefore not compromising the original roof timbers supporting it. The original steel central ventilator will be retained to form the core and it will stabilise the structure. The costing has been accepted by the client.

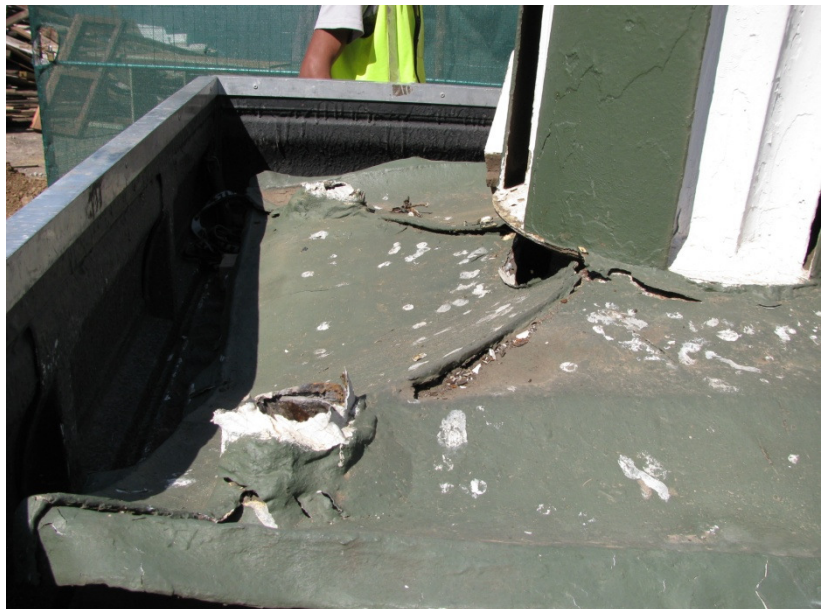
Lead capping and post base

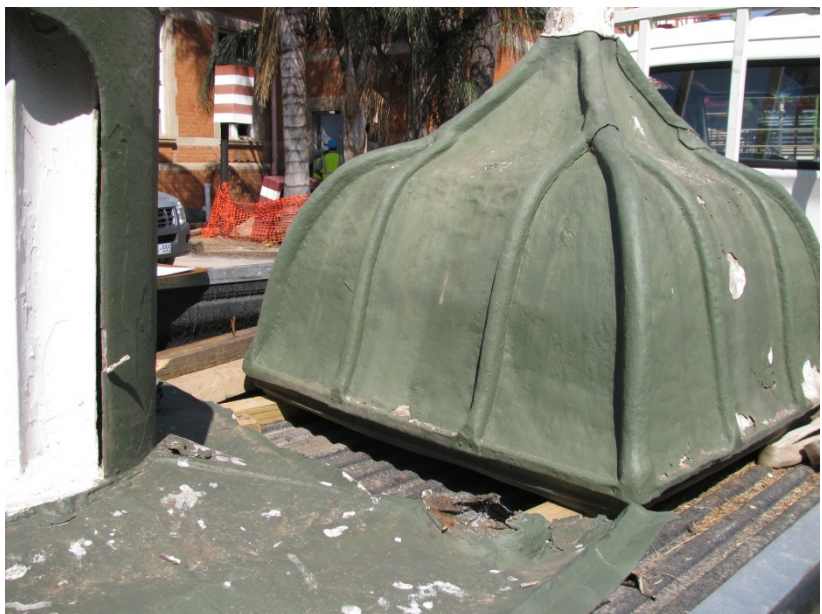
Domed roof and ventilator in
Foreground.

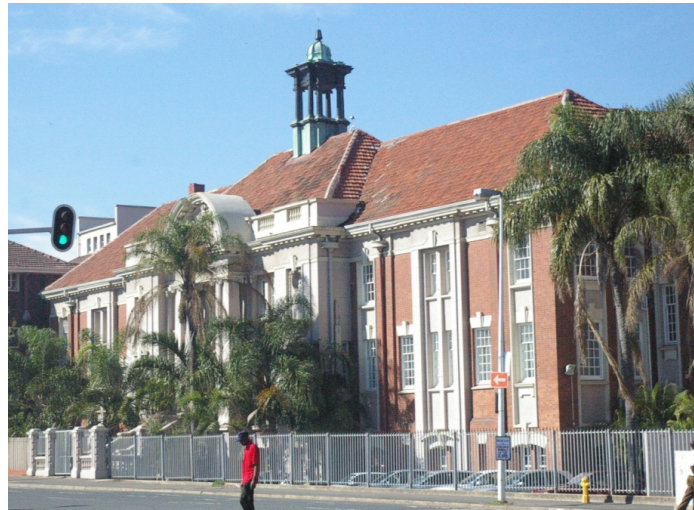
Reference is made to the Durban University of Technology Smith Street Campus where a similar situation arose. Due to budget constraints and practicalities of project the turret was replaced in fibreglass. The roof was able to be restored within the budget, which would not have been possible if the turret were reconstructed. The architects for the project have informed us that it has performed well in the 3-year period it has been in place.

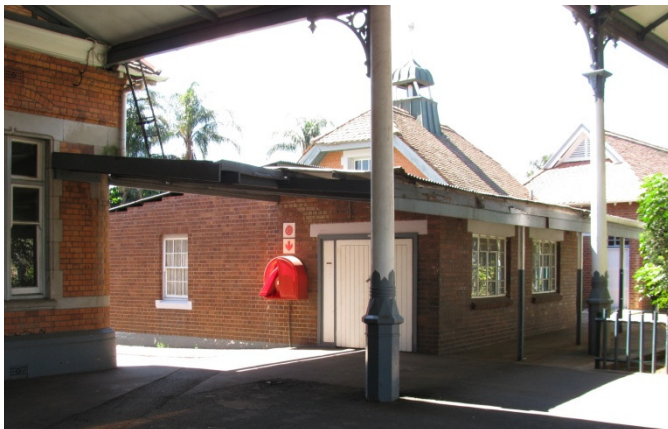
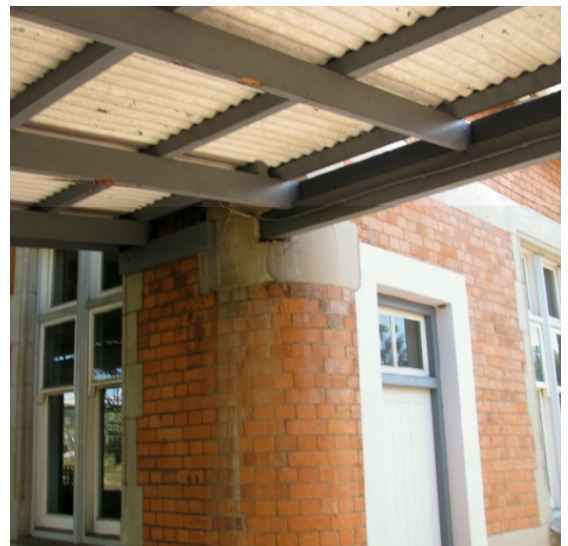
(2.) Retention of existing roof over staff quarters entry :

The client has requested that the roof over the staff entry door not be removed as recommended in the specification. This roof was an addition to offer protection from weather to the double door entrance off the Lane and platforms.
