Evangelical Lutheran Church Complex

Martin Melck House, 96 Strand Street, Cape Town

Cellar Renovations – 2nd May to 14th August 2019

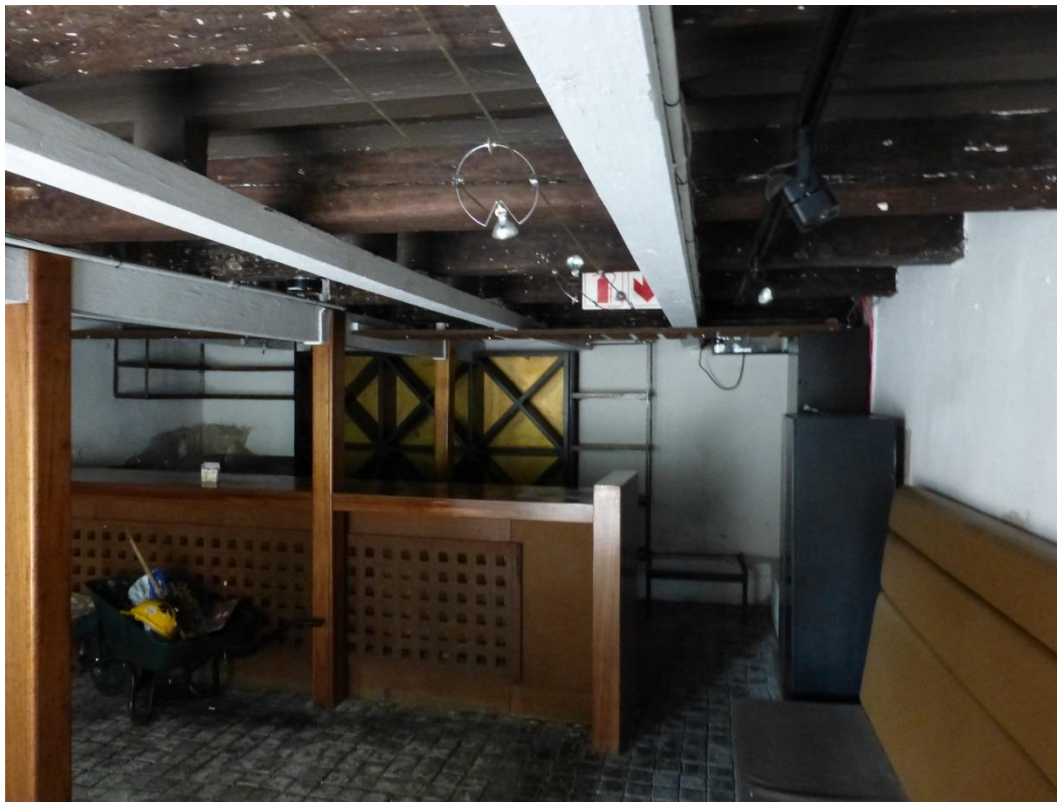
1.2 The property had been tenanted by The Gold of Africa Museum and then The Nelson Mandela Museum from 1 January 2000 to 31 December 2017 during which time the cellar was used as a coffee shop, bar and storage area. During the period of these leases, the cellar continued to have major problems with rising damp during the winter months and, on a number of occasions, had standing water 100mm above the level of the cellar floor. Despite an overhaul of the sump and automated pump, the problem continued to occur and was never fully investigated to determine the best methodology to address the persistent rising damp issue.

The cellar area in Martin Melck House, 96 Strand Street, Cape Town. Note the cobbled floor is showing signs of dampness and the quality of the furniture and fittings is poor.

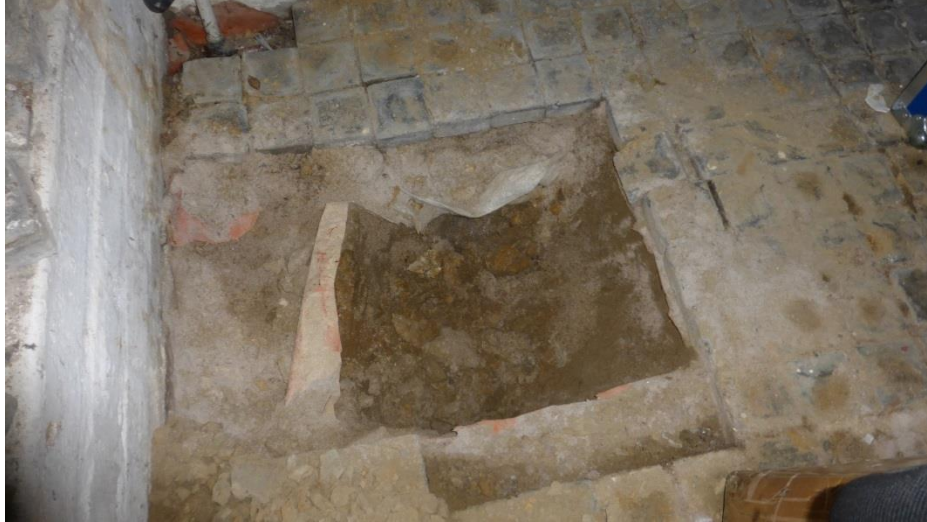
2.4.1 The loose cobbles were removed and DPM sheeting with a number of large holes was found underneath the cobbles.

Cellar floor with loose cobbles removed showing DPM sheeting and underlying clay and stone.

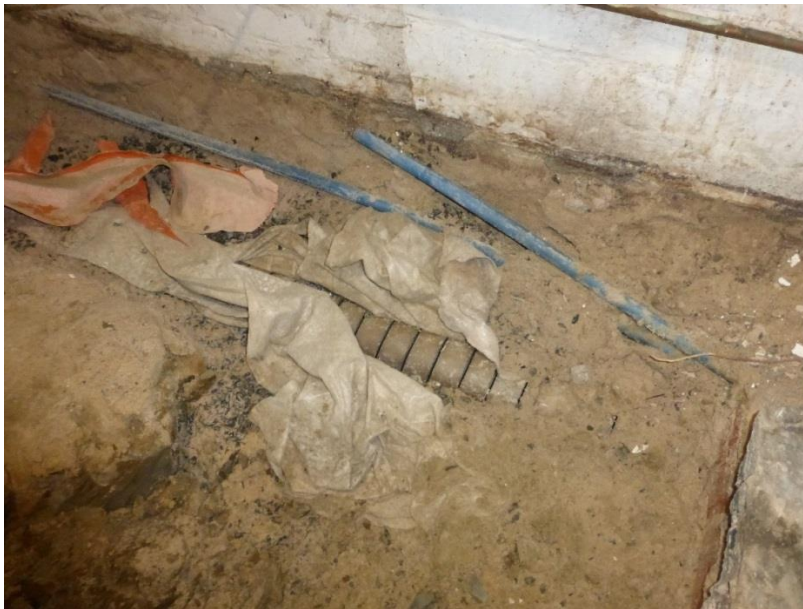
2.4.3 The floor was then excavated down to the level of the previous excavation and revealed that the original agricultural drain had been laid along the western wall, was of poor design, it had been covered with gravel of a very small particle size which had not allowed for proper seepage, the waterproof membrane did not cover the entire floor area and this had then been covered with the previously excavated material which was predominantly clay and small rocks.

Cellar floor excavated down to reveal previous agricultural drain, small gravel and waterproofing along the eastern wall.

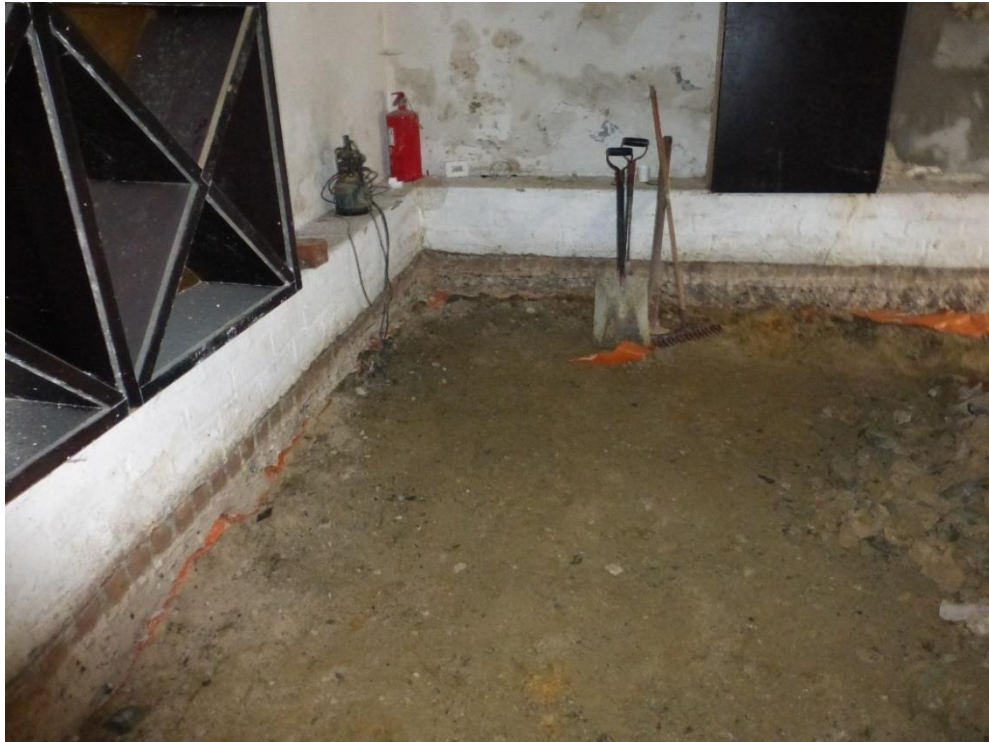
South western corner of the cellar excavated down to the previously excavated level. The base layer is predominately clay with some small rocks.

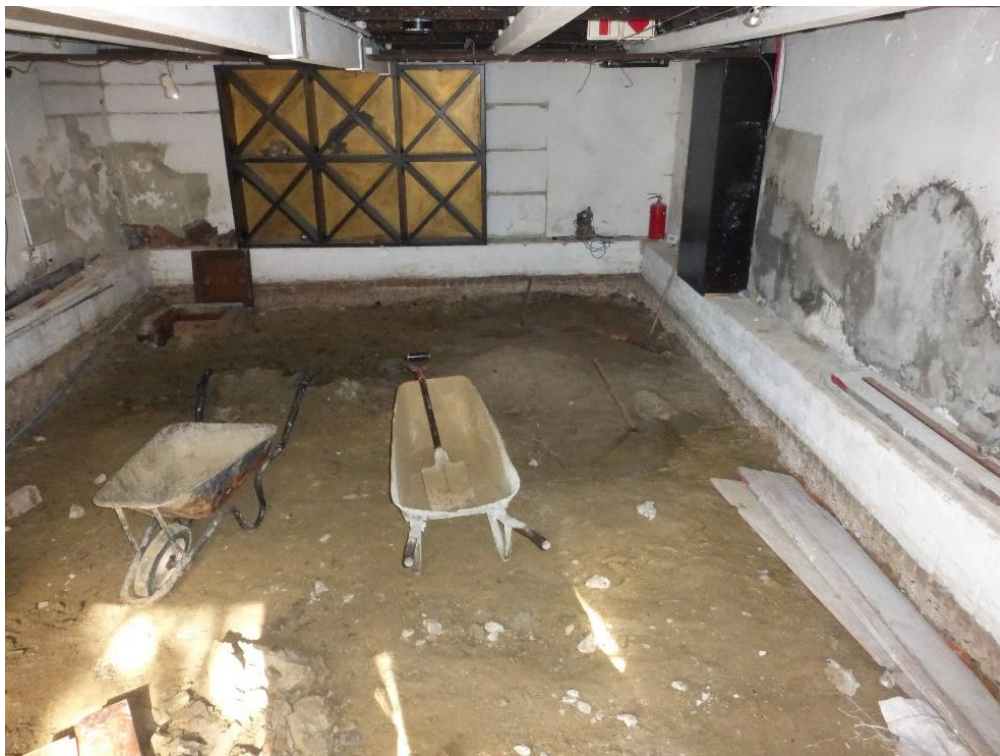
The sump is visible in the top left corner of the picture (south eastern corner of the cellar). Note the numerous previous repairs to the walls using a cementous mixture.

4.1 The majority of the plaster on the internal walls was of a cementous mixture with numerous cracks and areas of dampness evident.

4.2 The cracks were raked out to a depth of 15mm and filled with a light weight sand and cement mixture. The whole wall surface was brushed down and then treated with a plaster primer before being painted with a standard Plascon acrylic paint.

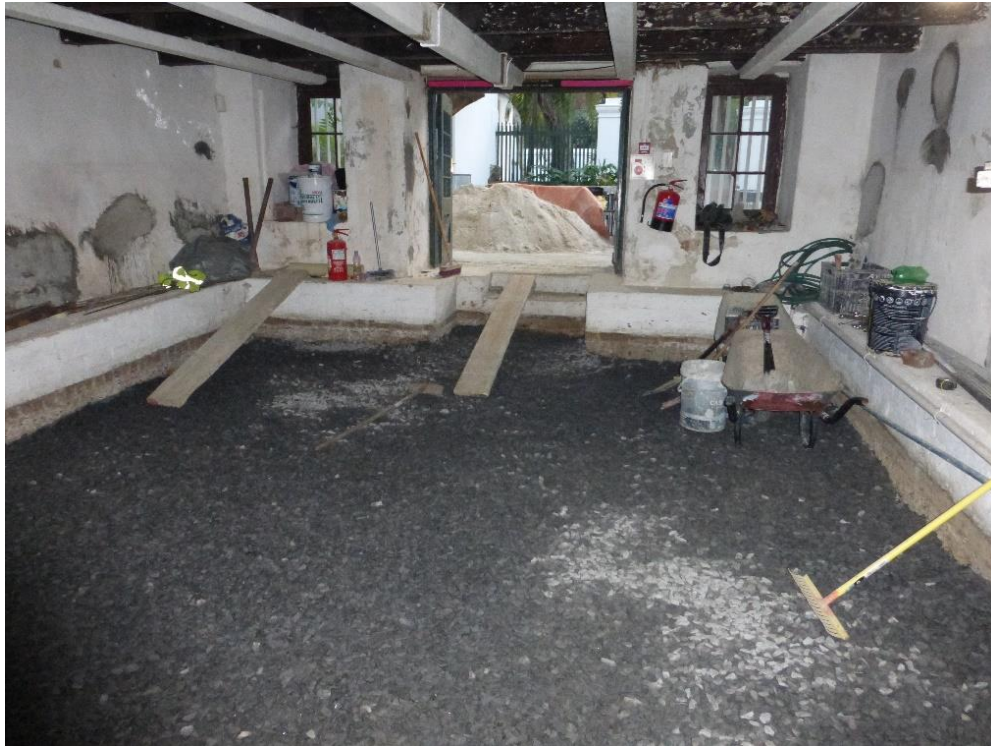
The agricultural drain covered with bidim material being covered with 19mm aggregate looking to the entrance door in the north of the cellar.

- 3.1.1 Bidim A2 fabric was laid on the floor. The new 110mm agricultural drain was laid in the centre of the floor from the northern doorway to the southern wall and the pipe had a 90° bend fitted at the southern end of the pipe to allow it to drain into the sump. As per the approved plans, the drain was wrapped in bidim filter fabric and then had a layer of 19mm aggregate evenly spread over the filter fabric to a depth of 150mm.

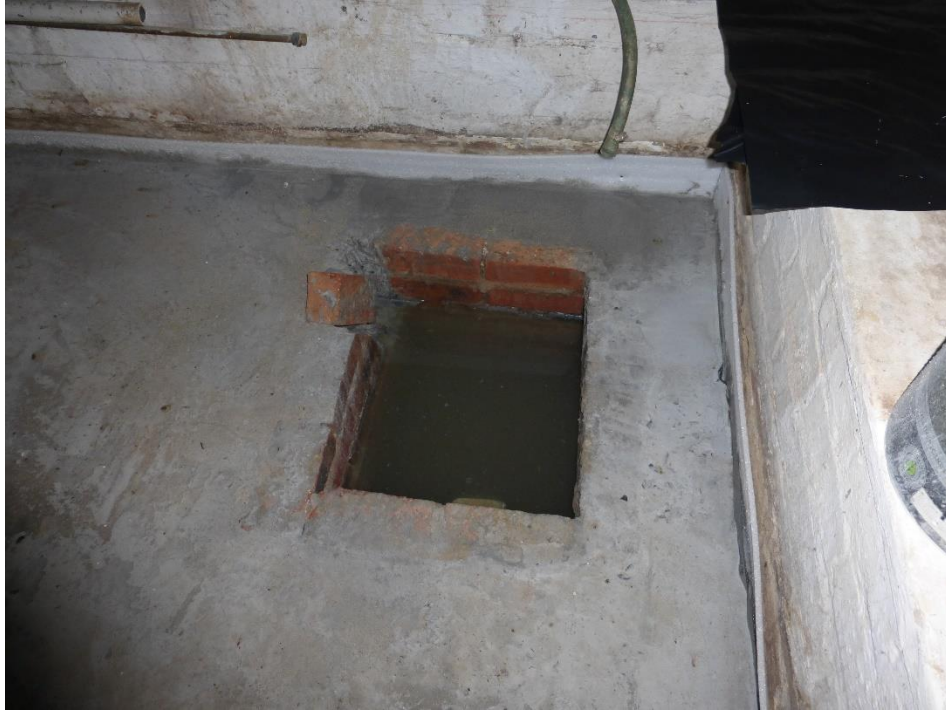
The concrete bed and screed around the sump in the south eastern corner of the cellar showing the 12mm jointex at the walls as per the approved plans. Note the sump has a significant amount of water in it.

- 3.1.2 A 375 micron polyethylene BDM was then placed over the aggregate and a 75mm concrete bed was then laid over this.
- 3.1.3 Once the 75mm bed had hardened, a 35mm screed was laid on top to finish off the basic flooring.

4.3 A new pipe was laid from the automated sump pump to the external drain in the courtyard and checked for correct operation.

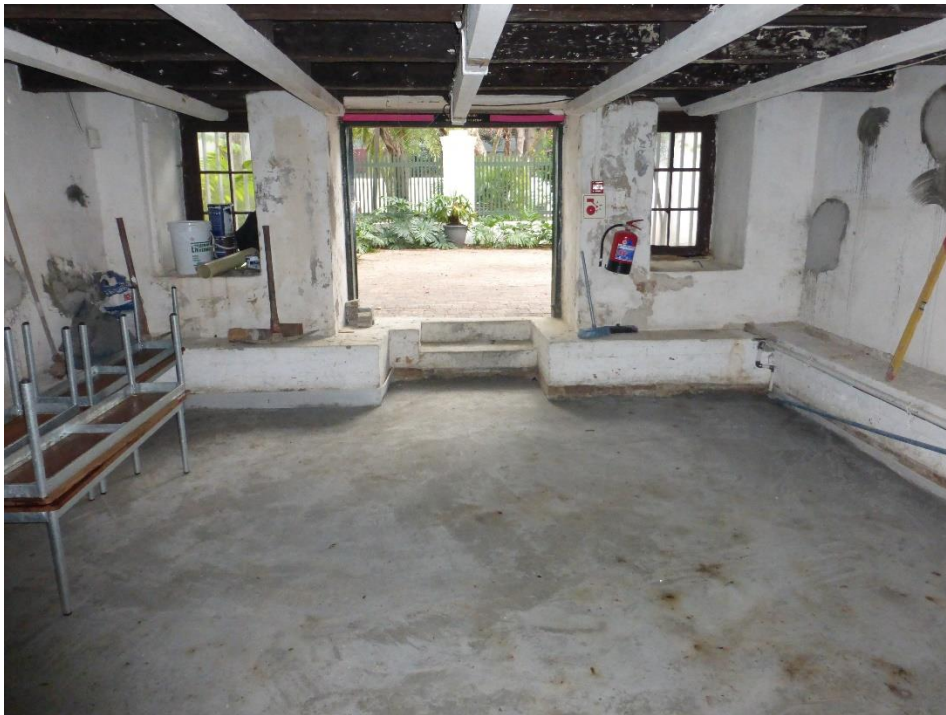
The concrete floor showing the existing door and steps at the northern wall

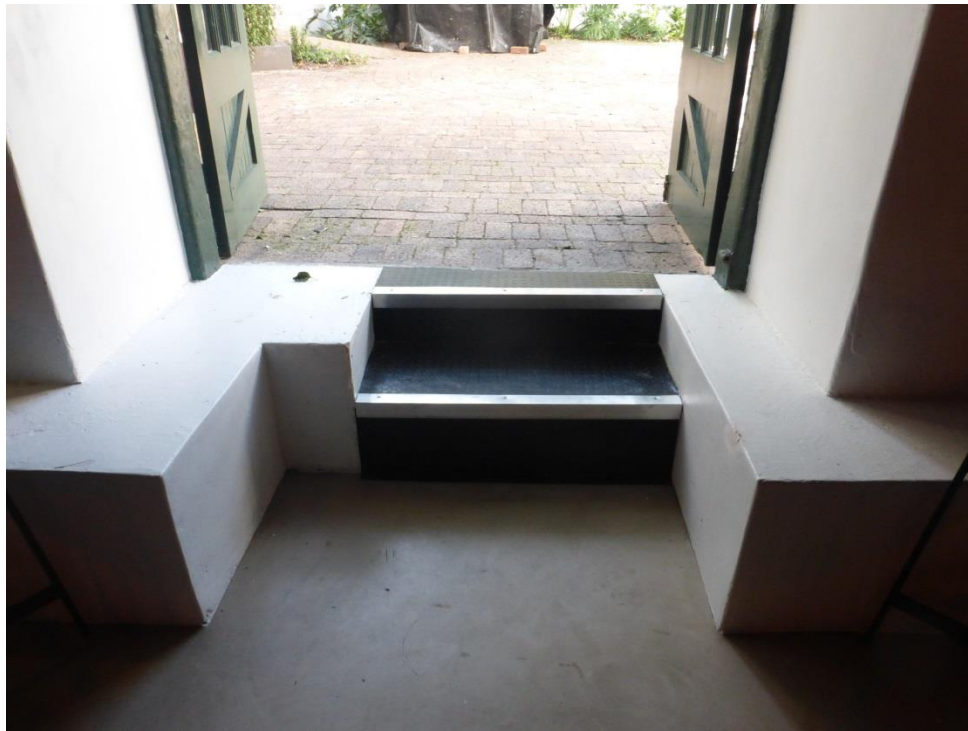
The entrance door and step in the northern cellar wall showing the polished and sealed concrete flooring.

4.5 The concrete floor was then polished and sealed.

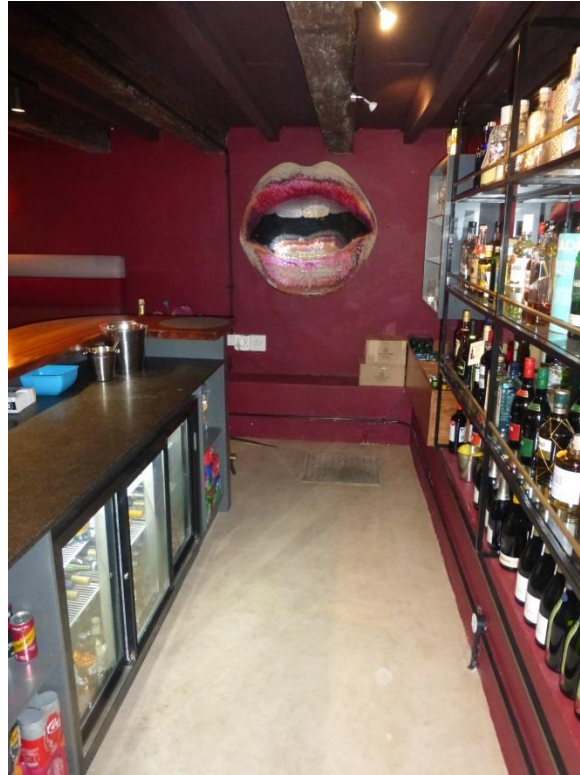
The behind bar area with the southern wall on the right. The bar is free standing. Note the sump cover in the upper part of the picture.

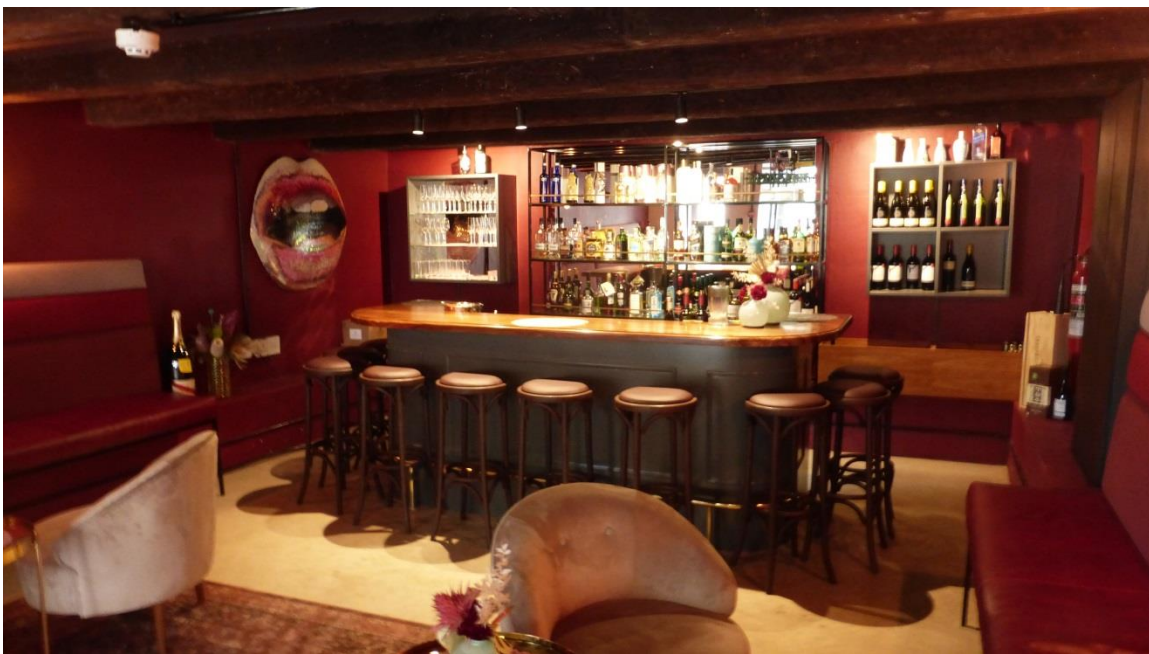
View from the entrance looking towards the southern cellar wall showing the bar area. The quality of the work and the fittings are of a very high standard.

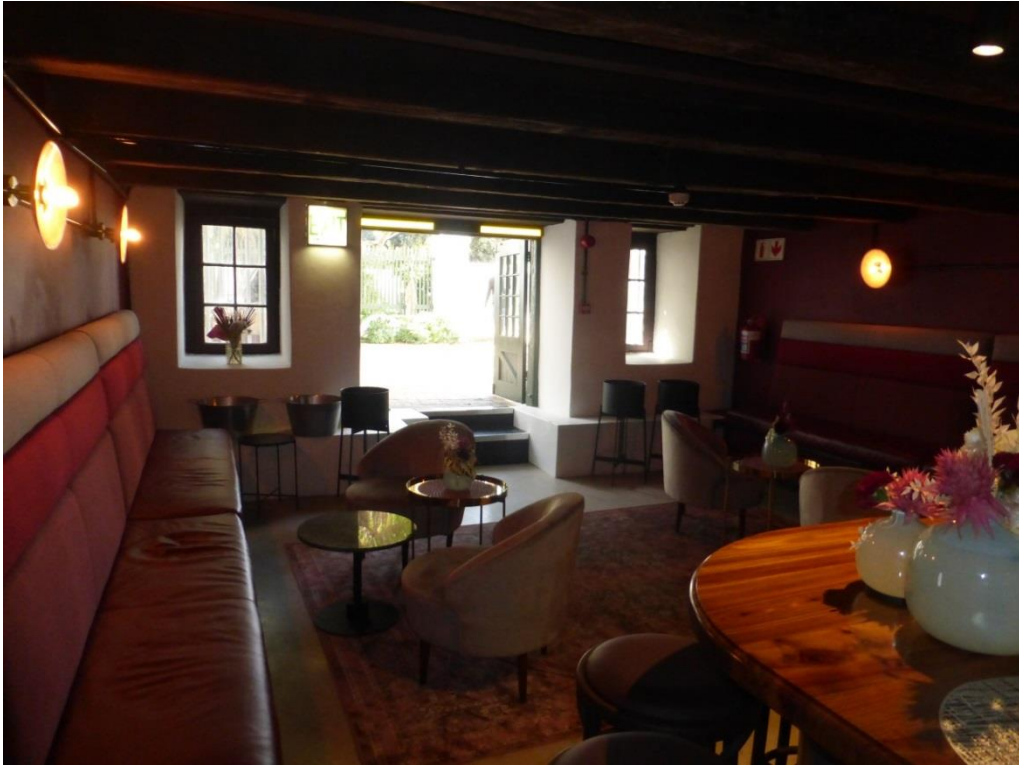
The renovated cellar looking from the southern cellar wall towards the northern entrance.
