Close-out report for the interior renovation to the west wing of the Old Fort Warder rooms at Constitution Hill, Johannesburg. The space is to be used as a meeting and event space.

FOR THE MEETING AND EVENT PROJECT AT THE OLD FORT,
CONSTITUTIONAL HILL, JOHANNESBURG

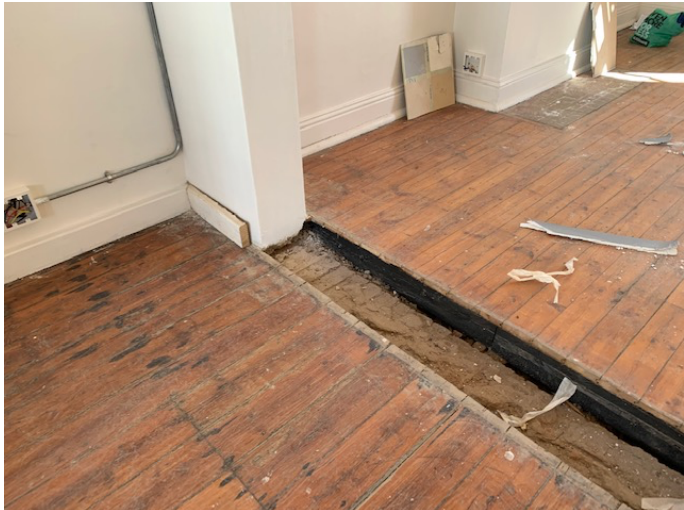
Through the making of an opening within an interior wall two rooms have been joined to form one larger functional space. The new wall opening has been demarcated with exposing the steel bottom face of the structural lintol, the horizontal lines are marked by decorative timber panels and the floor is demarcated with a glass panel in the area where the removed wall was. Please note that the floor had to be slightly raised here in order to achieve a level floor surface. The timber double doors and frame have been removed and stored safely.

Figure 1
Event room floor showing new opening,
during construction.

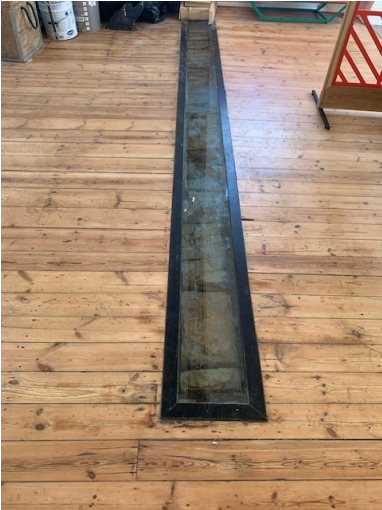
Figure 2
Event room floor with
Glass inset

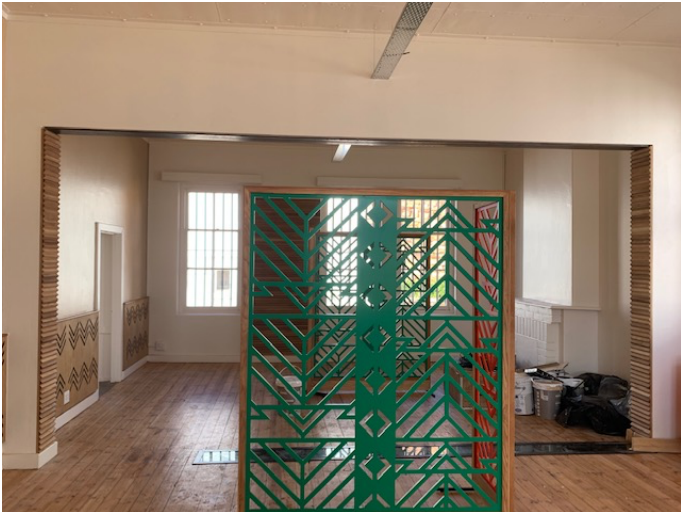
Figure 3
Event room, showing demarcation of new opening.

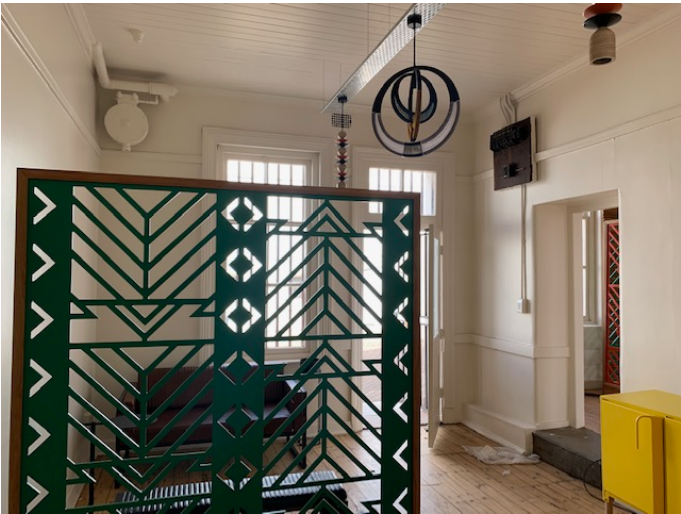
Figure 5
Foyer, showing ceiling.

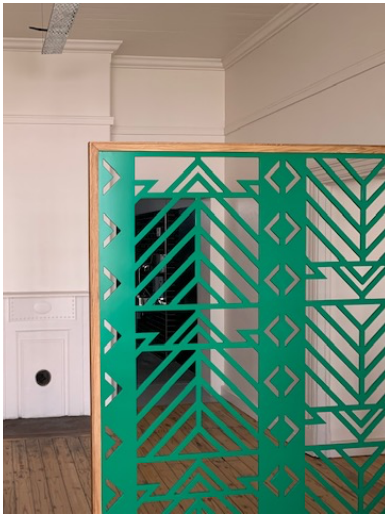
The main item of renovation was to make a new opening to the bathroom. This opening is not marked in anyway. There was no issue with patching the floor here as the bathroom floor is a concrete grano finish. The pressed metal fireplace backdrop has been retained. A new contemporary closed fireplace has been installed in front of this existing pressed metal backdrop. The ability to warm the space using the fireplace reaffirms the contrast between Warder and prison spaces. In order to use the existing flue and to comply with the flue height a new discreet opening has been made into the pressed metal.

Figure 6
Foyer, showing new opening and fireplace.

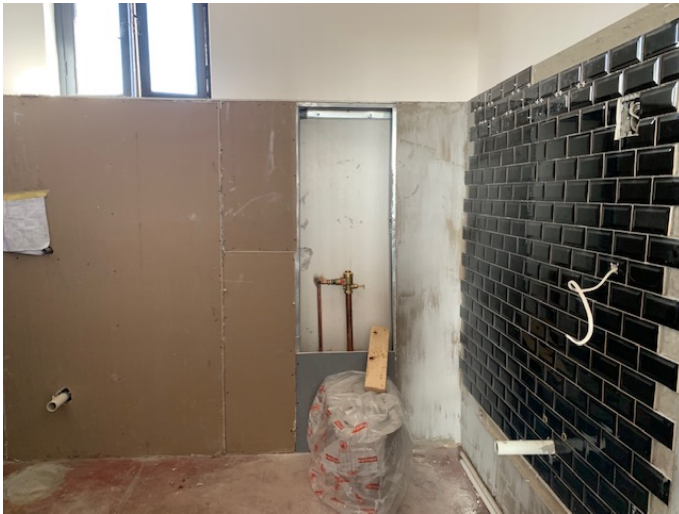
The ablutions have been upgraded as per drawings to allow for a paraplegic bathroom. Tiling was done onto a drywall skin, making it easily reversible in the future.

Figure 7
Tiling onto drywall in the ablutions, during construction.

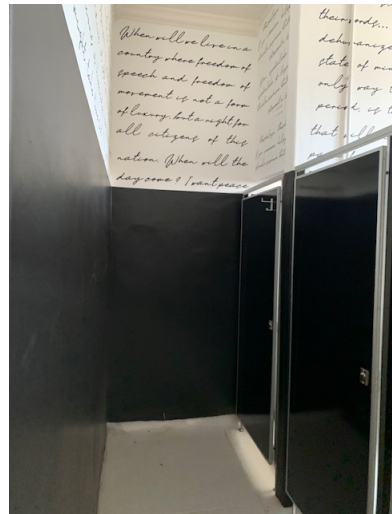
Figure 8
New freestanding panel and door system.

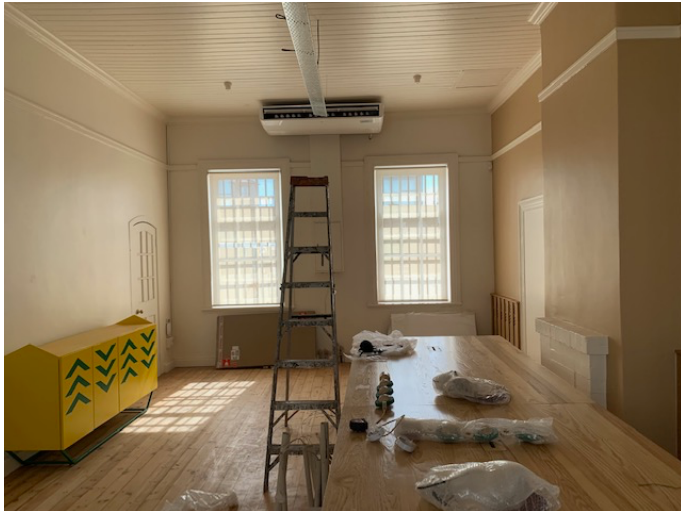
This room was being used as a kitchen. All the kitchen equipment has been removed as have the tiles. The floor was a painted shutterply. This has been removed and replaced with matching salvaged Oregon pine floors. As this is a new floor, three floor electrical points have been installed to allow future flexibility of the space.

Figure 9
Meeting room, showing new
AC and floor points

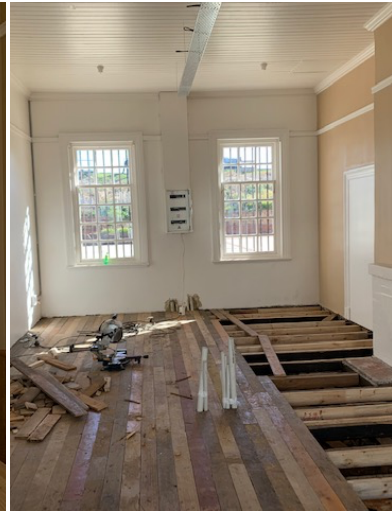
Figure 10
Meeting room, installation of
new timber floor, during
construction.

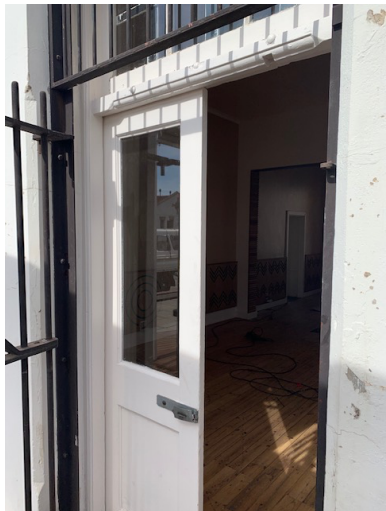
The exterior timber work has been prepared and repainted as part of routine maintenance. Exterior exhibition panels are intended for both the warder rooms and the hospital courtyard. These will follow the Constitution Hill design template as is already configured on site.

Figure 13
Exterior view of newly painted timber door

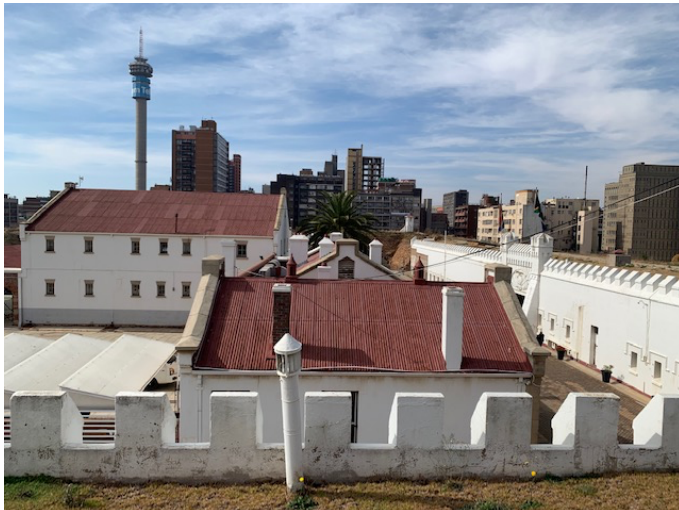
The Refrigerant piping goes through an existing defunct kitchen extraction duct that sits on the roof. The condenser units are placed on the inner face of the North Parapet, which is over a meter tall and conceals the condensers.

Figure 14
Exterior view of roof – showing hidden AC installation

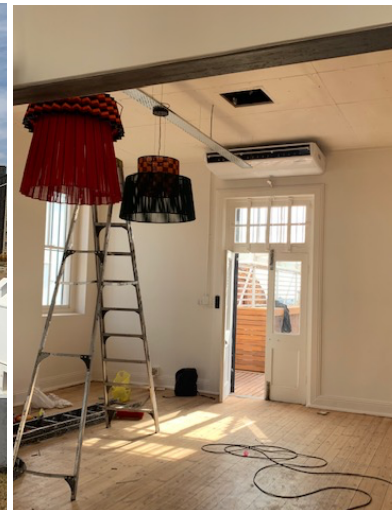
Figure 15
Interior view showing AC installation in events room

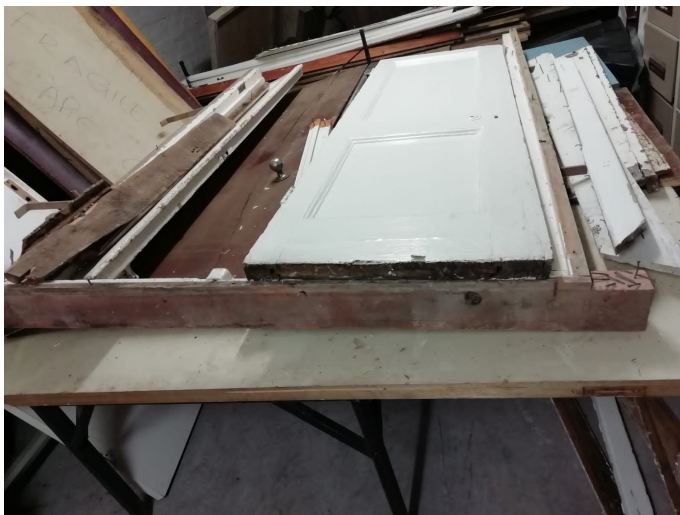
Figure 16
Door that was removed from Event room, stored on site.

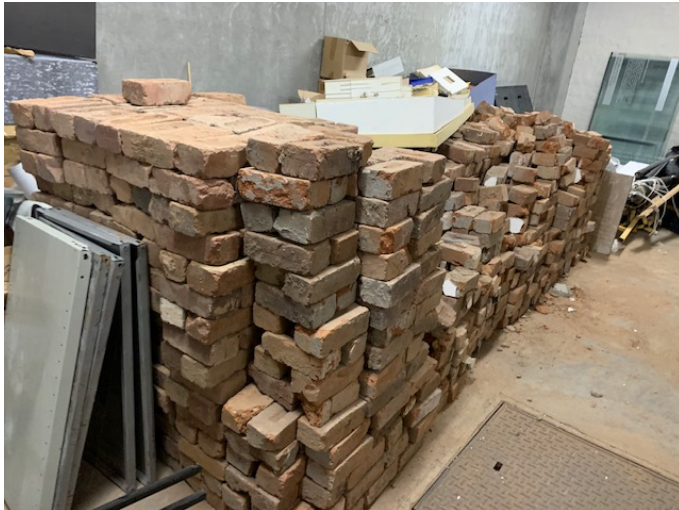
Figure 17
Bricks that were removed from internal walls, stored on site.

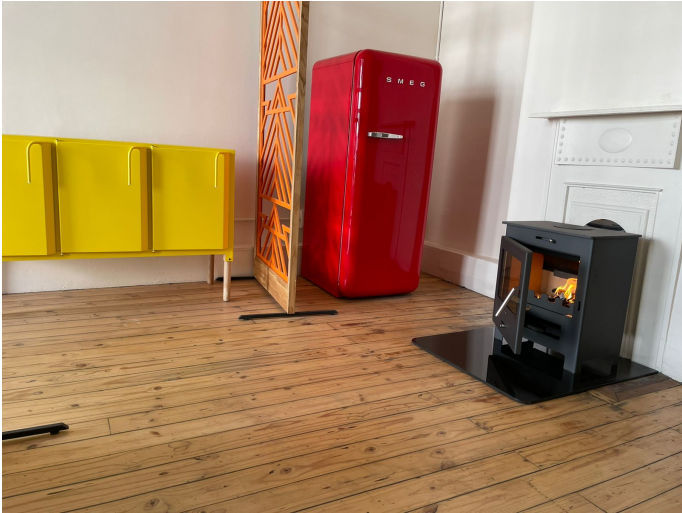
Figure 21
Foyer, looking North-west, new fireplace fitted at original fire surround. Fire place specification: Nero by Hydrofire.co.za, 39.8 x 51.5 x 65cm 150mm flue diameter

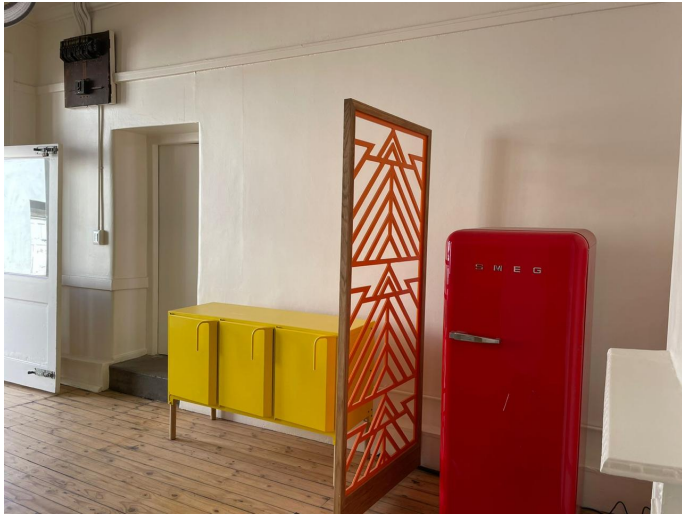
Figure 22
Foyer, looking North-west, new fireplace fitted at original fire surround
